File In Section: Product Recalls
Bulletin No.: 01073
Date: April, 2002

PRODUCT SAFETY RECALL

SUBJECT: 01073 – STOP LAMPS/HAZARD LAMPS INOPERATIVE

MODELS: 2000-2001 CHEVROLET BLAZER AND TRAILBLAZER (CLASSIC); GMC JIMMY AND ENVOY (CLASSIC); AND OLDSMOBILE BRAVADA (CLASSIC)
2002 CHEVROLET BLAZER; GMC JIMMY AND ENVOY (CLASSIC)

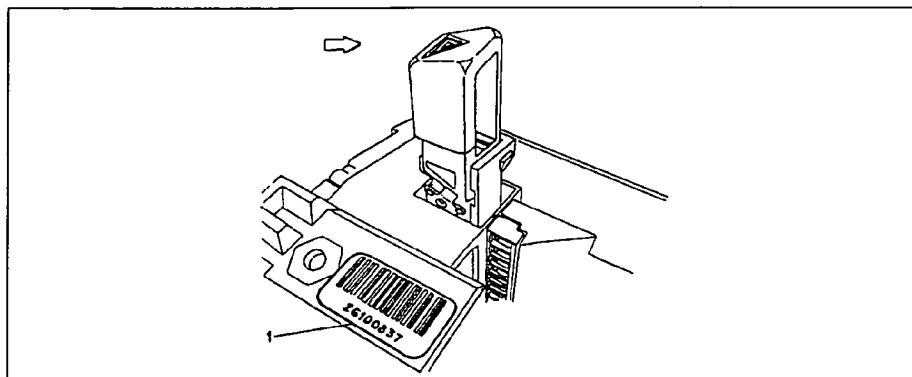
849940

12. Inspect the part number (1) on the multifunction switch at the location shown in the illustration.

- If the part number is 26100837 or 26100838, no repair is required. Proceed to the section titled "Reassemble Vehicle."
- If there is NO part number or barcode on the switch, or if the part number is 26083635 or 26083636, proceed to the next step and replace the hazard warning flasher switch.
- If the part number or barcode on the switch is 26090641, 26090642, 26096832, or 26096833, replacement of the multifunction switch is required. Proceed to the section titled "Replacing the Multifunction Switch."
