**RQ08003/FORD
MISCELLANEOUS**

Job #2 Design Liftgate Glass Hinges

U152 Hinge Dealer Warranty Data

U152 Liftgate Glass Hinges Warranty Returns Analysis

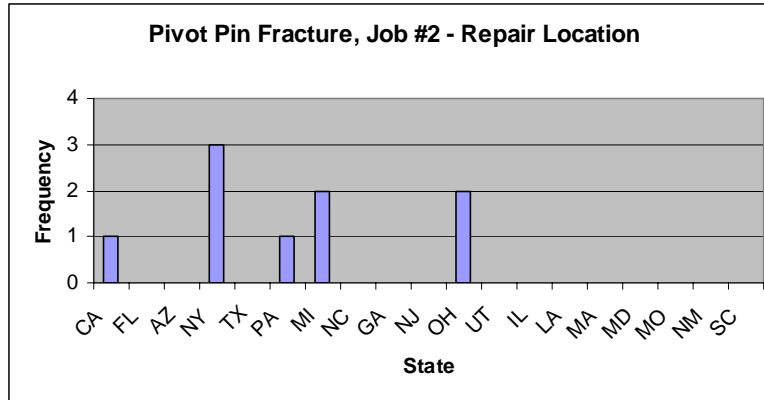
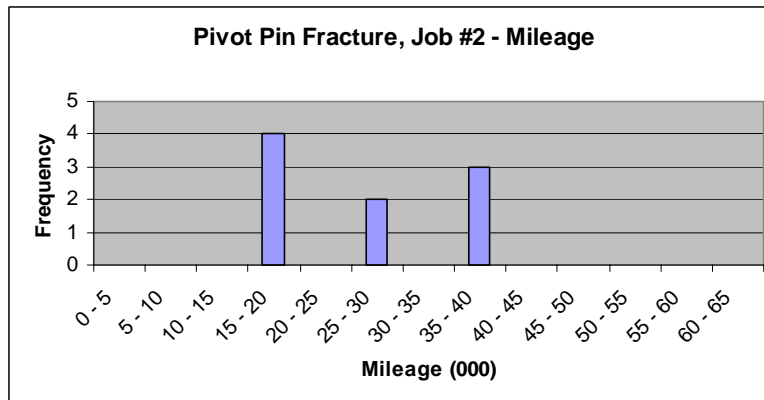
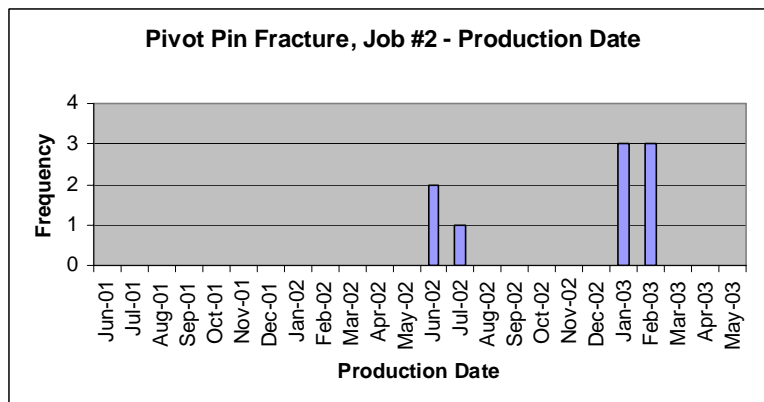
Hinge Pivot Pin Fracture

- ✓ 11.3% Of Returned Hinges (12 of 106)
- ✓ 14.1% of Returned Vehicles (9 of 64)
- ✓ 0% of Returned Job #1 Hinges (0 of 25)
- ✓ 0% of Returned Job #1 Vehicles (0 of 16)
- ✓ 14.8% of Returned Job #2 Hinges (12 of 81)
- ✓ 18.7% of Returned Job #2 Vehicles (9 of 48)

- ✓ 100% on Side of Hinge Pin Toward Center Line of Vehicle

- ✓ Pivot pin fractures on one side of pin, tears through hinge body on other.
- ✓ 5.7% Returned Hinges

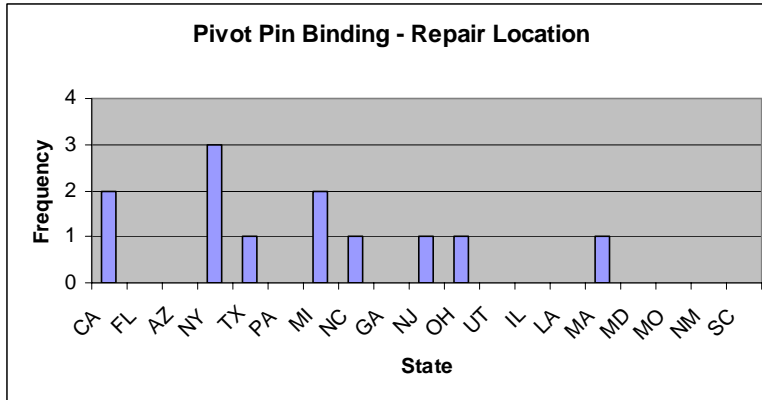
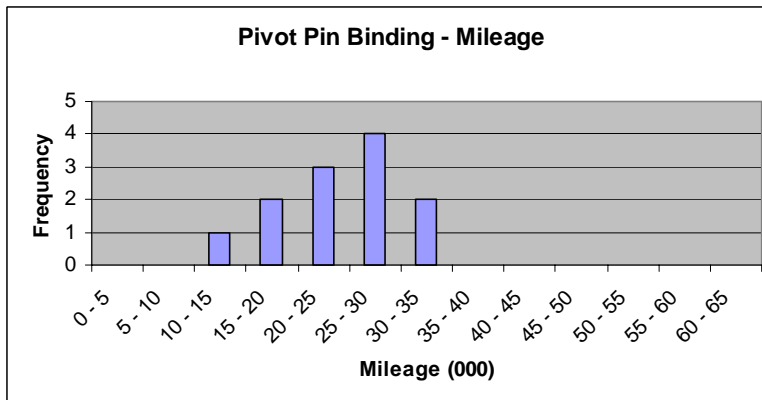
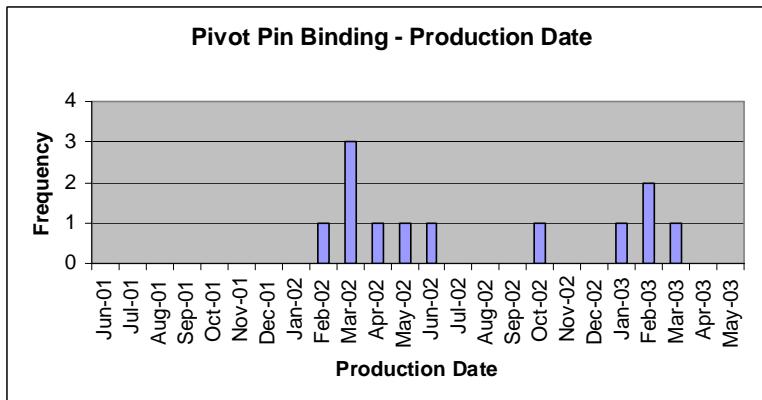
Hinge Pivot Pin Binding (Excluding Pin Fractures)

- ✓ 14.9% Of Returned Hinges (14 of 94)
- ✓ 21.8% of Returned Vehicles (12 of 55)
- ✓ 4.0% of Returned Job #1 Hinges (1 of 25)
- ✓ 6.2% of Returned Job #1 Vehicles (1 of 25)
- ✓ 18.8% of Returned Job #2 Hinges (13 of 69)
- ✓ 28.3% of Returned Job #2 Vehicles (11 of 39)

- ✓ 50% of Returned Binding Hinges Had Light Binding
- ✓ 50% of Returned Binding Hinges Had Heavy Binding

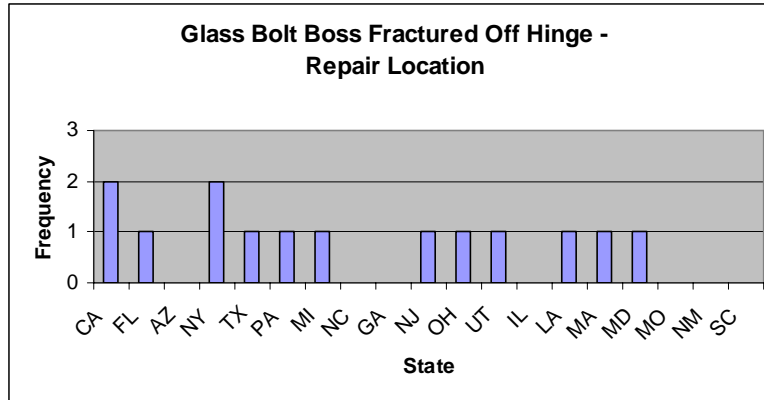
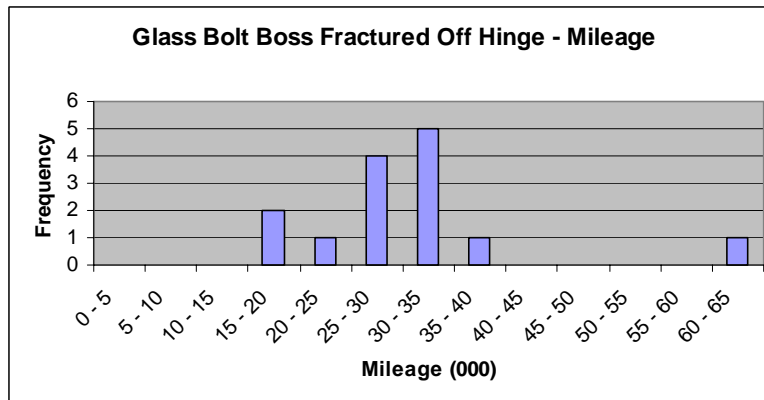
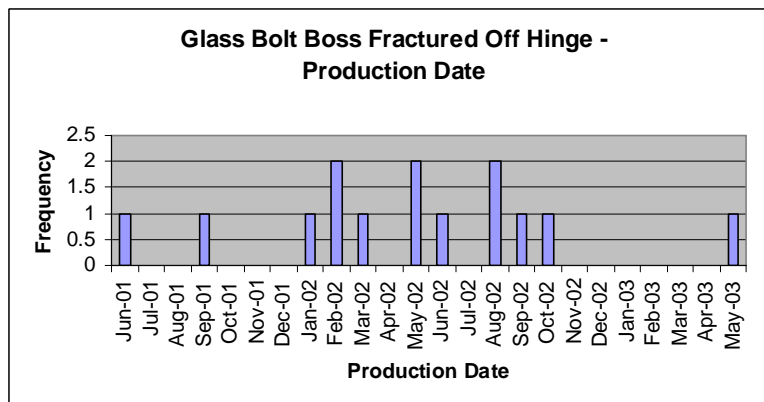
Glass Bolt Boss Fractured Off Of Hinge

- ✓ 13.1% Of Returned Hinges (14 of 107)
- ✓ 21.5% of Returned Vehicles (14 of 65)
- ✓ 20.0% of Returned Job #1 Hinges (5 of 25)
- ✓ 29.4% of Returned Job #1 Vehicles (5 of 17)
- ✓ 11.0% of Returned Job #2 Hinges (9 of 82)
- ✓ 18.7% of Returned Job #2 Vehicles (9 of 48)

- ✓ 100% Hinges With Glass Bolt Boss Fractured Off
- ✓ Note: One Fracture Site Showed Less Porosity Than Average

- ✓ 36% of RH Returned Hinges W/ Boss Fractured Off
- ✓ 64% of LH Returned Hinges W/ Boss Fractured Off

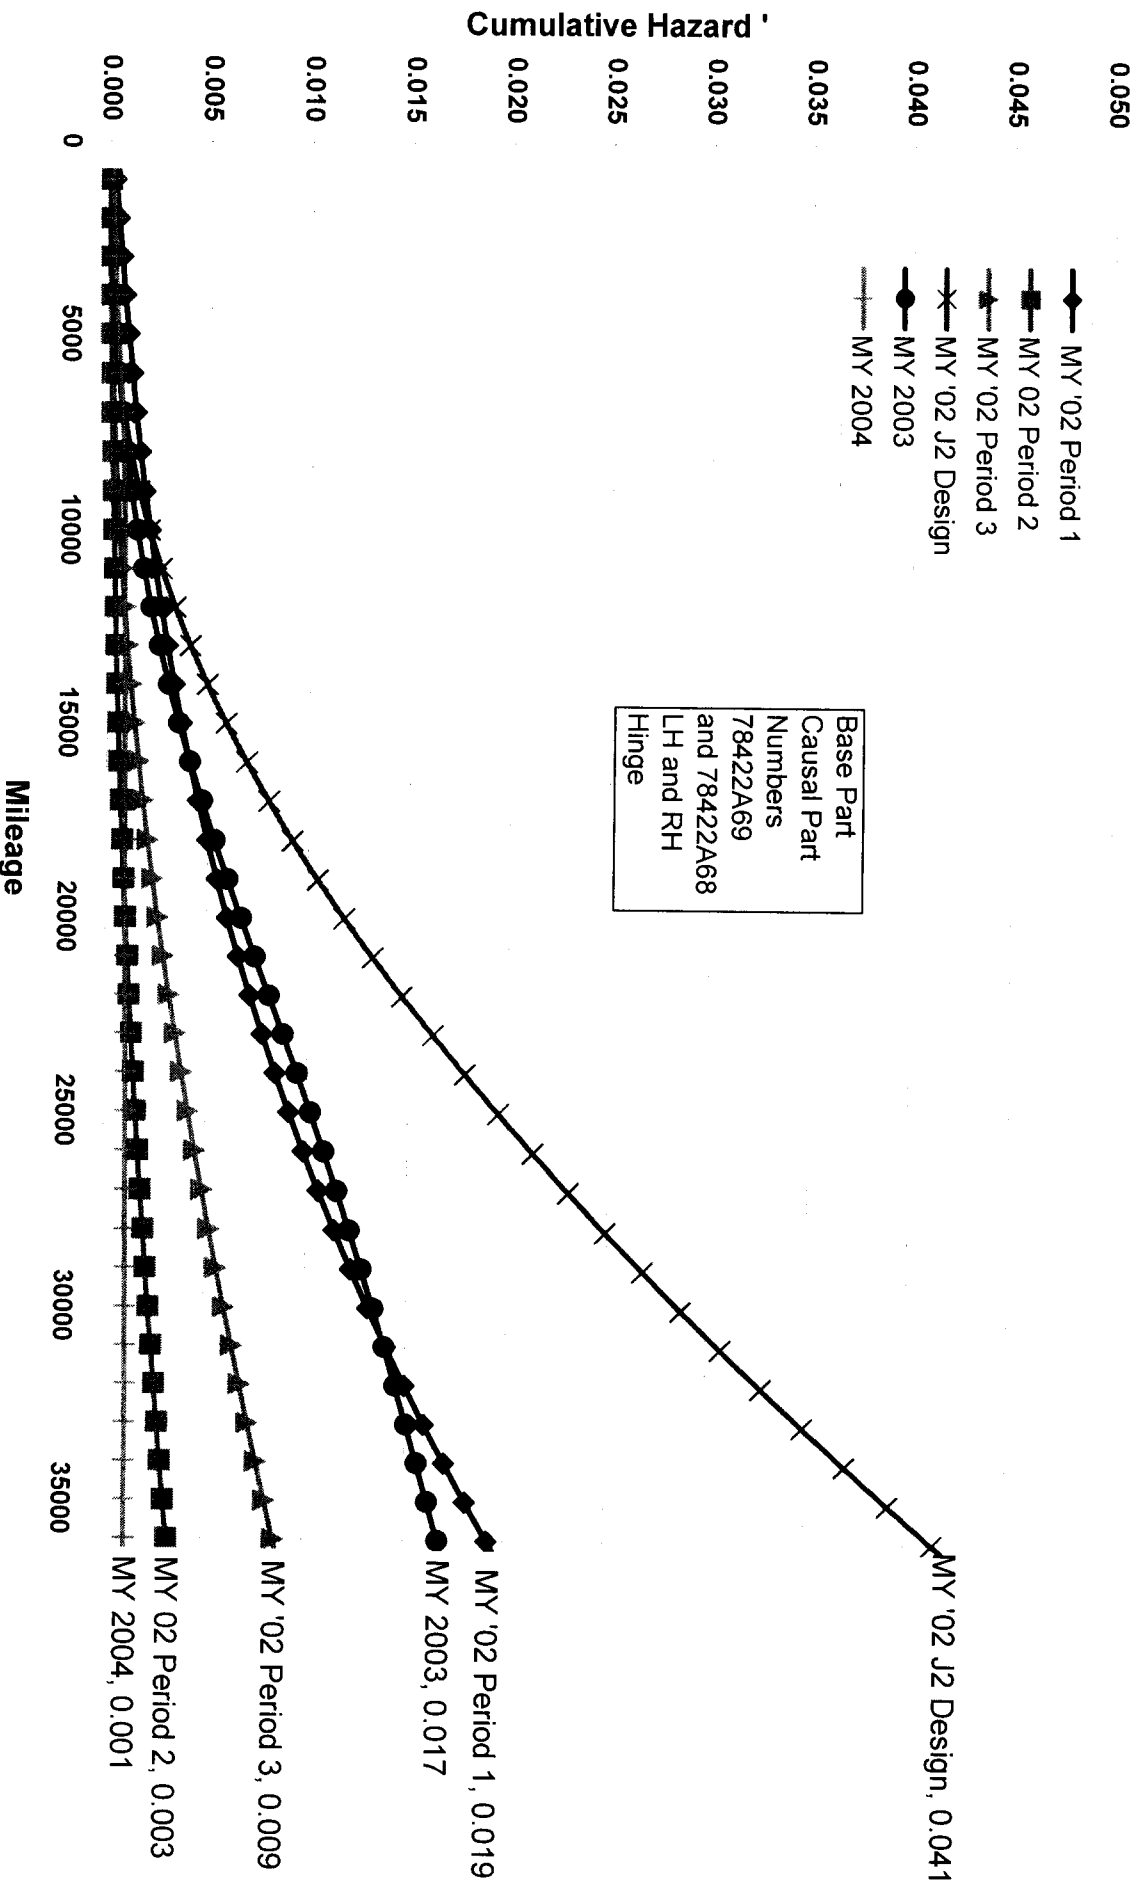
Hinge Issue 36000 Miles

J2 Design 7 times better than
Period 3 at 36,000 MIS

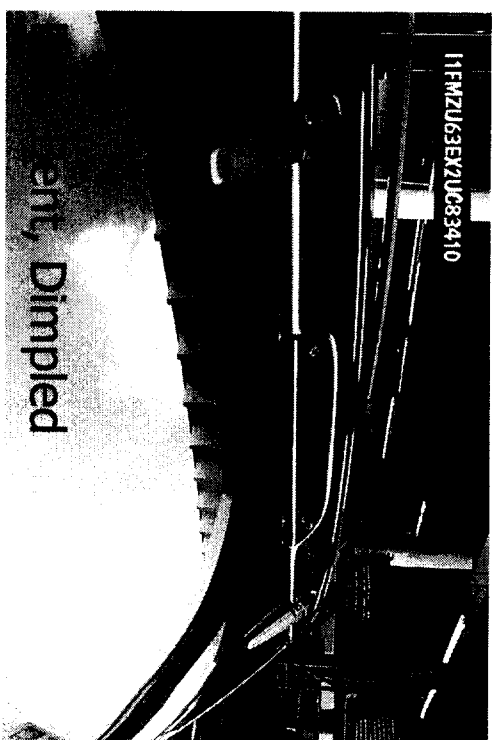
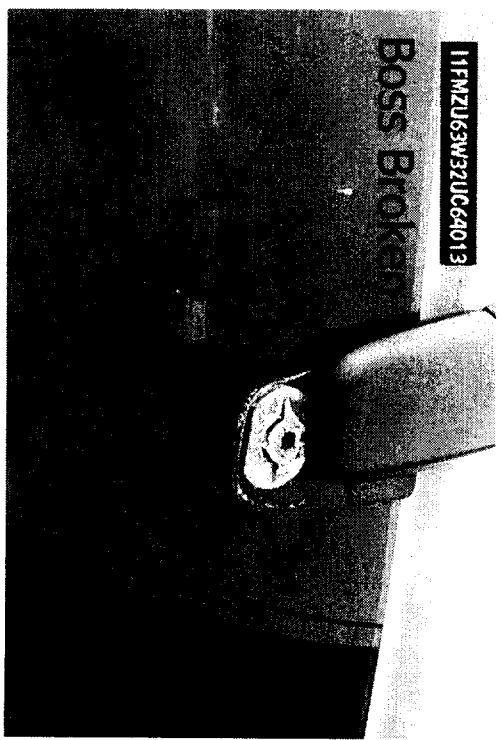
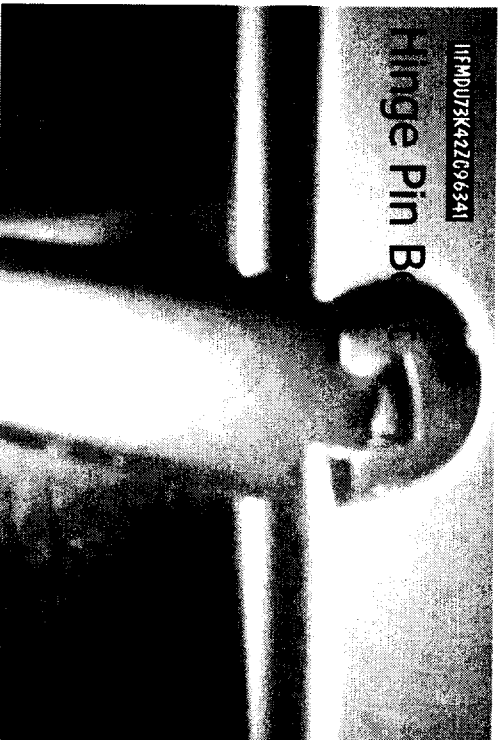
Pictures of Issues

- Review of 109 warranty field returns showed
