Document 1 QIS SCWA-030618-04

QUALITY IMPROVEMENT SHEET (Q.I.S.)

**Document #2
QIS MV20040426180508**

**Document #5
Analysis Report of Failed Part**

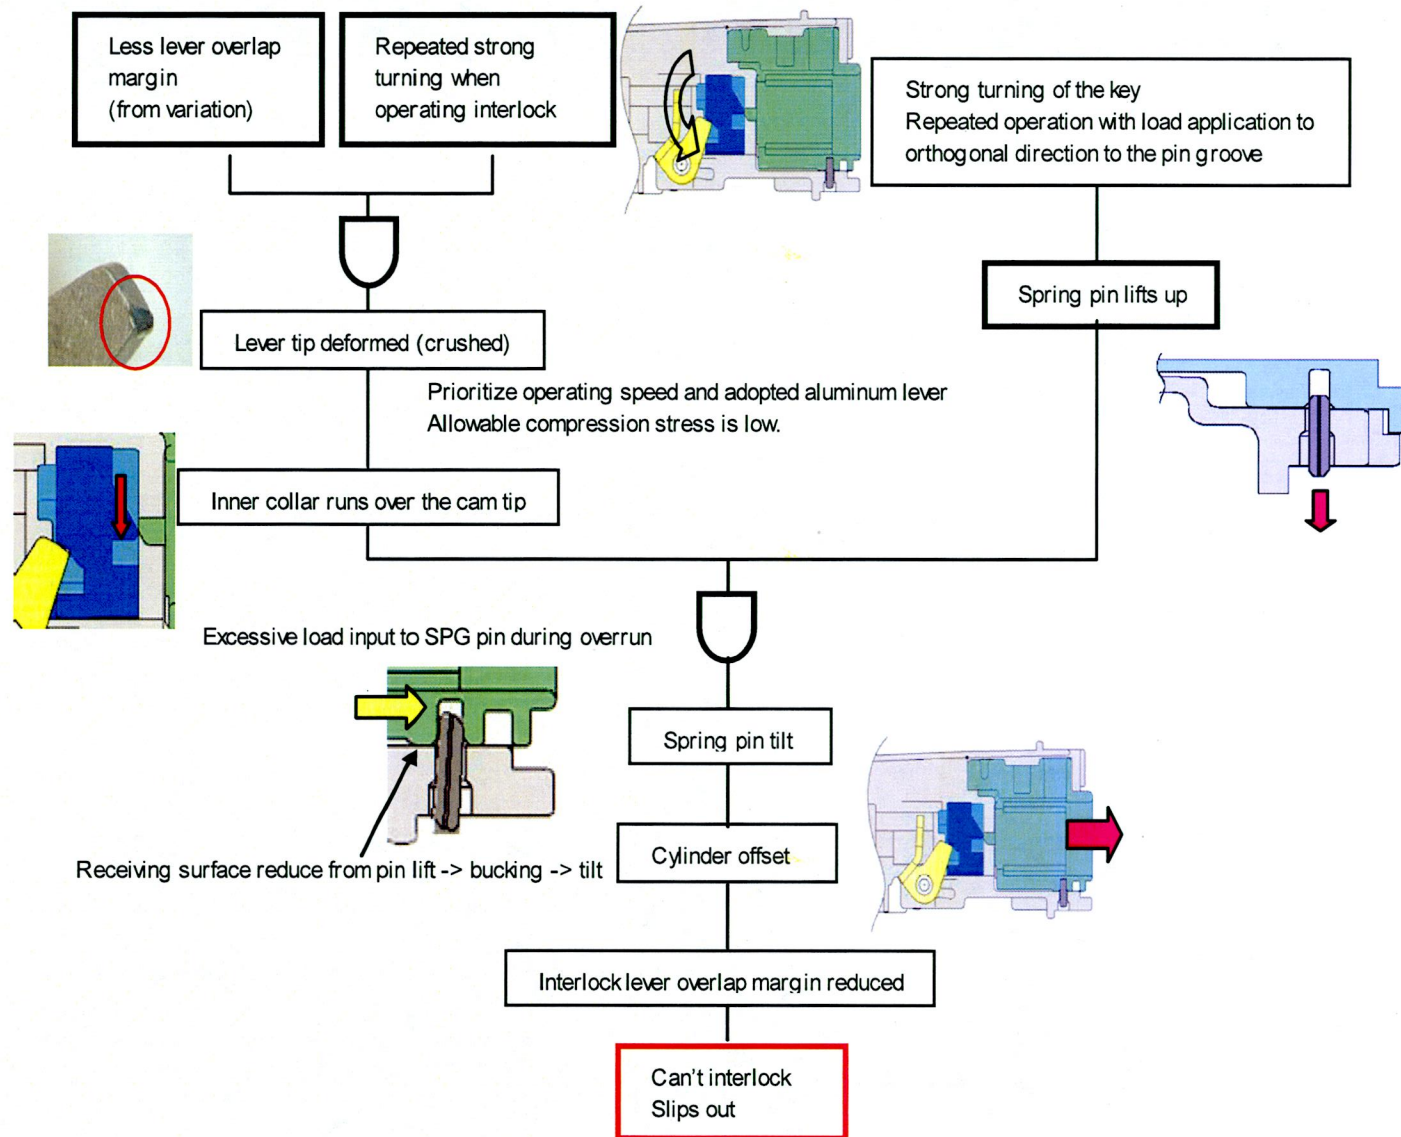
<Separate sheet-2>

Occurrence mechanism of the failure

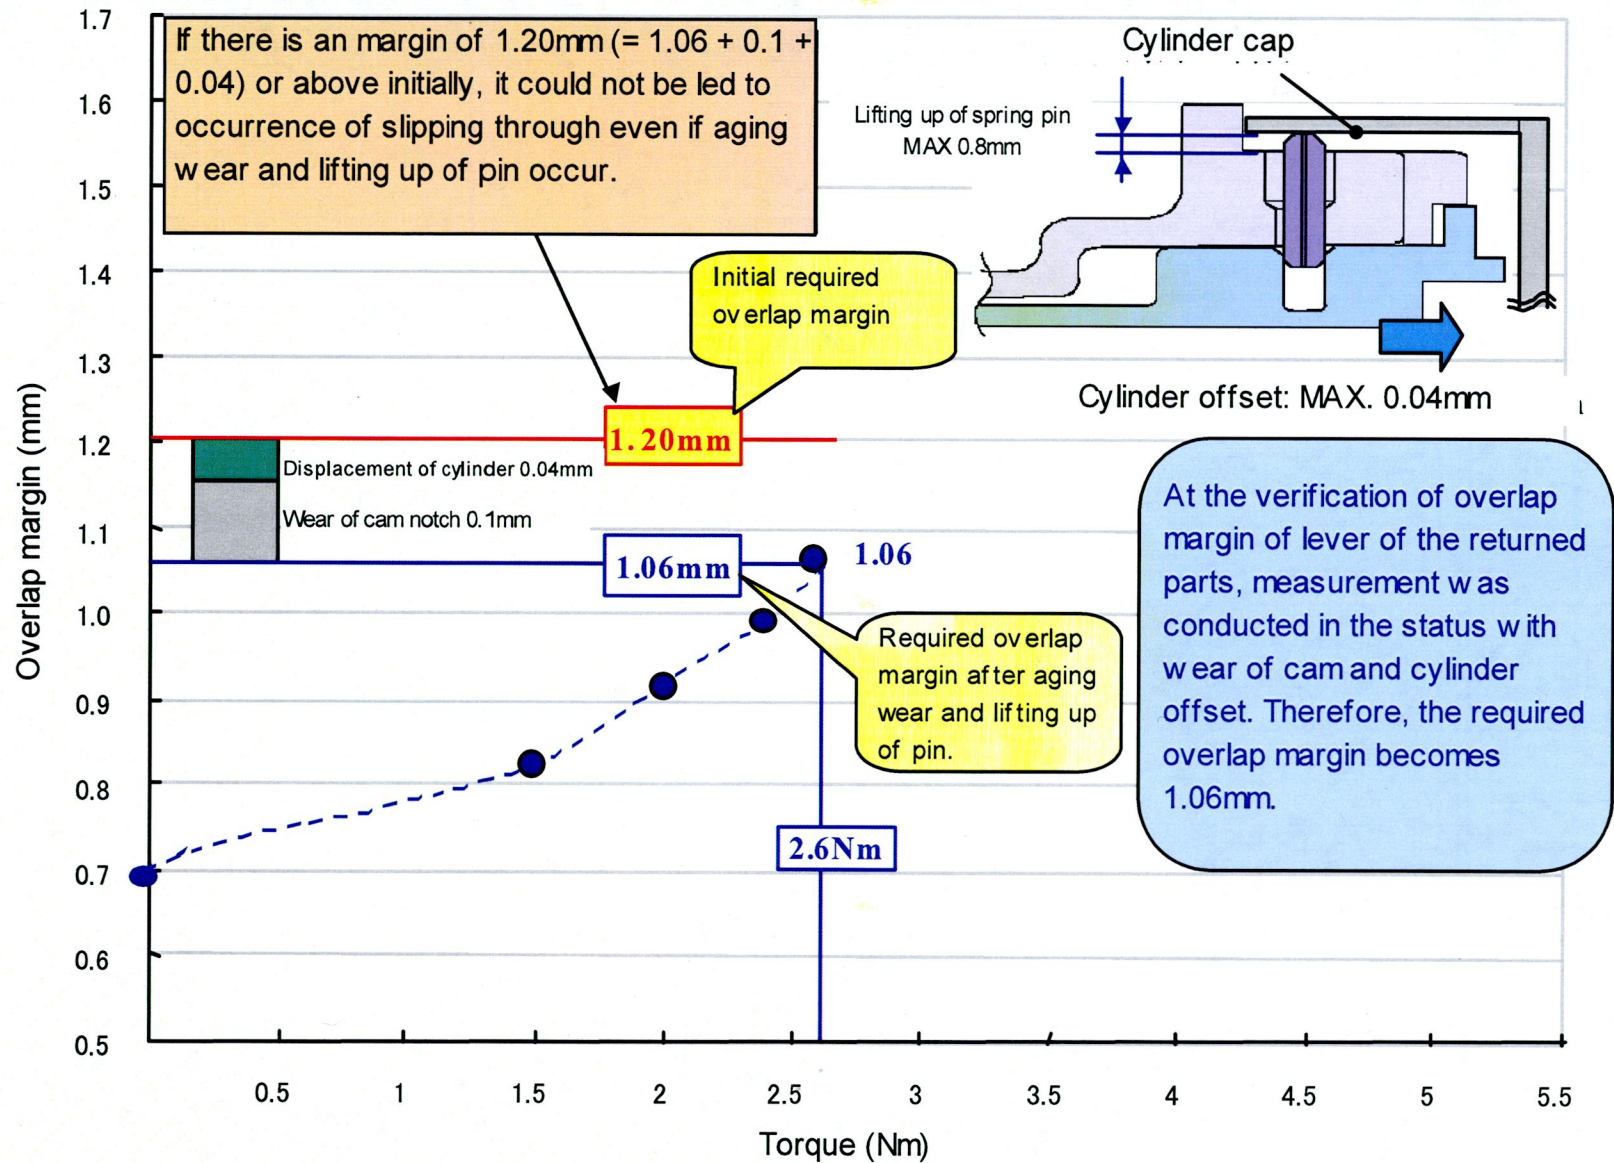
Required overlap margin with consideration of SPG pin lift up. (US Market) <Separate sheet-2>

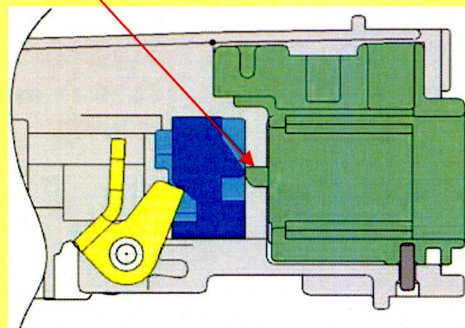
Void on surface area

Cylinder cam tip is significantly worn (0.48-0.96mm), and overlap margin is reduced.

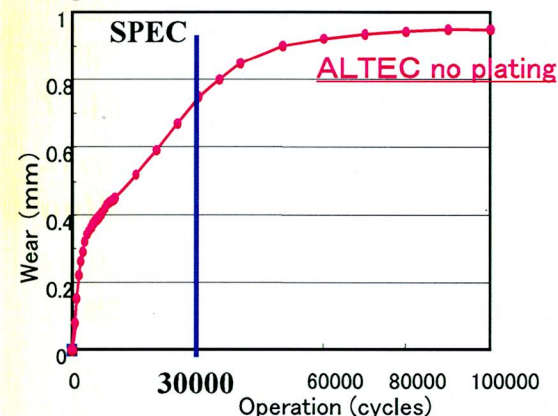
Voids on cam tip surface area, so operation with key pulled (10N) will result in significant wear.

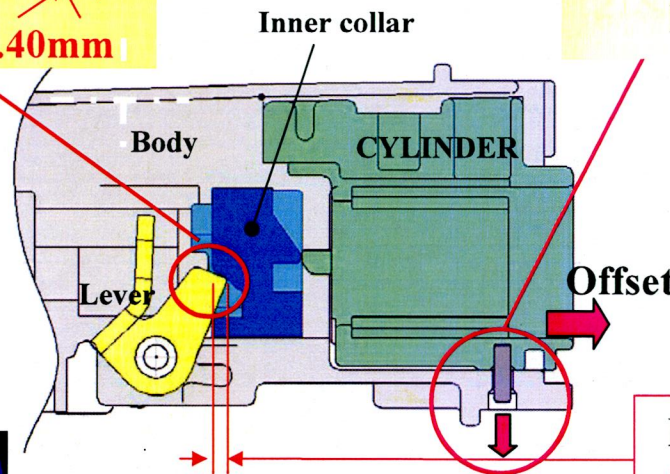
Reduced lever overlap margin
Overlap margin of failed part 0.77 ~ 0.96mm

Initial setting: min. 1.02mm

Recreated slip out on all parts.

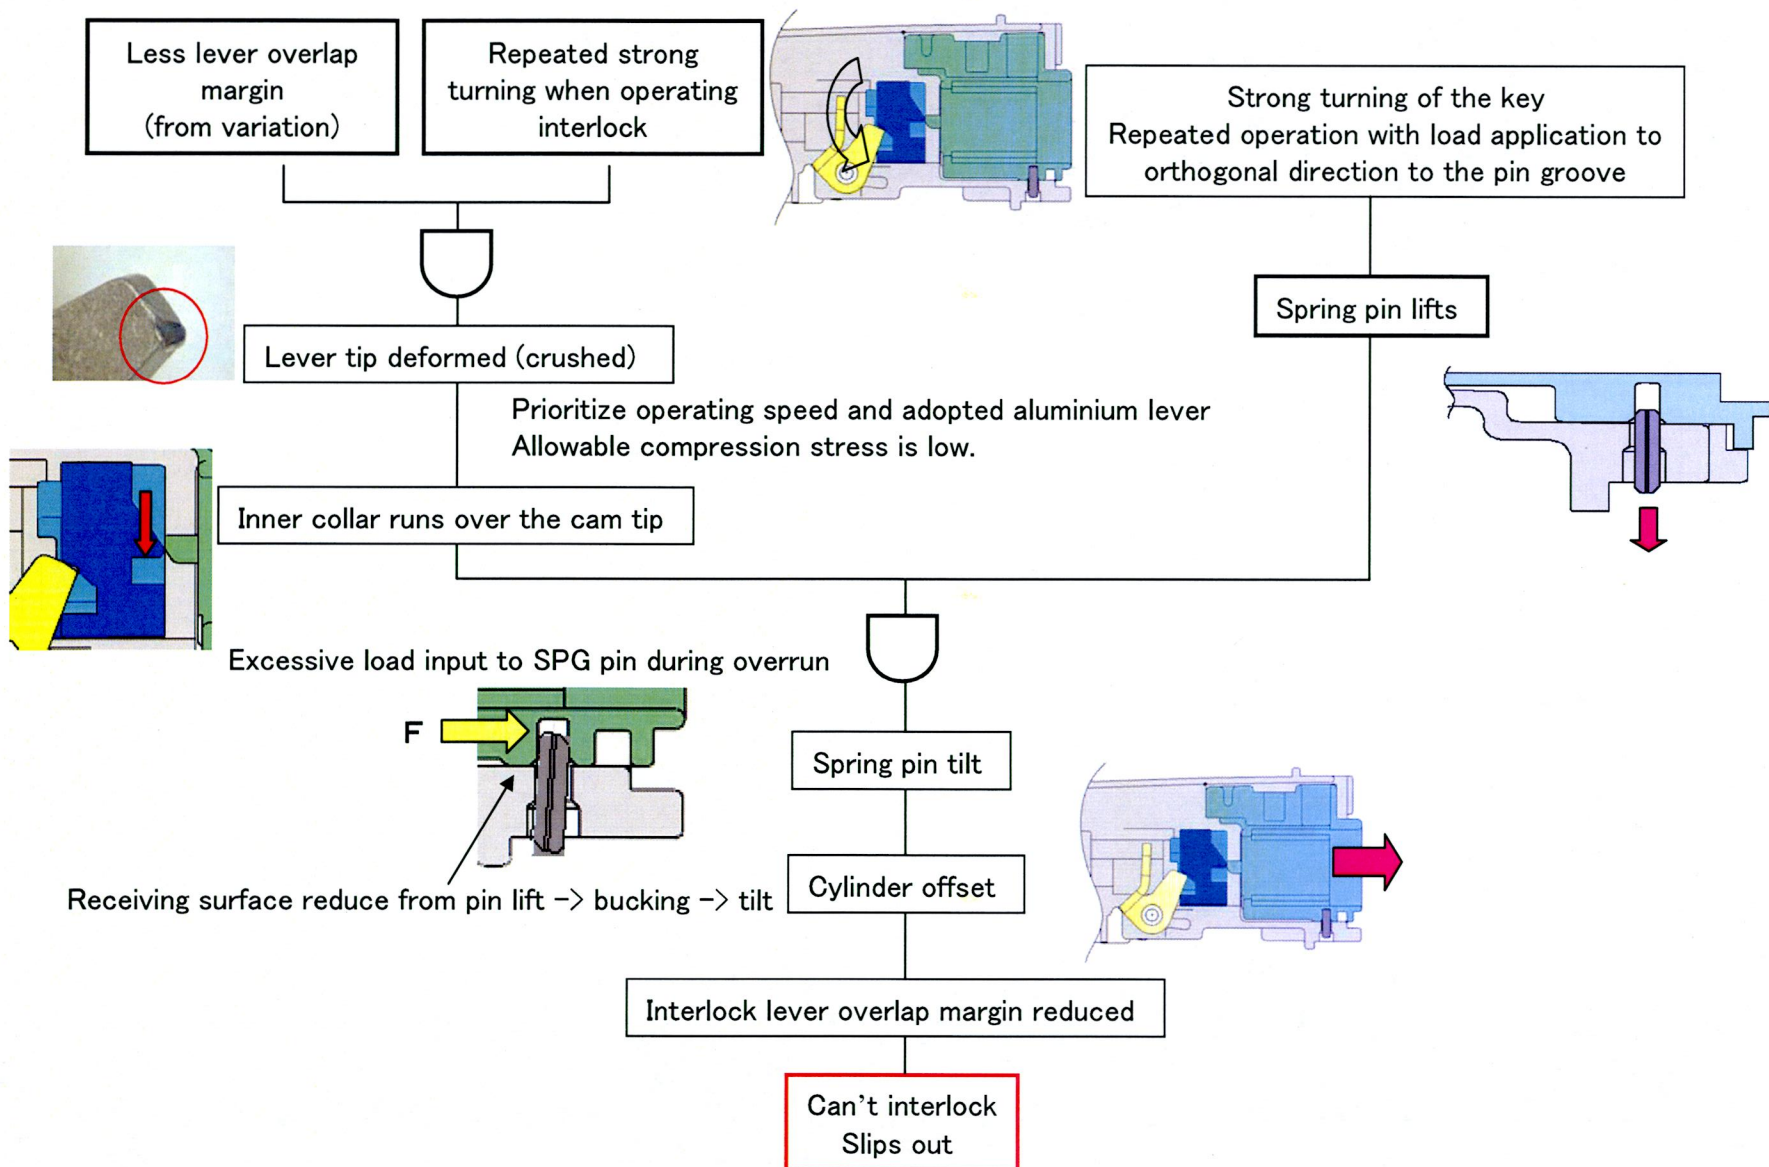
Occurrence mechanism

Regarding the failure this time, the overlap margin when returned was 1.04 mm compared to the required margin 1.06 mm. Repeated strong turning of key beyond expectation at interlock blocking with overlap margin of 1.06 mm or below leads to slip out. Therefore we judge that the failure occurred with the returned part due to worn lever from repeated strong turning of key beyond expectation.

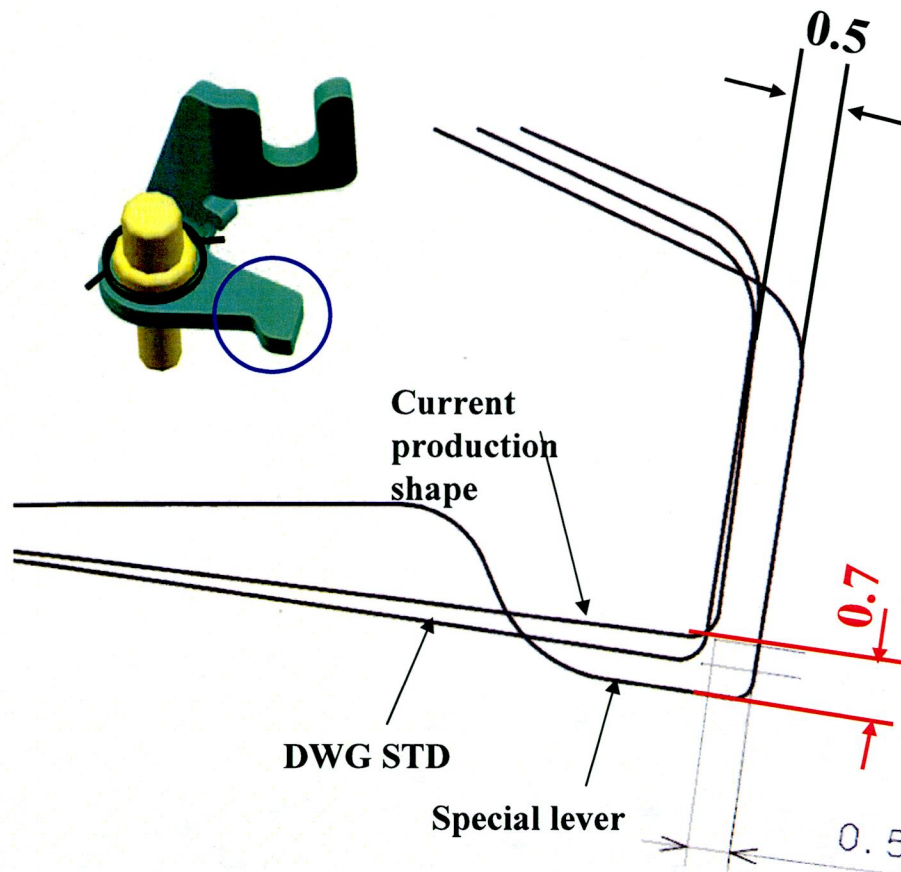
Even with Type I where the overlap margin is the smallest, this can secure overlap margin of 1.75mm, providing enough margin for the required 1.20mm.

Increase lever overlap margin (replacement to special lever)

Increase overlap margin by 0.7mm more than production lever, to secure overlap margin more than the limit value.

(increase 0.5mm in longitudinal direction, so it won't result in overrun easily)

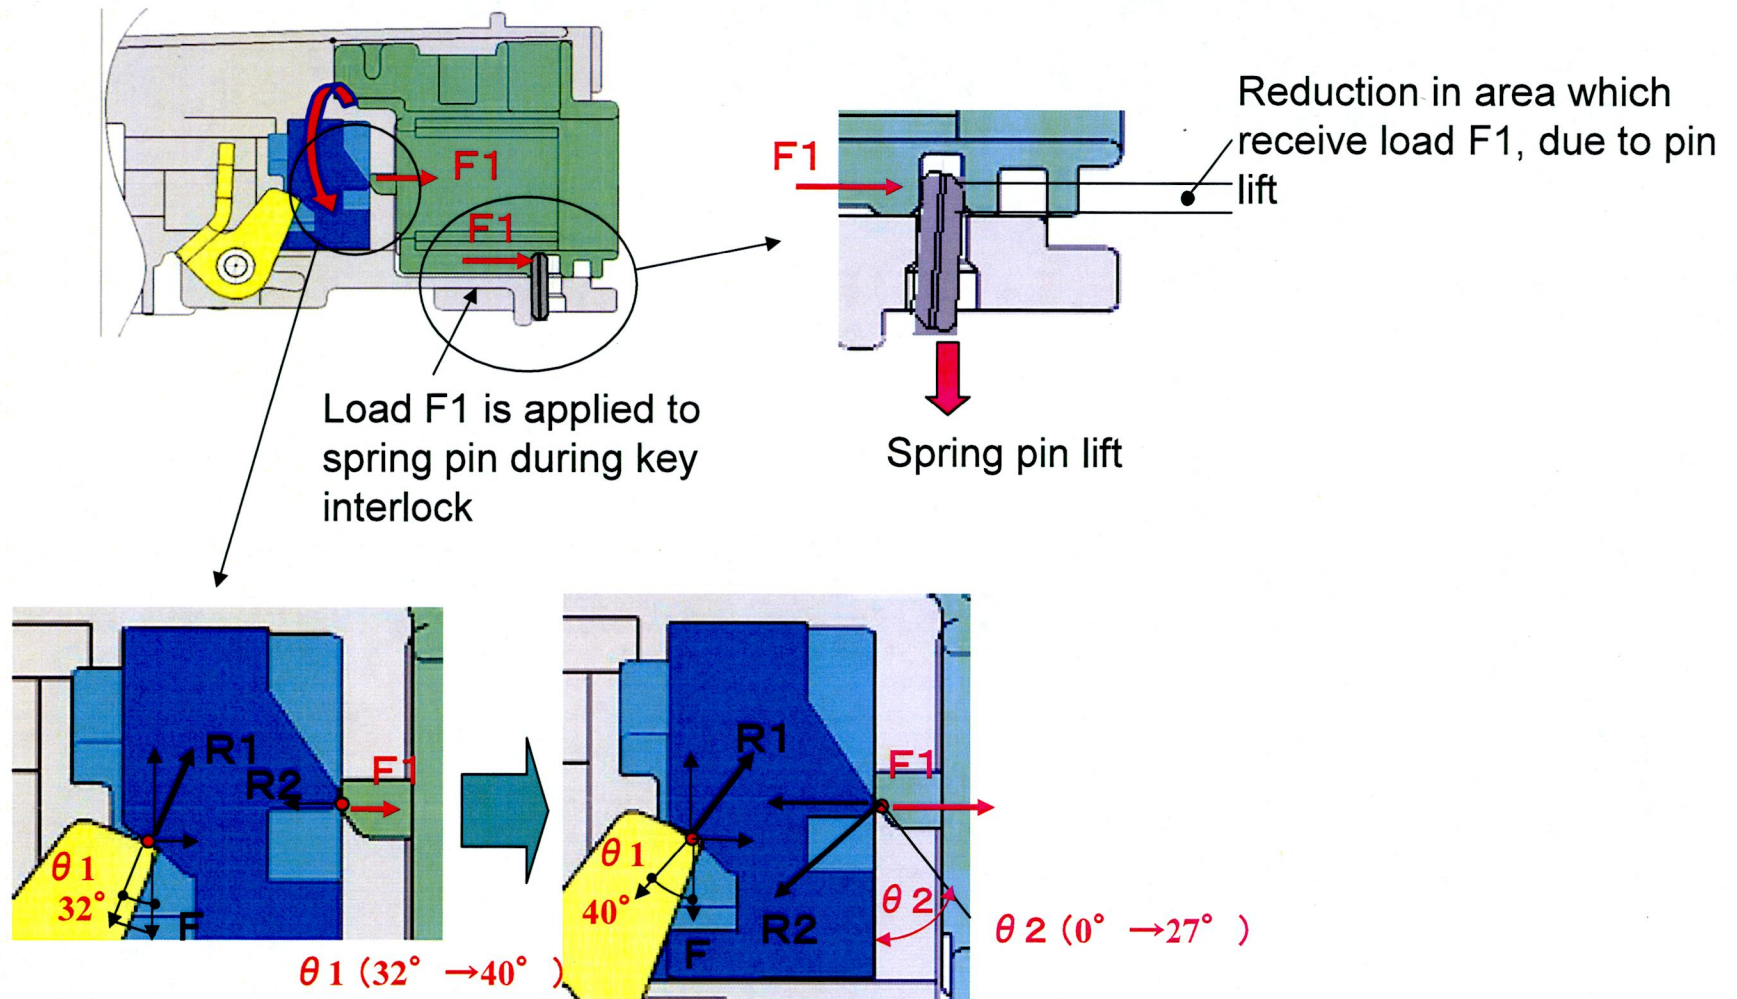
Occurrence mechanism (spring pin tilt)

From lever tip deformation, inner collar rotates more than normal, so it rides over the cam tip (overrun), increasing F1 by approx 2.3 fold.

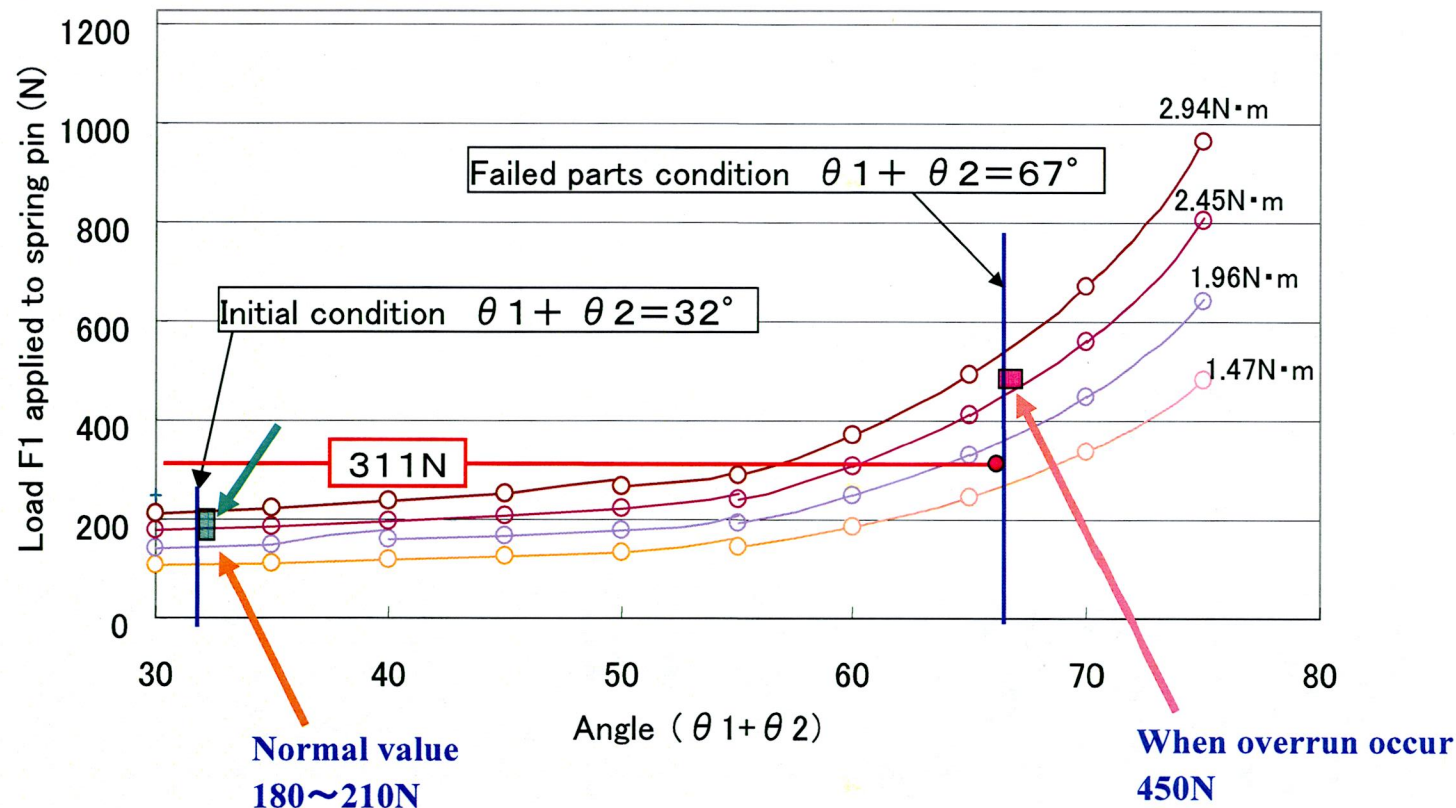
Load of 450N is generated, and is over allowable stress for the cylinder material so cylinder buckles \Rightarrow spring pin tilts \Rightarrow cylinder offsets

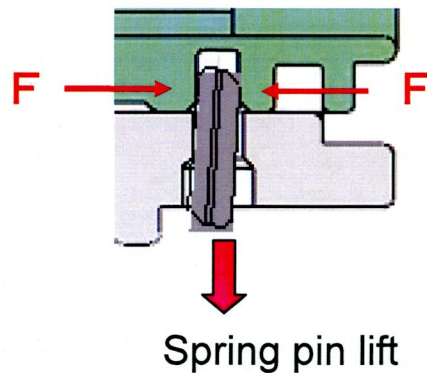
Load is input to spring pin with normal key operation.

Load input to radial direction of the spring pin cause spring pin to repeatedly be stretched/compressed, lifting gradually.

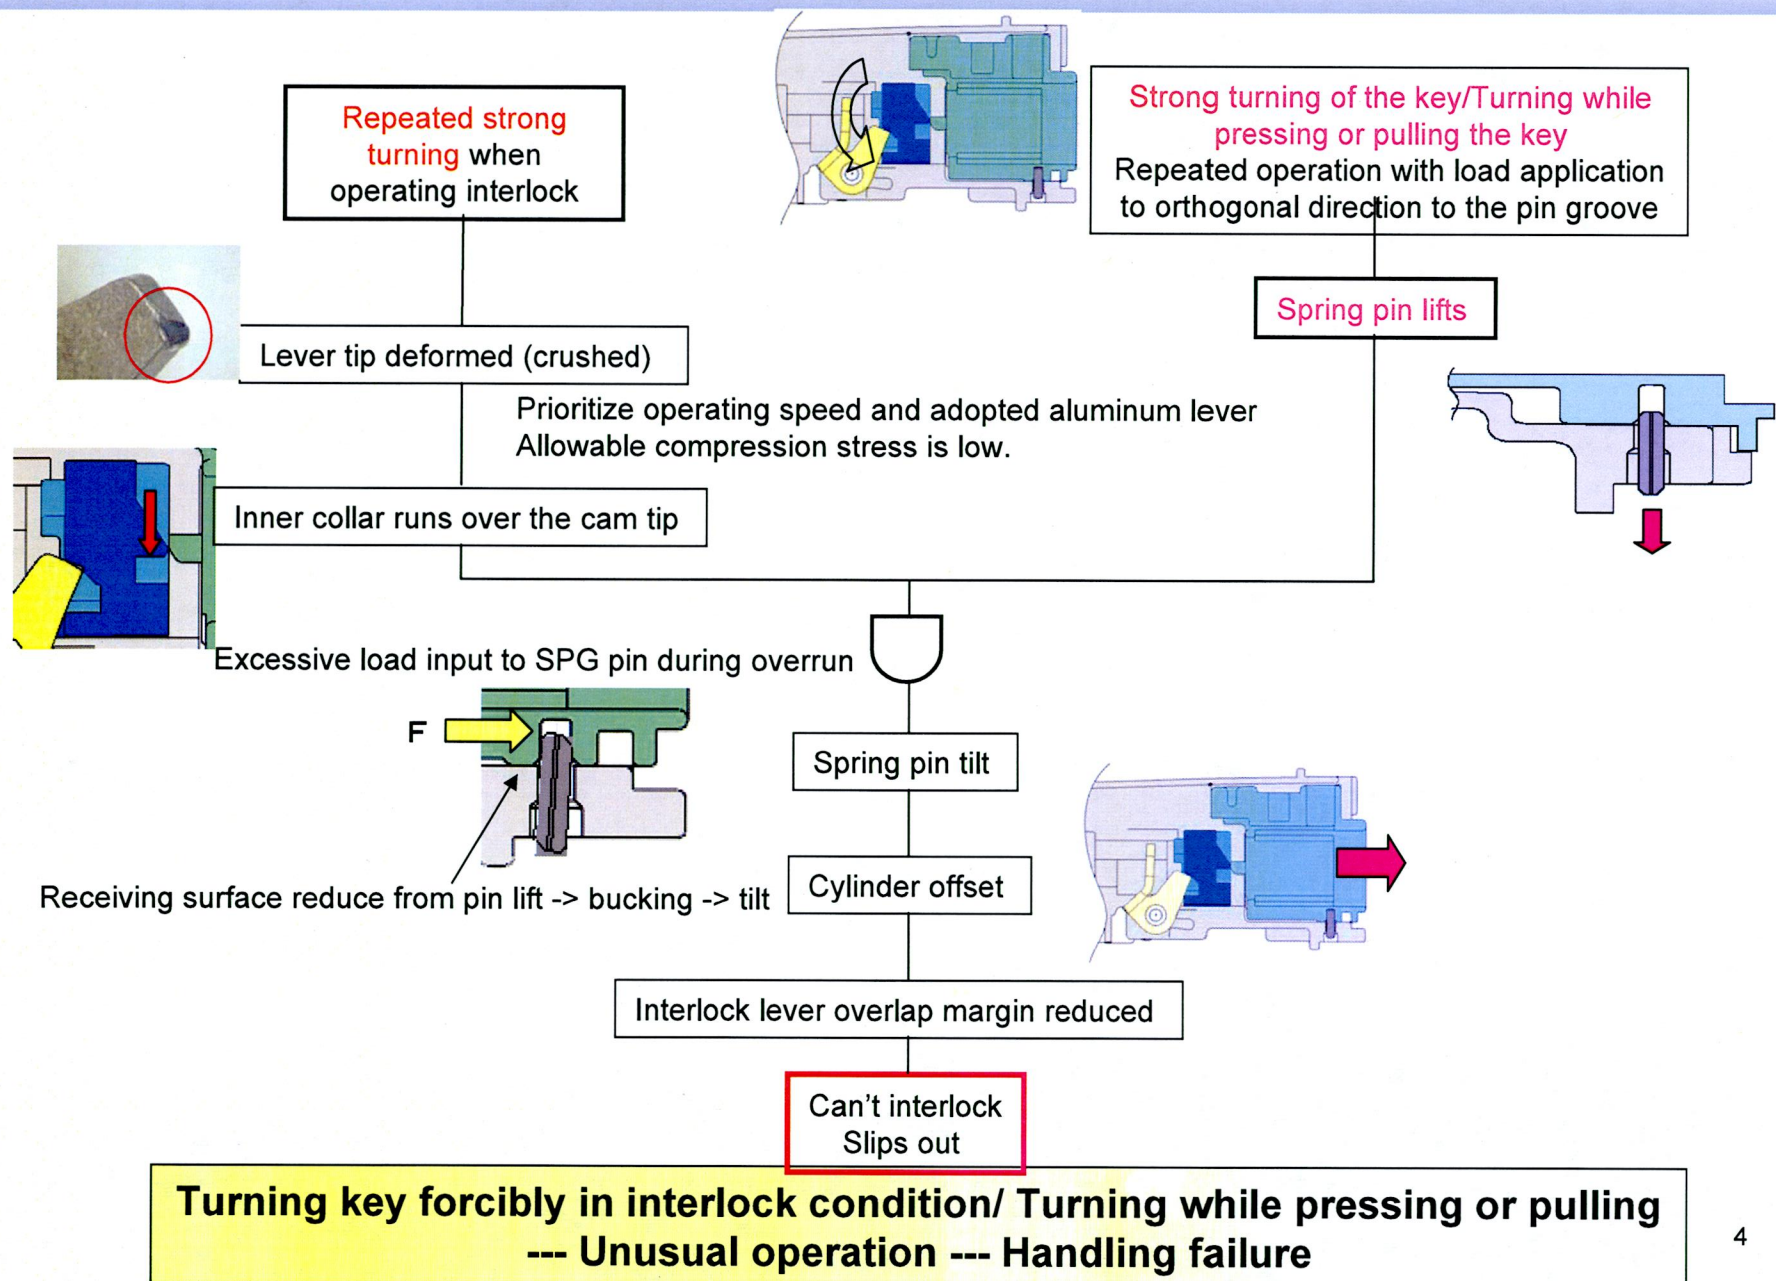
3. Occurrence mechanism

◆ Overlap margin decreases due to worn lever and slipping out was recreated. (SPG pin lifted up too.)

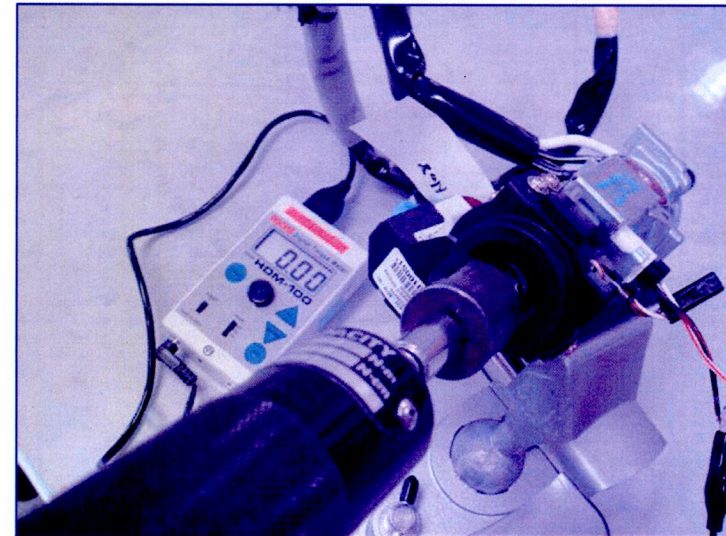
- Slip out with 0.25 Nm when interlock is blocking.

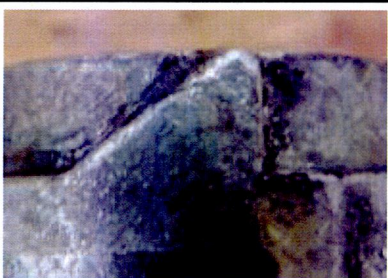
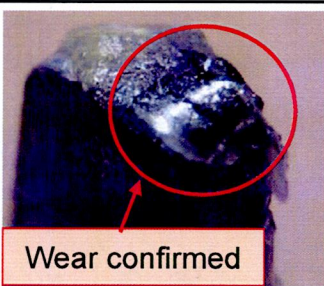
Inner cam	Lever tip	<div> <ul style="list-style-type: none"> - Lever tip is worn - With SPG pin lift up </div>

Wear confirmed

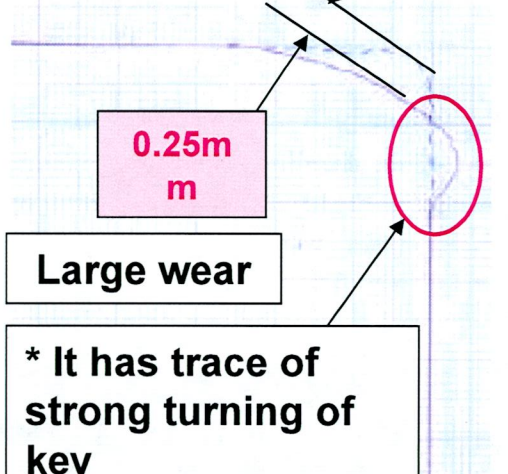
<p>0.13m m</p> <p>Wear confirmed</p>

<p>0.25m m</p> <p>Large wear</p> <p>* It has trace of strong turning of key</p>

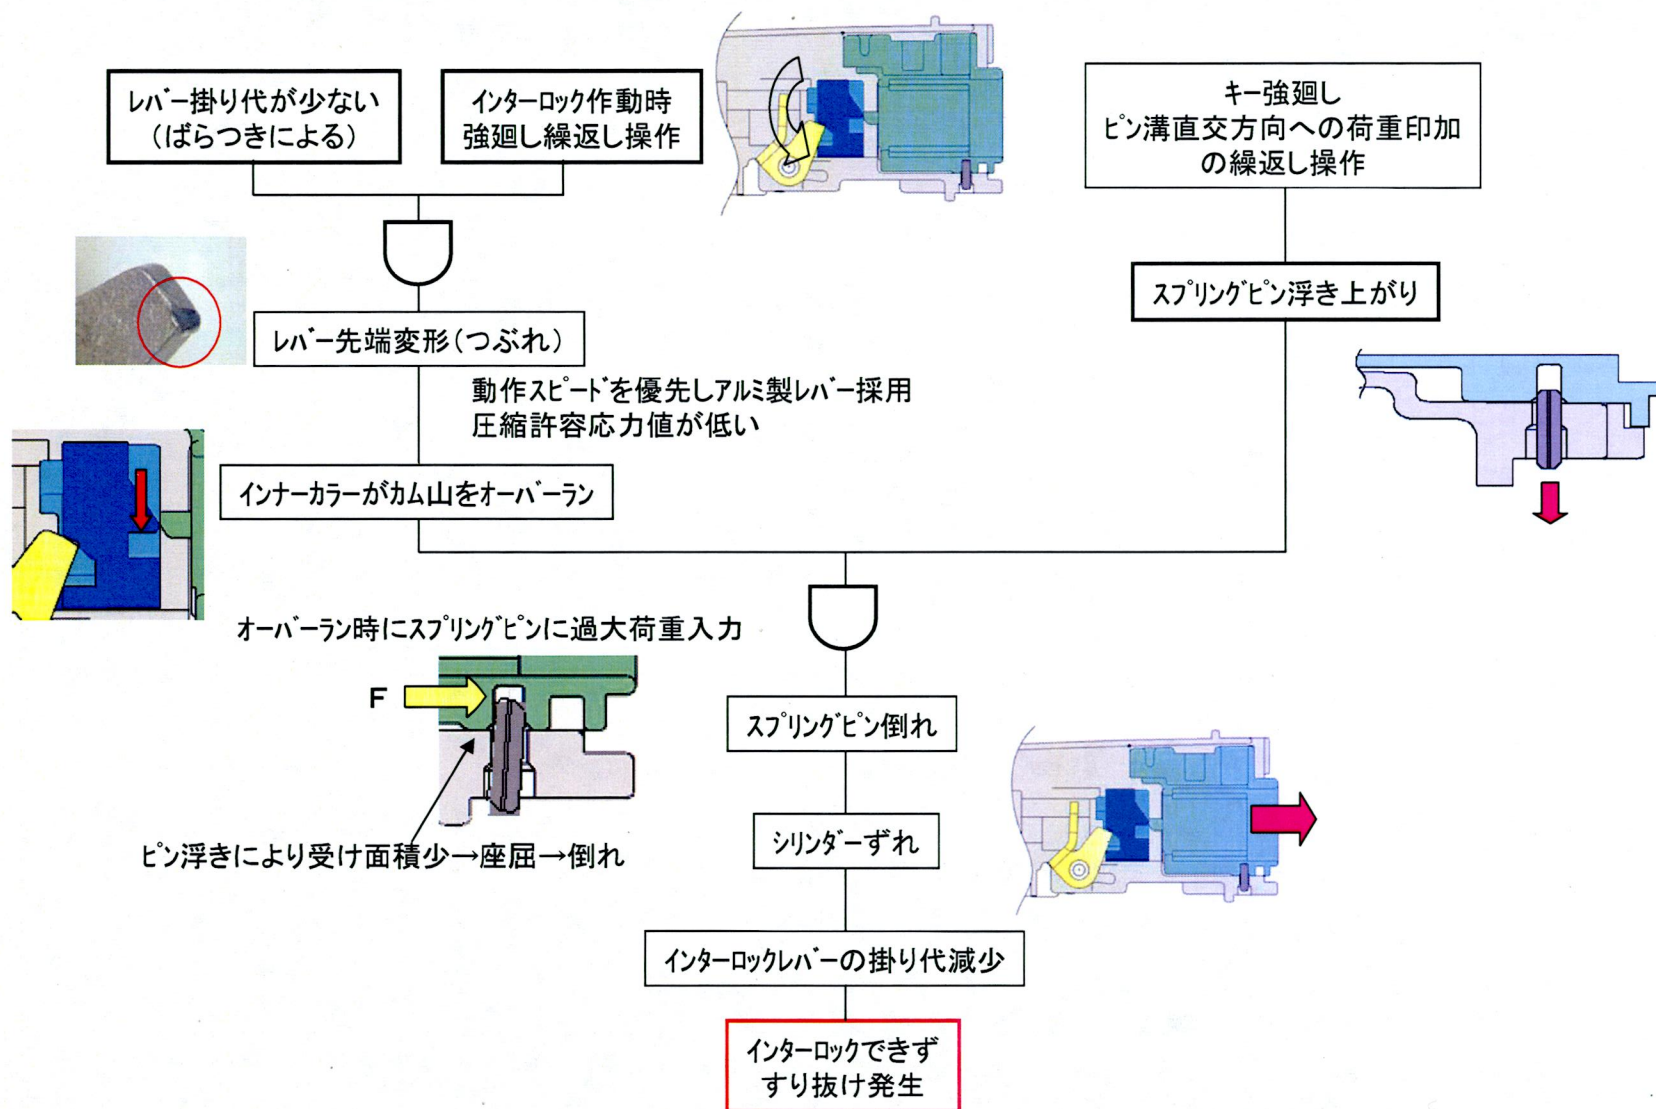
2002MY Failure Mechanisms

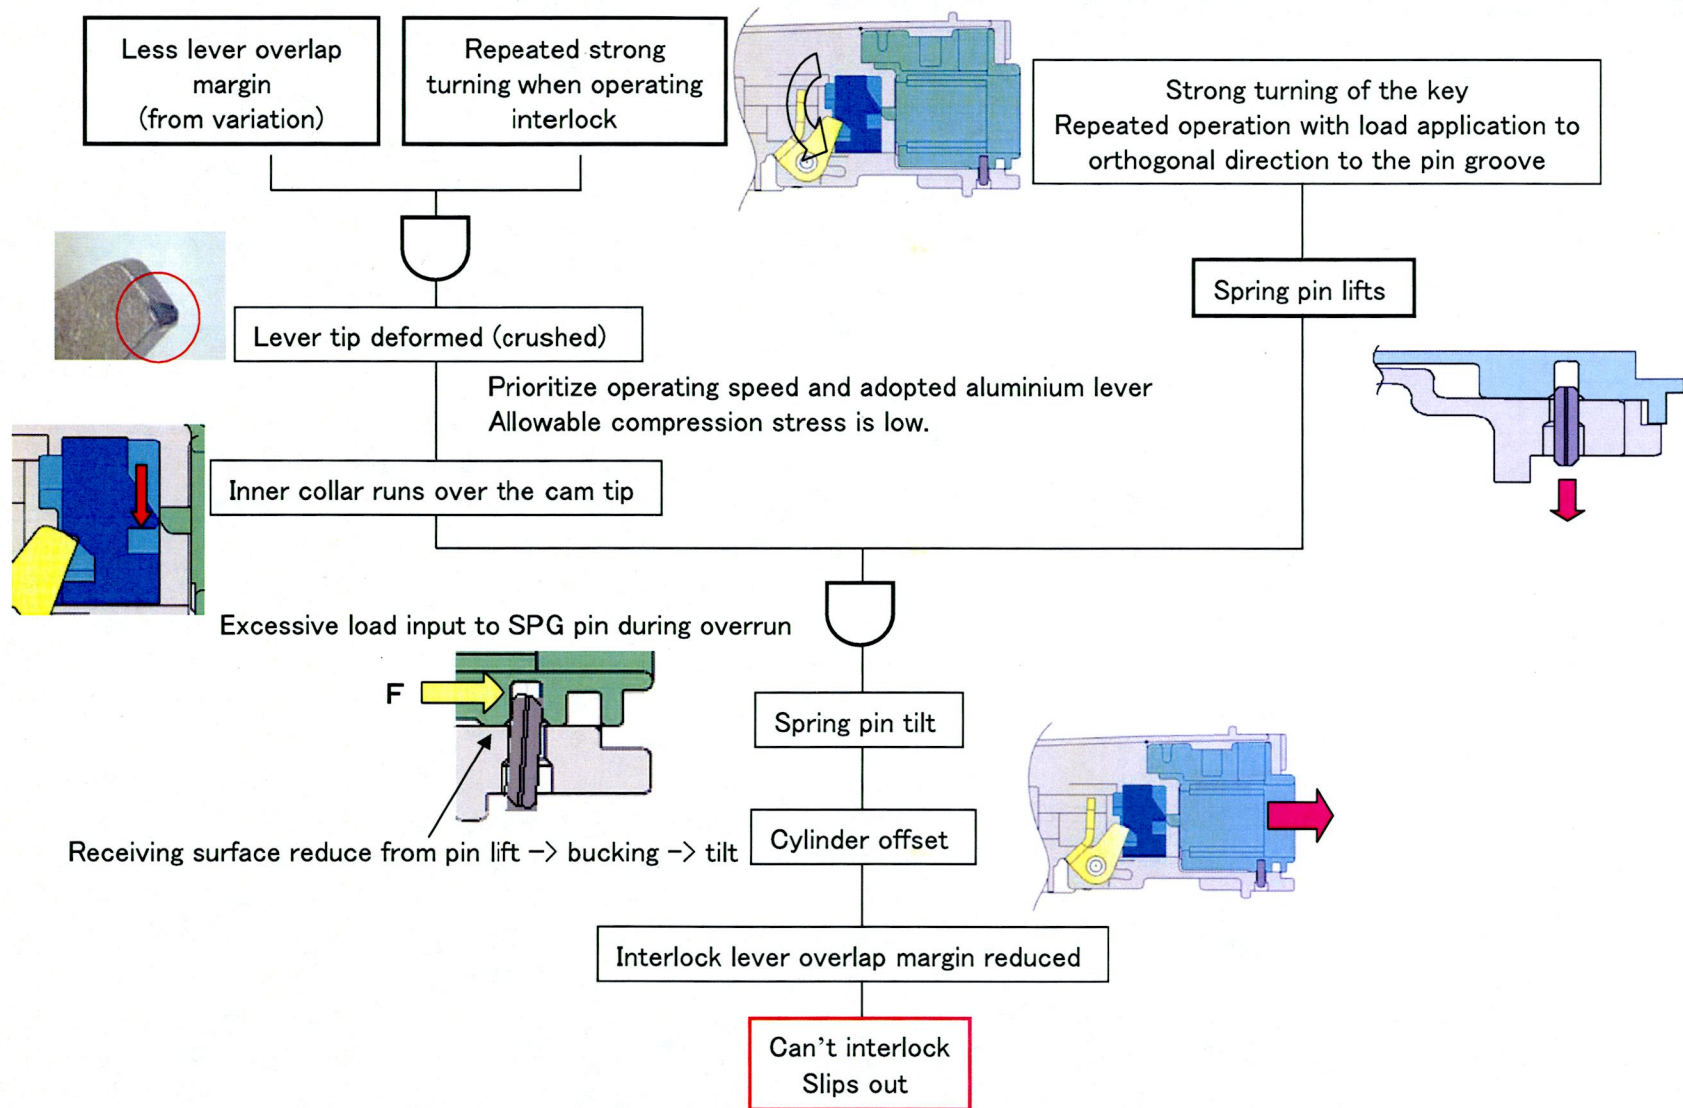
2002MY Failure Mechanisms

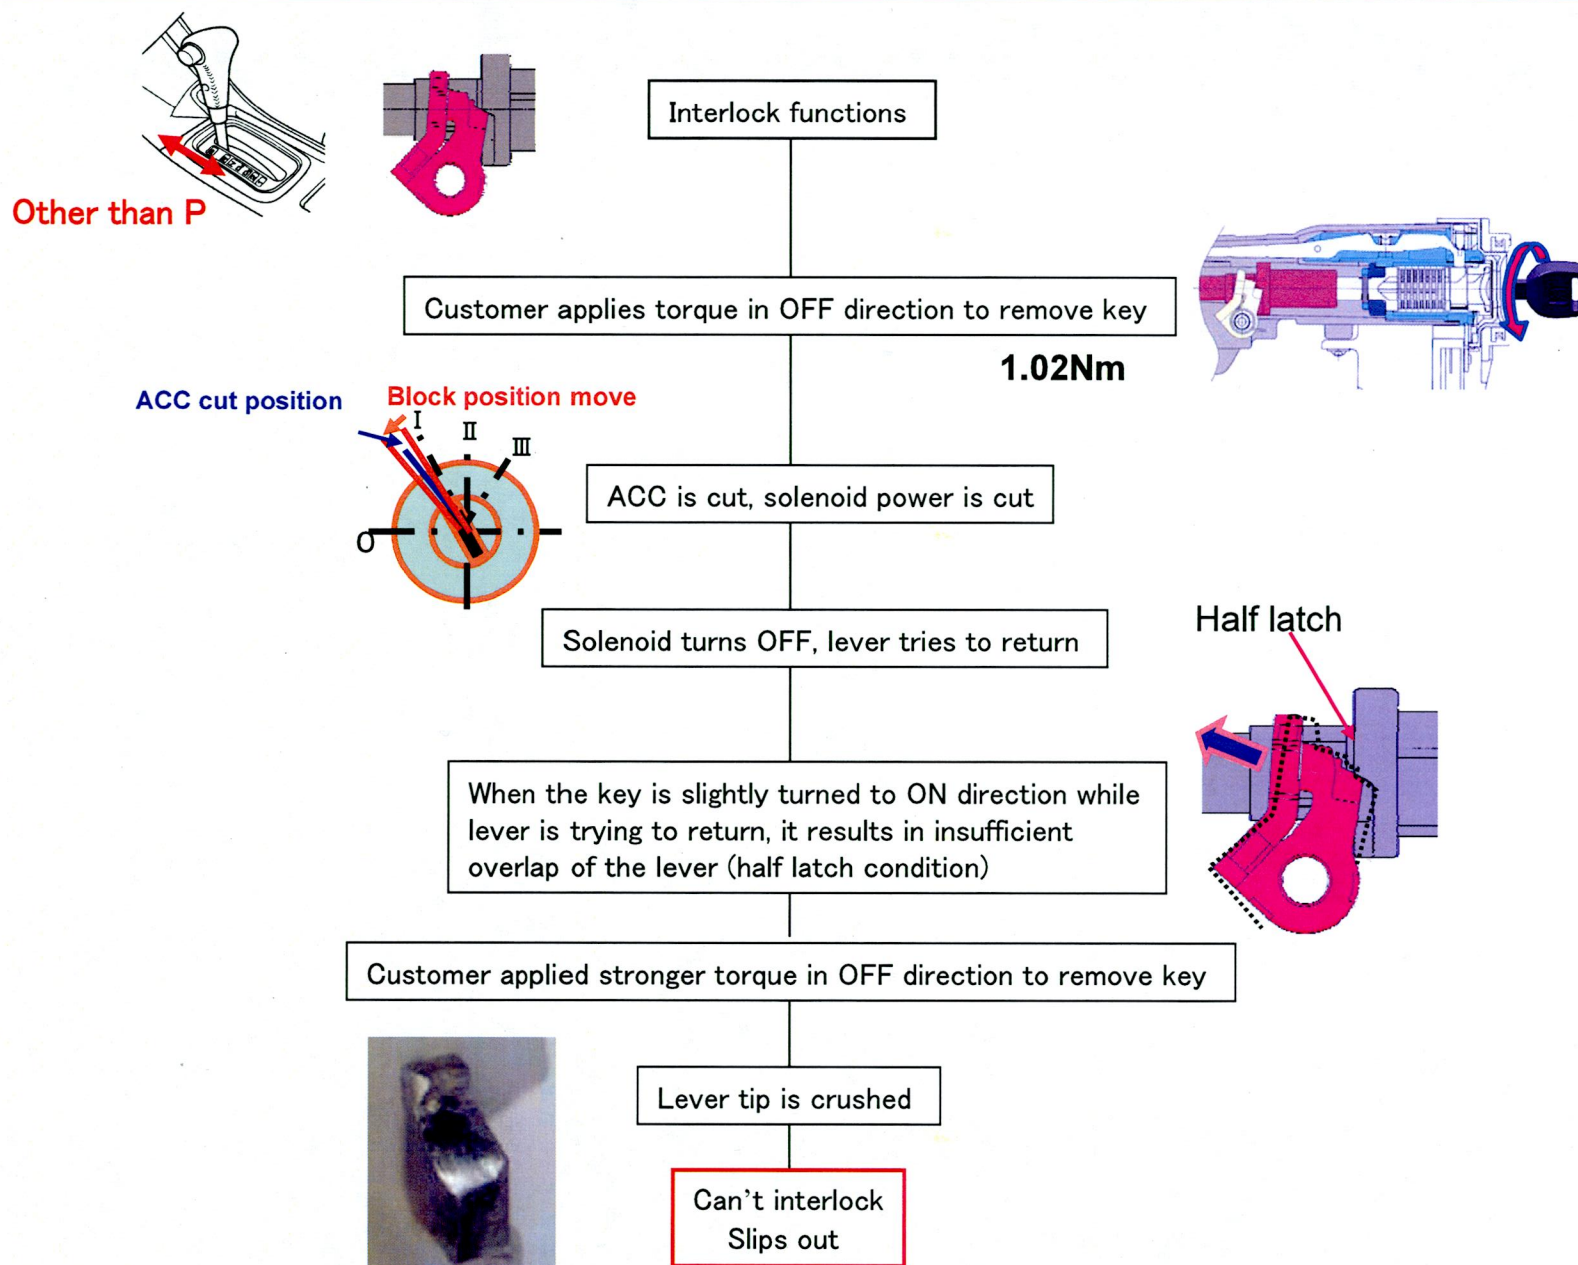
Occurrence mechanism 3-2 S5A type

2003M Failure mechanism
