# HONDA

NVS-212mjl  
PE08-026

# Attachment Q18-22

# Strut Failure + Pinch Detection

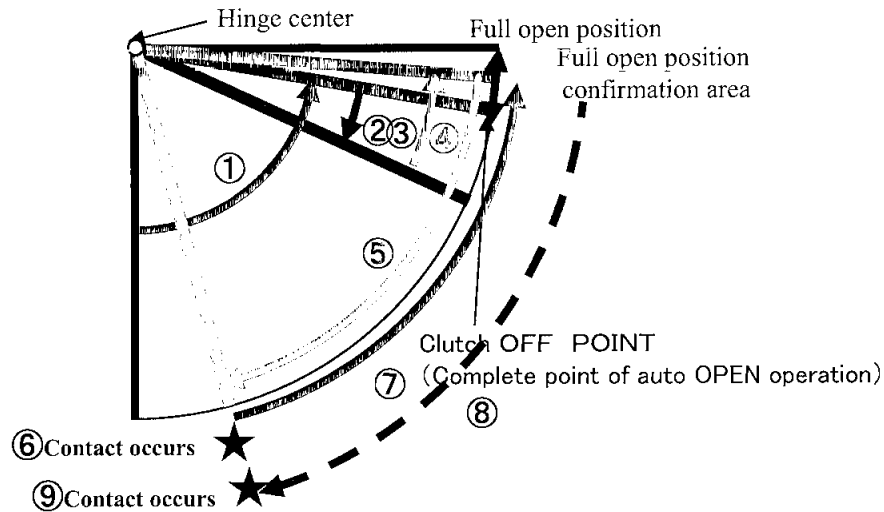
### Normal condition

Reverse function in closing operation during strut failure detection  
(No contact on the way of reverse to open)

⑥ Contact occurs ⇒ ⑦ Rise toward the full open position confirmation area ⇒  
⑧ Then, close operation ⇒ ⑨ Contact occurs during closing  
⇒ system ends

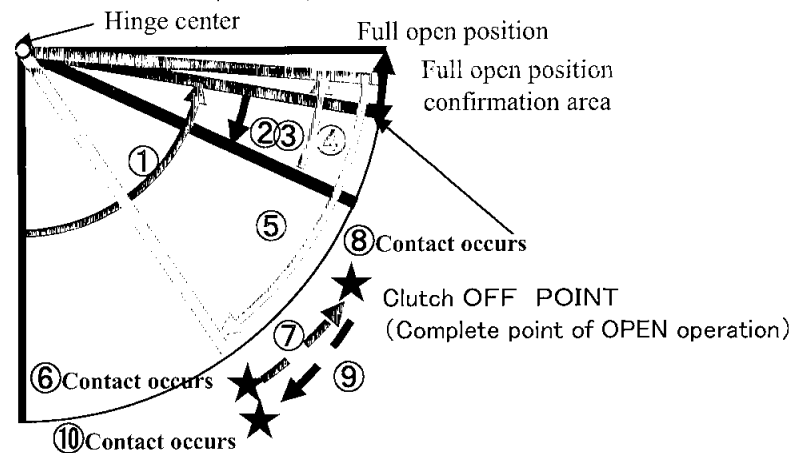
### As seen in attached video (slide 3)

Reverse function in closing operation during failure detection  
(Contact is occurred (sensed) on the way of reverse to open)

⑥ Contact occurs ⇒ ⑦ Rise toward the full open position confirmation area ⇒  
⑧ Contact occurs ⇒ ⑨ Then, close operation ⇒ ⑩ Contact occurs during closing  
⇒ System ends
