RE: NVS-213aan, PE08-029

EF CROSSMEMBER DESIGN CHANGE (EO NO: N3830284)

EF-CAR CROSS MEMBER PROCESS

EF CROSSMEMBER CORROSION PATH

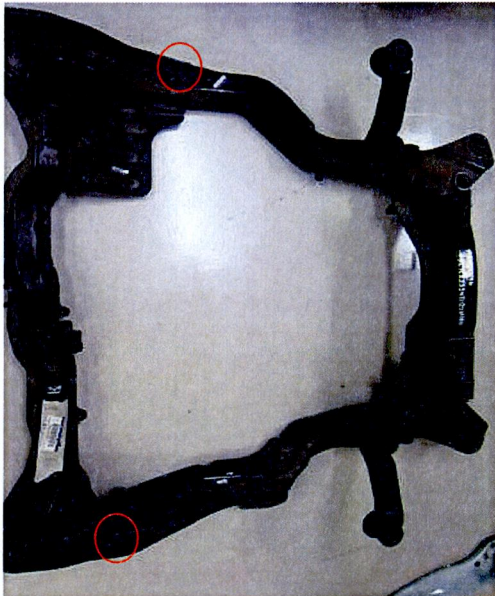
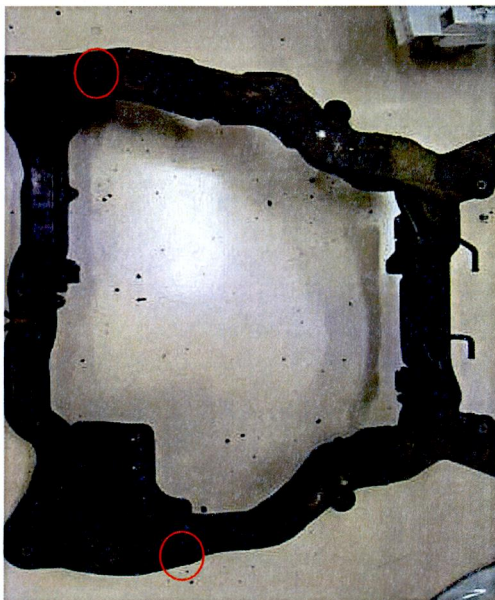
| BEFORE AND AFTER | | UPPER PANEL | | LOWER PANEL | | NUMBER OF HOLES |
|---|--|--|---|---|--|---|
| 개선前 ORIGINAL | | | <div>기존 HOLE UPR 2EA LWR 2EA (TOOL'G HOLE)</div> <div>ORIGINAL HOLES</div> | | | |

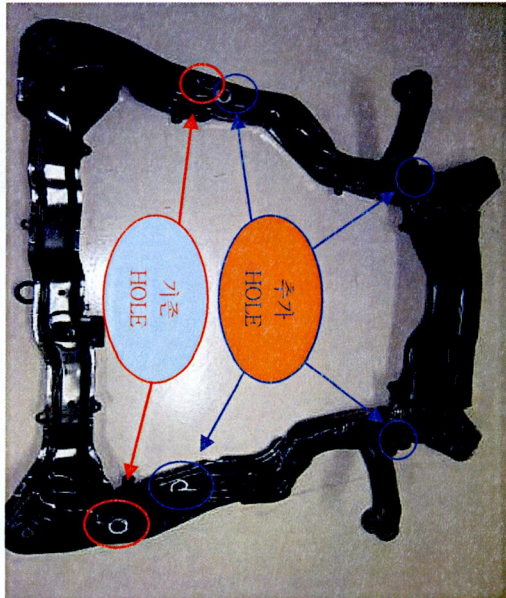
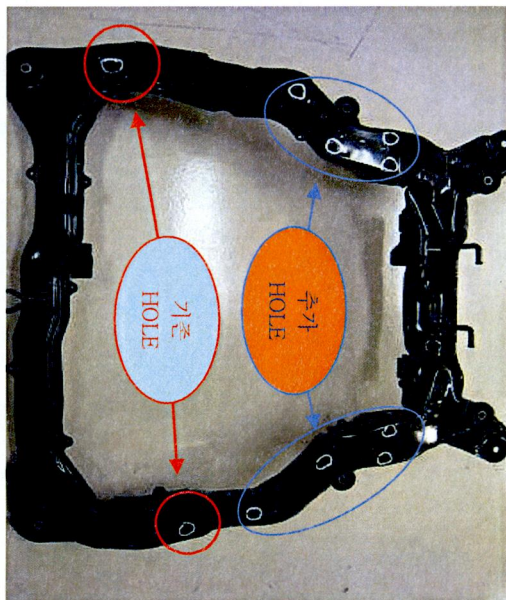
| BEFORE AND AFTER | | UPPER PANEL | | LOWER PANEL | | NUMBER OF HOLES |
|---|--|--|---|---|--|---|
| 개선後 COUNTER MEASURE | | | <div>기존 HOLE UPR 2EA LWR 2EA 추가 HOLE UPR 4EA LWR 8EA</div> <div>ADDED HOLES</div> | | | |

Hyundai made a running change in the crossmember as of November 20, 2003. As reflected in the engineering order, the change was part of a continuous quality improvement effort. The change was made to add drain holes to allow better painting access to increase the thickness of the paint within the crossmember.

| LINE | DATE | DESCRIPTION OF CHANGE | REMARK |
|---|---|---|---|
| ASSEMBLY LINE | 11/20/2003 | - CROSSMEMBER AND SIDEMEMBRR ADDED 12 DRAIN HOLES EACH (UPPER : $\Phi 15$ mm - 4EA, LOWER : $\Phi 12$ mm- 4EA, $\Phi 15$ mm - 4EA) | |

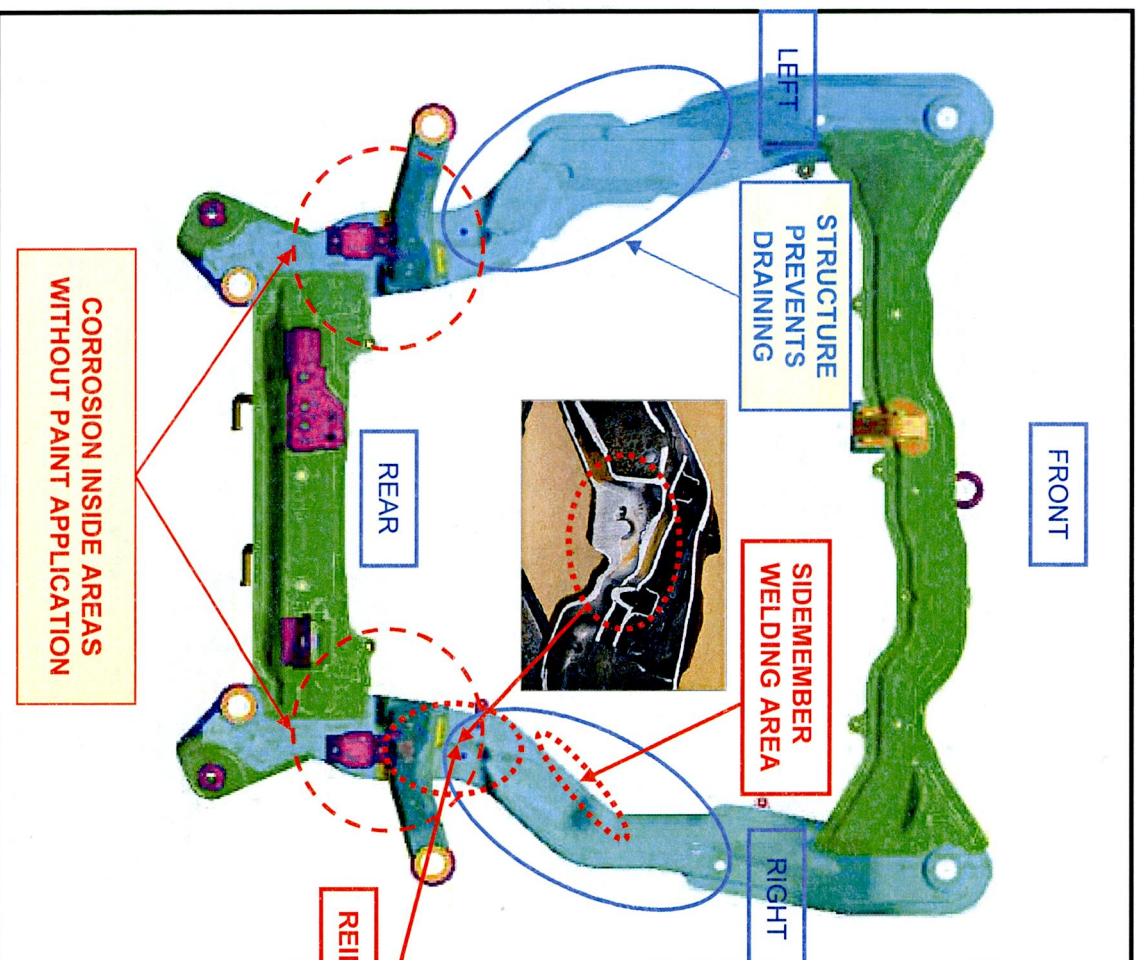
Road salt contamination of the crossmember complete assembly, which may be referred to as the subframe, can result from vehicle operation over roads that have been coated with salt to promote deicing during the winter months. Some of this road salt contamination may not be washed off of the subframe during normal car washing procedures. Some of the road salt contamination may find its way into the interior of the subframes and cause corrosion of the inner surfaces. Prolonged exposure to the road salts may result in corrosive damage to the subframe.

The corrosive damage to the subframe may be exhibited at various locations on the subframe. Depending upon the severity of the corrosion, porosity may develop in the surfaces of the subframe, which may weaken or cause separation of the porous portion of the subframe.

| | <p> <input checked="" type="checkbox"/> 겨울철 내부 보강판이 있어 도장이 미흡한 부위에 지속적으로 염화칼슘 등이 내부에 남아 있을 경우 발생 </p> <p> <input type="checkbox"/> 부식 부위 </p> <ul style="list-style-type: none"> - SIDE MEMBER 용접부 - 보강판넬부/코너부 도료칩투 부위 |

- DURING WINTER DRIVING ROAD SALT
MAY DEPOSIT NEAR REINFORCEMENTS
INSIDE THE CROSSMEMBER**
- AREAS OF CORROSION**
- SIDE MEMBER WELDING AREA**
 - AREA WHERE REINFORCEMENTS MAY
PREVENT ANTI-CORROSION TREATMENT**
- REINFORCEMENT PANEL AREA**
