RE: NVS-213aan, PE08-029

EF CROSSMEMBER DESIGN CHANGE (EO NO: N3830284)

CROSS MEMBER PART NUMBER CHANGE HISTORY
(BASED UPON SERVICE PARTS)

EF CROSSMEMBER CORROSION PATH

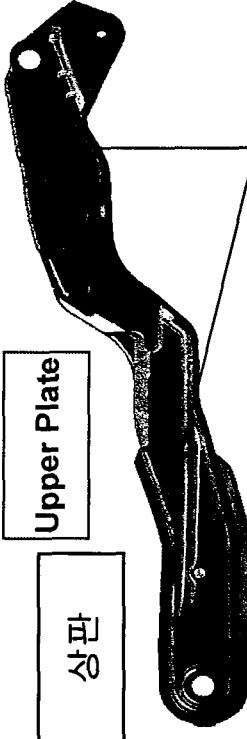
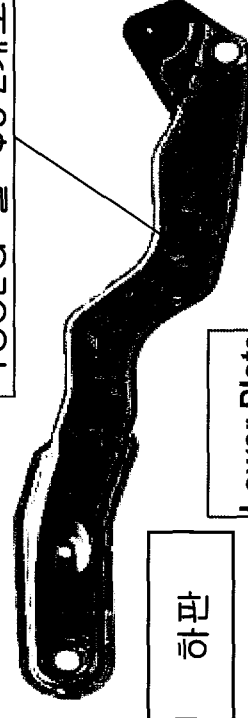
</div> <div> 도료유입 및 드레인 홀 없음 *TOOL'G 홀 $\phi 5$ 2개소 있음 </div> <div> No Drain Hole or Hole for Paint Application 2 Tooling Holes of 5 mm Diameter </div>		<div> <div>상판</div> <div>Upper Plate</div>

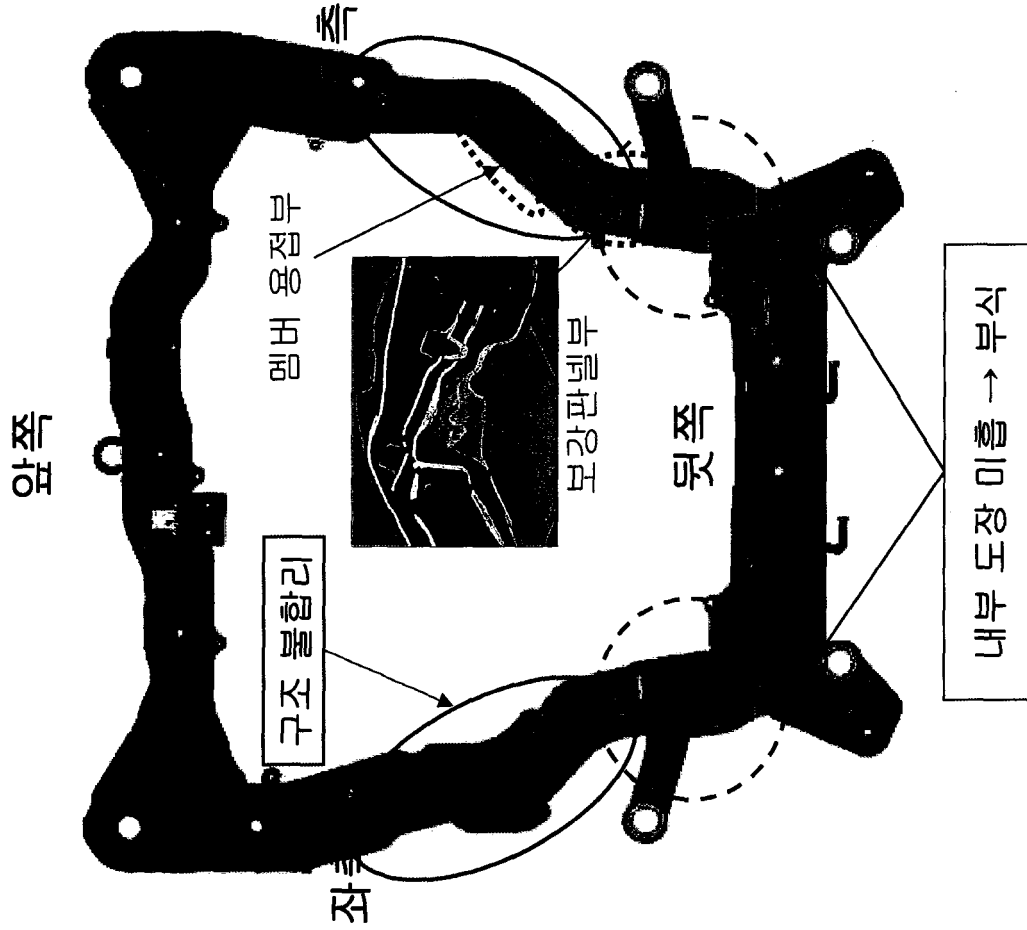
EF CROSSMEMBER COROSSION 경로

☒ 거울철 내부 보강판이 있어 도장이 미흡한 부위에 지속적으로 염화칼슘 등이 내부에 남아 있을 경우 발생

☐ 부식 부위

- SIDE MEMBER 용접부

- 보강판넬부/코너부 도료침투 부족 부위

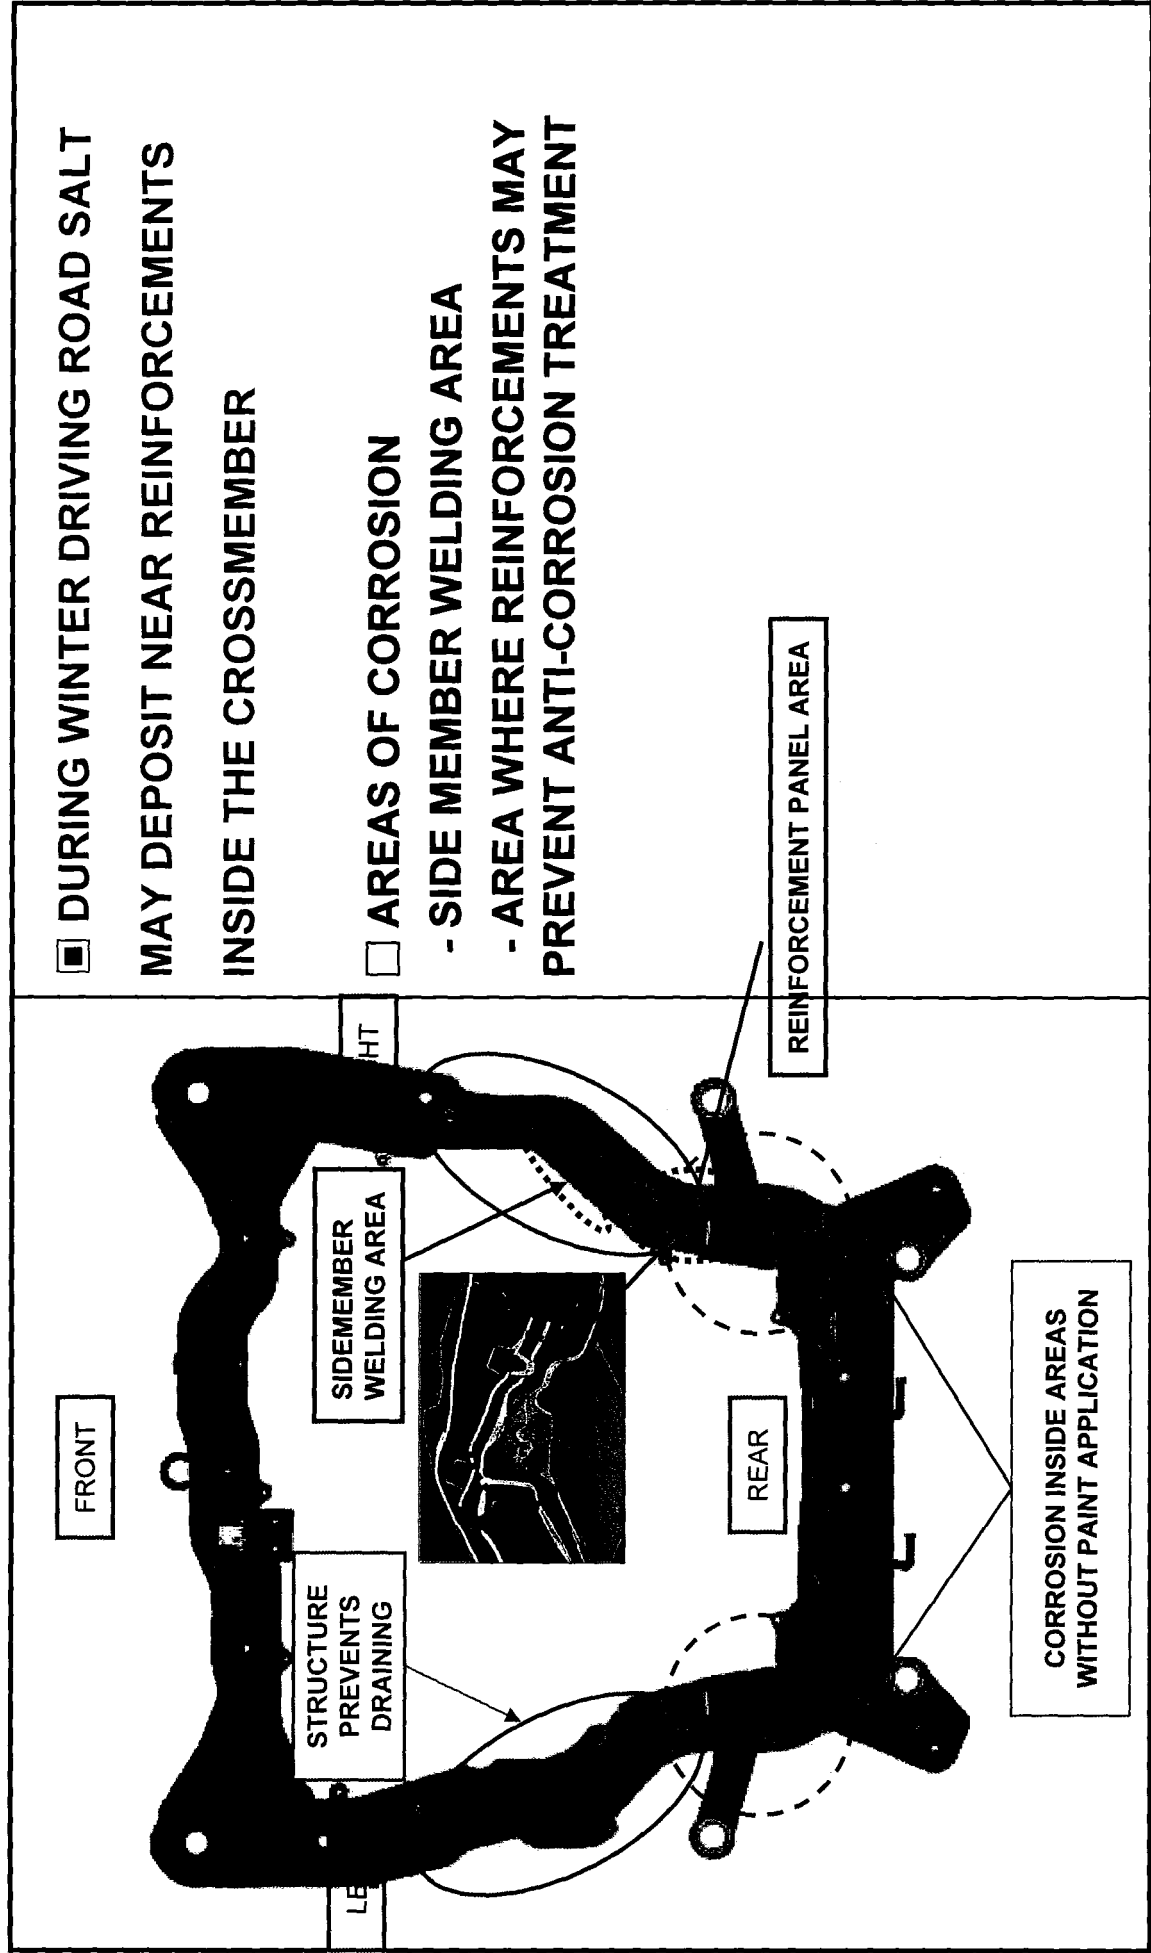
Road salt contamination of the crossmember complete assembly, which may be referred to as the subframe, can result from vehicle operation over roads that have been coated with salt to promote deicing during the winter months. Some of this road salt contamination may not be washed off of the subframe during normal car washing procedures. Some of the road salt contamination may find its way into the interior of the subframes and cause corrosion of the inner surfaces. Prolonged exposure to the road salts may result in corrosive damage to the subframe.

The corrosive damage to the subframe may be exhibited at various locations on the subframe. Depending upon the severity of the corrosion, porosity may develop in the surfaces of the subframe, which may weaken or cause separation of the porous portion of the subframe.
