TOYOTA MOTOR NORTH AMERICA, INC.

September 30, 2008

Re: NVS-213aan; PE08-041

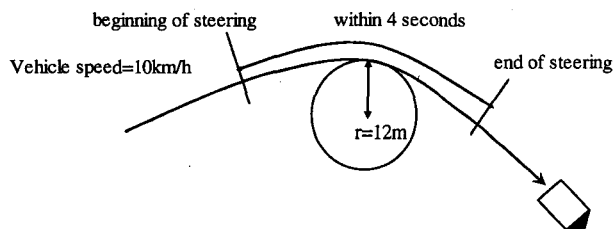
While steering effort is not regulated in the United States, the European Union (through the United Nations) has ECE 79 for vehicles sold in those countries. As prescribed in ECE 79, a vehicle of the Sienna class (M1) would need to maneuver into a 12 m turning circle by steering the vehicle within 4 seconds with a steering input force of less than 15 daN with a normally functioning power steering system and into a 20 m turning circle within 4 seconds with a steering input of less than 30 daN when the system has failed.

Intact Steering (15 daN max.)

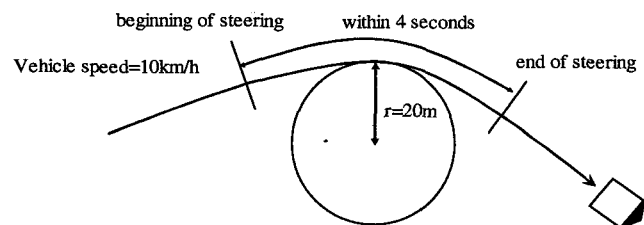
Failed Steering (30 daN max.)

Toyota conducted a similar test for a normally functioning power steering on a test vehicle with the intermediate shaft which exhibited the highest steering effort described above. For the test, the vehicle is loaded to the Gross Vehicle Weight Rating (GVWR) with the front axle is loaded to its rated capacity. Force measurements are calculated at the steering wheel rim. The vehicle speed is very low, 10 km/hr, and maneuvers into a 10 m turning circle instead of 12 m turning circle. The resulting steering effort was measured at maximum 3.28 daN, which fully complies with the regulation for a normally functioning steering system prescribed in ECE 79 with ample margin (78%).
