**National Highway
Traffic Safety
Administration**

ODI RESUME

Investigation: EA 09-004
Prompted by: PE08-062
Date Opened: 03/20/2009
Investigator: Ali Motamedamin
Approver: Richard Boyd
Subject: Turn Signal Lamps

Engineering Analysis EA09-004 Closing Report

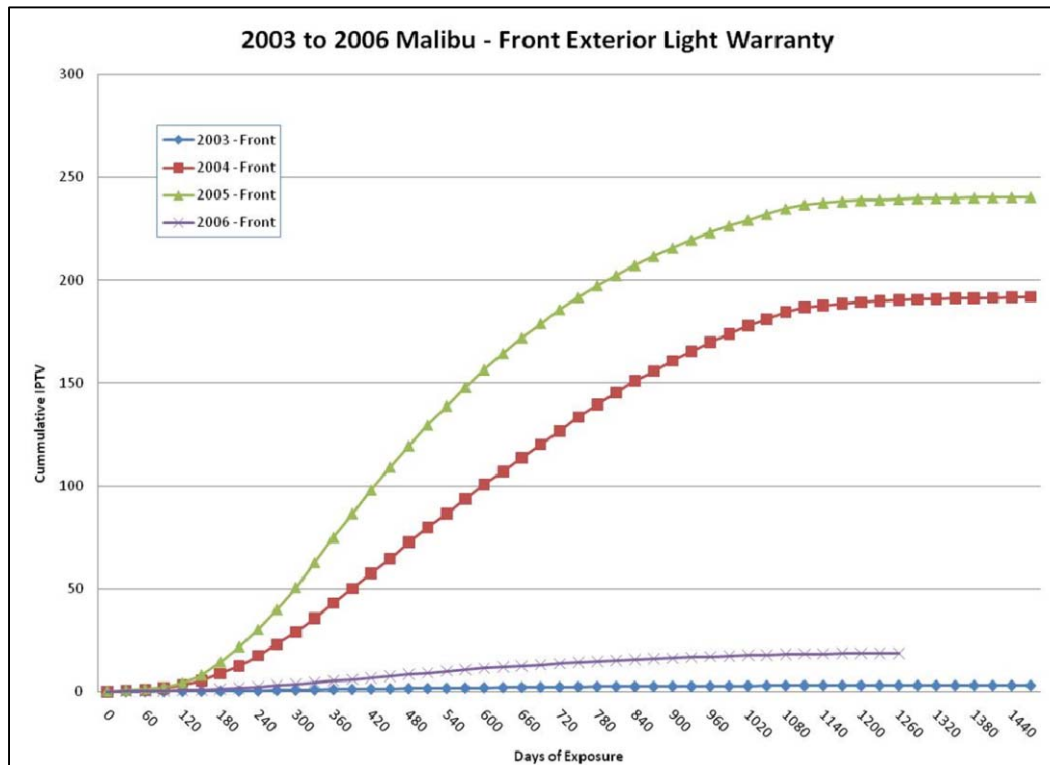
Figure 1: Subject vehicle cumulative front exterior light warranty claims versus days in service (1080 days = 3 years)

Bulbs on subject MY 2004 and 2005 vehicles appear to be failing at a higher rate than those on peer MY 2003 and 2006 vehicles. From Figure 1 above, the warranty chart indicates that the MY 2003 and MY 2006, which use the (reduced voltage) low beam bulb filament for the DRL functionality, have lower levels of front bulb warranty claims compared to the subject vehicles, which have the (full voltage) turn signal based DRL. The graph appears to support that dual turn signal/DRL functionality reduces bulb life.

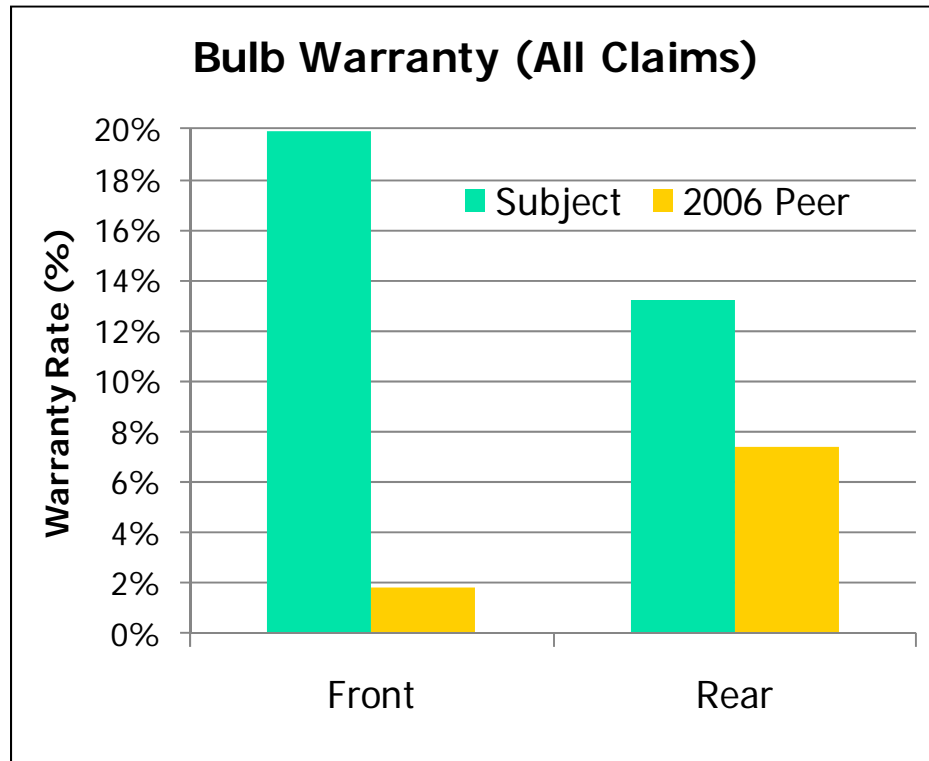
Figure 2 below provides data comparing the warranty claim rates for front and rear turn signal bulbs between the subject vehicles and peer MY 2006 vehicles. The data indicate the front turn signal/DRL and rear turn bulbs on subject vehicles fail at a higher rate than the MY 2006 peer. One significant difference is that the MY 2006 vehicles do not use the front turn signal for the DRL function (thus the front bulb has a lower duty cycle). Additionally the MY 2006 peers did not contain the bulb quality issues described in Table 1 above, which further explains the differences in front and rear bulb warranty between the subject and peer vehicles.

Figure 2: Comparison of Warranty Claims rate between the Subject (turn signal based DRL) and MY 2006 Peer (headlamp based DRL).

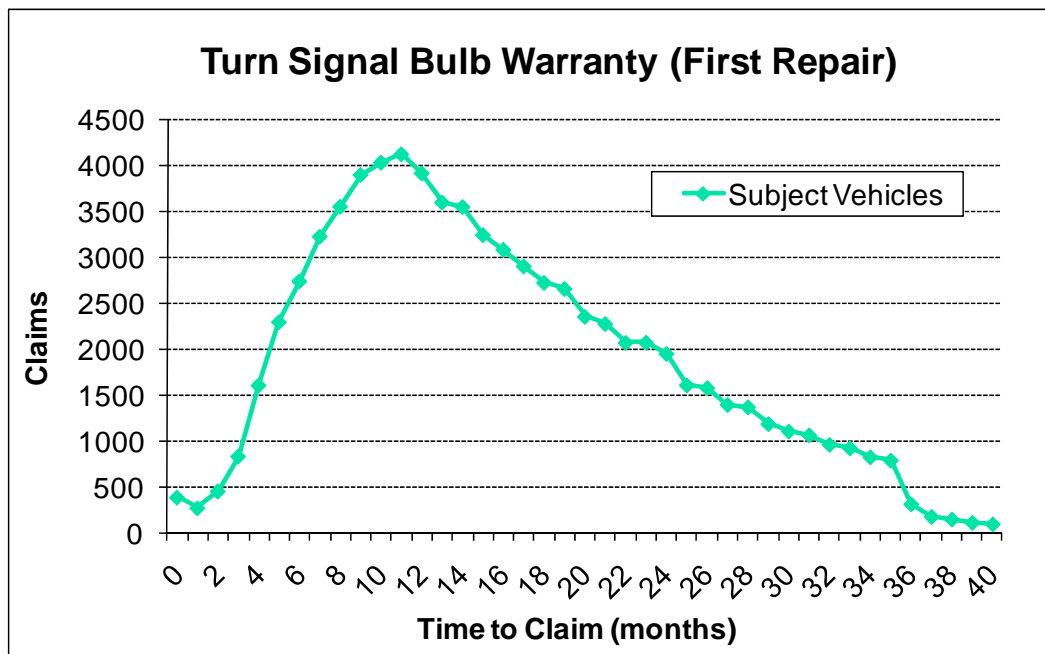
Figure 3 below shows a plot of front turn signal/DRL and rear turn signal bulb warranty claims versus the age of the vehicle (in months) the first time the bulb was replaced on a particular vehicle.² (Subsequent bulb replacement(s) on the same vehicle are not represented on Figure 3.) The plot appears to indicate that the warranty claim rate was highest during the first 12 months of the vehicle's service life and decreased thereafter. This data suggests an early life failure mechanism with a declining failure trend.³

Figure 3: Turn Signal Bulb Warranty versus Age at Time of Claim

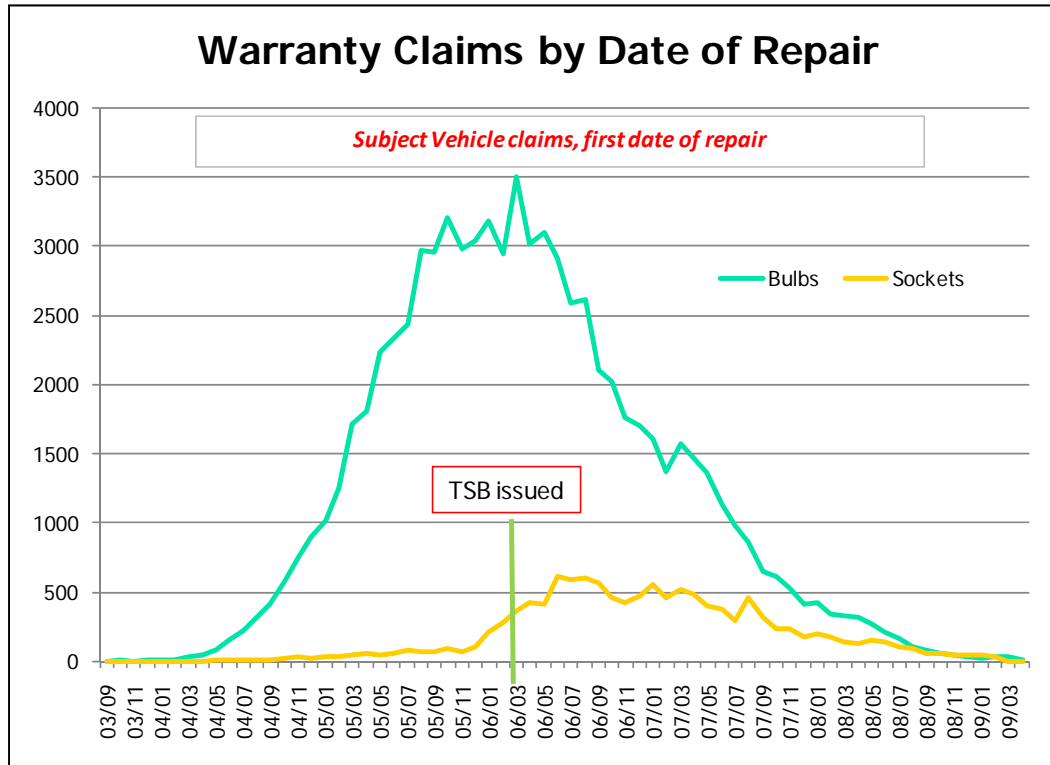
Figure 4 below is a plot of the turn signal bulb and socket warranty claims versus the date of warranty repair.⁴ The chart indicates that, starting in calendar year (CY) 2005, GM received significantly more warranty claims for turn signal bulb replacement than claims for socket replacement. The claims for both the bulbs and the sockets fell after GM issued its TSB in March 2006. Warranty coverage expired for most subject vehicles approximately in mid to late CY 2008. The TSB addressing component bulb quality issues apparently lowered the failure rate of the bulbs.

Figure 4: Malibu Bulb/Socket Claims versus Date of Repair.

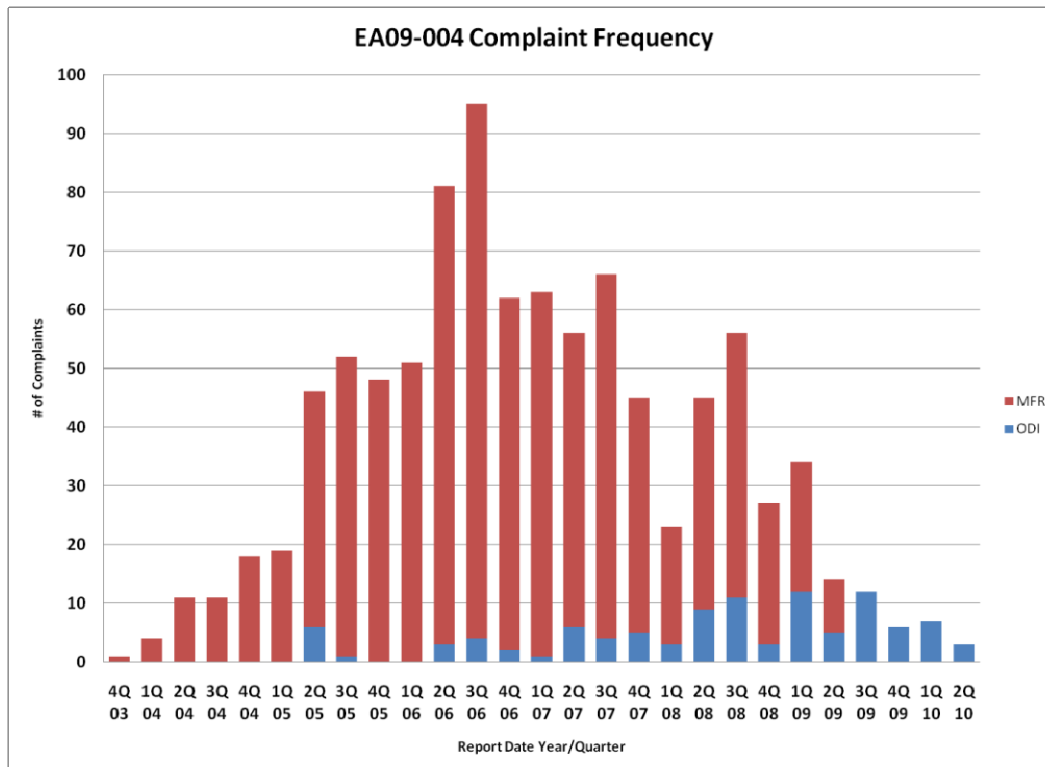
Figure 5 below shows the numbers of subject vehicle consumer complaints for turn signal related concerns (bulbs and sockets), by date of receipt, as reported to ODI and GM. The complaints increased until around mid 2006, about the time GM issued the TSB, and decreased thereafter. This declining complaint trend is consistent with the likelihood that most of the original bulbs have been replaced and those remaining in use likely will soon be replaced. The warranty rate for subject vehicle bulb sockets is low (3.9% in total) and, like the bulb replacement warranty rate, shows a declining trend. Thus the alleged problem has passed.

Figure 5: Malibu Complaint Frequency by Quarter.
