## ODI RESUME

| <b>Investigation:</b> | EA 09-008 | <b>Date Closed:</b> | 08/27/2010 |
| <b>Subject:</b> | Horton Fan Hub Failures | | |

## ENGINEERING ANALYSIS CLOSING REPORT

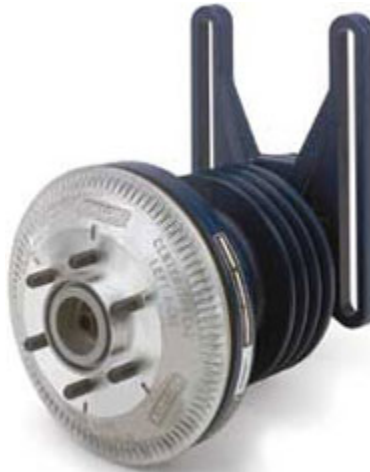
Figure 1: Subject Component

**DESCRIPTION OF COMPONENT/VEHICLE SYSTEM:** The engine cooling fan hub mounts a fan to the front of the engine harnessing the rotation of the engine's crankshaft to cool the engine. Figure 1: Subject Component, visually displays a typical Horton Fan Hub. Horton's on/off design is spring-engaged and air-disengaged. This allows the hub to free spin when the engine is below a defined temperature. When the coolant temperature exceeds a predetermined value, air pressure is removed from the hub and the springs cause the friction disks to engage, therefore spinning the engine cooling fan to draw air through the radiator. Once the coolant temperature has been reduced to the predetermined lower limit air pressure is returned to the hub and the clutch discs disengage.

**DESCRIPTION OF ALLEGED DEFECT:** The alleged defect is a premature failure of the fan hub bearing. A failure of the fan hub bearing can cause the fan to separate from the fan hub, which leads to the engine overheating and the vehicle becoming disabled. The subject and peer vehicles use a progressive shut-down system which, through a series of steps such as decreasing engine power and vehicle speed, eventually leads the truck to shut off the engine, leaving the truck disabled until the engine cools back down.

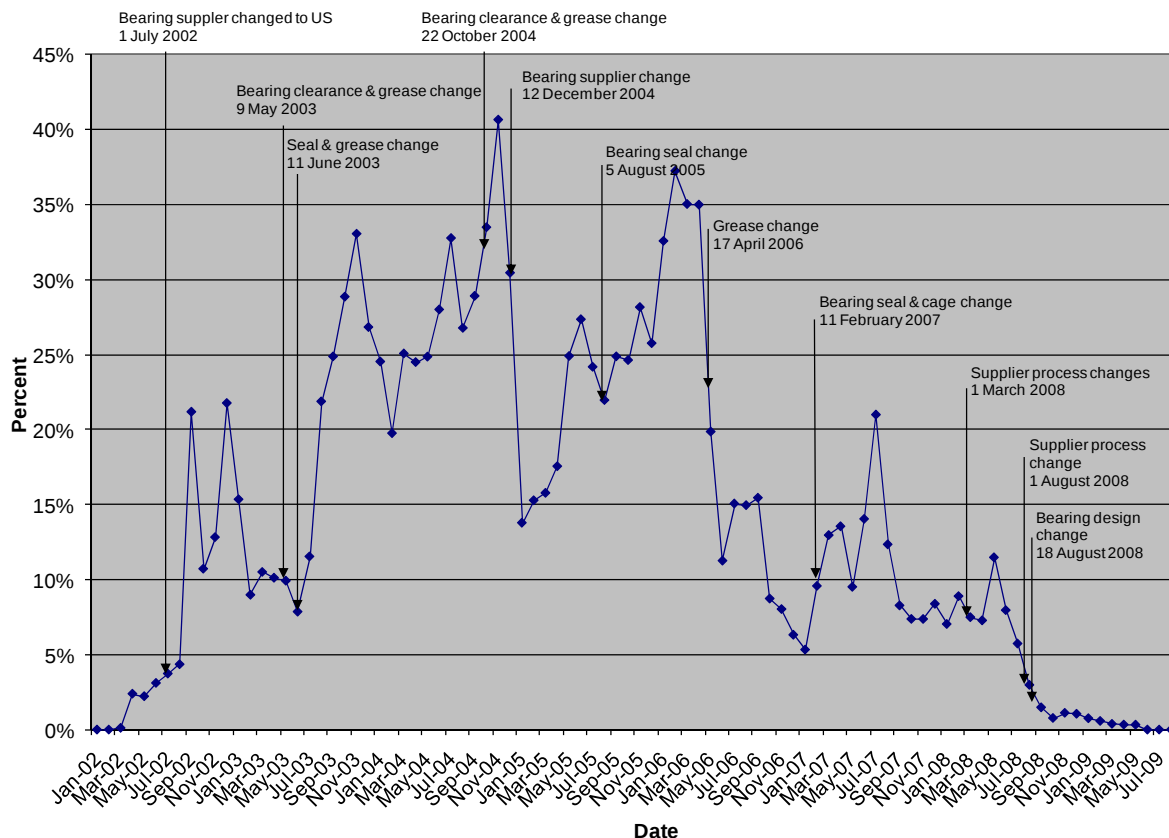
Figure 2:  
Normalized Warranty Data: Failures per Build Month

Figure 2: Normalized Warranty Data: Failure per Build Month, visually displays the overall warranty rate of the alleged defect for subject and peer vehicles. Also shown on the graph are all the dates that design changes were implemented on the subject fan hub.

The warranty rate peaked in November 2004 at 42% and again in February 2006 at 37%. Since the last design change in August 2008 the warranty rate has stayed below one percent.

**MANUFACTURE, DESIGN, MATERIAL COMPOSITION MODIFICATIONS:** The subject and peer vehicles received eleven (11) design, material or supplier changes. These changes are graphically displayed on Figure 2: Normalized Warranty Data: Failure per Build Month. The first change was a bearing supplier change on 1 July 2002. A bearing clearance and grease change was initiated on 9 May 2003. Another grease change and bearing seal change was initiated 11 June 2003. The bearing clearance was changed again along with the grease on 22 October 2004. Seventeen months after the last bearing supplier change, it was changed again on 12 December 2004. This was the first change that had a dramatic improvement. However the improvement did not last and on 5 August 2005 the bearing seal was changed again. This did not improve the product so on 17 April 2006 the grease was changed for the fourth time, this time resulting in significant improvement. The bearing seal and cage was changed on 11 February 2007. The supplier changed some processes 1 March 2008 and again 1 August 2008. The final change was made 18 August 2008 and appears to have fixed the problem.

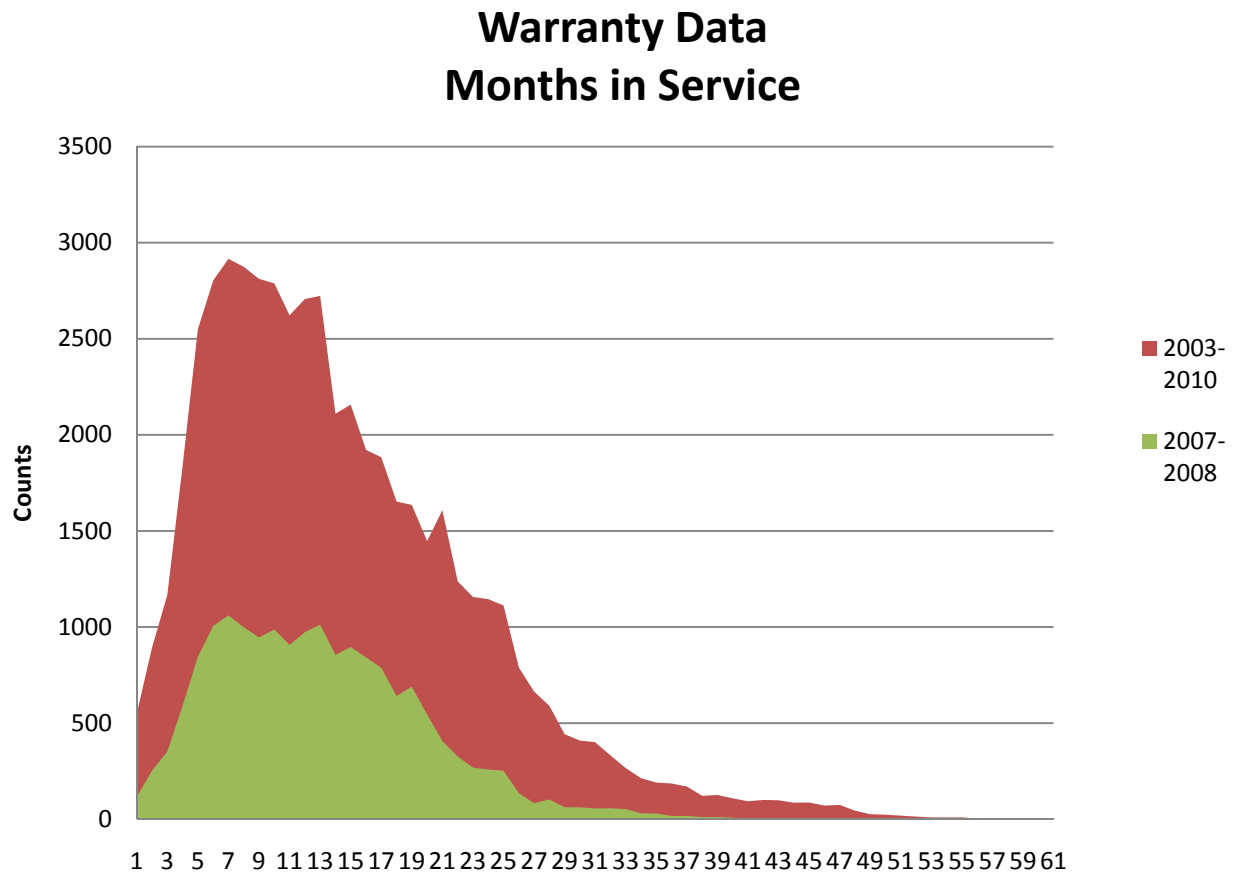
Figure 3: Time in Service

ODI considered the average time and mileage to failure. Figure 3: Time in Service, reveals that the subject vehicle's peak failure time was between seven and thirteen months in service. Figure 4: Failure Mileage reveals that the majority of subject vehicle hubs failed within 100,000 mile and nearly all failures occurred within 350,000 miles.

Horton made several product improvements on PACCAR's behalf over the duration of the peer/subject vehicles production. Looking at the time to failure ODI noted that the failure rate appeared to peak between seven and thirteen months. The final product change was made in August 2008, twenty-two months prior to the current date (10 August 2010). Nearly all hub failures occurred within thirty-five months of their build date.
