**National Highway
Traffic Safety
Administration**

ODI RESUME

Investigation: EA 09-010
Prompted by: RQ08-058
Date Opened: 06/18/2009
Investigator: Tom Bowman
Approver: Richard Boyd
Subject: Air Brake System

Manufacturer: NEW FLYER INDUSTRIES LTD
Products: MY 2004 -2008 NEW FLYER TRANSIT VEHICLES
Population: 1,000
Problem Description: DIMINISHED VEHICLE BRAKING / STOPPING PERFORMANCE

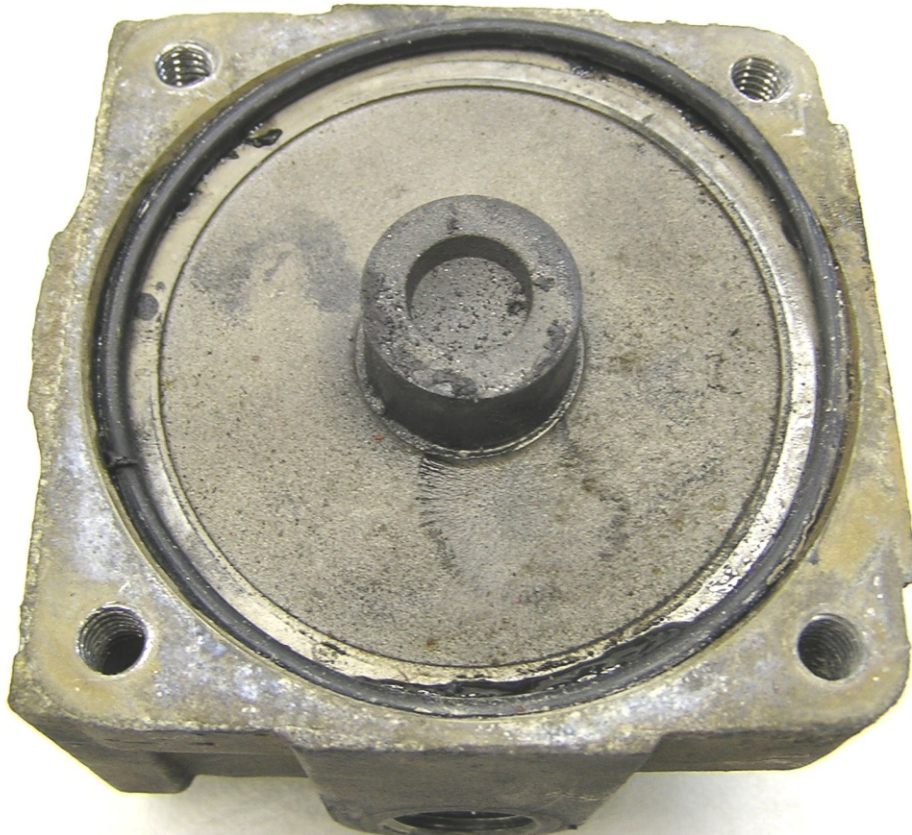
Top of Piston with Cover O-Ring

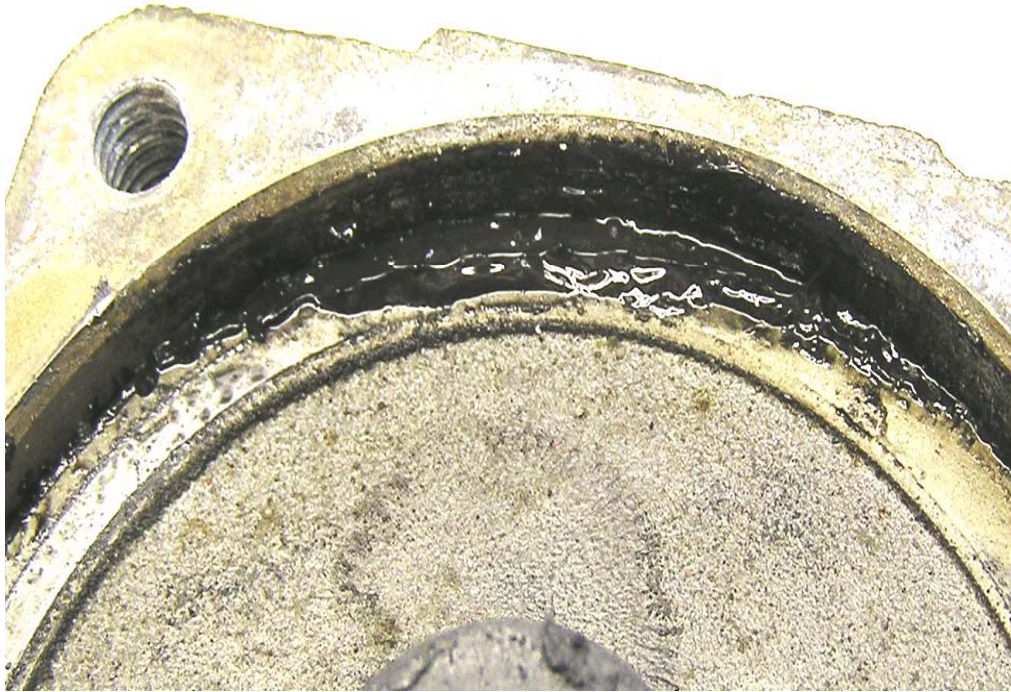
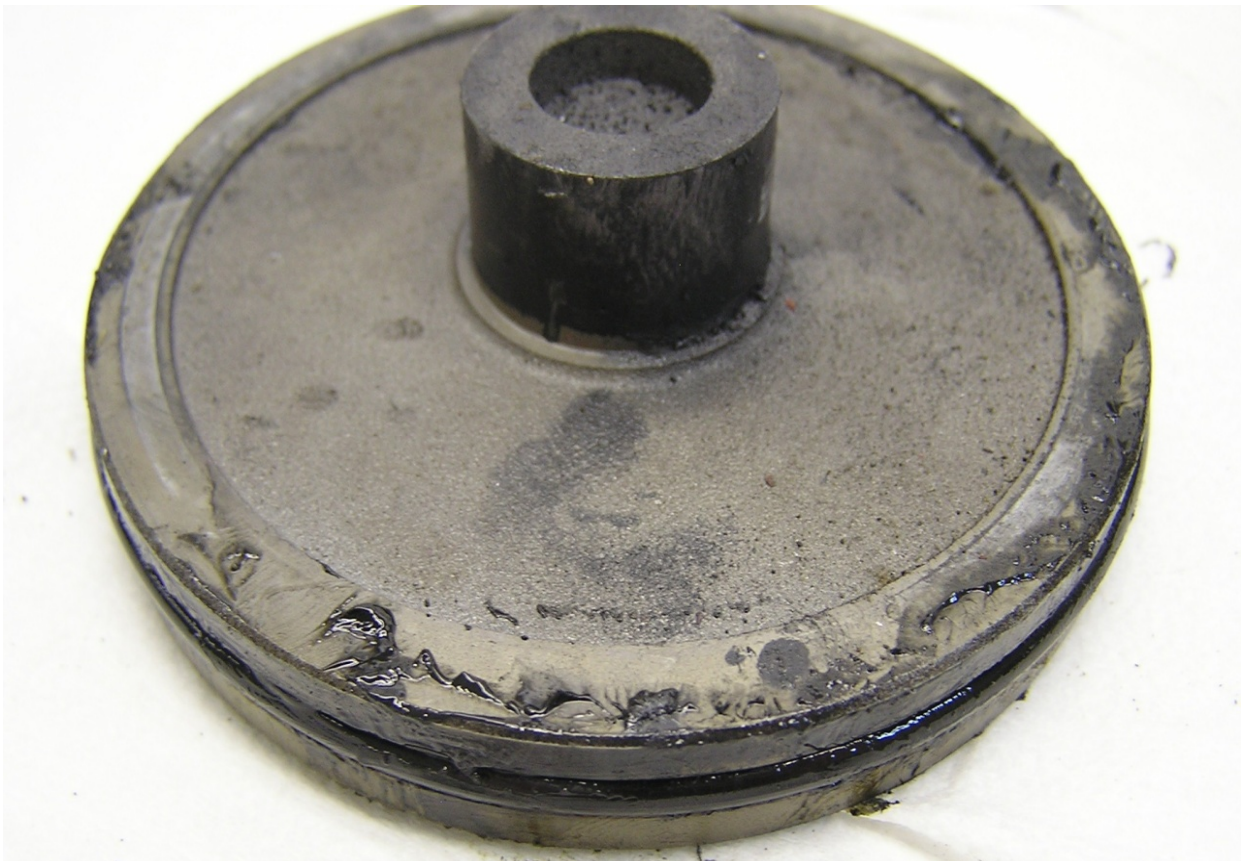
The valve was then disassembled to check for any liquid or particulate contamination and determine if any seal degradation has occurred. The valve had a moderate amount of greasy, oily deposits in the internal delivery cavity, as well as the underside of the piston.

Top of Piston with Sticky Deposits

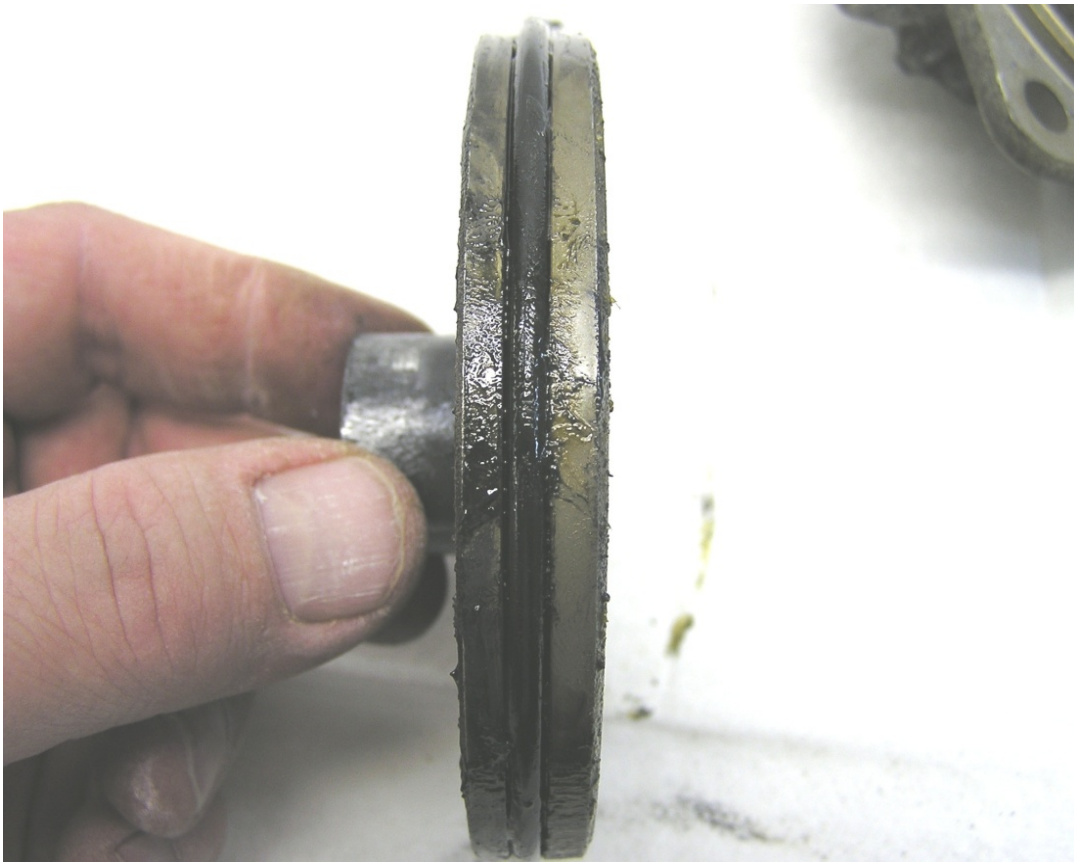
Piston O-Ring

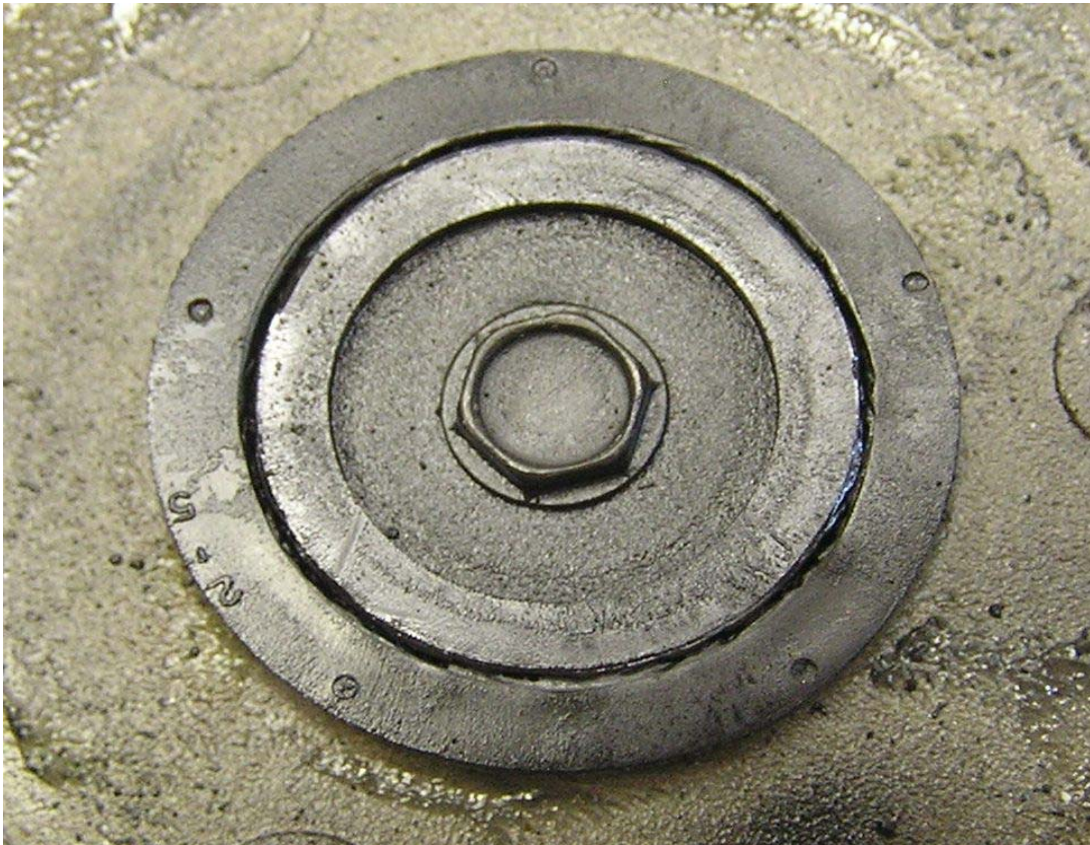
The Inlet seal was swollen and pitted around the seat landing area had a significant amount of set. The exhaust seal had a deep cut where the seat lands on the seal. The following pictures show the internal valve cavities and the inlet and exhaust seals:

Exhaust Seal & Piston Underside

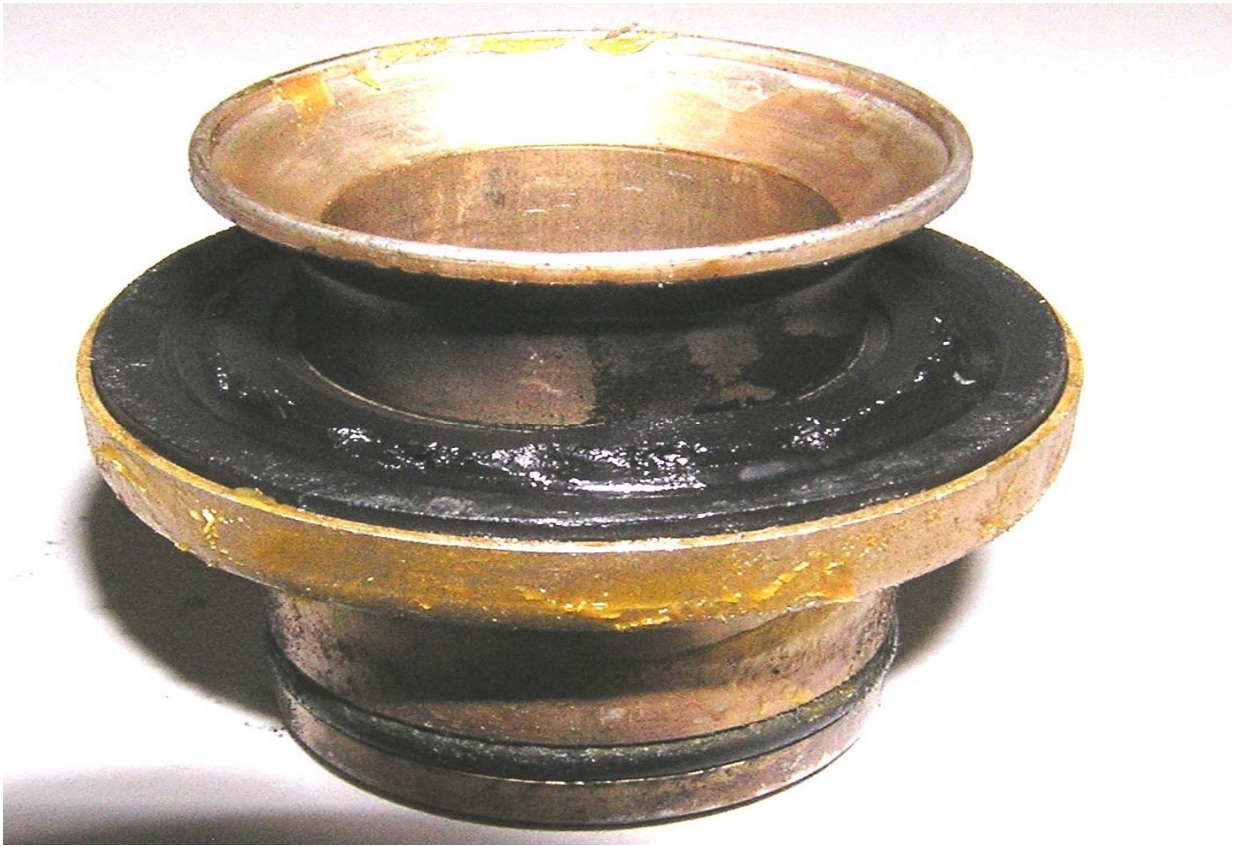
Modulation Tube with Inlet Seal and Exhaust Seat

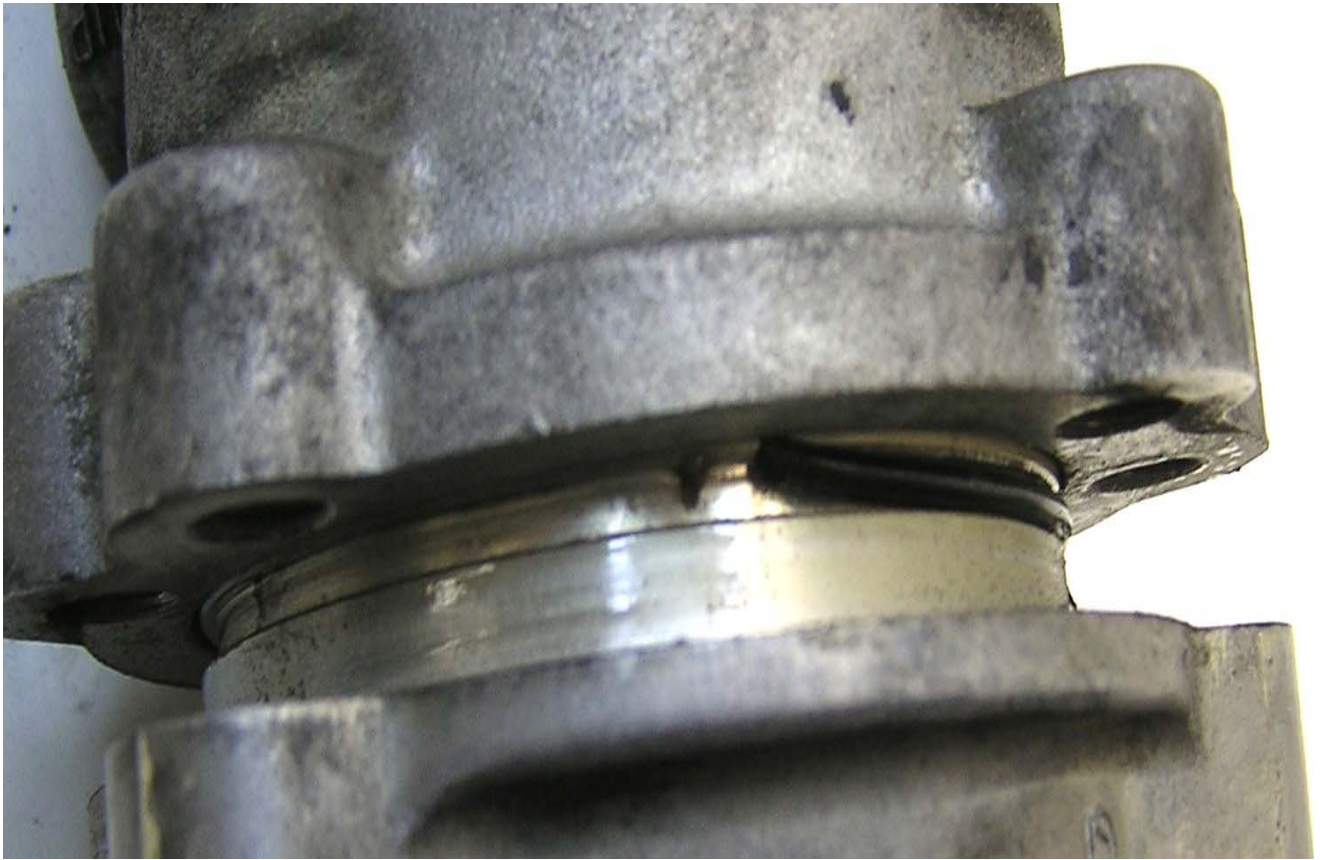
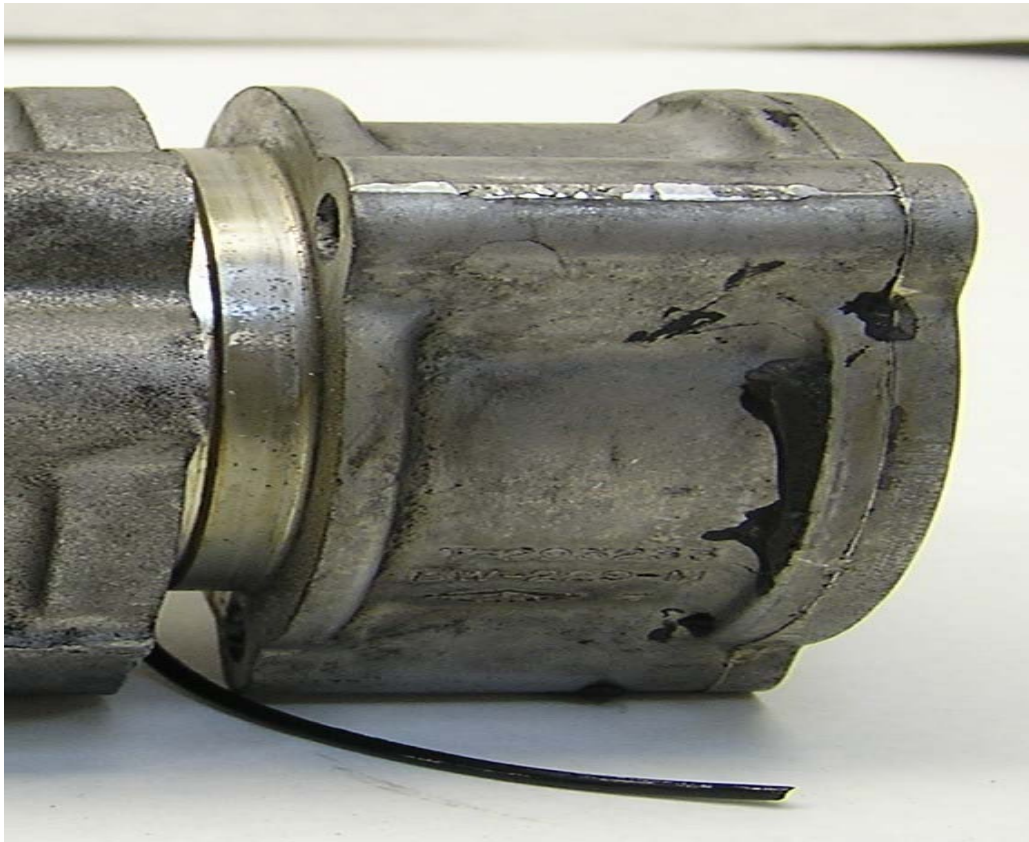
It was discovered that the O-ring seal between the primary body and steel spring adapter had been cut, resulting in a leakage path from the primary supply cavity to atmosphere. The valve showed a moderate amount of liquid oil contamination on both the primary and secondary pistons and in both delivery cavities. Both inlet/exhaust seals appeared to show some wear at the seat contact points. The following pictures illustrate the condition of the internal seals and cavities:

Steel Spring Adapter & Cut O-Ring

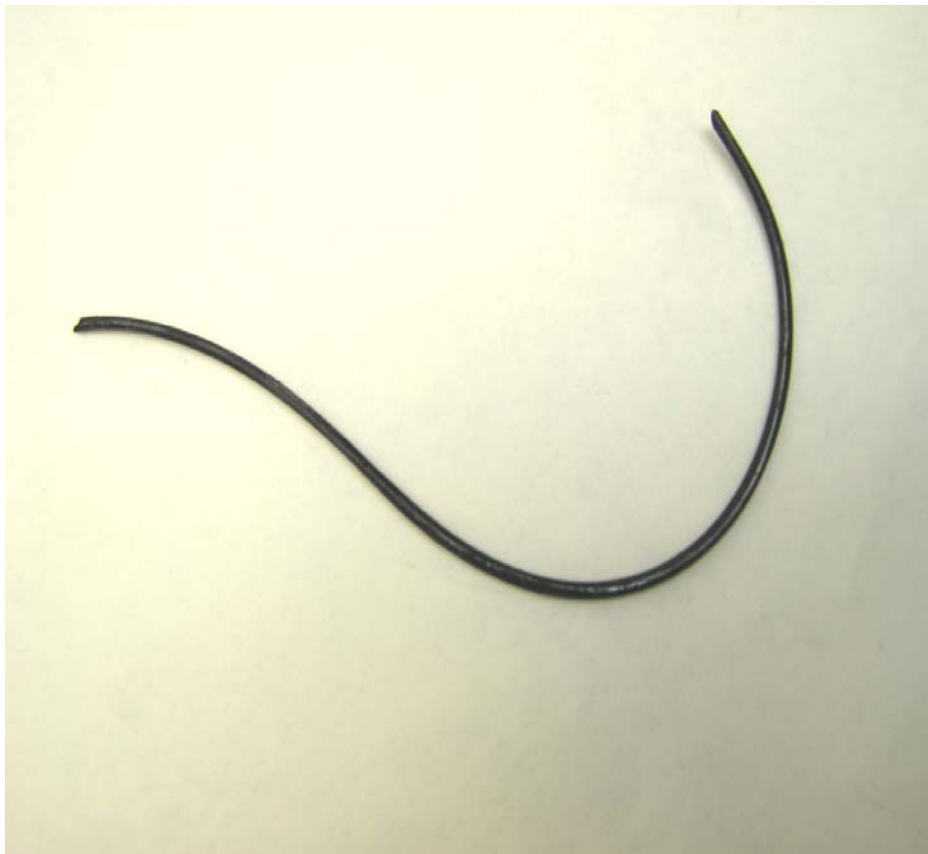
Cut O-Ring

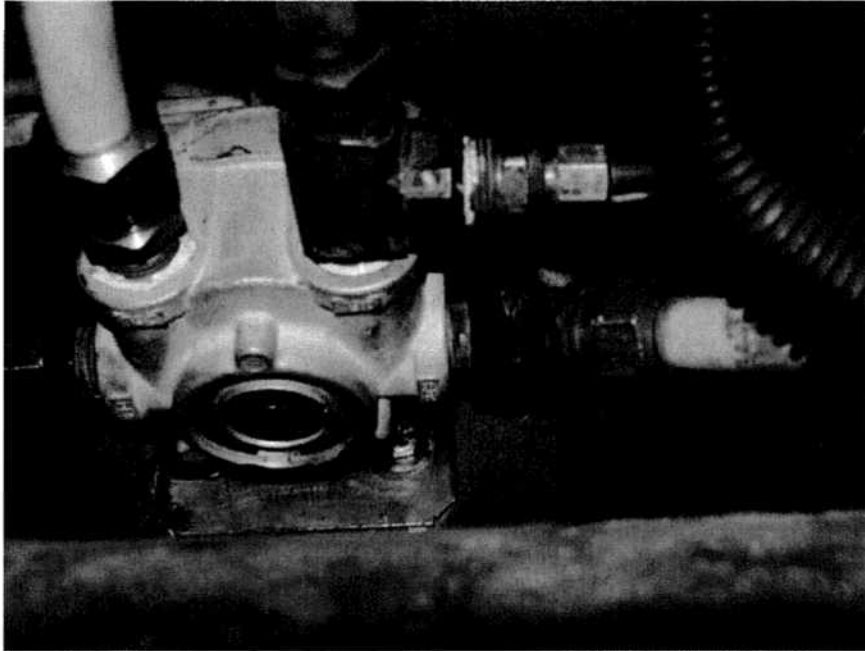
Photograph 1 – New replacement rear brake control valve shown in the as-installed position in a vehicle evaluated at a northeast transit bus operation. New valve assemblies were installed so that the previously-installed valves could be removed and inspected at the manufacturers' laboratories as part of this investigation. Source: ODI photograph taken at site visit, October 27-28, 2009.

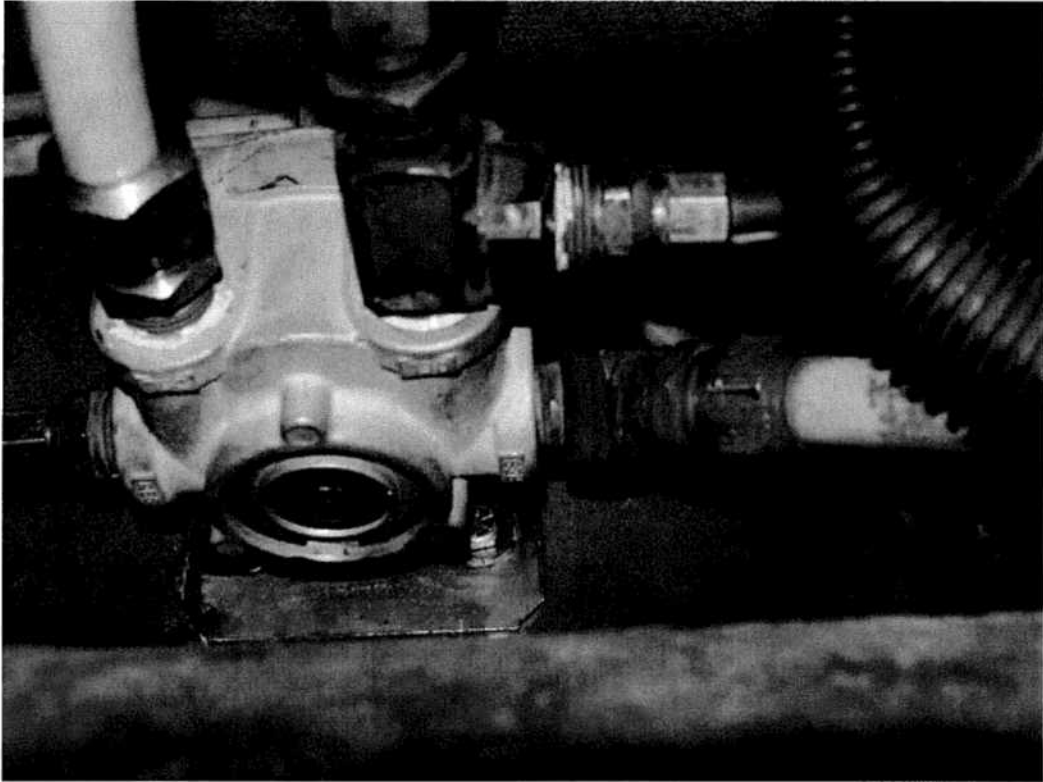
New replacement rear brake control valve as installed.
