**National Highway  
Traffic Safety  
Administration**

## ODI RESUME

**Investigation:** EA 09-013  
**Prompted by:** PE09-020  
**Date Opened:** 08/18/2009  
**Investigator:** Derek Rinehardt  
**Approver:** Frank Borris  
**Subject:** Vehicle Rollaway Allegations

## EA09-013 Closing Report

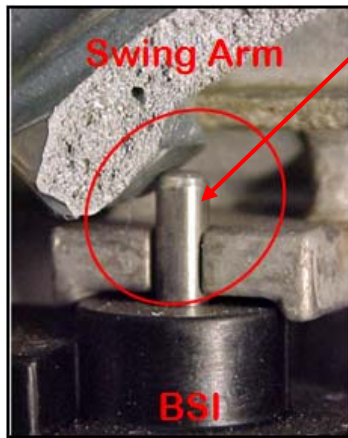
**Figure 8**

When production of the subject vehicles began in MY 2002, incorporated into the design of the BSI solenoid was a delay in the retraction of the BSI solenoid pin of up to 0.4 second from the time the driver applied the brakes. This delay in the retraction of the pin was implemented to resolve a rattle issue created by the BSI solenoid that was discovered during pre-production.

Drivers who apply the brakes and shift from Reverse (or Drive / Neutral) to Park within the 0.4 second time frame (or drivers who do not apply the brakes at all when shifting into Park) may experience a condition where there is contact of the pin to the steering column swing arm ramp because the BSI solenoid pin has not retracted (see Figure 8.) Repeated contact of the BSI solenoid pin to the swing arm ramp can create a deformation of the swing arm. (See Figure 9.) Depending on the size of the deformation, the BSI solenoid pin can become caught in the deformation, resulting in an increased amount of force required for the driver to shift to Park or, if the deformation is deep enough, the inability of the driver to shift to Park. As explained below, in this situation the gear indicator (the PRNDL) on the dashboard will indicate that the vehicle is not in Park.

**BSI Solenoid Pin**

On June 14, 2004, Ford released into production a BSI Solenoid with the pin retraction time (from when the brakes are applied) shortened from 0.4 to 0.03 seconds. This was also the date the revised BSI Solenoid was released as a serviceable component separate from the steering column

On November 15, 2004, Ford released Technical Service Bulletin (TSB) 04-22-12.<sup>5</sup> The TSB stated that some 2002-2005 Explorer 4dr/Mountaineer vehicles may require a greater effort to move the gear shift lever to Park, possibly due to a time delay with the BSI solenoid pin retraction. The recommended action was to replace the BSI Solenoid with a shorter Pin retraction time.

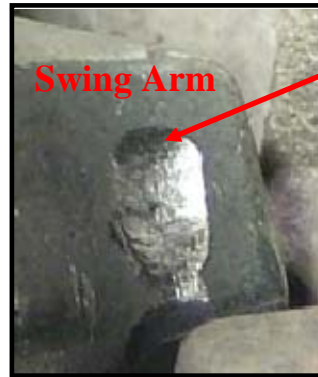
**Figure 9**

**Deformation created in the swing arm.**

After repeated shifts to Park (within 0.4 seconds after applying the brakes) resulting in contact of the BSI solenoid pin with the swing arm, the deformation described above may increase in depth. The depth of the deformation depends on the force and the rate at which the driver applies it to the gear shift lever. The deeper the deformation, the greater is the force the driver needs to apply to the gear shift lever to place the vehicle in Park. Thus, a driver may experience difficulty shifting the gear shift lever to Park. If the deformation is deep enough, the driver may not be able to shift to Park at all.

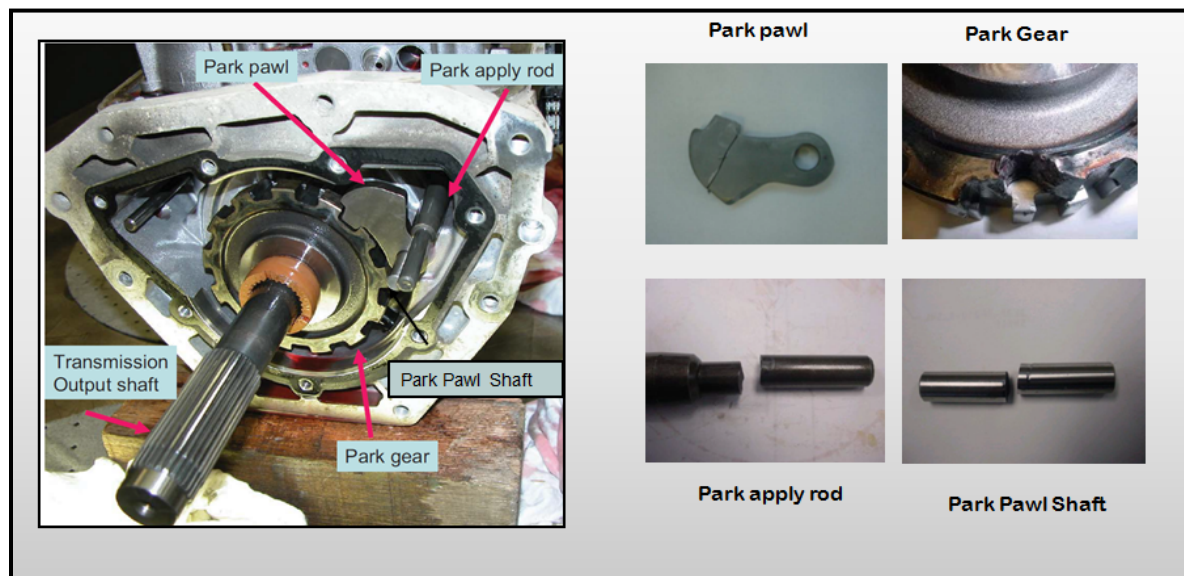
**Figure 10**

Multiple components of the automatic transmission parking system, including the park pawl and the park apply rod, can be damaged (as shown in Figure 10 below) as a result of impulse loading during transit by rail or a car hauler if the park brake is not applied. Failure of one or more of these components can result in a failure to prevent rotation of the transmission output shaft. As a result, the vehicle is able to move, even though the PRNDL indicates to the driver the vehicle is in Park (see Figure 11 on the following page).

On February 27 2004, Ford issued Quality Bulletin #171 to the vehicle assembly plants that manufactured Explorer platform-based vehicles. The bulletin emphasized the requirement that the parking brake must be fully applied once vehicles are loaded, constrained and prepped for shipment on rail or car haulers. The bulletin explained that full parking brake application decreases the drive line torque (rotation of the transmission output shaft) that stresses the transmission park system during impulse loading events as seen during rail or car hauler shipment.

No TSBs were released to the dealer network. An internal Quality Assurance Bulletin (#171)<sup>6</sup> was sent to assembly plants and logistic personnel on February 27, 2004 to emphasize the requirement that Parking Brake must be applied to the maximum when shipping the subject vehicles.

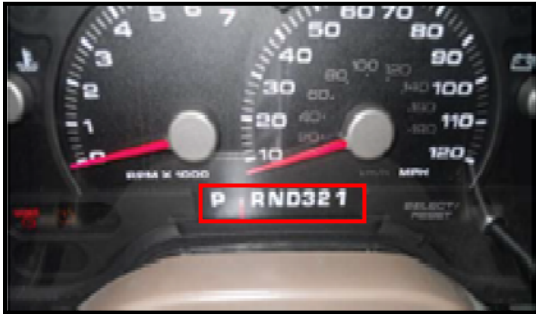
Figure 12.1

If the driver is not able to shift into Park, the vehicle will be placed in the following state: (1) the PRNDL will show the vehicle is not in Park (“P”) (Figure 12.1); (2) the transmission parking pawl is not engaged with the parking gear (Figure 12.2), potentially allowing the vehicle to move; and (3) the key cannot be removed from the ignition because the vehicle is not in Park (if the gear shift lever is not in contact with the Park Detection Switch, the key cannot be removed) (Figure 12.3). A vehicle in this state may rollaway unexpectedly, particularly if the driver does not observe the PRNDL and believes the vehicle to be in Park. For example, one warranty claim states that the “transmission selector will not go into park at times. The vehicle started rolling back thinking it was in Park.”<sup>3</sup> The technician road tested the vehicle and “verified that the shifter won’t go into park all the time removed the steering column trim, the steering column and replaced the shifter lock solenoid.”

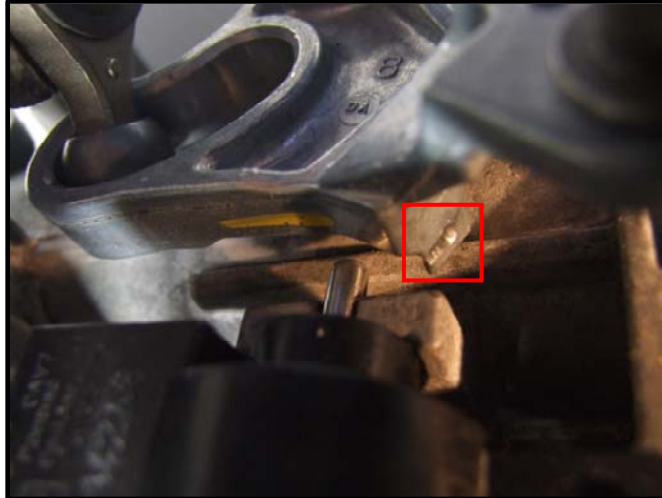
**Figure 13**

went all the way to park, but it really stops (and won't move) at Reverse. Letting off the brake, assuming it is in Park, causes the vehicle to roll backwards.” The vehicle inspection showed that a small divot and gouge existed in the steering column swing arm (see Figure 13 below) and that the divot was making it difficult to engage Park unless the brake pedal was depressed to activate the BSI solenoid.

Further inspection showed that, under normal operating conditions (ignition on, then depress the brake pedal) the BSI solenoid pin had a delay of  $\sim\frac{1}{2}$  second from the time that the brake was depressed until the BSI solenoid pin retracted.

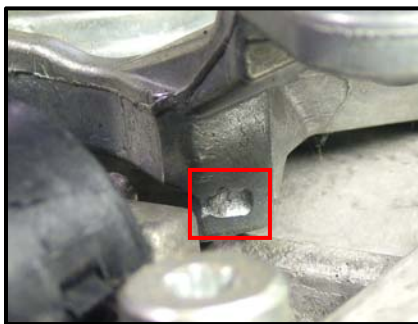
**Figure 14**

In addition, VRTC also inspected a vehicle belonging to a questionnaire respondent. Upon inspection, the vehicle was extremely difficult to shift into Park without depressing the brake. Removal of the steering column showed a larger divot than any that had been previously found on other vehicles (see Figure 14 below).

After installing this steering column into the test vehicle, an attempt was made to determine the force/movement characteristic. When the mechanical device (see Figure 15 below and the complete test report) could not push through the divot on the swing arm, a hand-held mechanical force gage was used and force was manually applied in an attempt to push the divot area on the swing arm past the BSI. Several loadings of 50 lb. failed to push through the divot, consistent with
