ODI RESUME

Investigation: PE09-026
 Date Opened: 05/18/2009 Date Closed: 09/18/2009
 Principal Investigator: Robert Young
 Subject: Motorcycle Front Wheel Separation

Manufacturer: BMW of North America, LLC, Bayerische Motoren Werke
 Products: BMW MY 2000-2003 F650GS
 Population: 4,294

Subject: BMW F650GS Fork Failures

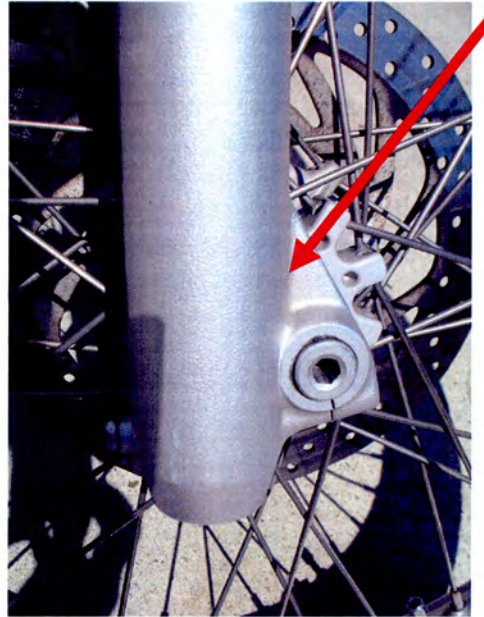
The alleged defective component is the lower fork tube, specifically, the interface between the fork tube and the front axle lug.

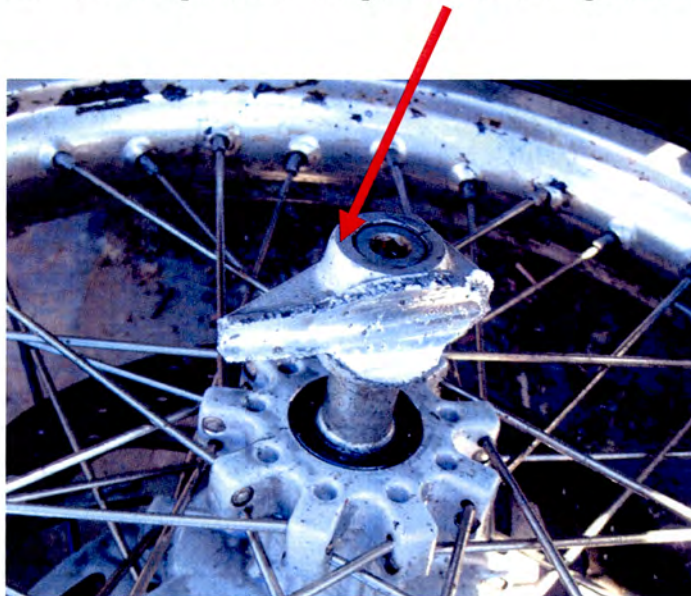
The alleged failure involves a spontaneous separation of the lug from the fork tube.

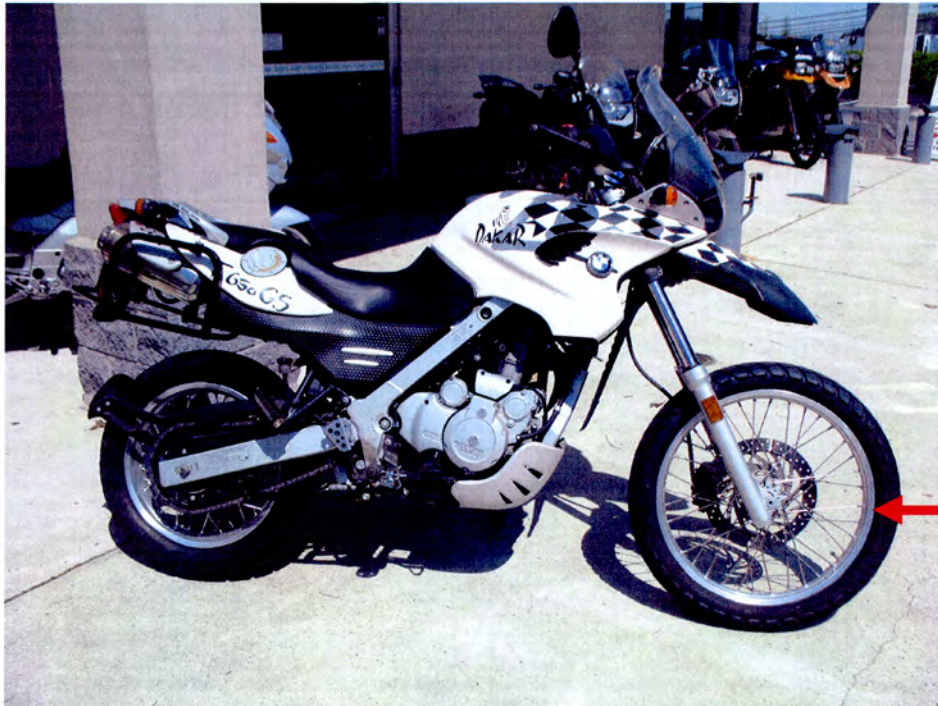
Following each event, metallurgical analyses conducted by BMW, independent analysts, or both, found the fracture occurred due to impact force (a “forced fracture”) rather than fatigue (a weakening of material over time). BMW’s testing found that these fractures would only occur if a force substantially greater than what would be found during normal riding were applied perpendicular to the wheel rim at this point with the fork at full lock.

This later point is important...with the fork at full lock, the assembly cannot rotate around the steering axis and maximum leverage is therefore applied. The type of force needed to break the lug can only be found in crash events (even minor ones) when the fork is bearing against the steering stop. Simply riding over a railroad crossing (as alleged by one ODI complainant), or hitting potholes or rocks while riding normally will not produce the unique combination of force, direction, and geometry needed to separate the lug. It is precisely this unique combination that explains why failures are infrequent. If simply riding over a railroad crossing, for example, would produce this failure, we would expect there to be many, many more failures since rail crossings are so common.
