# Memorandum

Subject: REPORT: Vehicle and Crash Site Inspection of 2009  
Lexus ES-350, VIN JTHBJ46G792282025

Date of Inspection: 09/03/2009

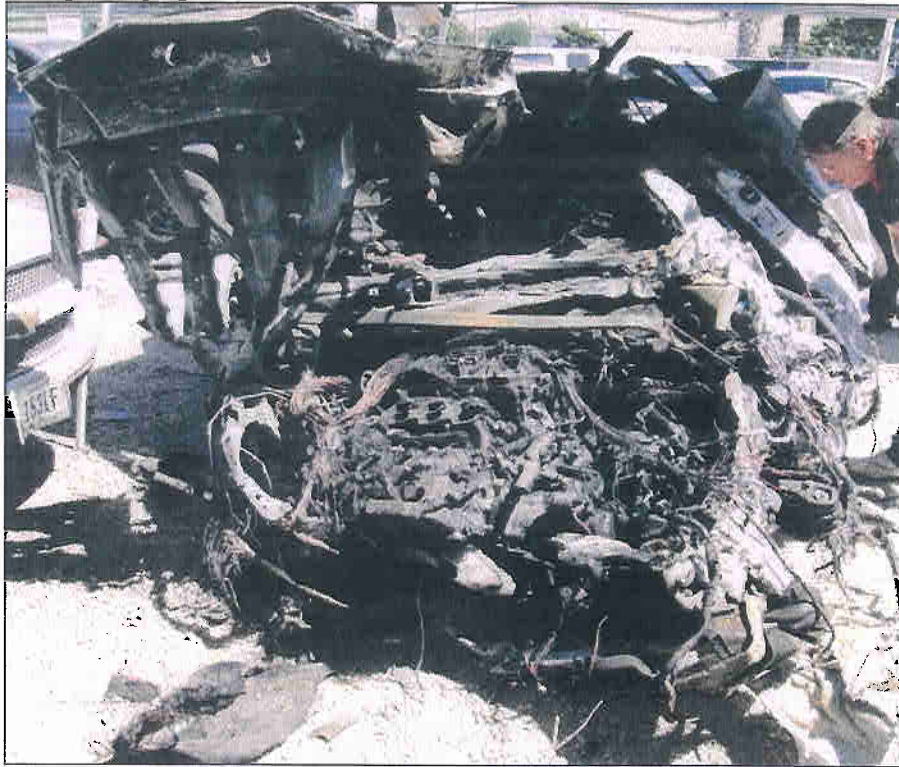
Vehicle condition at time of inspection: Catastrophic damage caused by severe frontal impact, roof impact, side impact, & fire damage. The driver's seat buckle was observed in a closed, connected condition.

**Figure 1 - Subject Vehicle 2009 Lexus ES-350 – Front**

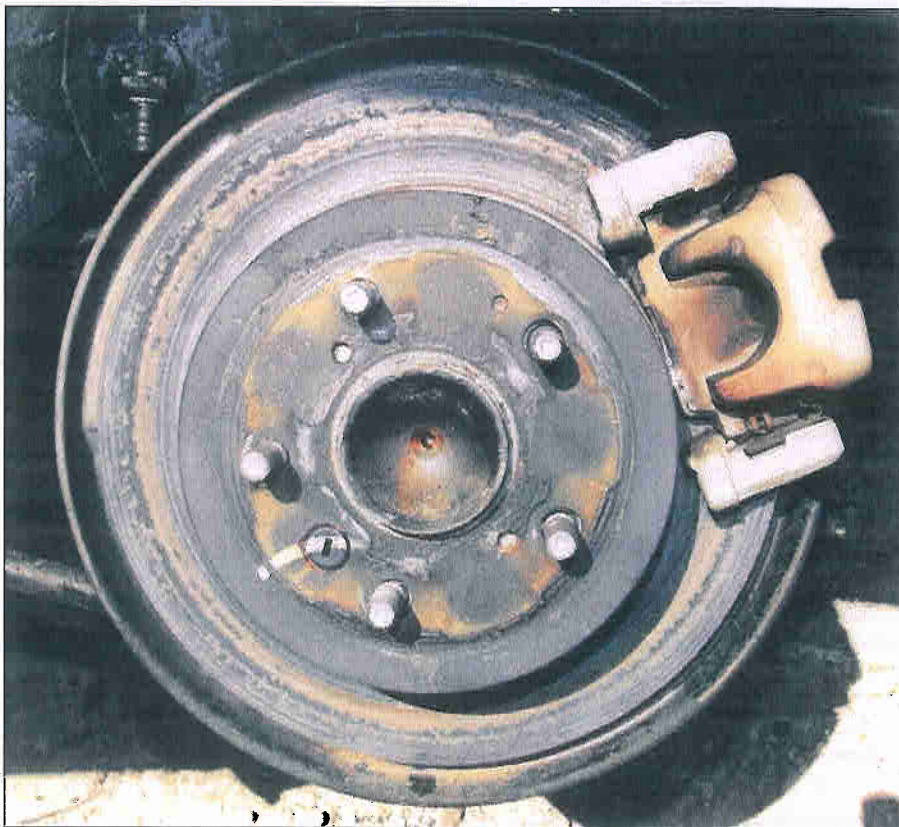
- 4- The brake pads and rotors were inspected for heat generated by emergency braking. While there was significant fire damage to the majority of the vehicle, the pads, rotors, and calipers could still be observed. The left front wheel assembly and suspension were torn from the vehicle in the crash and had not been involved in the fire. Other rotors on the vehicle generally exhibited similar conditions. Rotors were discolored and heated, had very rough surfaces, had substantial deposits of brake pad material, and showed signs of bright orange oxidation on the cooling fins consistent with endured braking. Pads were melted and rough with a considerable amount surface material dislocated to the leading edge. The friction surfaces were burned but somewhat reflective. The edges of the pads were bubbled. The calipers were also heat discolored with heat patterns in the area adjacent to the rotor.

**Figure 2 - Rear Left Caliper and Rotor Exhibiting Signs of Endured Braking**

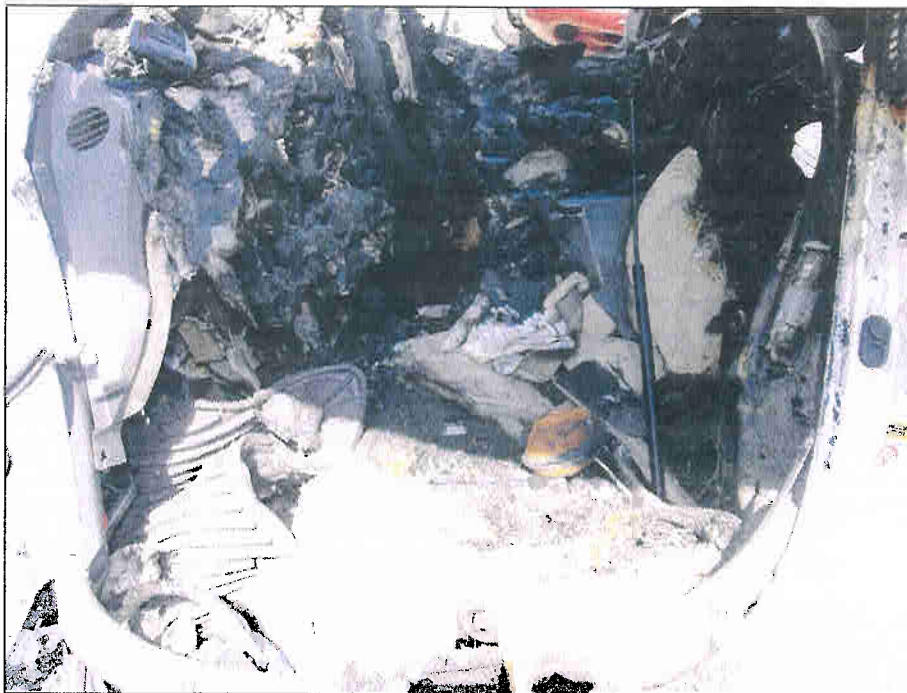
- 2- Upon inspection of the crashed vehicle, it was found that an all-weather floor mat bearing the Lexus insignia was present in the driver's foot well vehicle with very minor fire damage. The mat was not secured by either of the two retaining clips. The right clip was installed into the grommet of the carpeting but not installed into the mat. The left clip was found under the middle of mat but was not clipped to either the carpet or the rubber mat. Removal of the mat was difficult because the bottom edge of the accelerator pedal had melted to the upper right corner of the mat. Further inspection of the mat revealed that while it was a Lexus brand mat, it was not the correct application for the vehicle. The mat part number was stamped and still visible on the reverse side. It read "PT 48050

**Figure 3 - Driver's Compartment with Lexus All Weather Floor Mat**

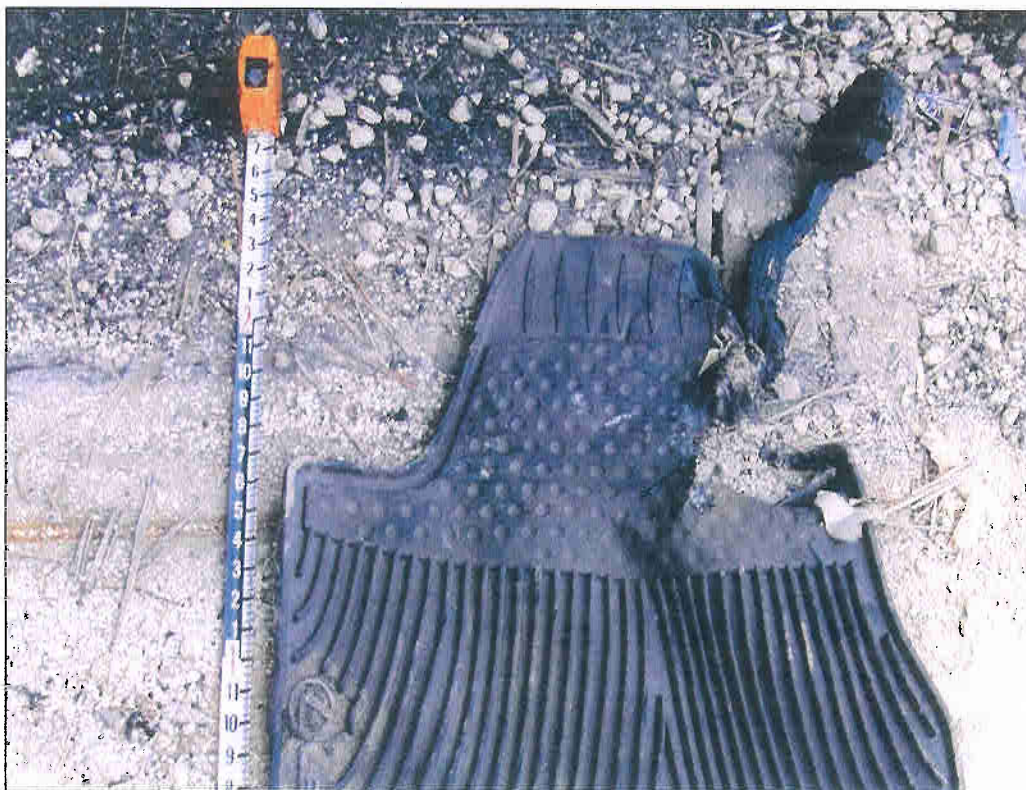
- 1- Accelerator Pedal – The pedal is made from a composite plastic that forms a rigid, one-piece lever. Beyond the main pivot, the lever is not hinged and has no means for relieving forces caused by interferences. Upon removing the pedal from the vehicle, the rotating motion of the pedal assembly was confirmed to still be operational. The return spring action was smooth and unencumbered.

**Figure 4 - All Weather Floor Mat Removed from Driver's Footwell, Bonded to Lower Edge of Accelerator Pedal Assembly**
