From: Hershman, Larry (NHTSA)
Sent: Wednesday, January 20, 2010 10:09 AM
To: Howell, Rosa (NHTSA)
Cc: Yon, Scott (NHTSA)
Subject: FW: Grand Cherokee Vulnerable Fuel Hose & Lines
Attachments: MVFRI Fuel Filler Tube Leakage Test Report.pdf; 2004 Jeep Grand Cherokee Fuel Hose Under Frame Rail.JPG; ZJ_FFH-1.JPG; ZJ_FFH-4.JPG; ZJ_FFH-2.JPG; ZJ_FFH-3.JPG; ZJ_Mesh_Close-up.JPG; ZJ_FFH_Part_Label-1.JPG

From: Clarence Ditlow [mailto:cmdiii@autosafety.org]
Sent: Tuesday, January 19, 2010 11:22 PM
To: Demeter, Kathleen (NHTSA)
Cc: Yon, Scott (NHTSA); KDIGGES@aol.com
Subject: Grand Cherokee Vulnerable Fuel Hose & Lines

MVFRI Fuel Filler Tube
Leakage Test Report

JEEP GRAND CHEROKEE
VULNERABLE FUEL HOSE
& LINE

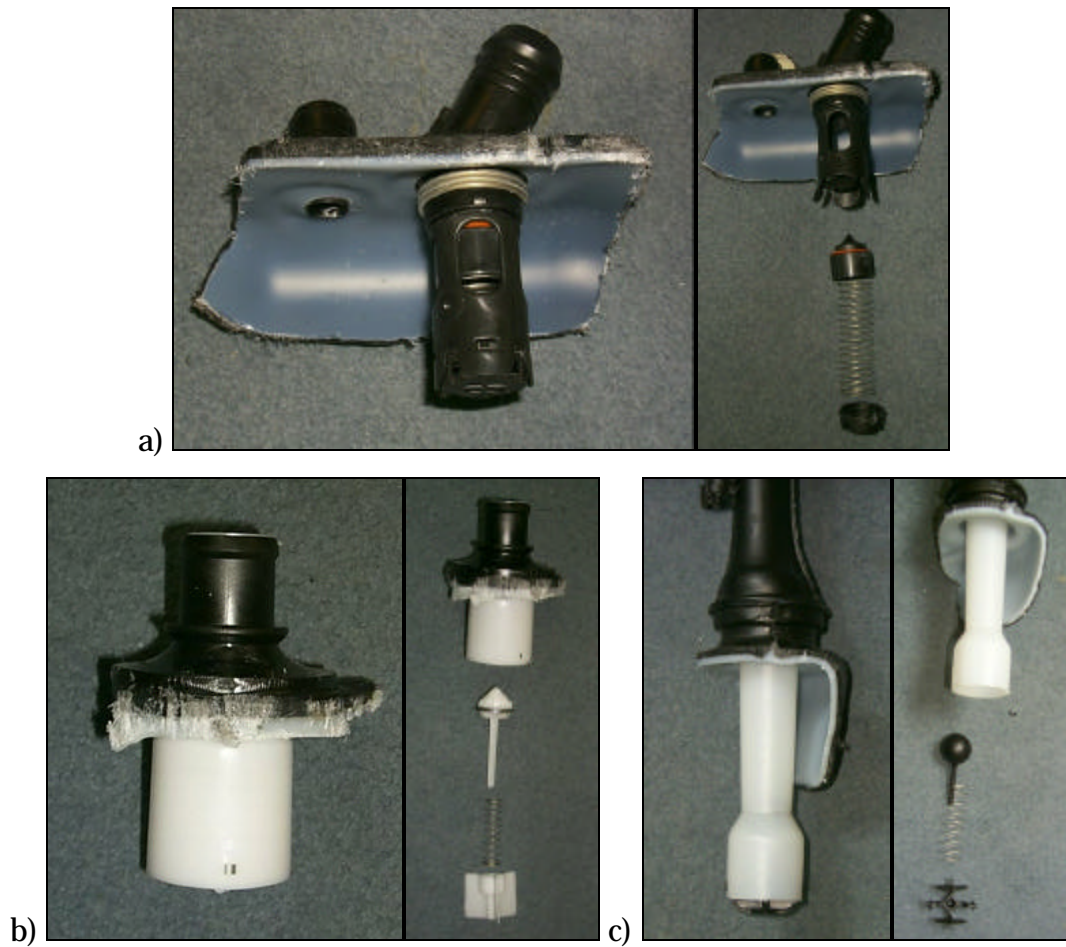
Figure 1: Spring and plunger type check valves from: a) Dodge Neon, b) Chrysler Cirrus and c) VW Jetta.

A plunger style check valve was installed in 7 tanks, 6 of which did not leak from the filler tube when the filler cap was removed. The mechanism shown in Figure 1 (c) was not effective at retaining fluid with the filler cap removed. The mechanism shown in Figure 1 (a) was discovered in 5 tanks from 3 different automotive manufacturers and was effective at preventing leakage from the filler tube.

Fluid loss was encountered with the Saturn SL which used a check valve as shown in Figure 1 (a). However, the leak stemmed from the filler venting tube

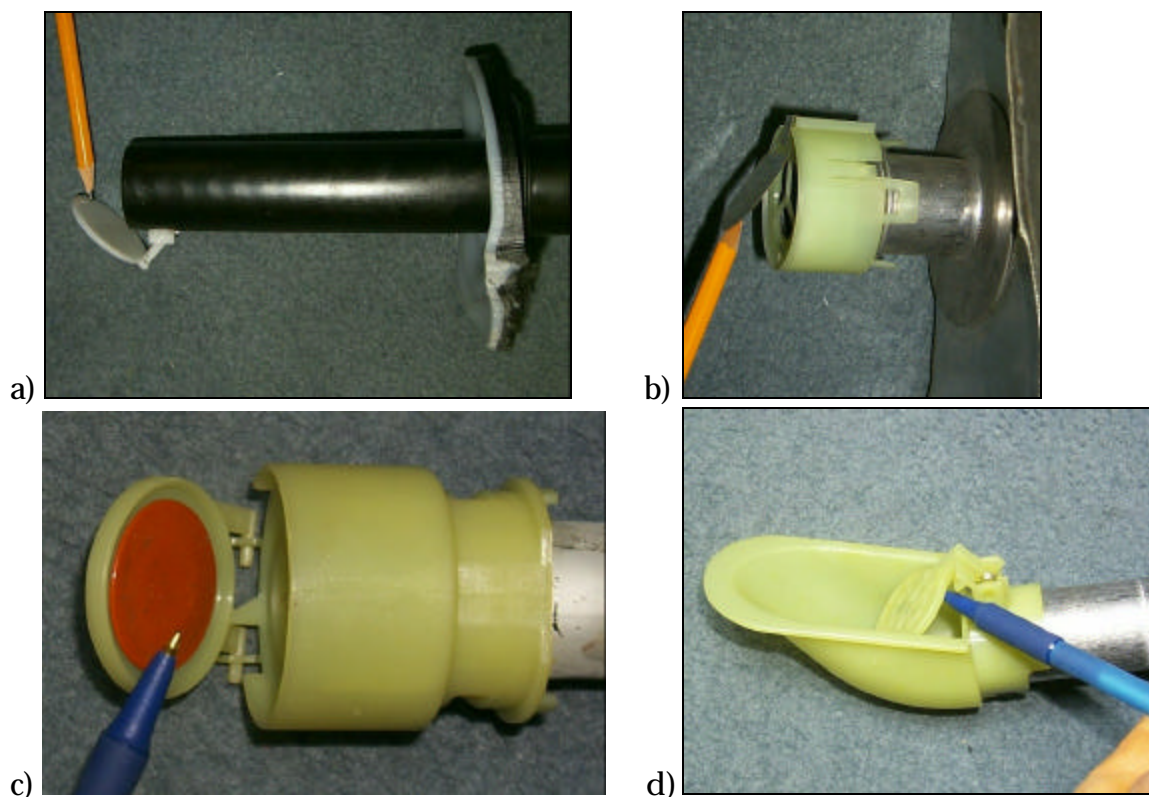
Figure 2: Flap door mechanism check valves from: a) Honda Odyssey, b) Toyota Corolla, c) Kia Spectra and d) Acura 3.2 TL.

Flap style check valves similar to those shown in Figure 2 were used in 7 fuel tanks. However, only the Kia Spectra flap valve seen in Figure 2 (c) was effective. All other flap valves permitted fluid loss. The difference between the Spectra flap valve design and other designs is that the Spectra valve enhanced the seal effectiveness by incorporating a rubber disc between the flap and the valve orifice. The other designs relied on steel to plastic or plastic to plastic parts sealing to prevent fuel from leaking. The rubber disk can be seen in the photograph shown Figure 2 (c).

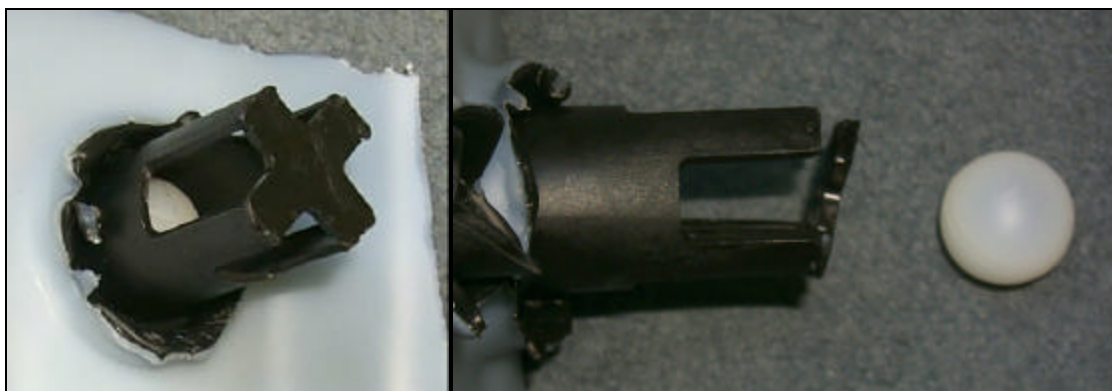
Figure 3: Float type check valve from a Jeep Cherokee.

Of all the check valves observed, the ball float type valve was the only system in which the state of the valve was normally open, meaning that the filler tube would only be sealed if the ball was engaged, by gravity, rising fluid levels relative to the tank filler spout, or the reverse flow of fluid. All of these circumstances would act to seat the ball in the filler tube opening to prevent reverse flow. In the single instance of its use, the valve shown was not effective in the rollover testing at preventing leakage or limiting the leakage rate to below 28 g per minute as specified in the FMVSS 301 standard.

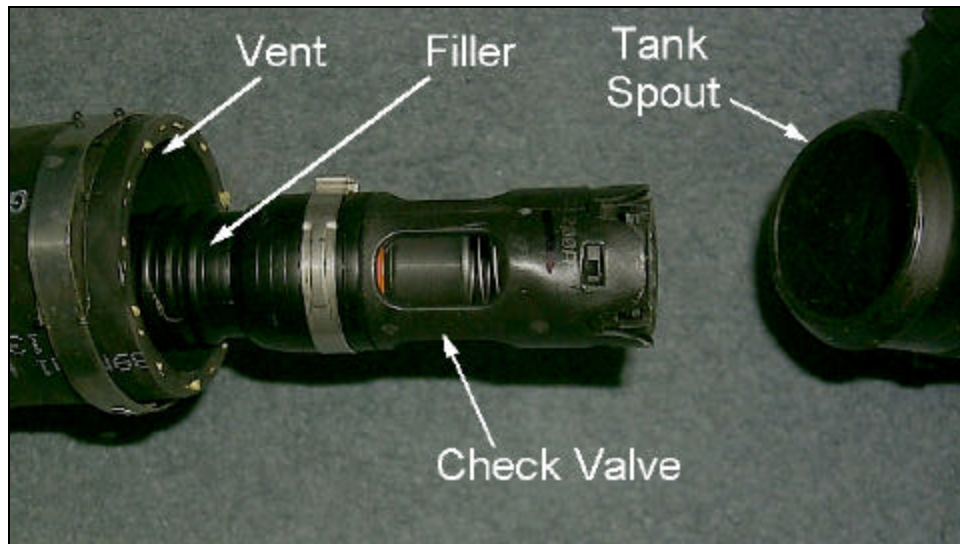
and not from the filler tube check valve. Figure 4 shows the filler tube which is routed inside the vent tube arrangement.

Figure 4: Saturn SL filler tube and vent tube arrangement.

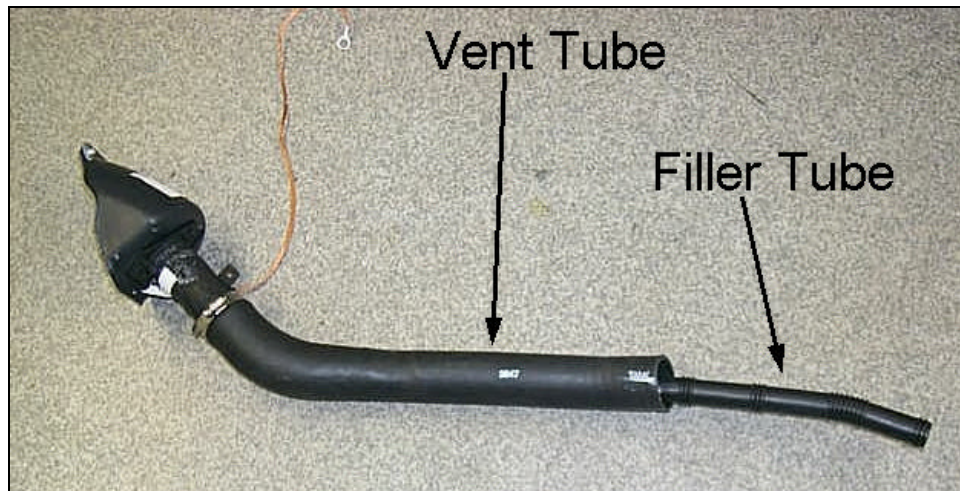
The GMC Sierra employed a similar filler design to the Saturn in that the filler tube was routed inside a larger tube which acted as the tank filler vent. Unlike the Saturn, the Sierra did not incorporate a check valve on the end of the filler tube (see Figure 5). Instead, inside the tank the filler tube extended to the far side of the tank, therefore, depending on the tank orientation and fluid level the filler tube design may prevent fuel spillage. A cut-away view of the Sierra tank is shown in Figure 6.

Figure 5: GMC Sierra vent and filler tube arrangement.

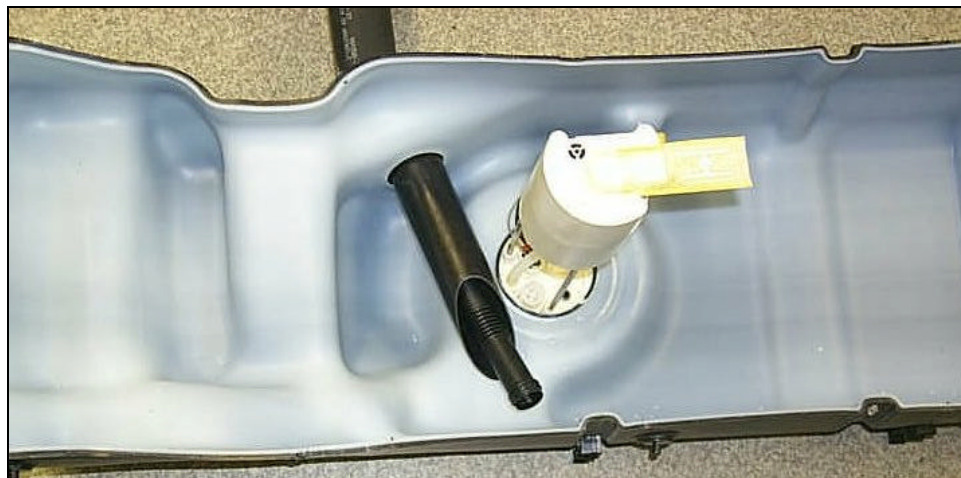
Figure 6: Cross-section of the upper half of a GMC Sierra gas tank.

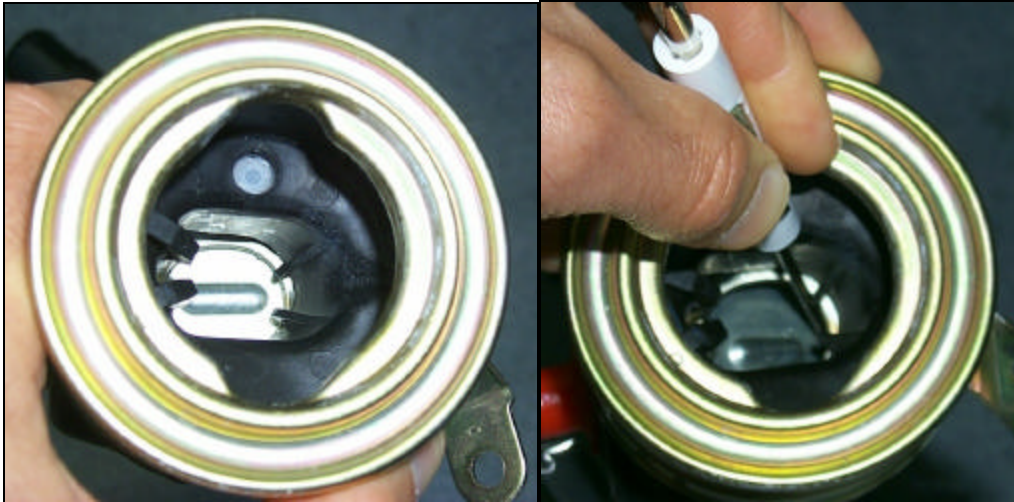
A flap valve in the filler tube just behind the gas cap was present in 12 fuel systems. The valves are physically opened by the fuel nozzle of the gas pump during refuelling. An additional 4 systems incorporated a flap valve in the filler tube closer to, but still exterior to, the tank. On these systems the fuel pressure is sufficient to open the valve during refuelling. These valves restricted flow yet

none were effective at preventing reverse flow of fluid out of the tank during the rollover leak testing. This suggests that their purpose may be for vapour entrapment for emissions reduction. A typical flap valve found in the filler tube behind the gas cap is shown in Figure 7. An example of a flap valve installed closer to the tank in the filler tube is shown in Figure 8. The use of these valves are identified in Appendix A.

Figure 7: Flap valve found immediately behind the gas cap.

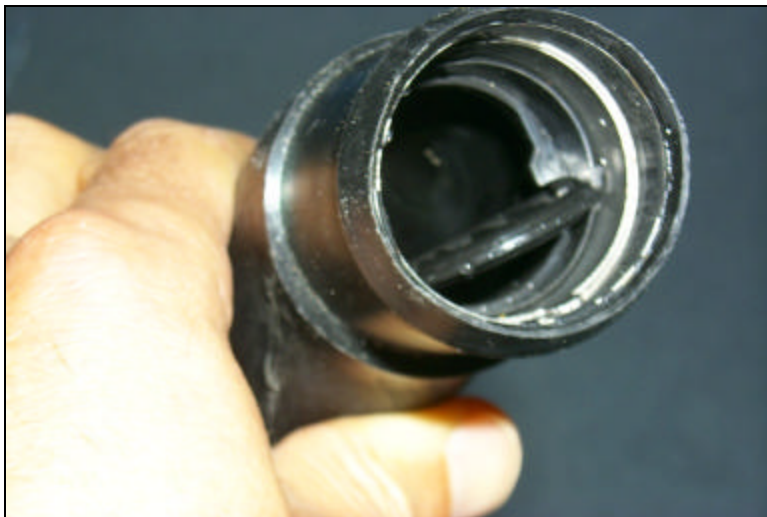
Figure 8: A flap valve installed closer to the tank in the filler tube.

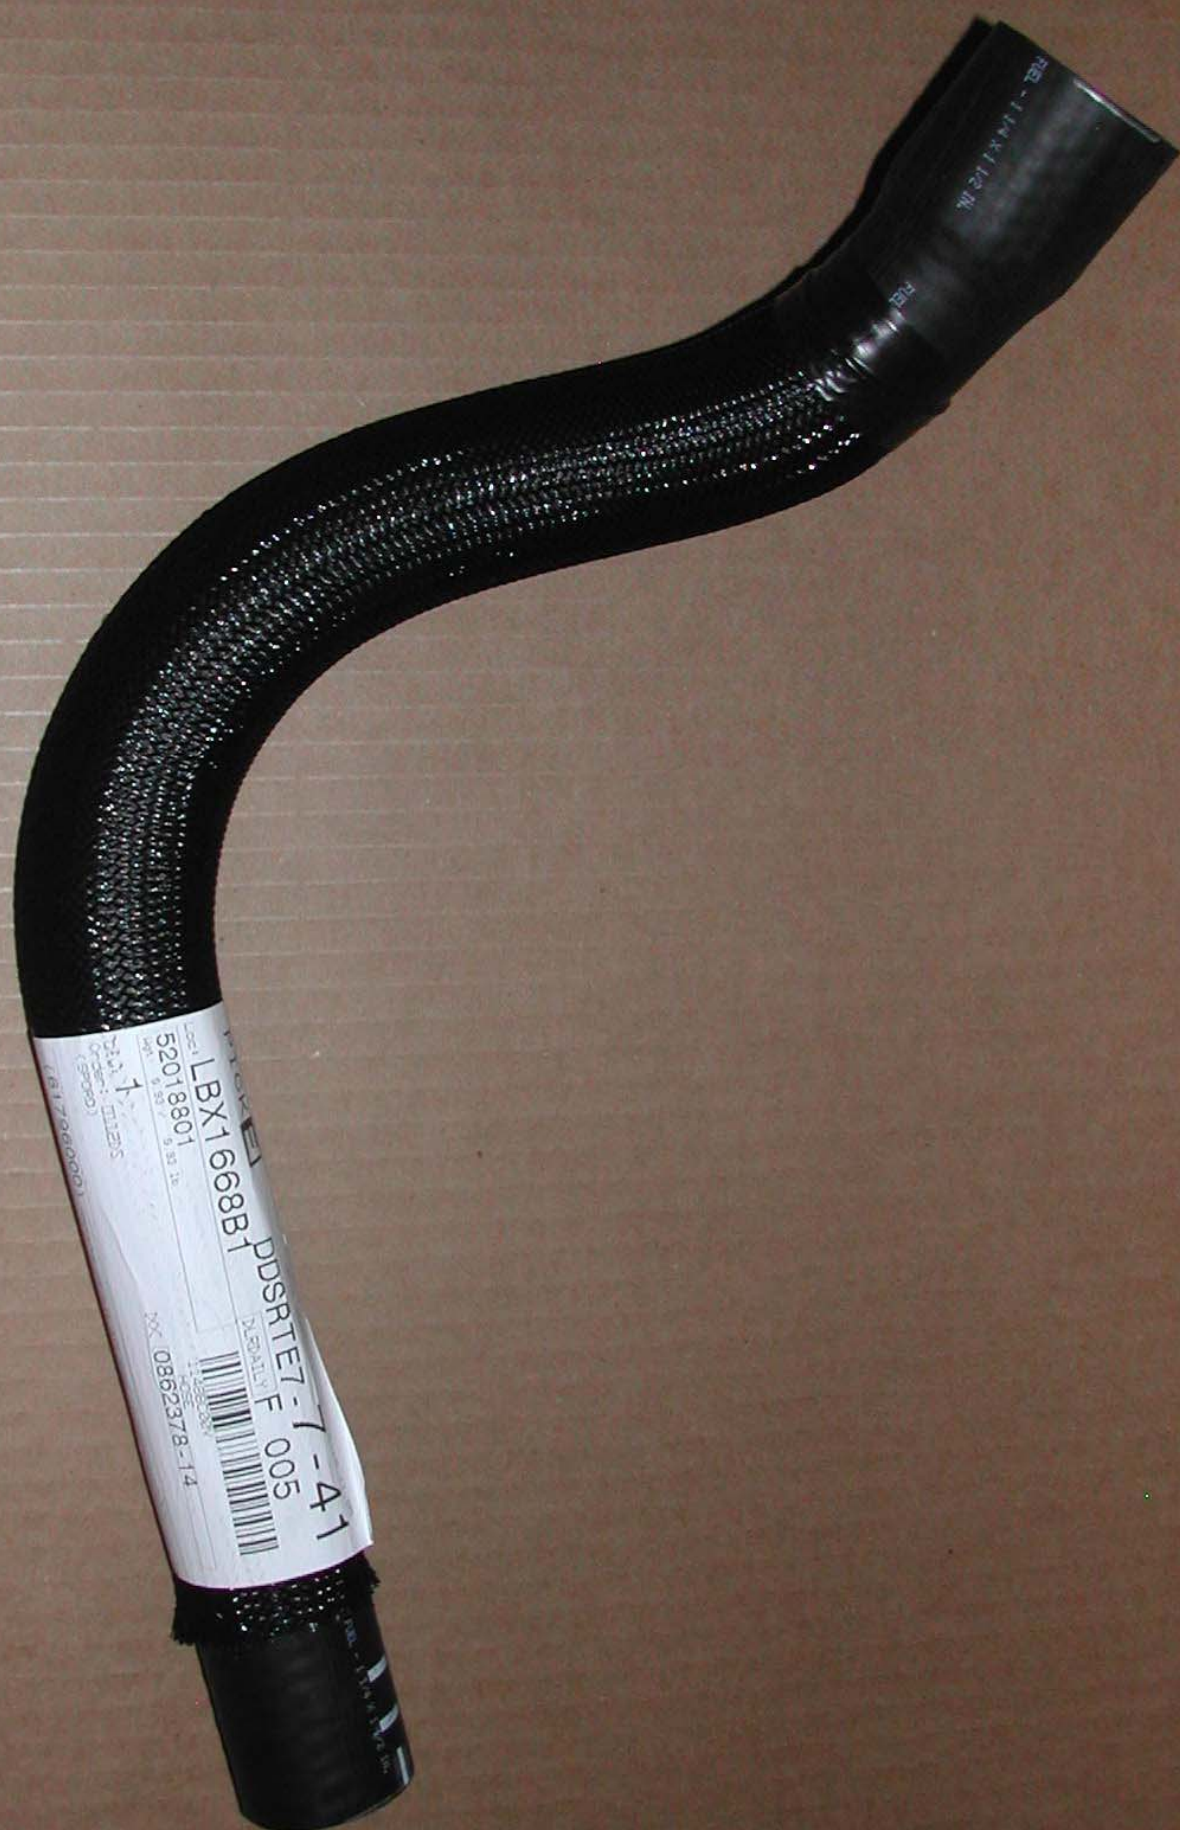
ZJ_FFH-1

One of the Grand Cherokee's fuel system defects is a rubber fuel filler hose and vent line located in a vulnerable position where it can be severed or dislocated. The attached Disconnected Fuel Lines Leakage Test Report from MVFRI demonstrates that the Grand Cherokee has massive fuel leakage when the fuel lines are disconnected with leakage 35 times greater than allowed by FMVSS. Attached are photos showing the fuel hose going under the frame. The remaining photos are of the an OEM 1993-98 rubber fuel filler hose purchased from a Chrysler dealer and an OEM 1998-04 rubber fuel filler hose also purchased from a Chrysler dealer.

Frame Rail

**Filler Neck
Hose**

Gas Tank

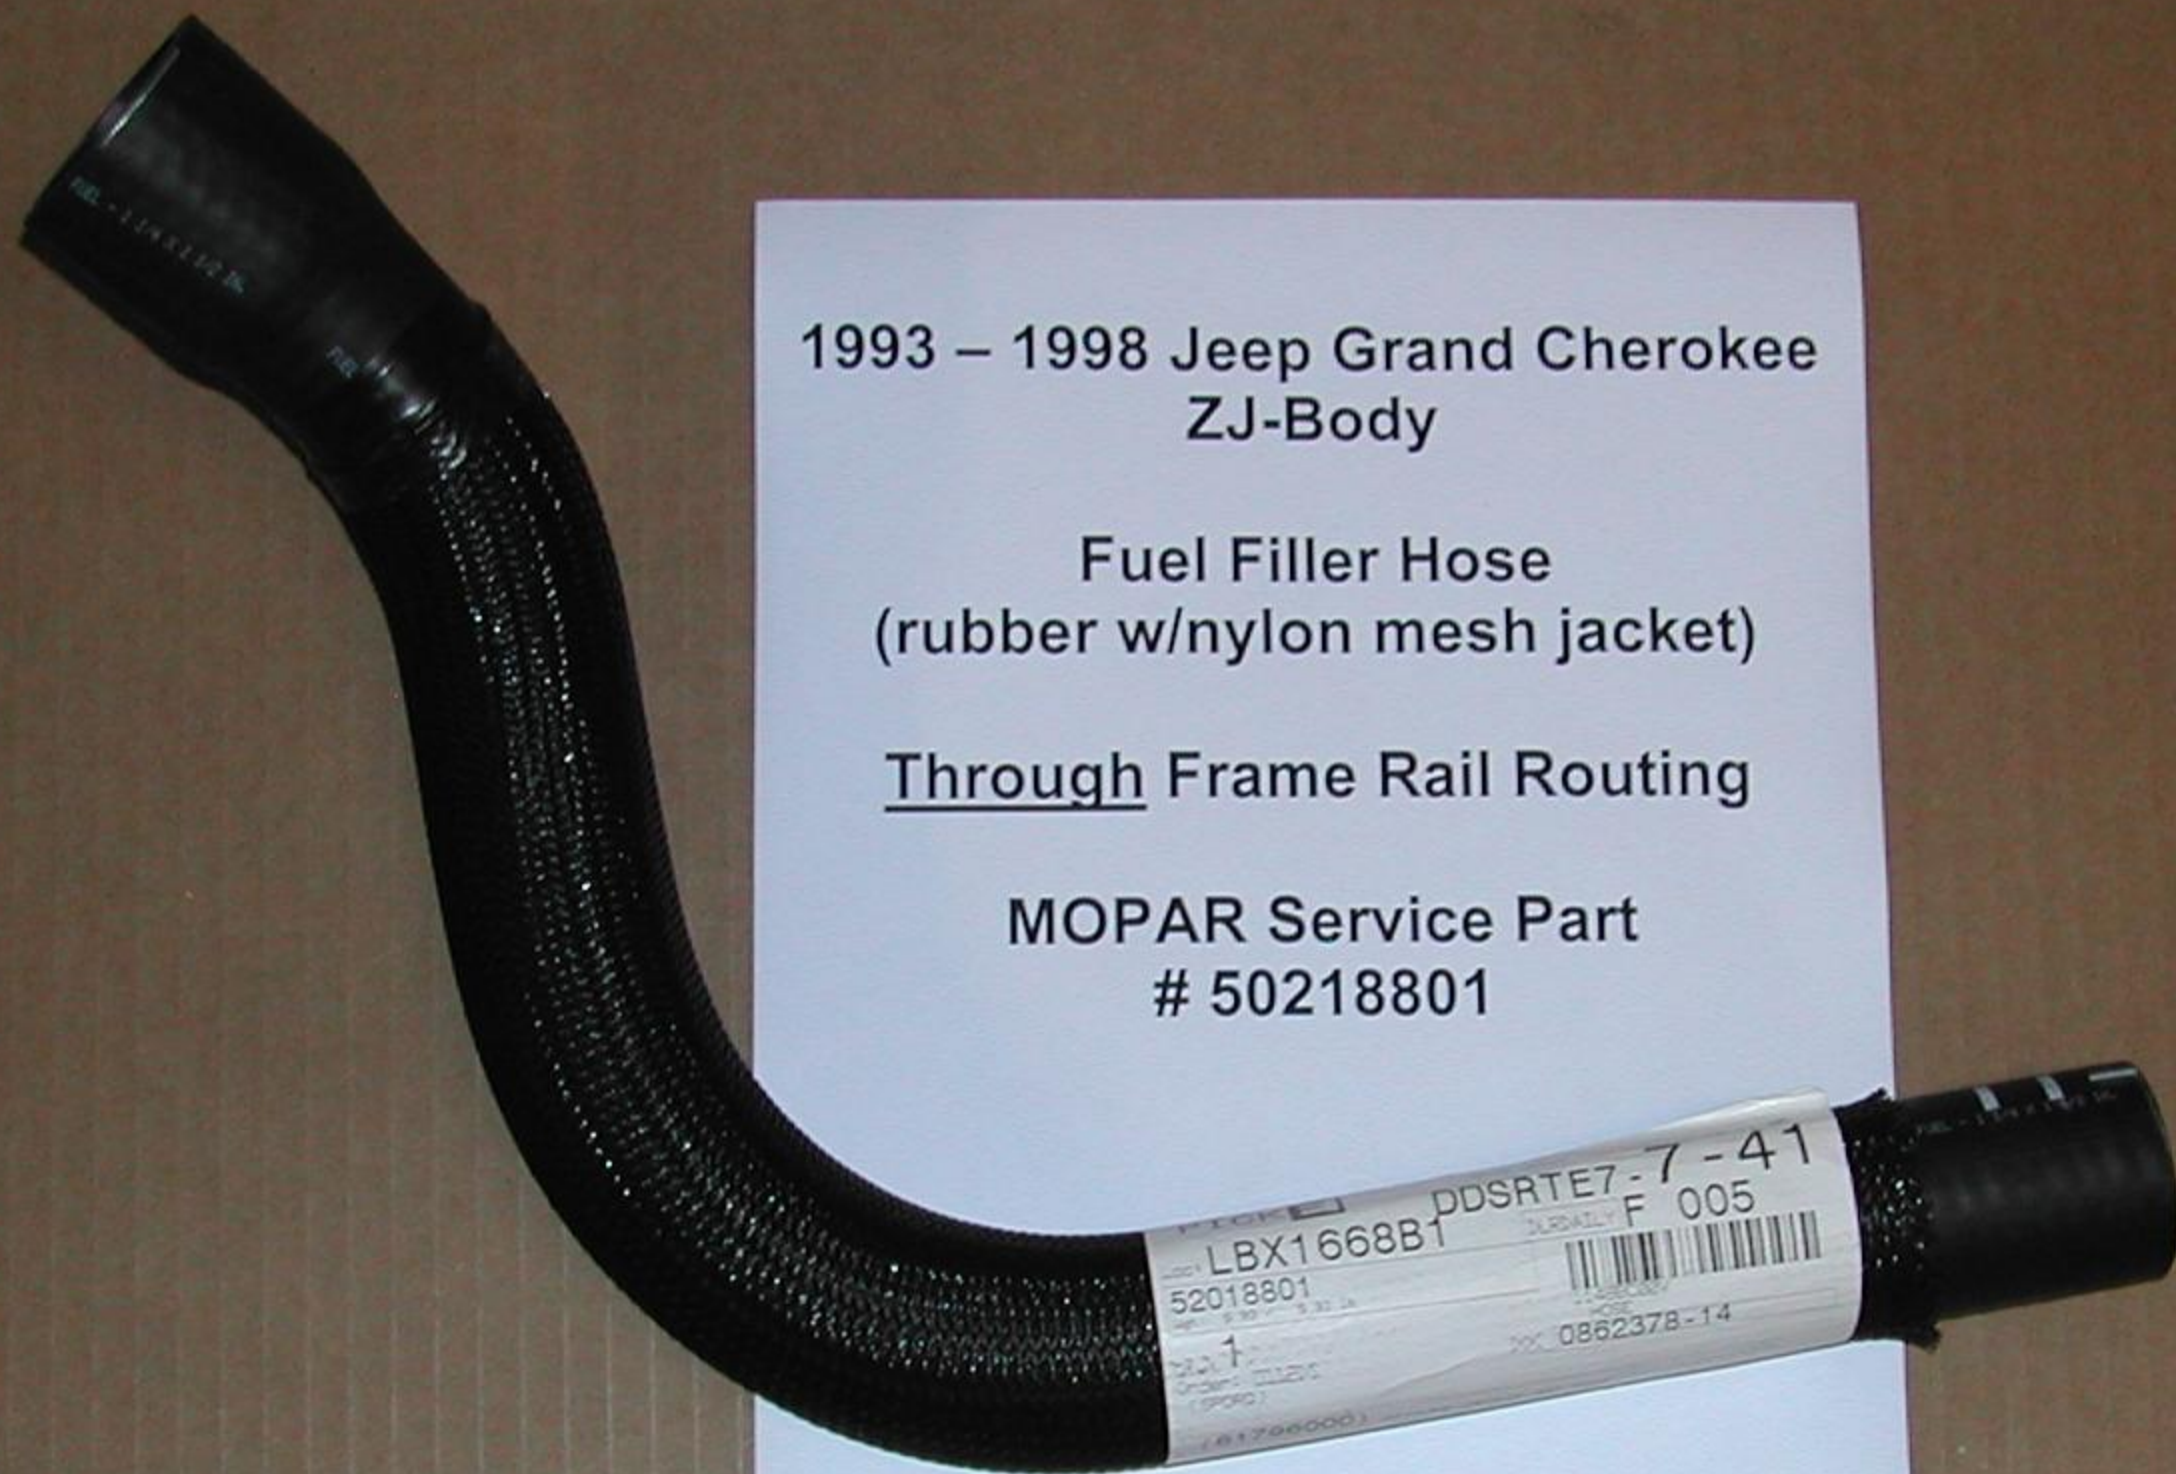
1993 – 1998 Jeep Grand Cherokee
ZJ-Body

Through Frame Rail Routing

MOPAR Service Part
50218801

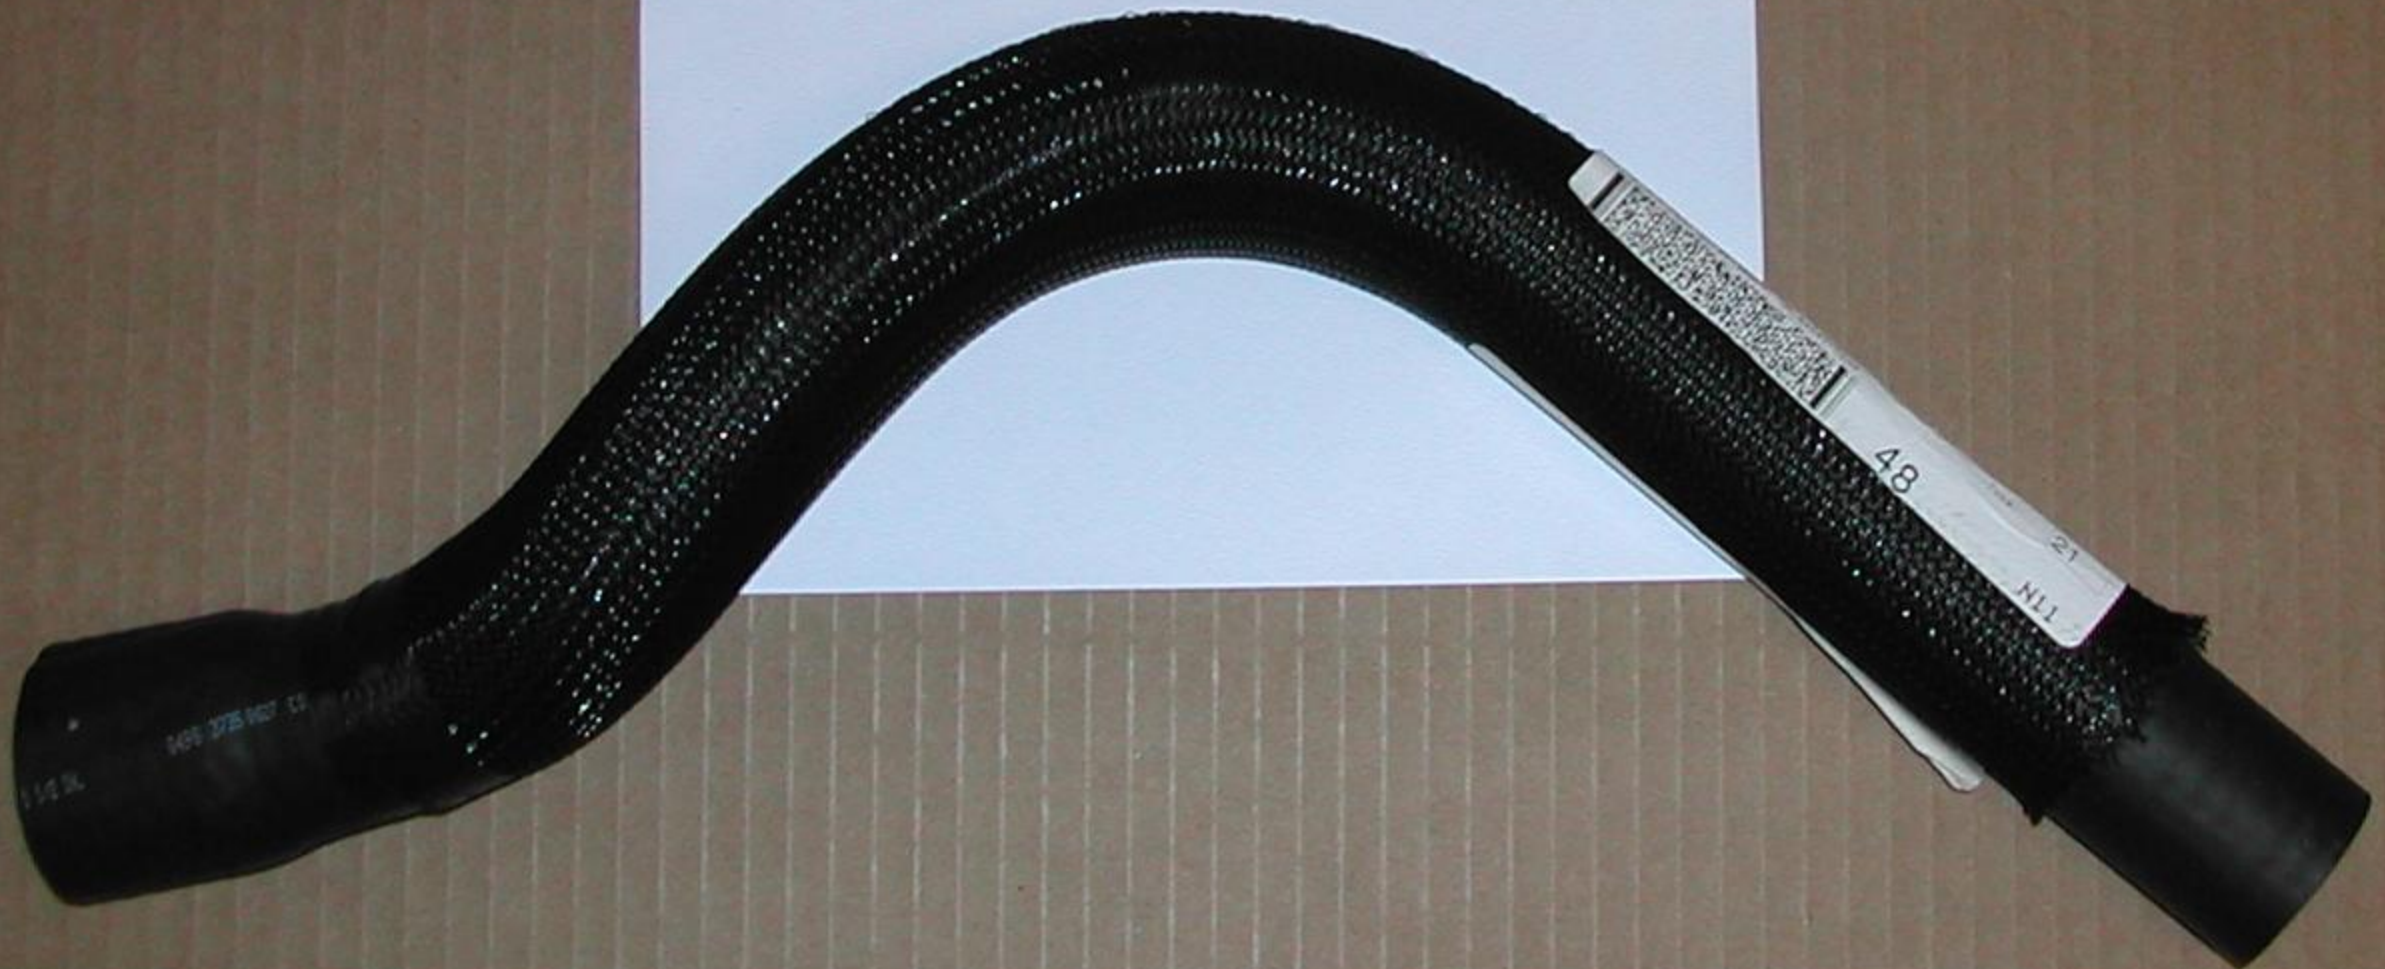
1993 – 1998 Jeep Grand Cherokee
ZJ-Body

Fuel Filler Hose
(rubber w/nylon mesh jacket)

Through Frame Rail Routing

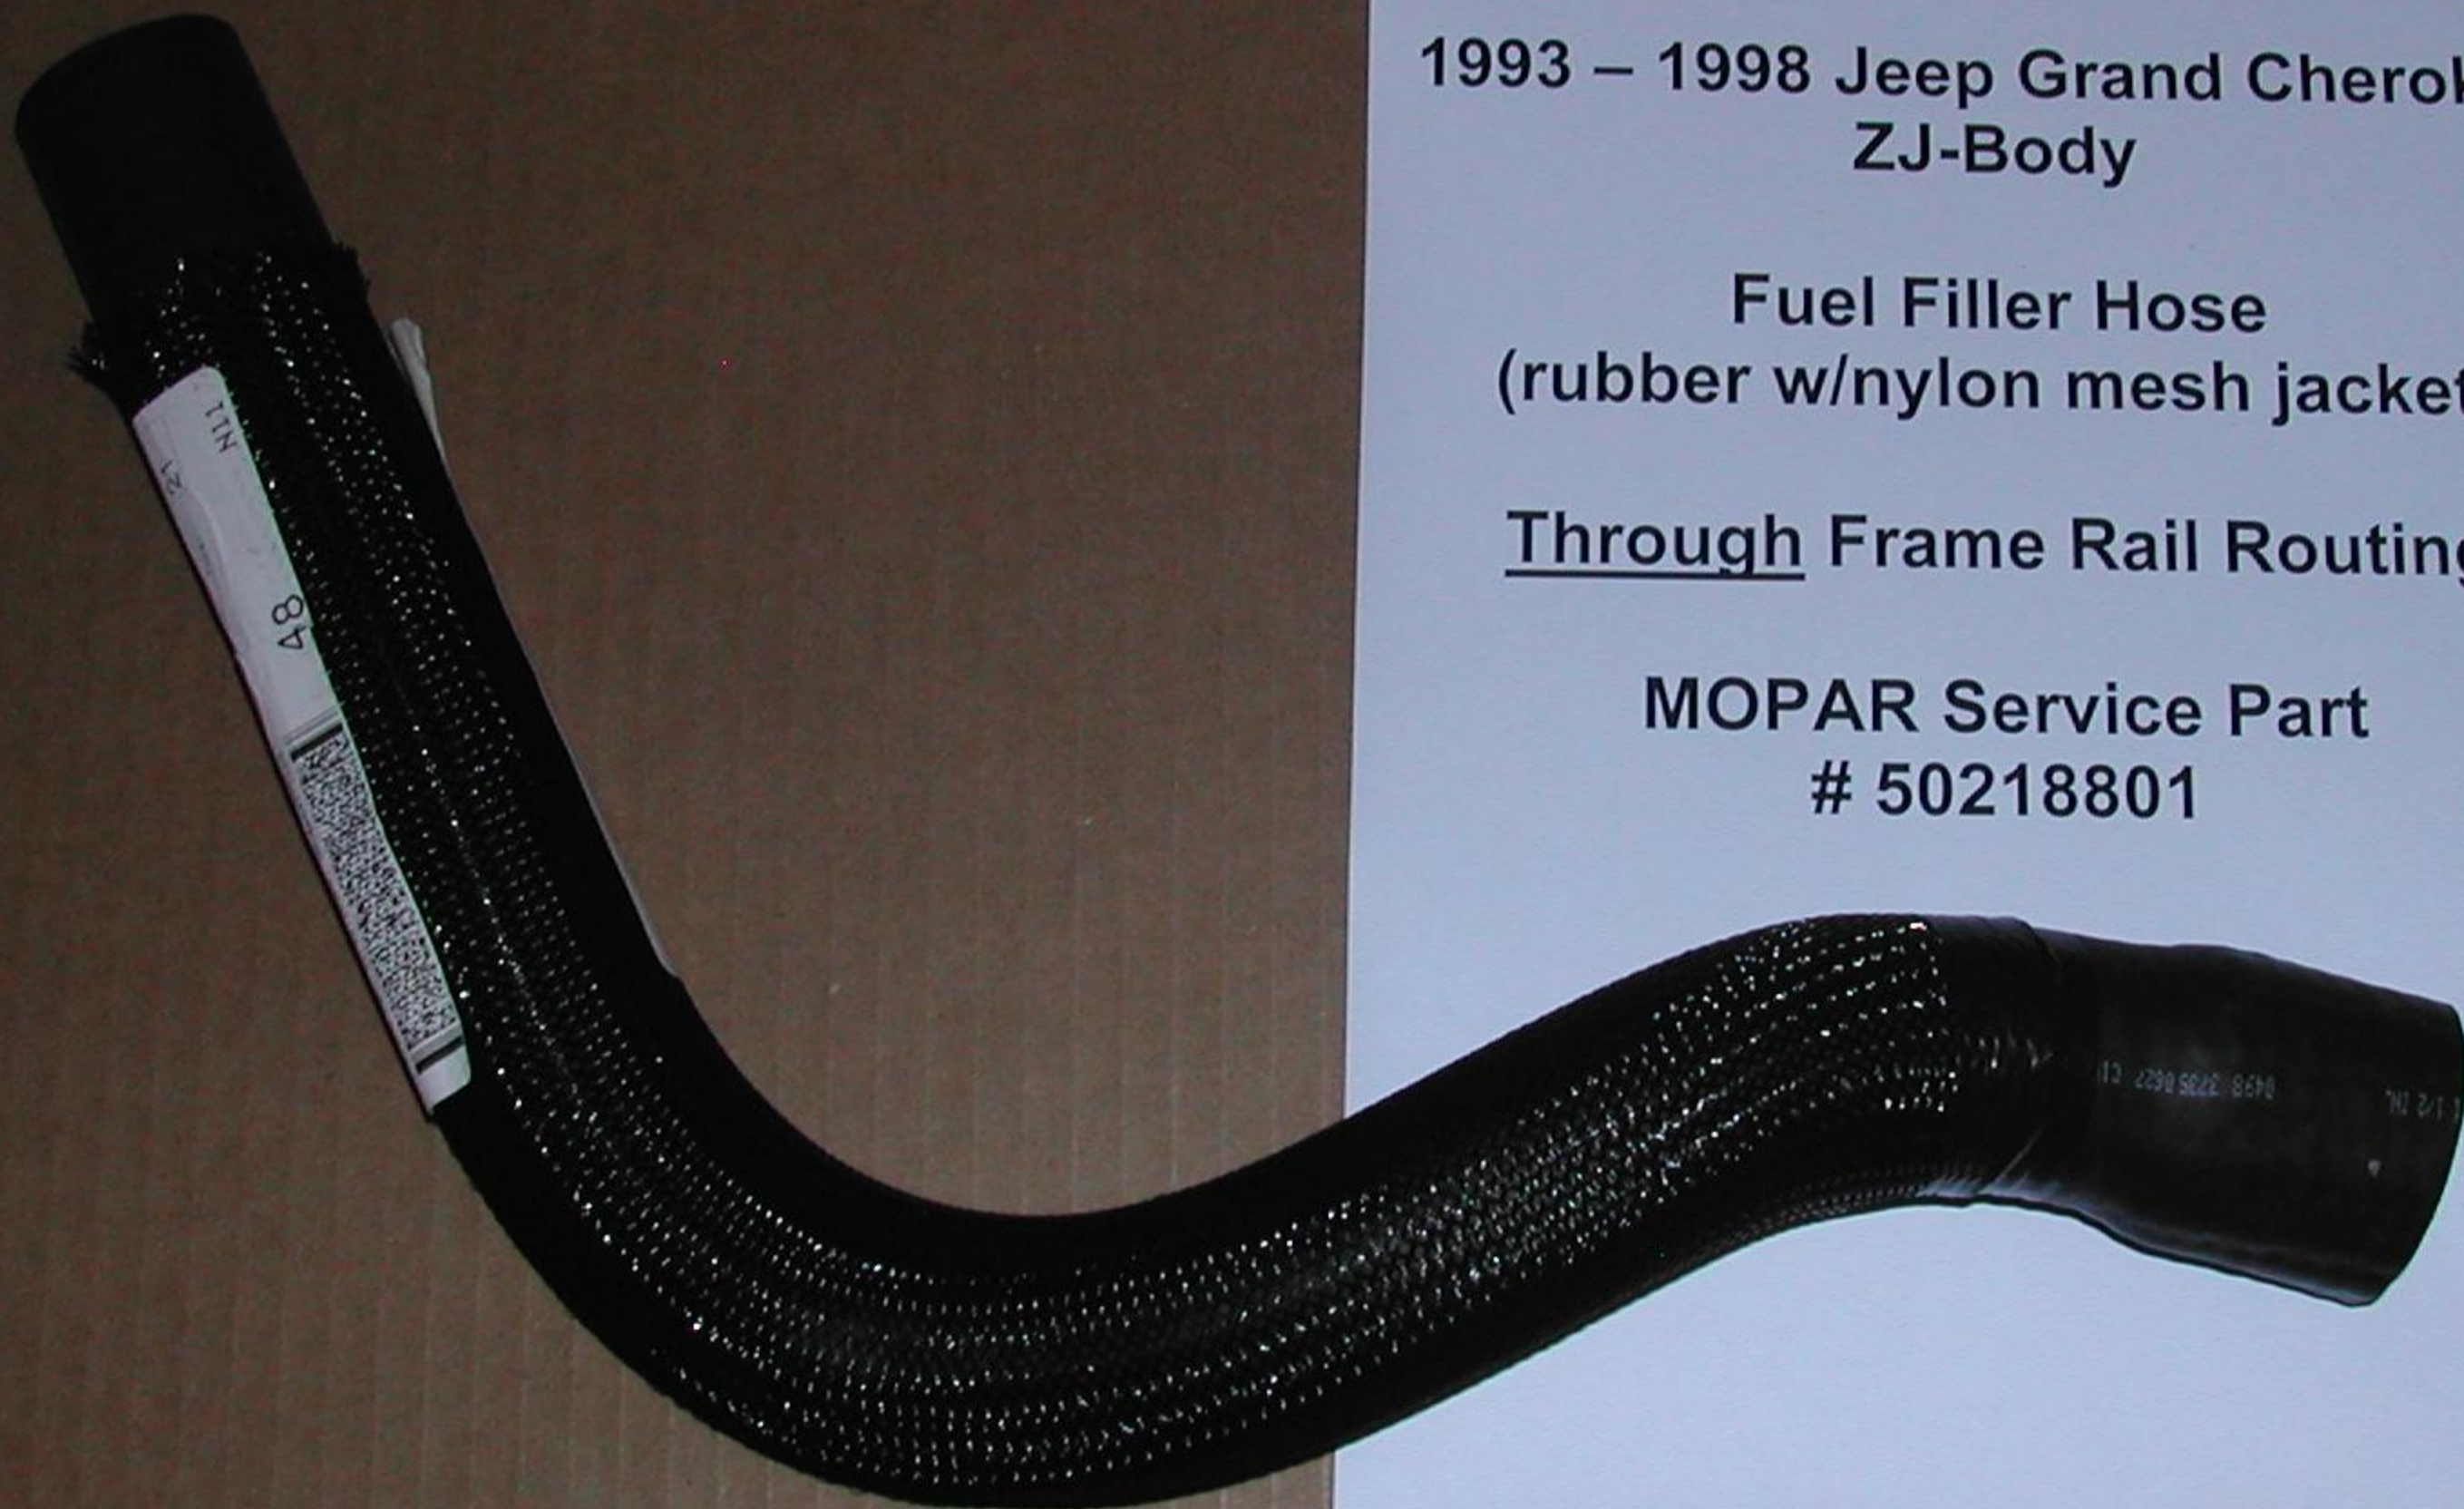
1993 – 1998 Jeep Grand Cherokee
ZJ-Body

Fuel Filler Hose
(rubber w/nylon mesh jacket)

Through Frame Rail Routing
