CENTER FOR AUTO SAFETY

Attached please find the Center for Auto Safety's September 1, 2011 letter to Chrysler CEO Sergio Marchionne. This letter contains a detailed analysis of fuel system failures in the Jeep Grand Cherokee, currently the subject of NHTSA Investigation PE10-031.

September 1, 2011

The Safety Problem

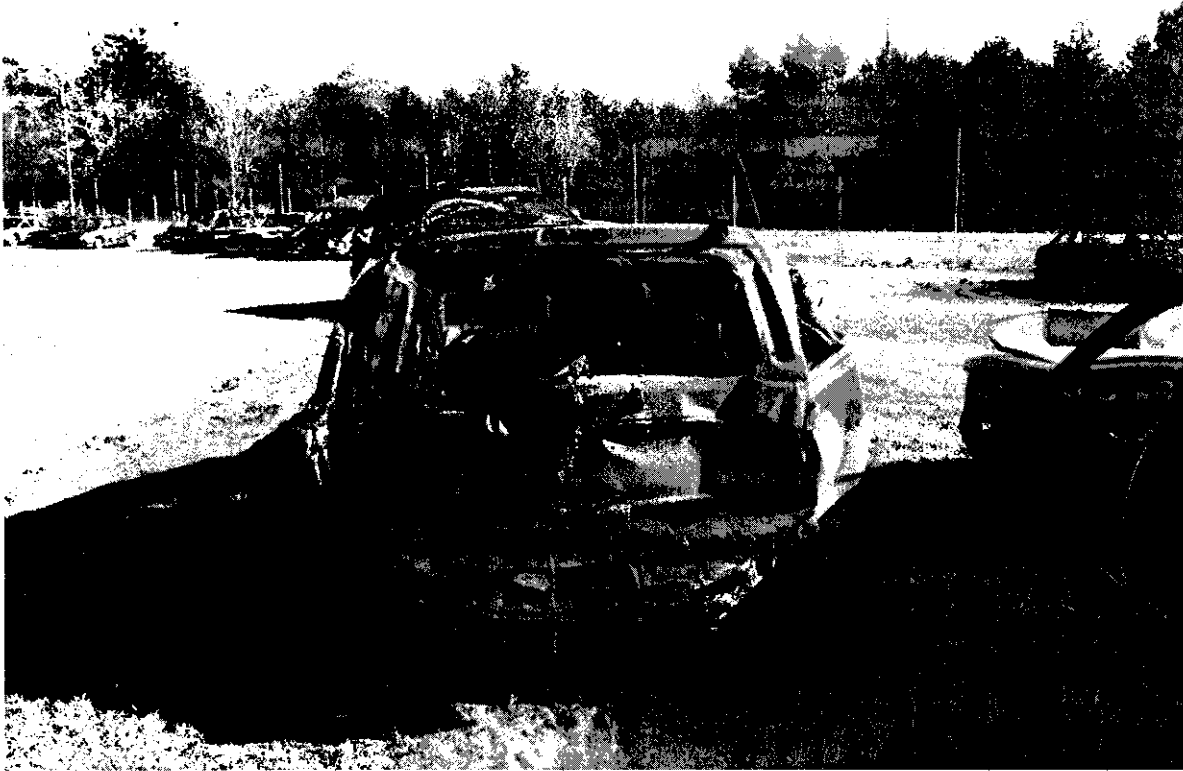
Rollover fires are all too common in Jeep Grand Cherokees with the FARS database showing 23 deaths in 15 fatal fire crashes involving rollover of 1993-2004 Grand Cherokees. Of these, 21 were coded by FARS as MHE fire which undercounts actual fire deaths. For example, [REDACTED] was burned to death according to the autopsy report in the rollover of the 2002 Grand Cherokee which is shown in Picture 11 below. The lack of an effective check valve used by other manufacturers in their SUV's could have prevented many of these fire deaths.

Picture 11 – [REDACTED] Crash
