From: Hershman, Larry (NHTSA)
Sent: Tuesday, August 30, 2011 2:11 PM
To: Reid, Randy (NHTSA)
Cc: Howell, Rosa (NHTSA); Yon, Scott (NHTSA)
Subject: DP09005 & PE10031 Jeep Grand Cherokee - Pinto submission
Attachments: PE10-031 Docket Submission

Re: 1971-1976 Pinto and 1975-1976 Bobcat
Fuel Systems (Except Station Wagons)
Campaign No. 293

SERVICE RECALL BULLETIN

Subject: Service Recall 293, Announcement of a Recall of 1971-76 Pinto and 1975-76 Bobcat 2-Door Sedans and 3-Door Runabouts for Fuel System Modifications.

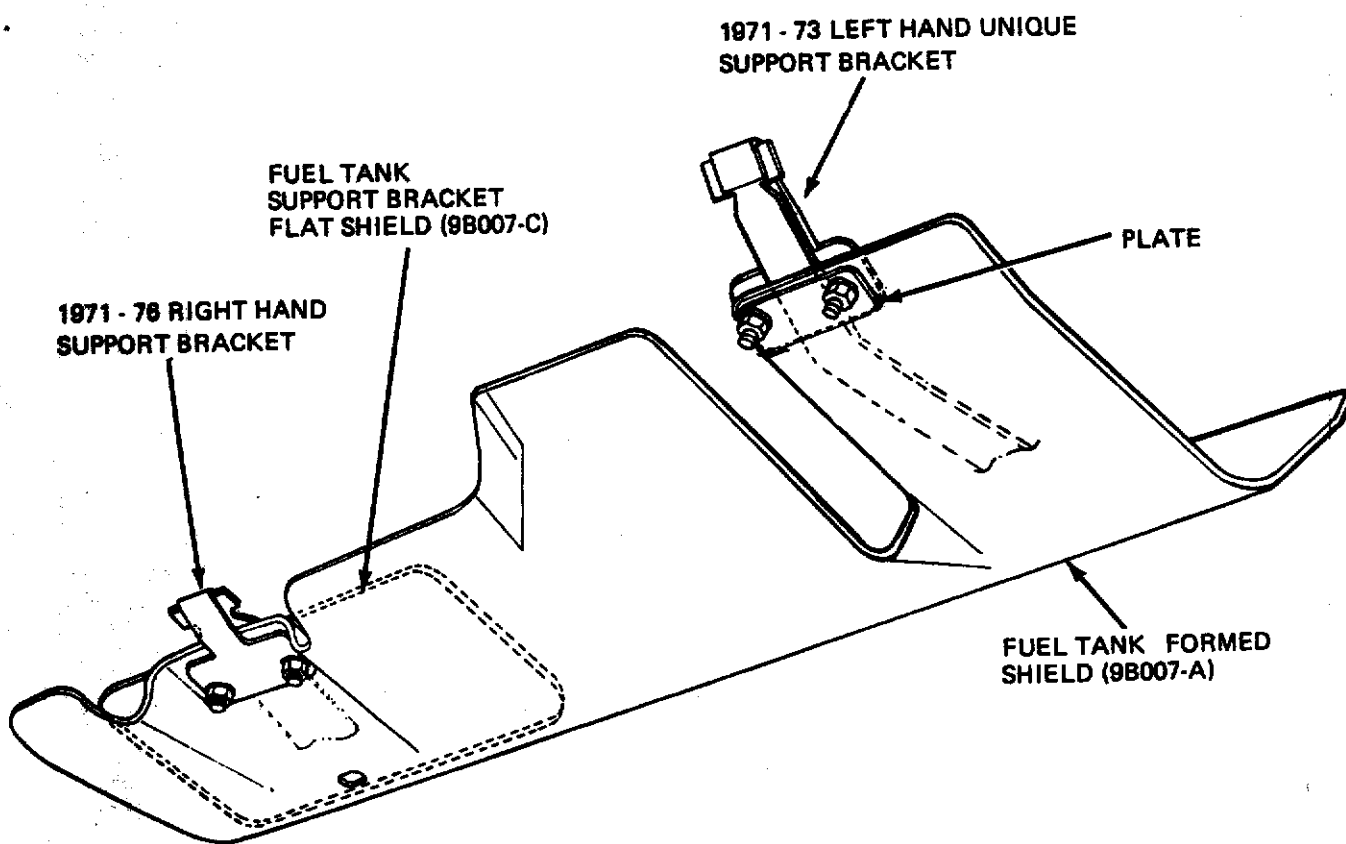
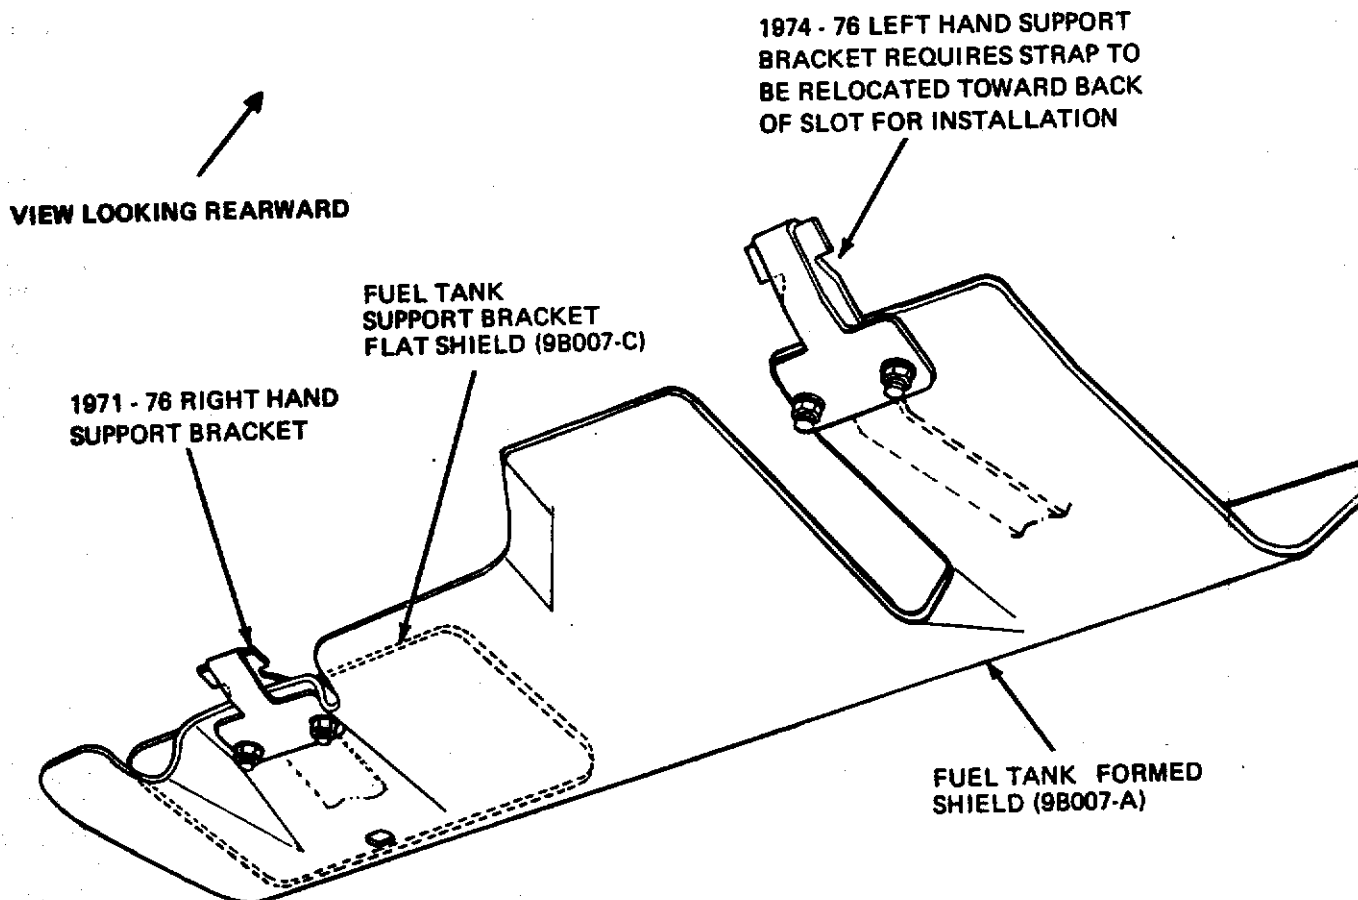
ATTACHMENT II
RECALL 293

FUEL TANK SHIELD SUPPORT BRACKET LOCATIONS

NOTE: PROPER LOCATIONS OF BRACKETS ON SHIELD AFTER SHIELD IS INSTALLED
(FOR REFERENCE ONLY)

For 1974-76 vehicles - Install the right and left hand brackets on the forward side of the strap as shown in Attachment II. The left hand strap must be pushed toward the back of the slot to allow installation of the bracket. Position the fuel tank support bracket shield (9B007-C) on the right hand side only as shown in Attachment II. Install the fuel tank shield (9B007-A) as shown in Attachments II and III, using the left hand holes indicated for 1974-76 (the 9B223 plate is not used for shield installation on these vehicles).
