Attached please find the Center for Auto Safety's September 1, 2011 letter to Chrysler CEO Sergio Marchionne. This letter contains a detailed analysis of fuel system failures in the Jeep Grand Cherokee, currently the subject of NHTSA Investigation PE10-031.

The Safety Problem

Grand Cherokee Has Highest Fire Death Rate of Similar SUV's – 20 Times Explorer

FHWA and CAS Vehicle to Vehicle Crash Tests

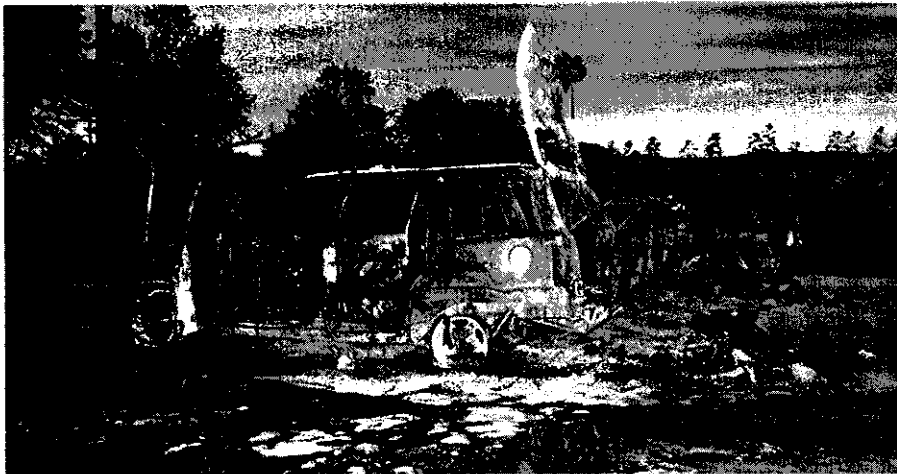
How apt that you made this address in Toledo the home of the Jeep and where the Grand Cherokee is made because the terrible and rising fire death toll of the 1993-2004 Grand Cherokee represents the largest social responsibility facing Chrysler today. Like a toxic waste site, these vehicles are legacy of the old Chrysler which the new Chrysler is called upon to clean up. As you told the Toledo graduates, "The essence of leadership, when all is said and done, is the personal assumption of the moral duty to be proactive in building our future." The future of the new Chrysler lies in not only the marketability of its new models but also how it handles the legacy of its older models, particularly the toxic 1993-2004 Jeep Grand Cherokee depicted in the hauntingly surreal photo of the burned out hulk of the 1997 Grand Cherokee that terribly burned the [REDACTED] sisters and burned [REDACTED] to death. Note the lack of structural damage showing there would have been no injuries but for the fire.

Picture 1 - [REDACTED] Crash Post Accident Photos

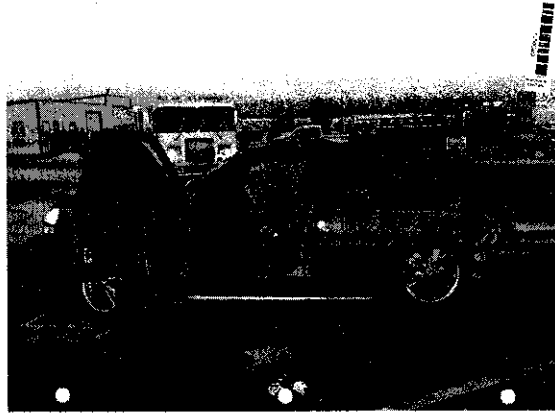
Picture 5 – Crash Photo

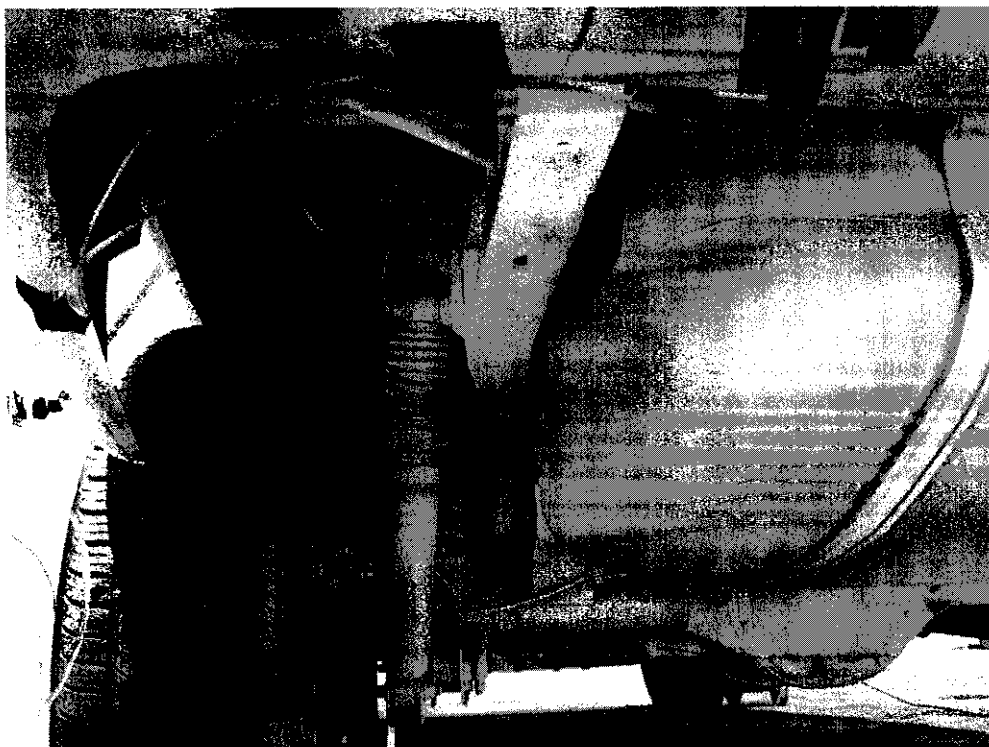
On the earlier models (through the 1998 model year) the filler and the vent hoses are routed through the left rear frame rail while in the later models, they are routed under the left rear frame rail. The earlier models had no standard shield protecting the fuel tank. On the later models, there is either a 1 mm brush guard or a 3 mm skid plate covering the underside of the tank. The skid plate is bolted to the rear frame rails so that the two hoses entering the tank are effectively tied to the frame rail. If the frame rail and fuel tank do not move together in a crash, this forces a separation of the filler hose from the tank. If they do move together, the filler hose can pull lose from the fuel filler inlet.

Picture 8 – Grand Cherokee Fuel Lines Routed through Frame Rail

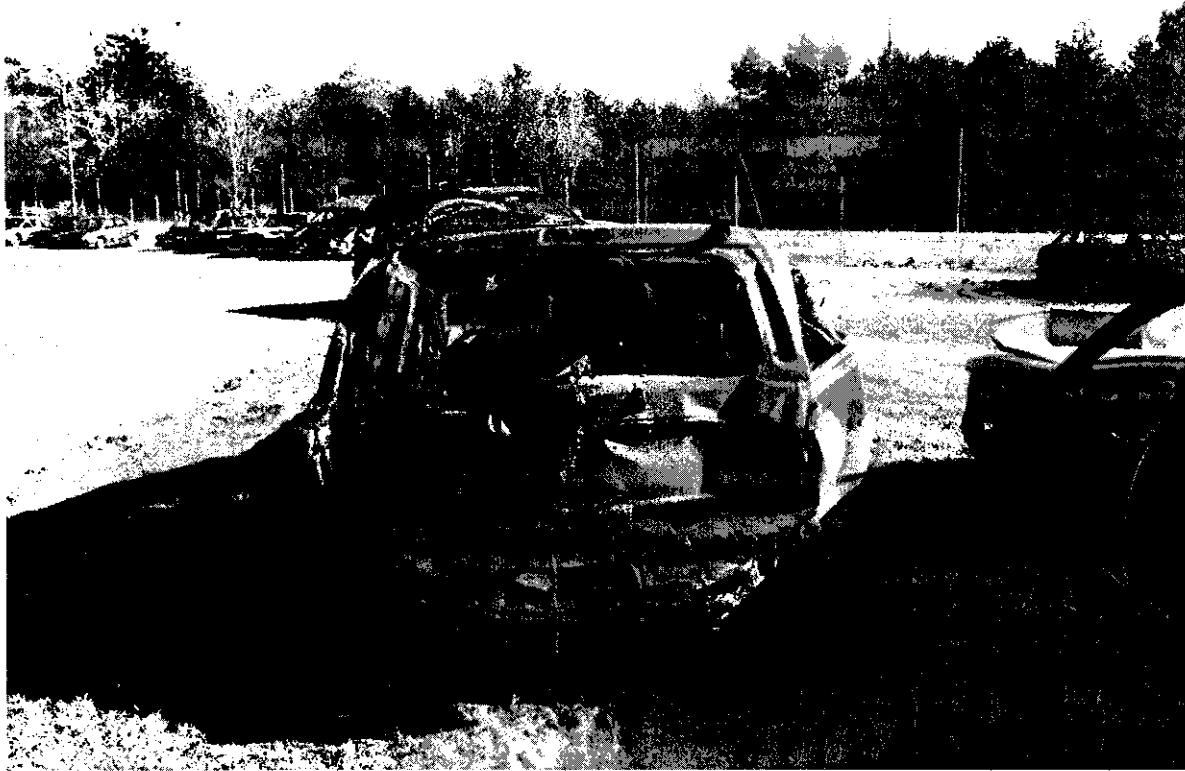
Rollover fires are all too common in Jeep Grand Cherokees with the FARS database showing 23 deaths in 15 fatal fire crashes involving rollover of 1993-2004 Grand Cherokees. Of these, 21 were coded by FARS as MHE fire which undercounts actual fire deaths. For example, [REDACTED] was burned to death according to the autopsy report in the rollover of the 2002 Grand Cherokee which is shown in Picture 11 below. The lack of an effective check valve used by other manufacturers in their SUV's could have prevented many of these fire deaths.

Picture 11 – [REDACTED] Crash
