Chrysler Group, LLC Failure-to-Warn/Comply under 49 CFR § 573.6, et al.

EA12-005 File Update (Chrysler Jeep Fuel Tank System Safety Defect)

Chrysler Jeep Fuel System Defect Investigation EA12-005

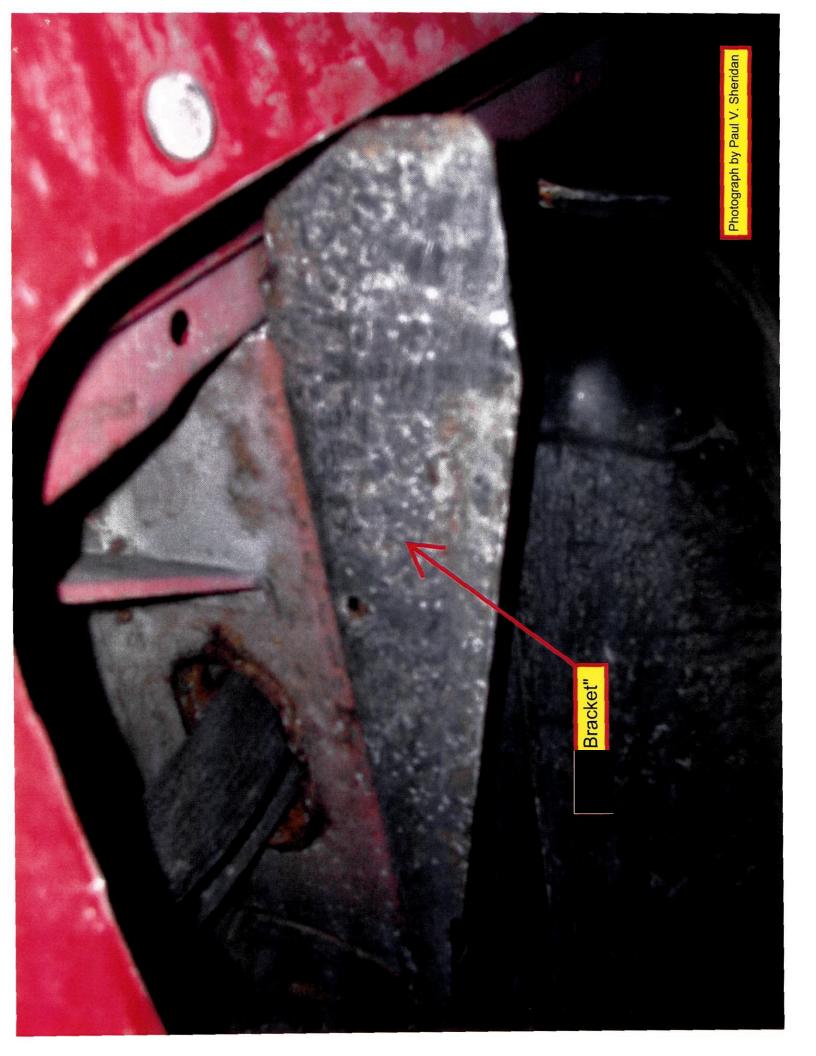
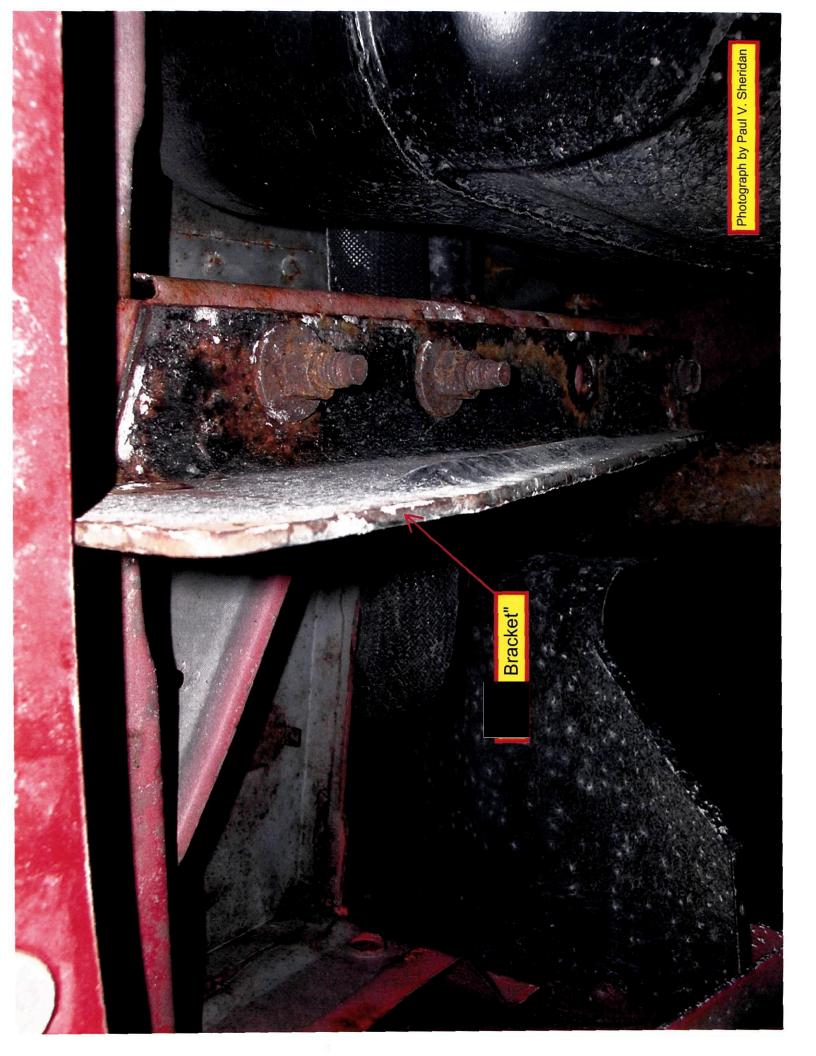
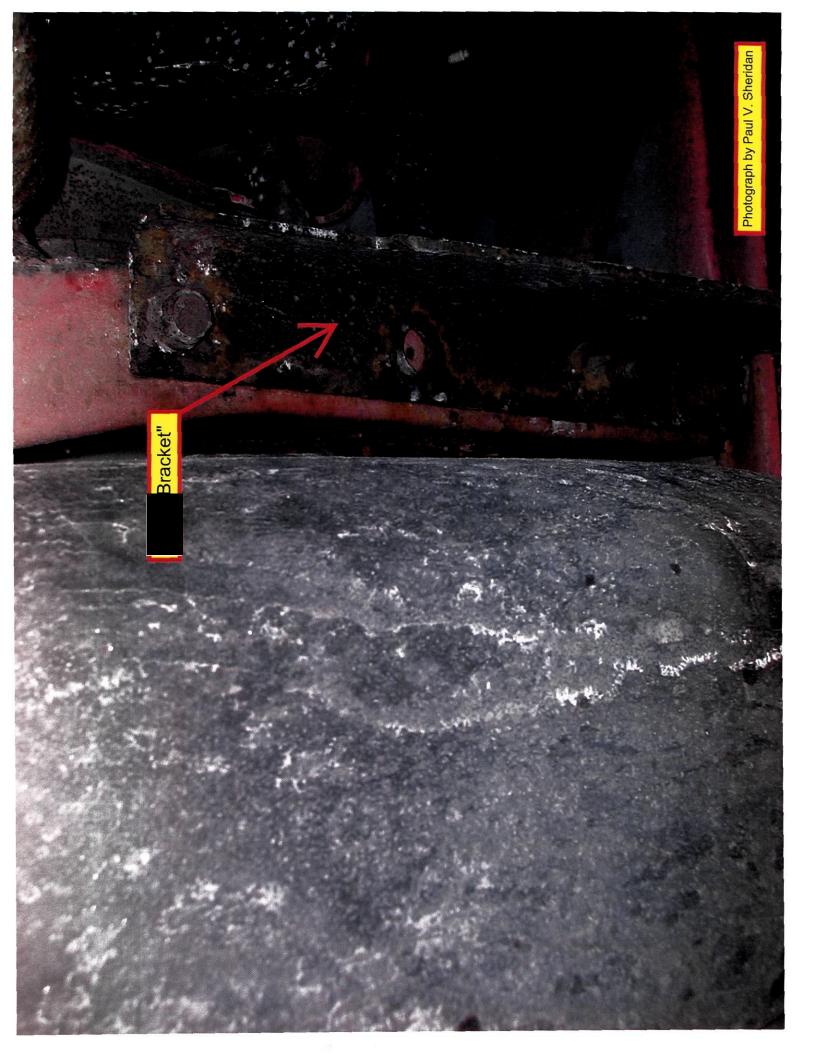
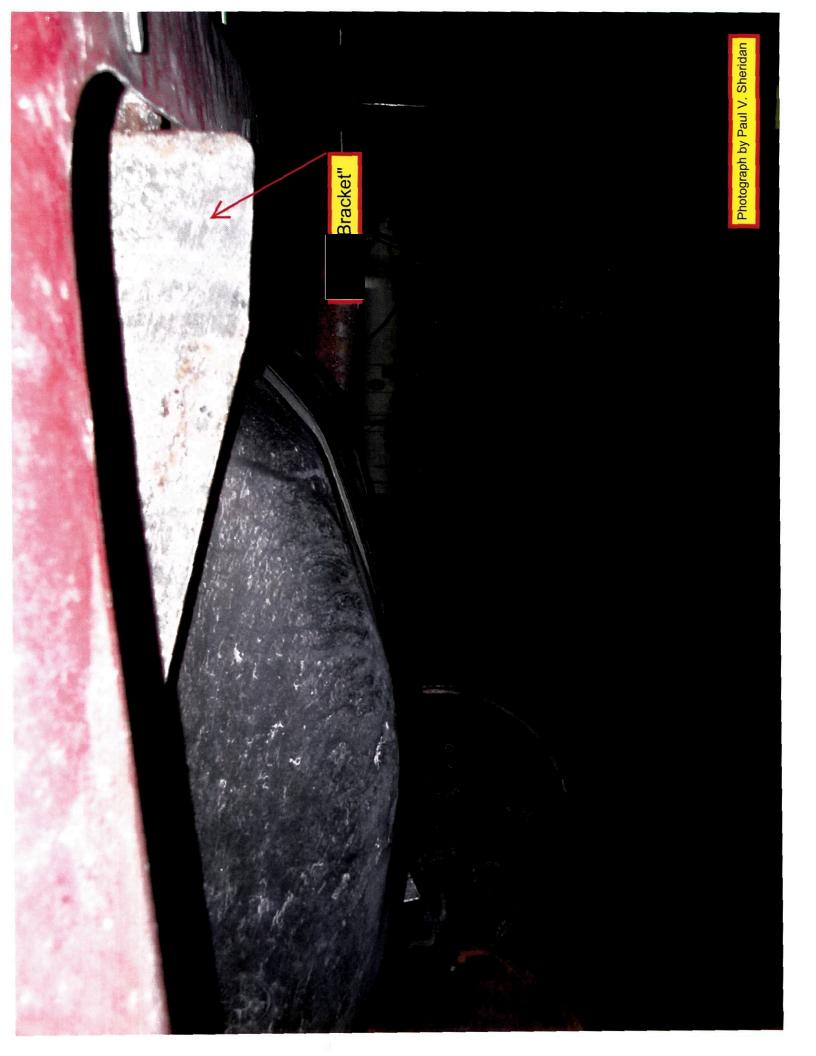
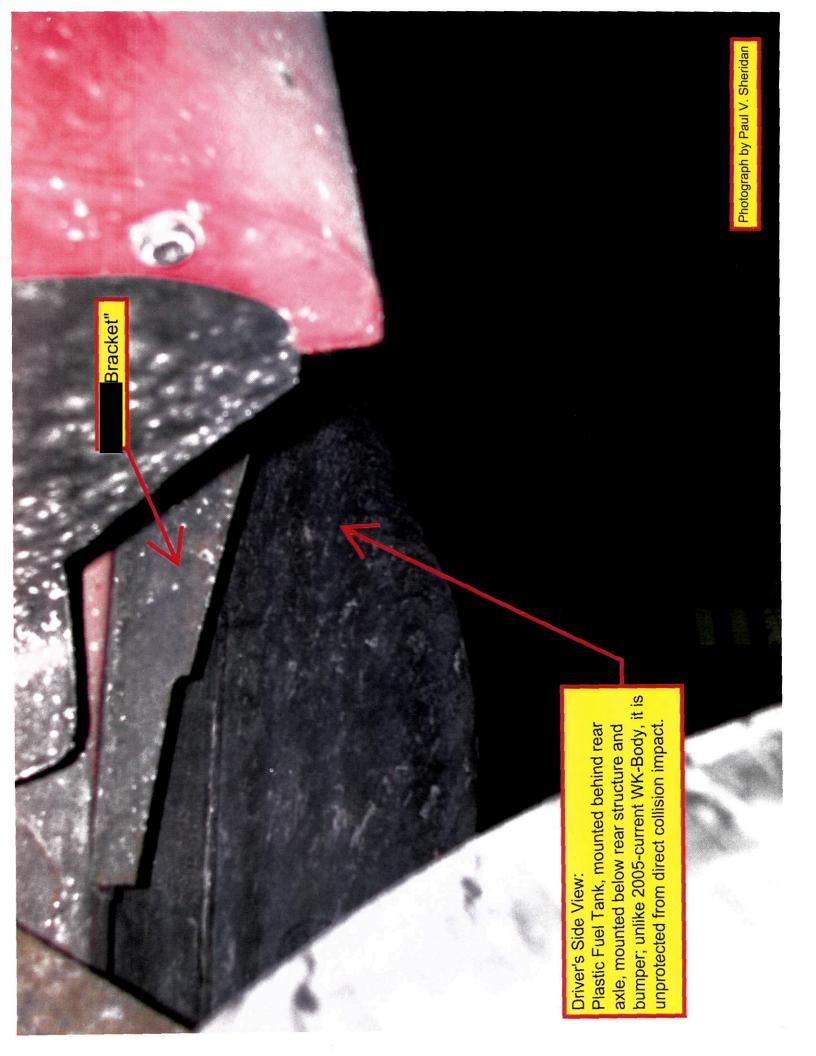
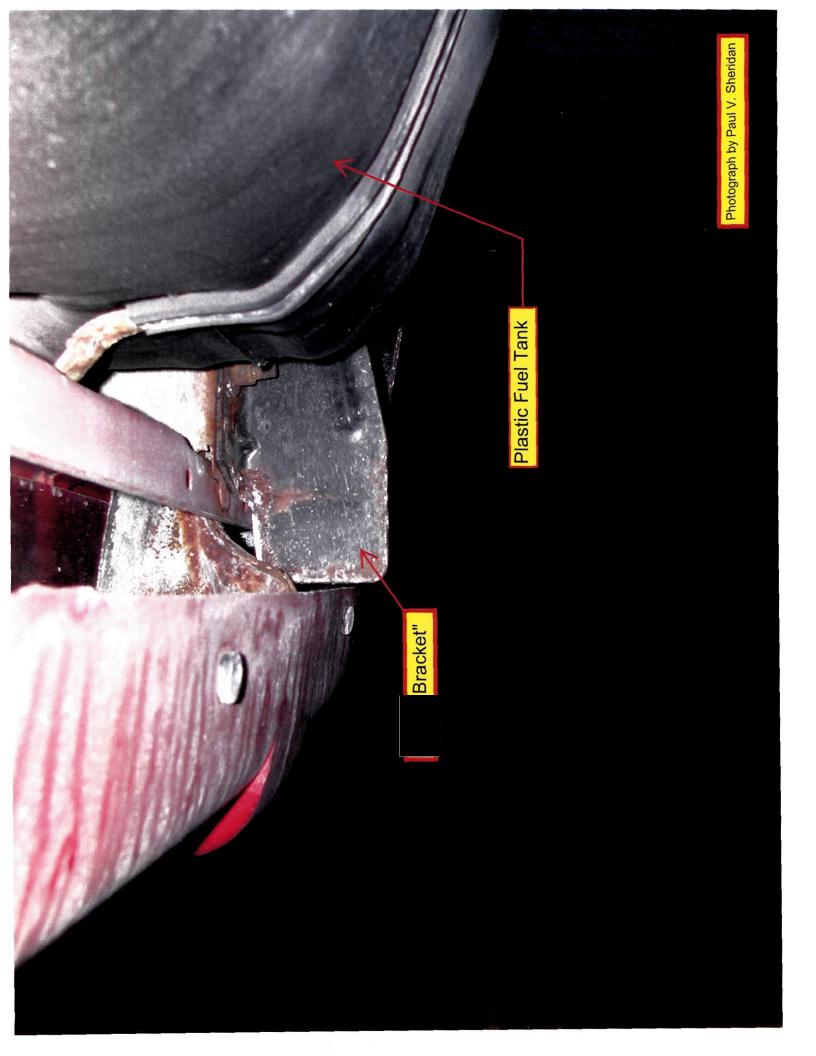
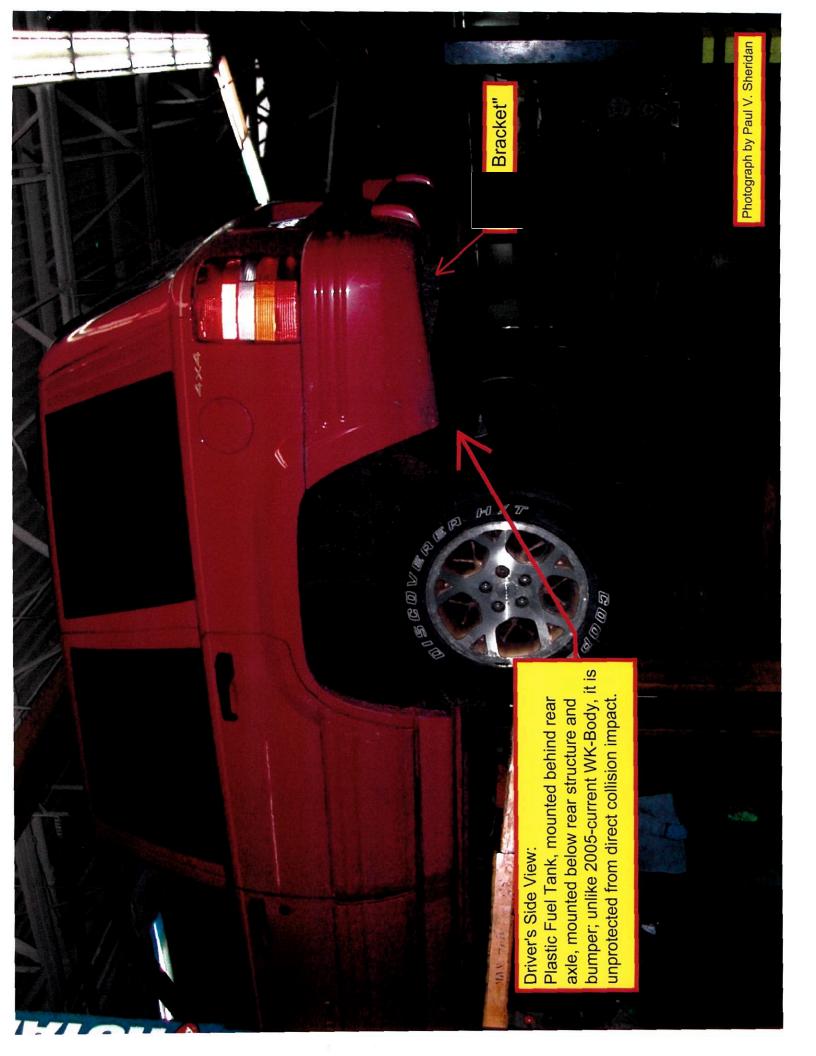
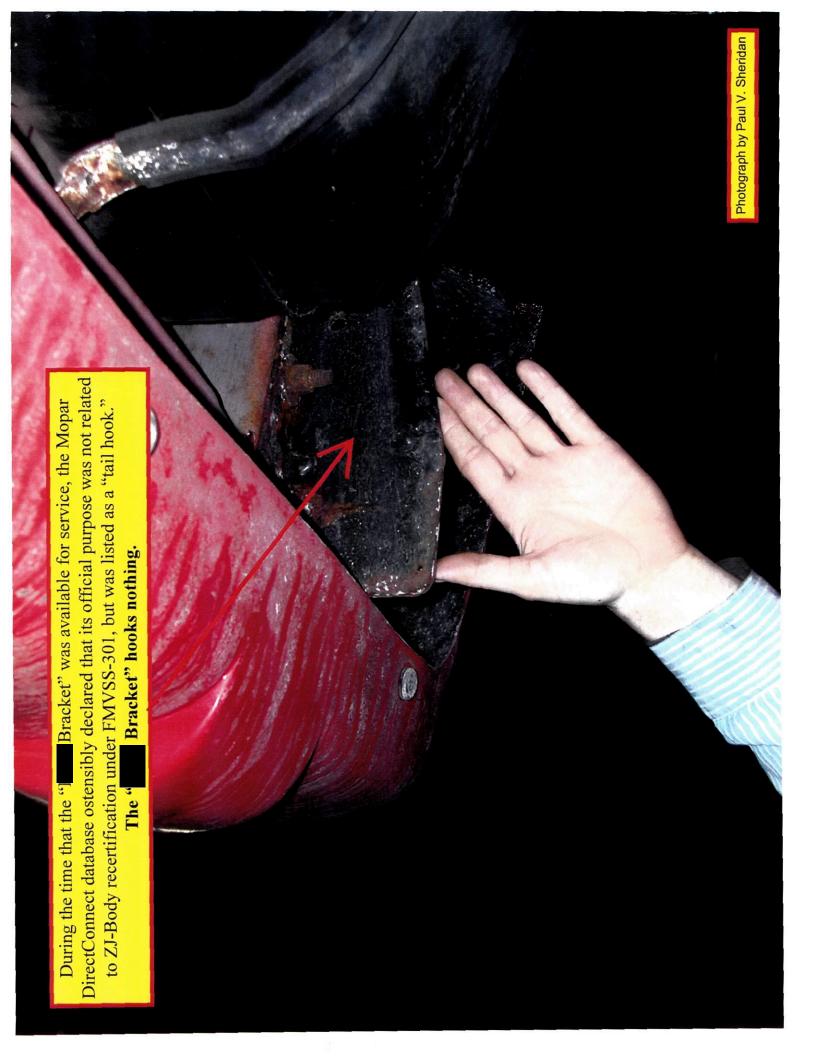
Photographs of last-minute release of preposterous, make-shift reinforcement to the rear frame rail, nicknamed the "" bracket" for the 1997 Jeep Grand Cherokee.

Last page of this attachment shows prior now-deleted MOPAR service graphics page for "Bracket" purposely misleading the public by referring to such as a "tail hook."

1997 ZJ-Body Jeep Grand Cherokee, which had "Estes bracket" installed at factory to ensure certification under the minimums of FMVSS-301.

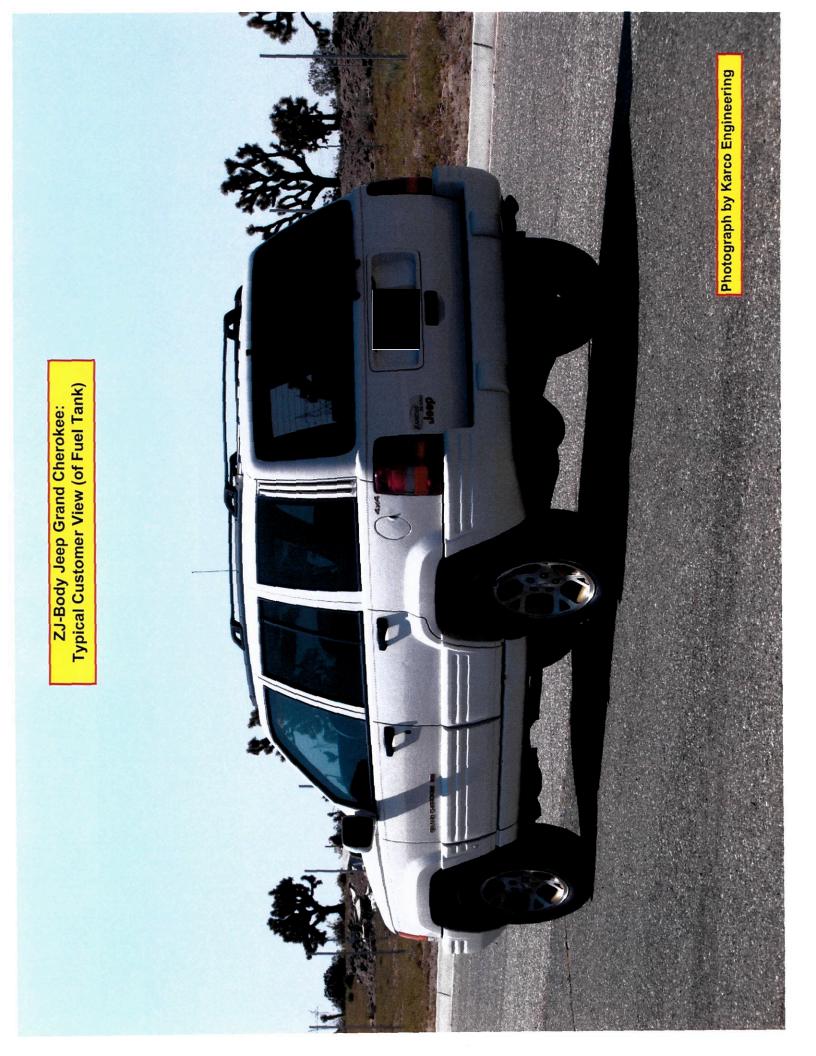
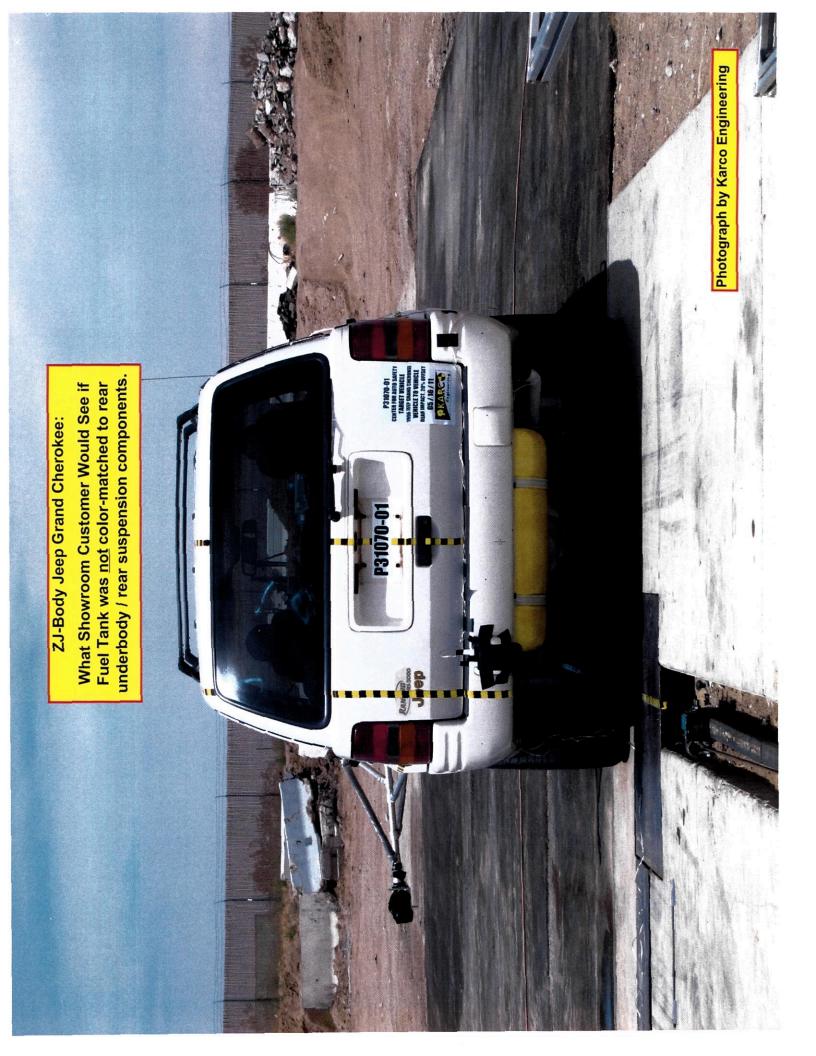
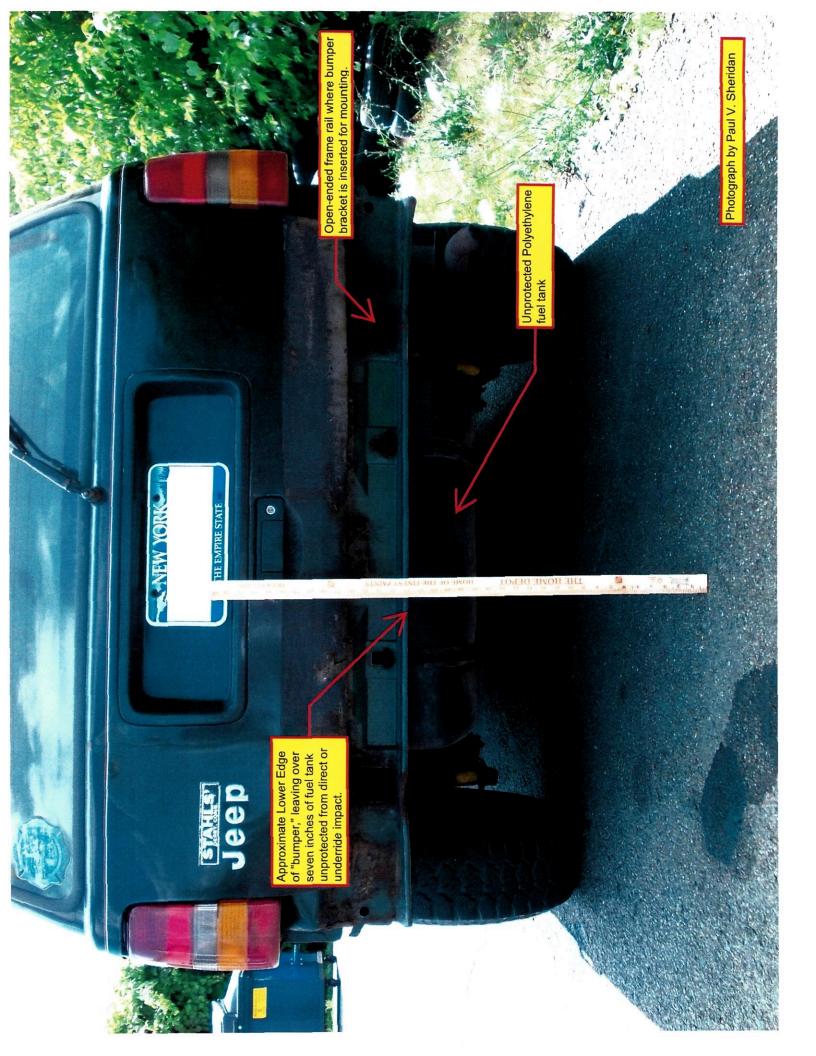
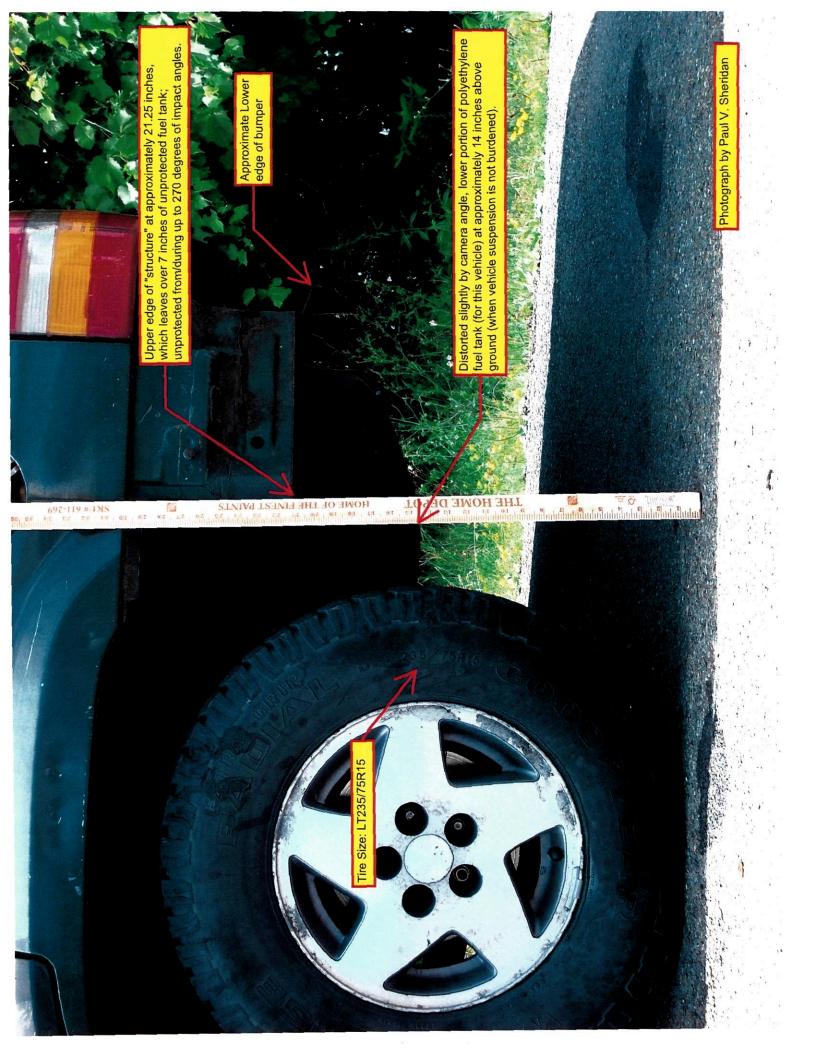
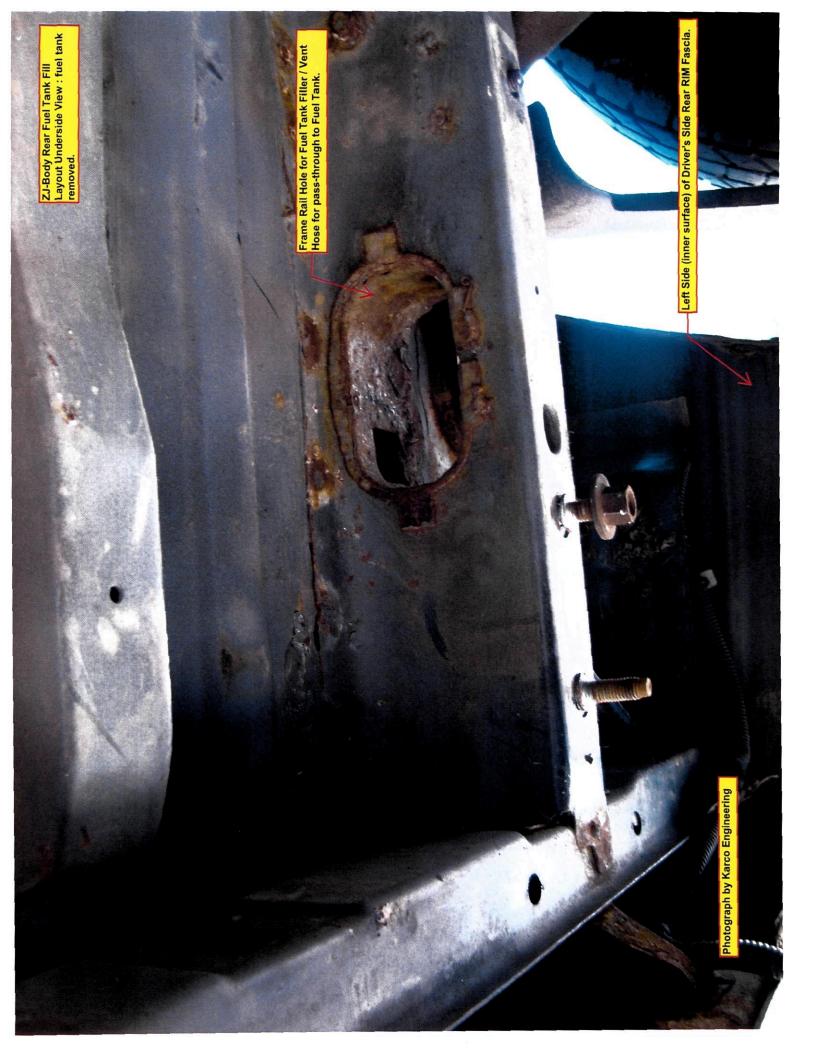
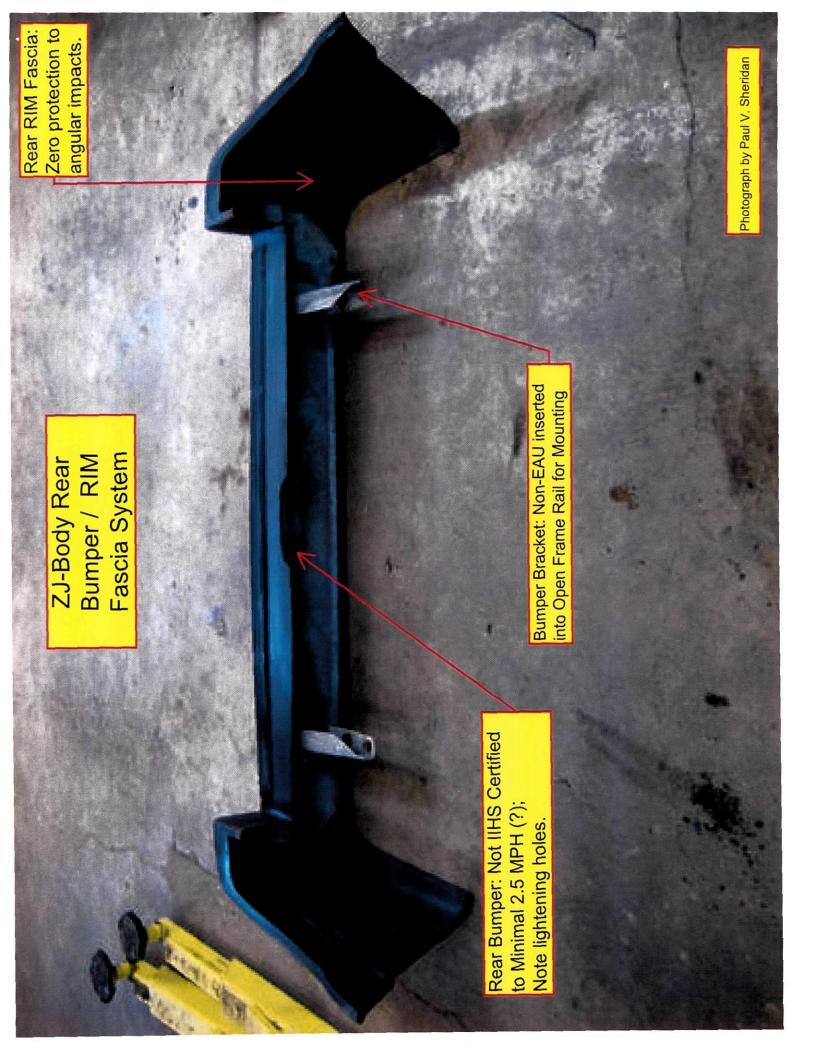
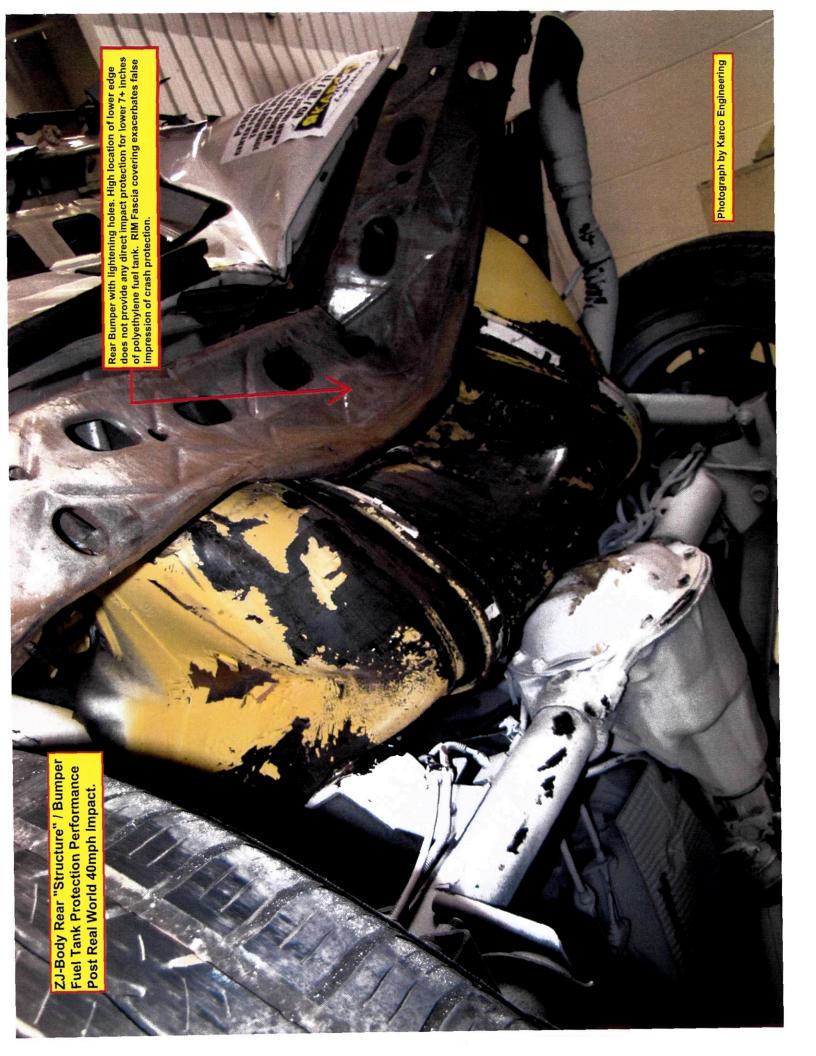
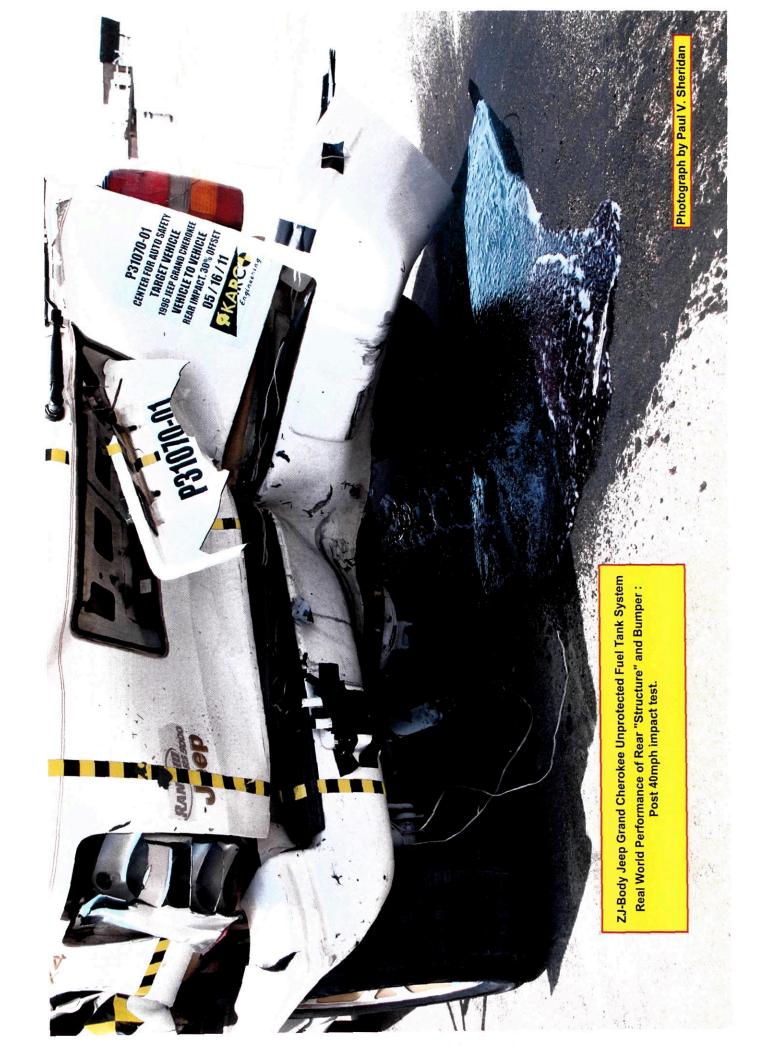
My letter of 24Sep2012 reviews the testimony of the highly qualified Chrysler defense expert Mr. Robert Banta. Referencing photographs that I had forwarded to you on 27Jul2012, Mr. Banta testified (ATTACHMENT 4):

Witness: Just the tank surface itself.

Witness: The tank's on its own.

10 11 12 13 14 15 16 17 18 19 20	marked Banta-28 through Banta-33 for identification.)  Q. Let's just start with photograph which I have marked Banta-29. Would you look at that photograph, Mr. Banta, this one?  A. Okay. Q. You've already testified that that depicts the back of the CARCO Jeep Grand Cherokee prior to being stuck. Correct?  A. Yes.	10 11 12 13 14 15 16 17 18 19 20 21 22	bumper both. They're both back there and they're tied together.  Q. So with the bumper off are you saying that the rear crossmember doesn't protect the tank?  MR. BRADLEY: Just note my objection. I believe he testified before there was a box that protected the tank.  THE WITNESS: They're in combination.  Q. I'm saying with the bumper off as you see it here in Banta-23, are you indicating there's no protection for any part of that tank?
10 11 12 13 14 15 16 17 18 19 20 21	marked Banta-28 through Banta-33 for identification.)  Q. Let's just start with photograph which I have marked Banta-29. Would you look at that photograph, Mr. Banta, this one?  A. Okay. Q. You've already testified that that depicts the back of the CARCO Jeep Grand Cherokee prior to being stuck. Correct?  A. Yes. Q. And you've already indicated that	10 11 12 13 14 15 16 17 18 19 20 21 22 23	bumper both. They're both back there and they're tied together.  Q. So with the bumper off are you saying that the rear crossmember doesn't protect the tank?  MR. BRADLEY: Just note my objection. I believe he testified before there was a box that protected the tank.  THE WITNESS: They're in combination.  Q. I'm saying with the bumper off as you see it here in Banta-23, are you indicating there's no protection for any part of that tank?  A. Well, I guess
