Center for Auto Safety White Paper on Concerns With
Chrysler Recall of the Jeep Grand Cherokee and Liberty
Presented to NHTSA July 1, 2013

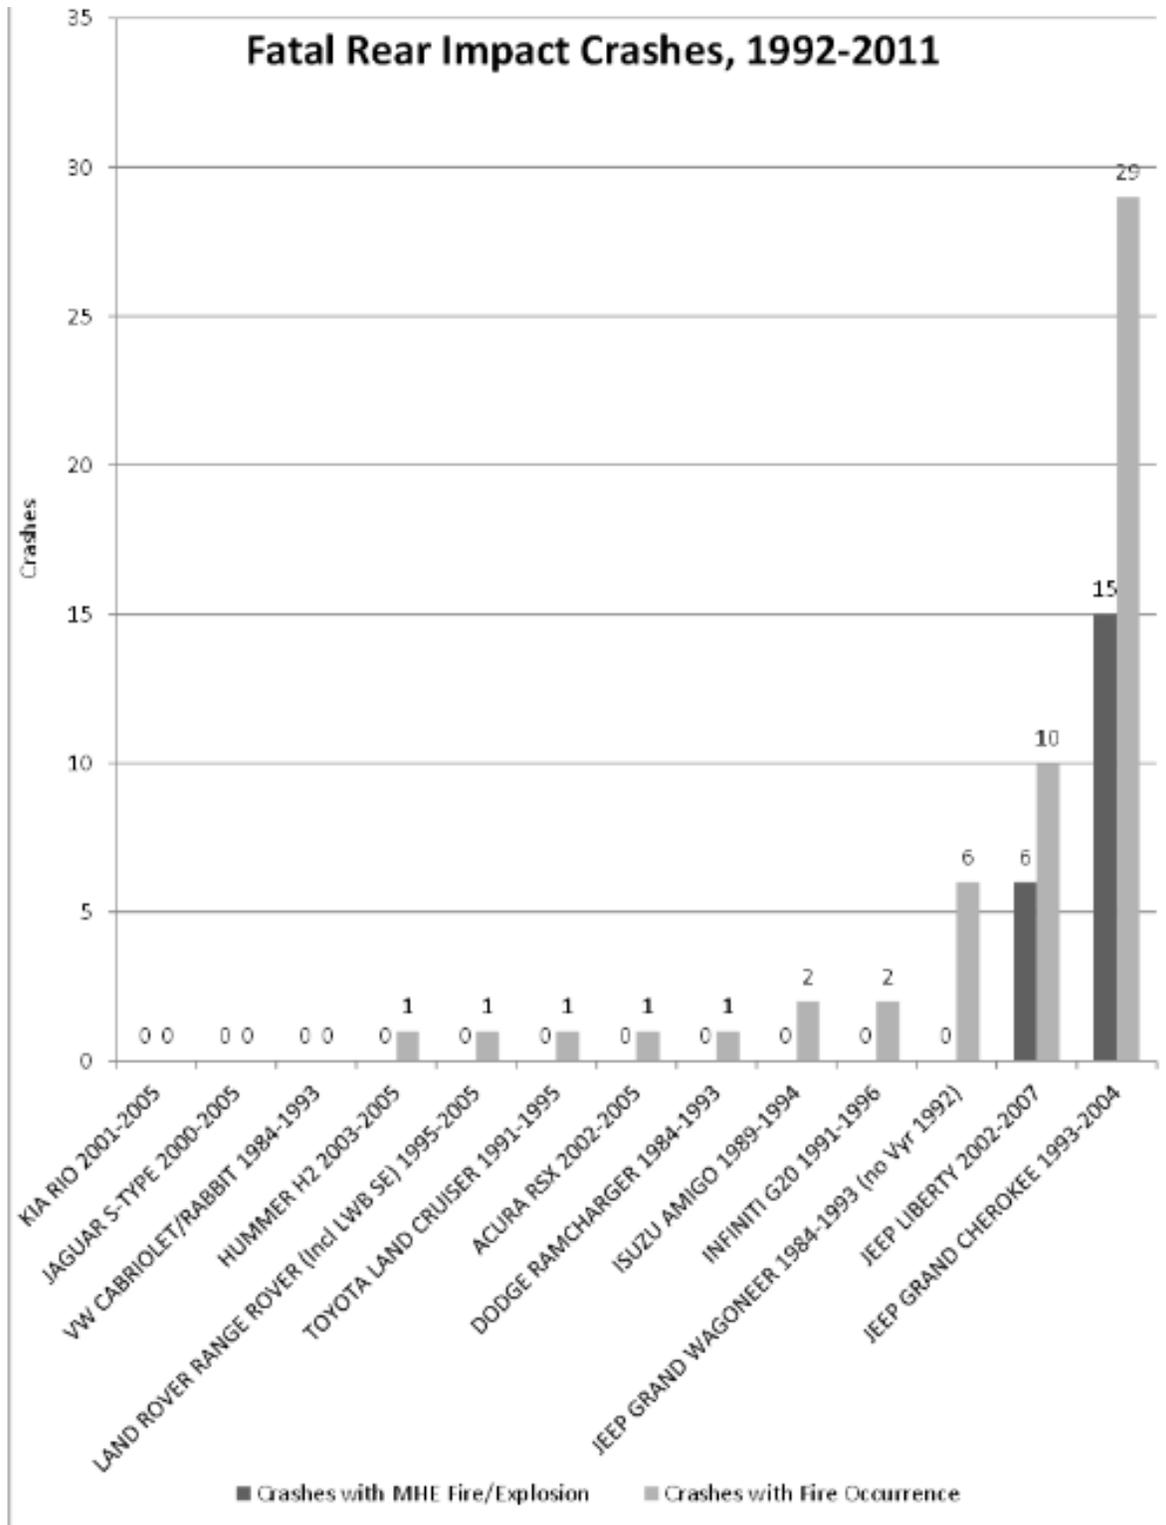
Figure 1. A comparison with the subject Jeeps and other vehicles that Chrysler had purported to show had worse rear impact fire performance but which had no deaths due to fire in FARS in rear impacts where there was a fire in the listed vehicle.

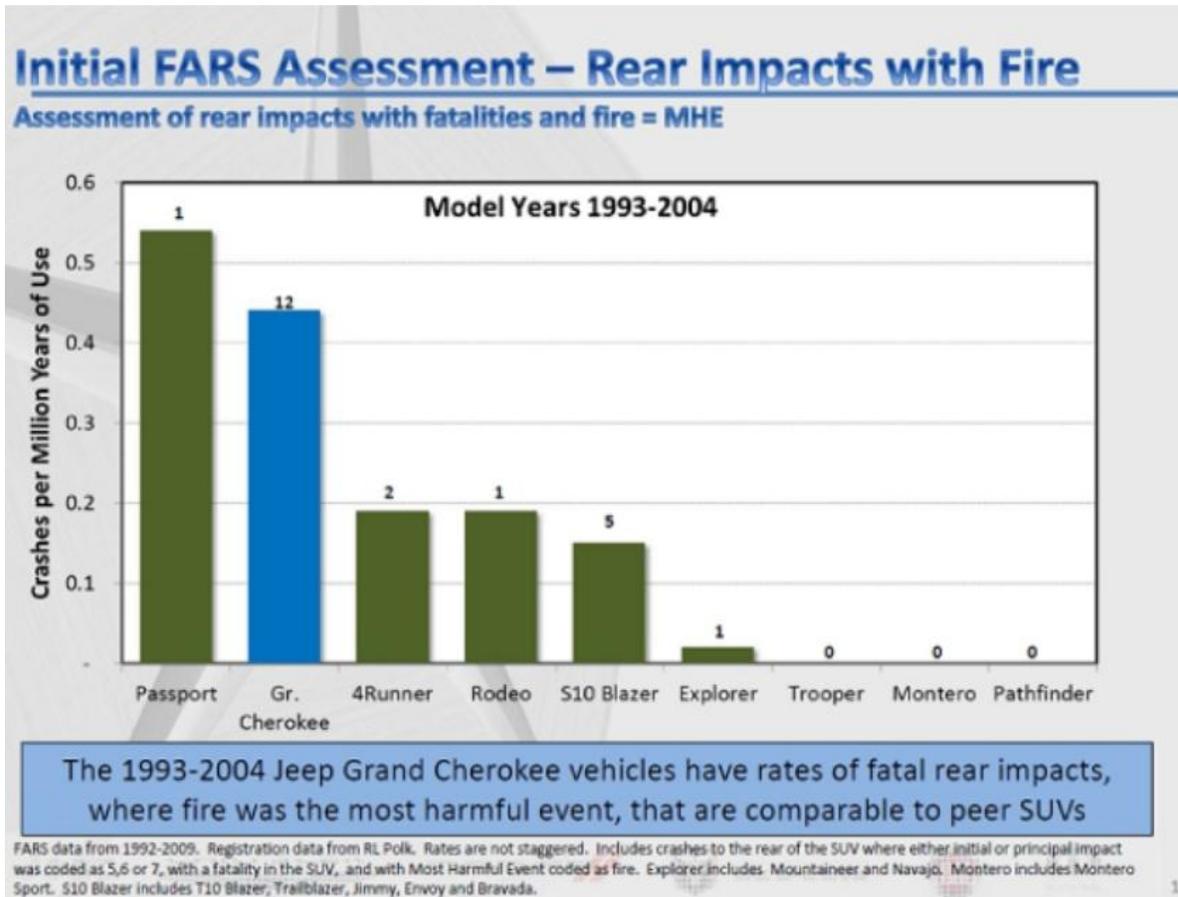
Looking at Chrysler's own chart which normalized these results (Figure 2) for the Grand Cherokee – with 12 cases where fire was the most harmful fatal event – had 4.4 per hundred thousand vehicle-years of use. The Honda Passport, which is a sister of the Isuzu Rodeo and should have been included with them, had only one crash on this chart, but when we looked at this case it was not even a rear impact but rather a frontal with a Chevrolet Tahoe.⁶ (Also, because of the small population of these vehicles, there were a

Figure 2. A chart submitted by Chrysler as part of their early response to NHTSA's investigation. Note that while Chrysler combined sisters and clones in most cases, it did not combine the very small volume Honda Passport with its sister Isuzu Rodeo.

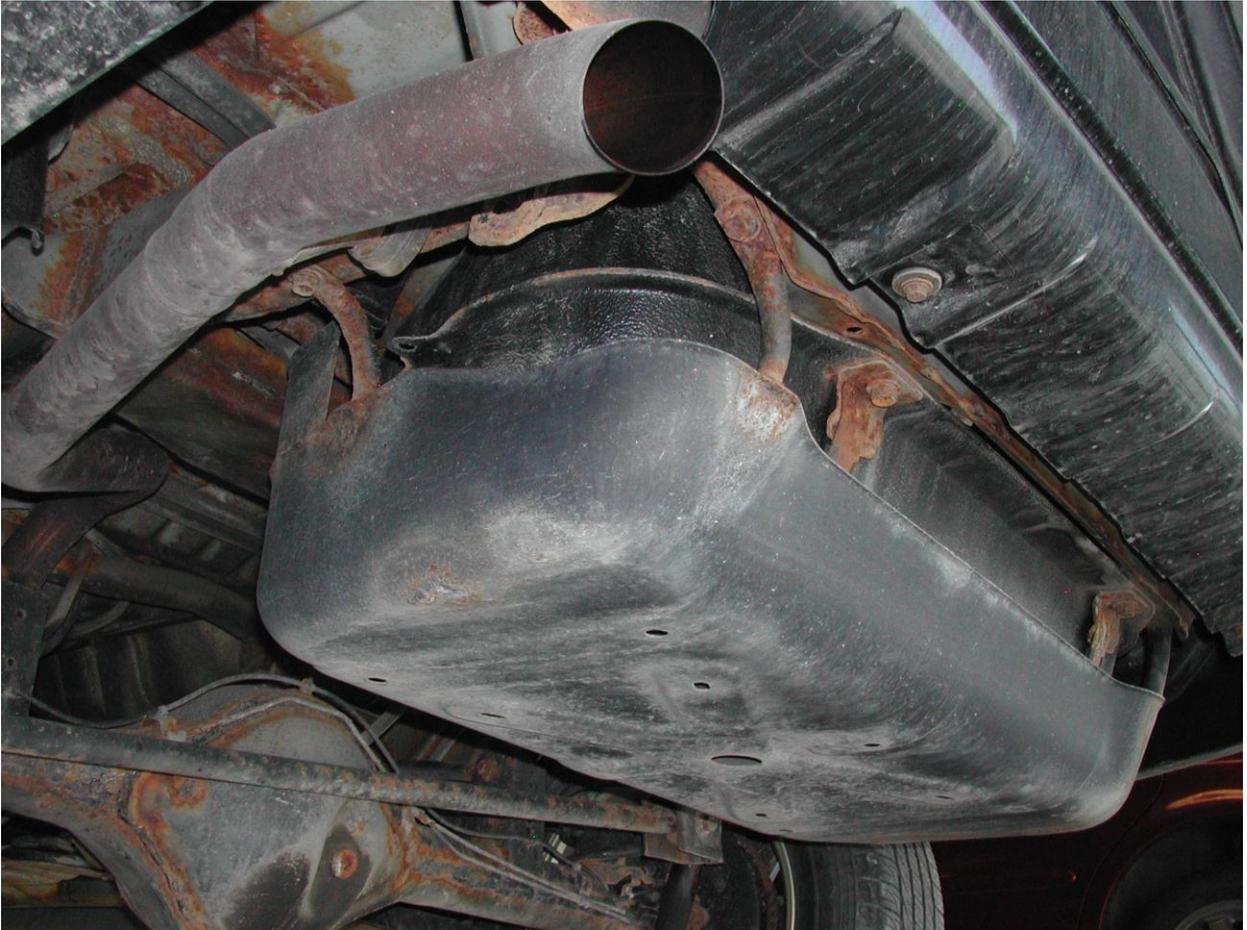
There is no significant production vehicle currently sold in the U.S. with the fuel tank located behind the rear axle. Even at the time the subject Jeeps were sold, only a few vehicle lines had fuel tanks in this location. And ones like the Suzuki XL-7 have a steel structure encapsulating the fuel tank. (Attachment A.)

Exhibit A – Encapsulated Suzuki SL-7 Fuel Tank

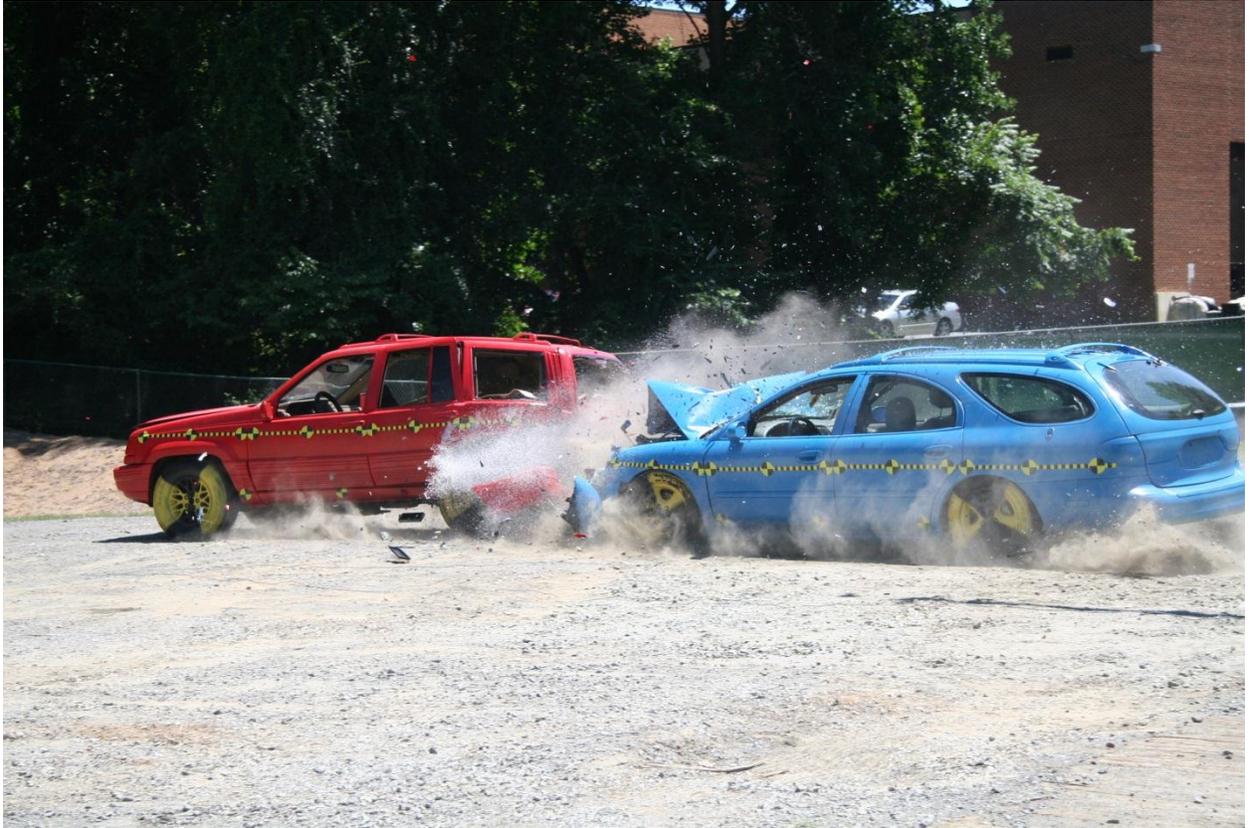
Exhibit B Fuel Spray from FHWA Due to Filler Hose Pulling Loose

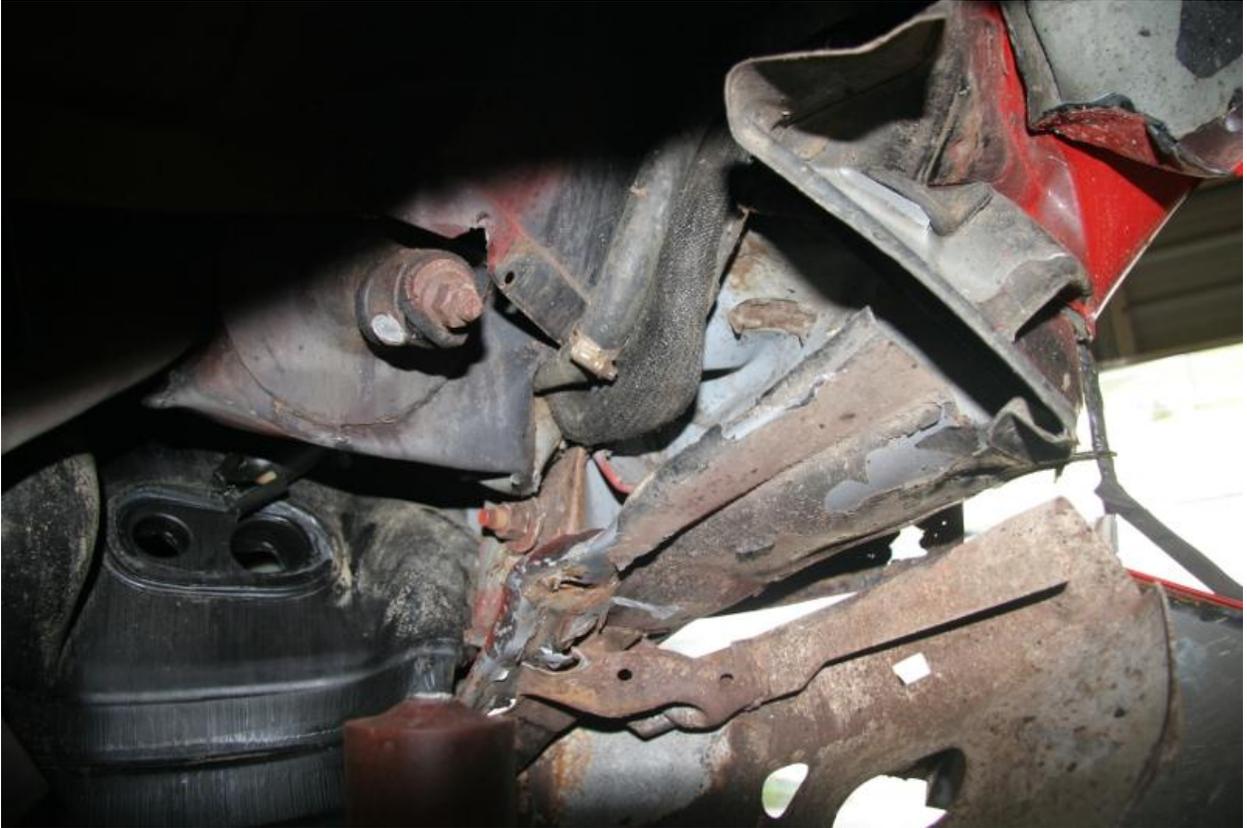
Exhibit C – Fuel Tank Connection Where Filler Tube Pulled Loose

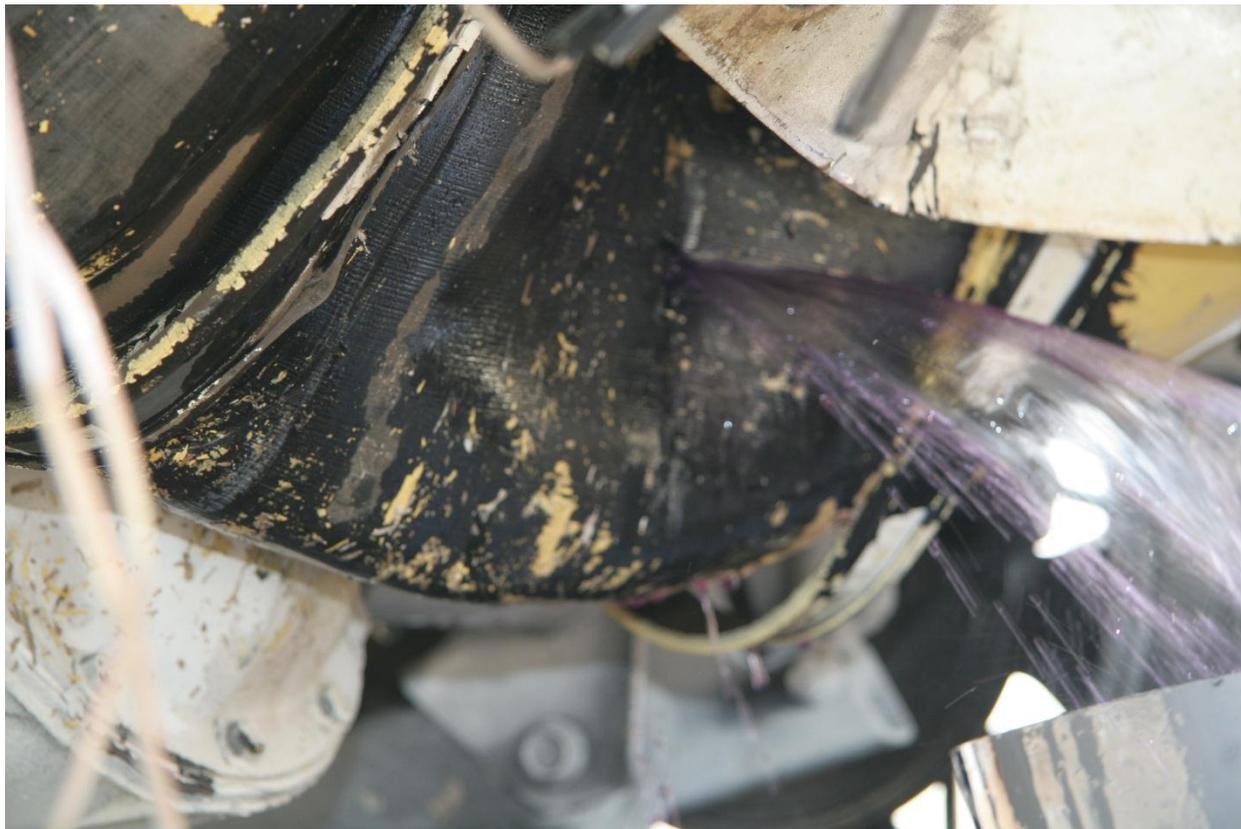
We are confident that the subject Jeeps could not pass the current FMVSS 301 despite Chrysler's claim that virtually all of the fatal fire crashes of Jeeps were more severe than this test. The last test conducted for the Center for Auto Safety was similar to the current fuel system integrity test except that it was conducted at 40 mph rather than 50 mph (about two-thirds of the energy). The tank failed in that test.

Exhibit D –Leak from Ruptured Grand Cherokee Fuel Tank in 40-mph Impact

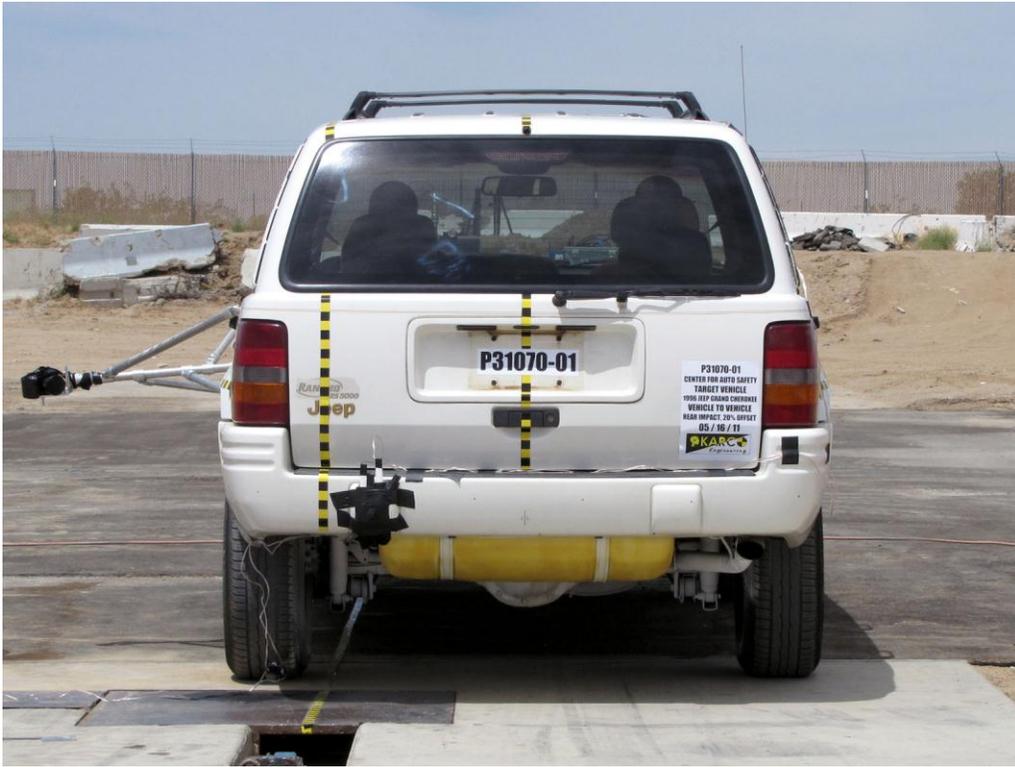
The trailer certainly provides no protection for rear impacts in which the nose of the striking vehicle goes under the Jeep's bumper which it will also go under the trailer hitch because the fuel tank extends downward 8.5" below the rear bumper. At best the trailer hitch extends downward only 1.2 inches below the bumper leaving more than 7" of the fuel tank exposed.

Exhibit E – Pre-Crash Photo Showing Exposed Fuel Tank
