**Chicago Transit Authority (CTA) - Articulating North American Bus  
Industries, Inc (NABI) Bus Fleet  
Trip Summary Report  
April 7, 2009**

Inspection Summary:

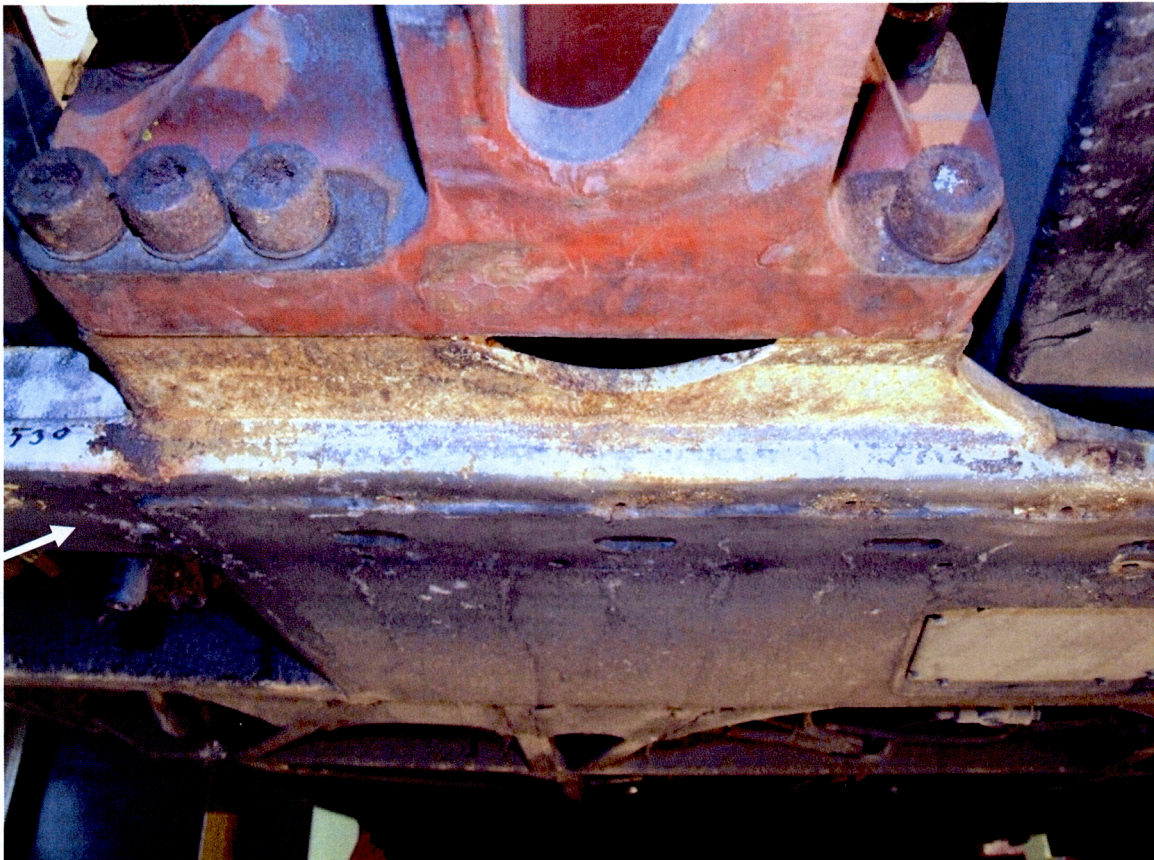
This bus had approximately 100,000 street miles and 150,000 simulated miles from a six post shaker at a test facility. The bus was inspected and showed signs of structural modification. Representatives from CTA confirmed this vehicle had been the subject of laboratory durability testing and that during the testing steel plates had been added across several structural members in close proximity to the main connecting weld in question. Evidence of previous scientific testing was corroborated based on the presence of abandoned strain gages, labeled areas, and other similar cues consistent with structural monitoring. At least one crack was identified on this bus at the cast receiving member. The crack was located toward the outside of the vehicle, just after the termination of the connection to the Hubner Joint. To the unaided eye, the main weld between the cast receiving member and the rolled structural plate appeared continuous and uninterrupted (figure 1).

Figure 1 Hubner Joint Weld

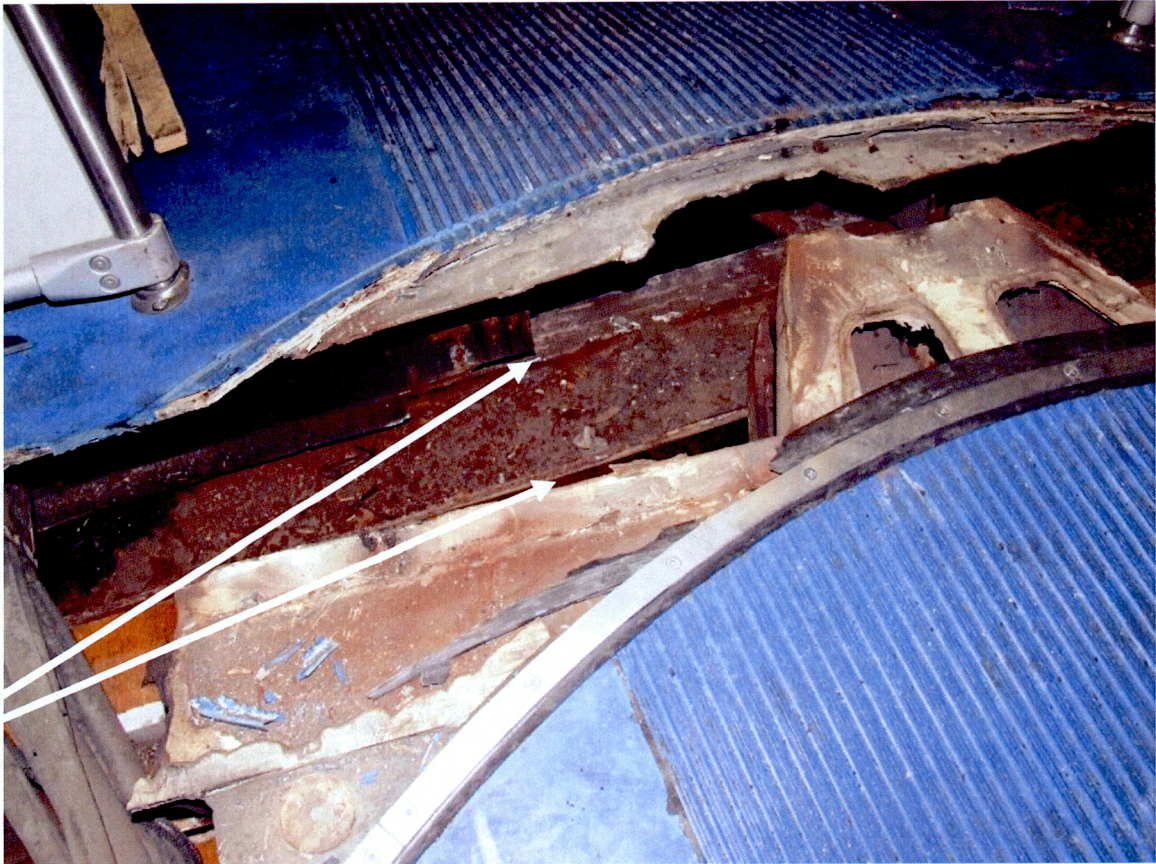
The fracture of the main weld on the subject bus could be characterized as a fatigue fracture that initiated toward the center of the bus and propagated in both directions outward. This was evident by the presence of advanced corrosion at the center, which tapered off to lighter corrosion as it worked outward. The final fracture point in the last half inch of weld appeared to be overloaded and was free of any corrosion. Penetration on the casting appeared adequate; however the size of the weld bead exceeded the thickness of the adjacent rolled structural plate, leading to a concern that this metal may have been embrittled during the manual Gas Metal Arc Weld process due to excessive heating.

Figure 2 Weld separations from bracket

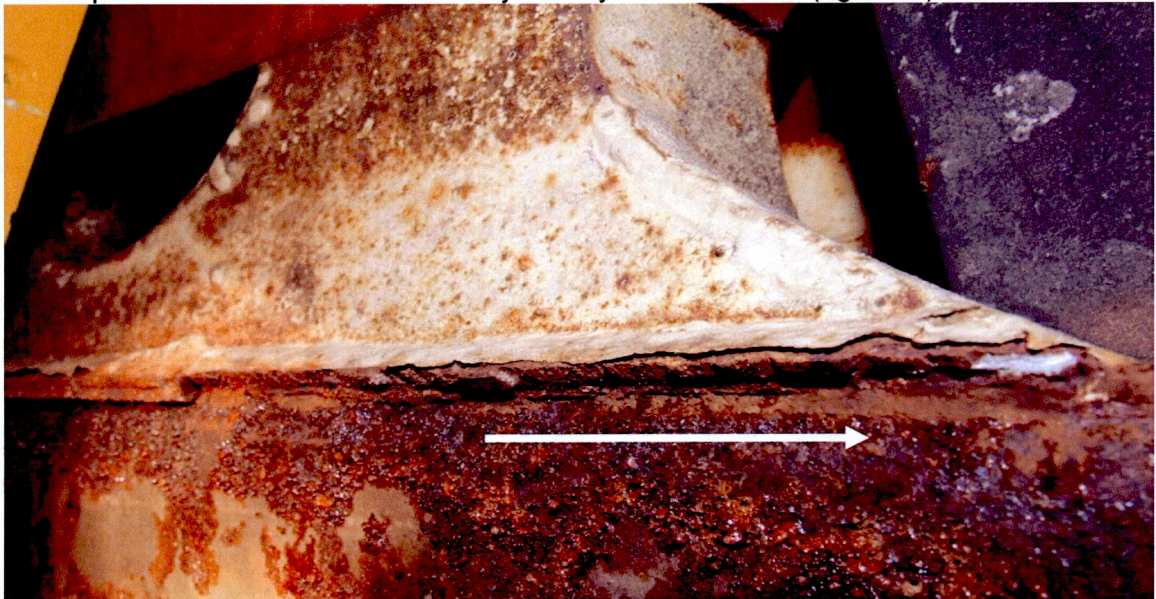
Consistent with that concern, the weld failure occurred in the parent metal of the rolled plate. The fracture occurred just beyond this weld (figure 3).

Figure 3 Weld separation spreading outward

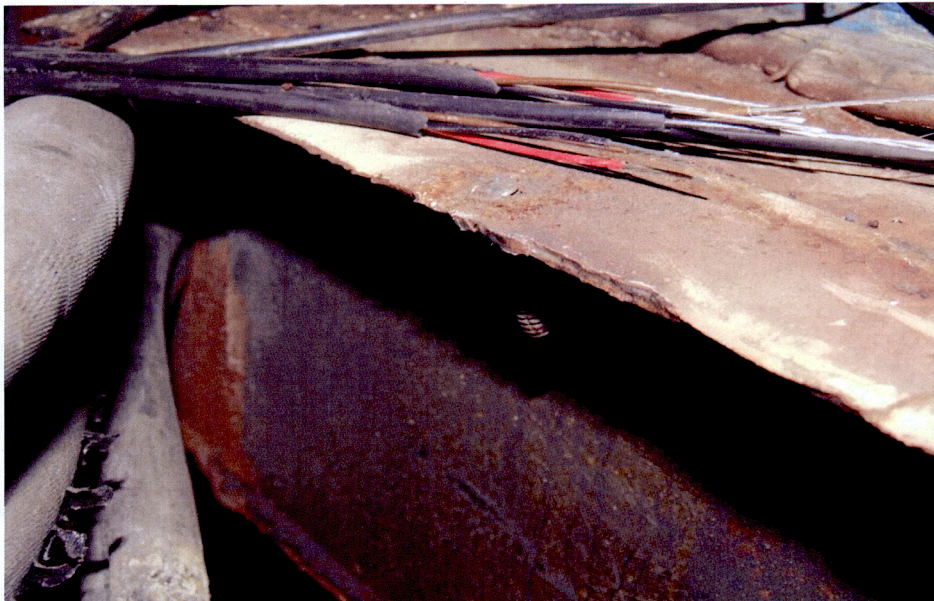
The fatigue fracture appeared to be generated by a torsional loading configuration. This would suggest the bending moment that initiated the fatigue was delivered by fore and aft rotational loading that could be generated by, among other forces, both positive and negative wheel torque (acceleration and braking). A cursory evaluation of the surrounding structure suggests that several welded members form a box beam that is intended to react to the torque and prevent the main structural weld from bending but the unreinforced materials appear to be inadequate for the forces generated in this application (figure 4).

Figure 4 Floor plate separation

Since NHTSA's visit to CTA, NABI has issued a recall notice (573) which includes CTA buses and all other buses with similar articulating weld attachment designs (total 579). Models affected by this recall are the 60BRT (352), 65BRT (1), and 60 LFW (226). All affected buses were built from January 1, 2003 through September 30, 2007. Later buses had a design change to the affected area and have not suffered the failures. CTA is the owner of all 226 "LFW" buses. NABI will arrange to have the buses repaired by the addition of reinforcement of the affected joint.
