FAILURE REPORT SUMMARY

A defect petition was received by the Office of Defects Investigation (ODI) requesting "an additional investigation into the unwanted and unintended acceleration of model year [MY] 2007 Lexus ES350 as the initial investigation (PE07-016) was too narrow in scope and did not adequately address all complaints made to the NHTSA with respect to vehicle speed control concerns."

DP09-001

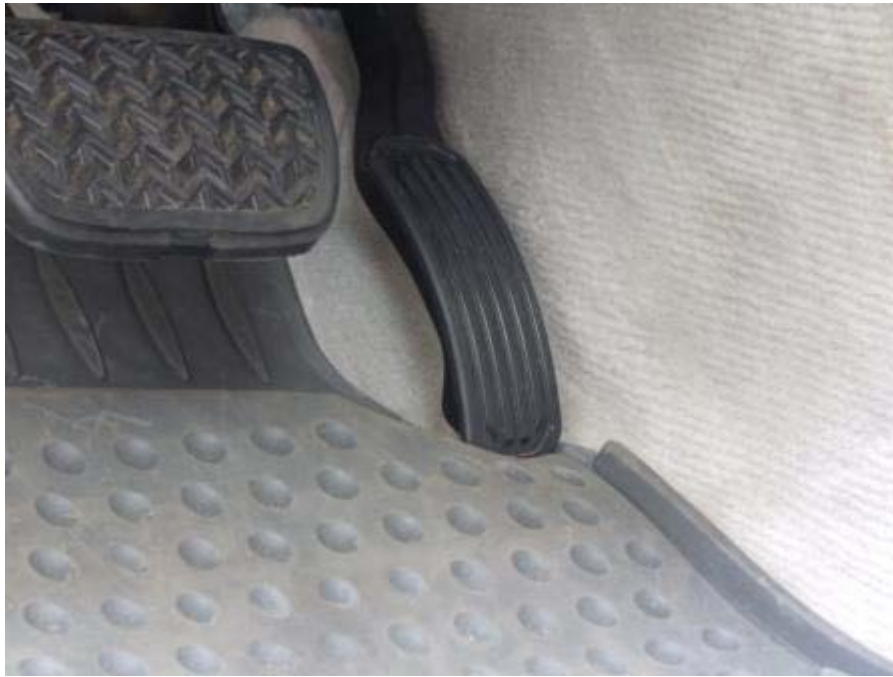
Example of an unsecured driver-side floor mat trapping the accelerator pedal in a 2007 Lexus ES350

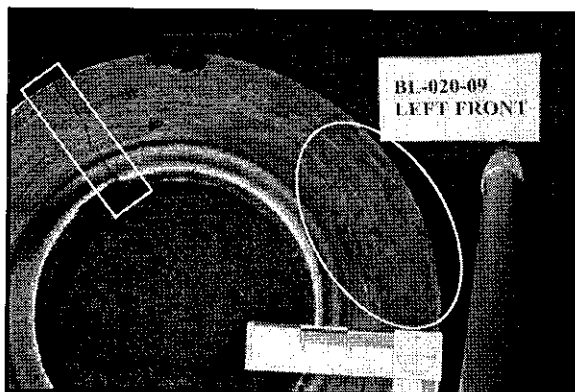
Image 6: Disc 5\DCIM\274CANON\IMG_0079.JPG

The rotor disc was circumferentially fractured and separated at the base of the rotor hat. The fractured surface had a rough crystalline appearance. Other than being fractured and separated from the disc, the rotor hat was generally unremarkable.

The ventilated design of the rotor was cast as two disc plates, separated by bridges (cooling fins) that joined them together, while allowing for the passage of air. The outer disc had a radial fracture that connected to the fracture at the base of the rotor hat and extended to the outer circumference of the disc (Image 18 boxed).

The swept areas on the disc were circumferentially scored and discolored to various shades of gray, blue, and bronze. There were sections on the swept areas of the rotor which were discolored darker than the surrounding surfaces. These sections appeared similar to the dimensions of the front brake pads. Within this same area, there were pieces of friction material bonded to the surface (Images 18 and 19 circled). There were discernible ridges about the inner and outer circumferences of the brake rotor discs, adjacent to the swept areas. There were two oblique gouges within the swept area of the outer disc (Image 19). The non-swept surface of the outer disc, adjacent to the fracture at the hat base, was discolored to a flat white. The remaining non-swept areas, including the cooling fins, were discolored to a reddish-orange.

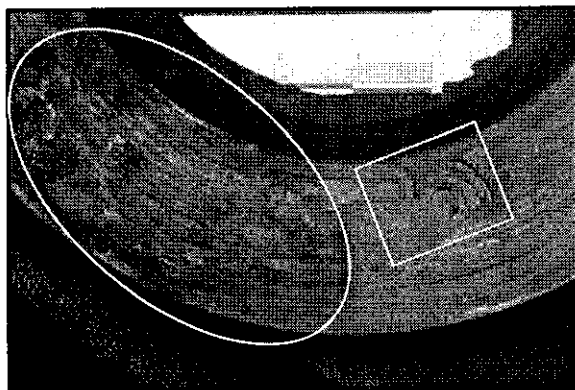
Image 20: Disc 5\DCIM\274CANON\IMG_0089.JPG

There was an area of crescent-shaped dents within the swept area of the inner disc (Image 20 boxed). A section of the inner disc was fractured and missing along the outer circumference. This missing section was crescent-shaped, 3 1/2-inches in length, and 1-inch wide, exposing the cooling fins. The fractured surface was silver in luster with a rough crystalline appearance (Image 21).

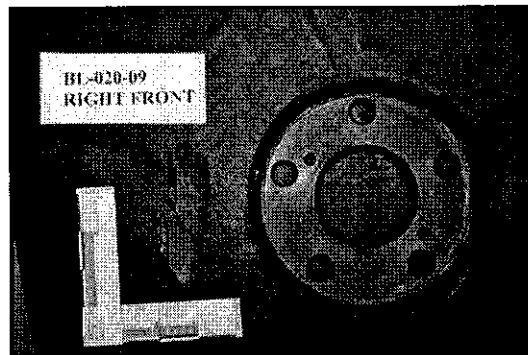
Image 22: Disc 5\DCIM\274CANON\IMG_0201.JPG

The rotor disc was circumferentially fractured and separated at the base of the rotor hat. The hat was fractured into two pieces (Image 22).

- The fractured discs and hats on the left- and right-front rotors. The fractured surfaces had rough crystalline appearances which were a characteristic of an instantaneous failure usually associated with shock load. A shock load is a sudden and powerful force that exceeds the strength of the metal.
- The gouges and dents on the left- and right-front rotors.
- The fractured banjo bolt and bleeder screw on the left-front caliper. The fractured surfaces had rough crystalline appearances which were a characteristic of an instantaneous failure usually associated with shock load.

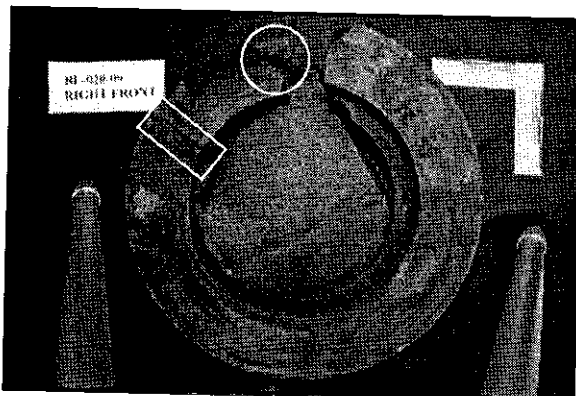
Image 23: Disc 5\DCIM\274CANON\IMG_0198.JPG

The fractured surfaces of both pieces of the hat had rough crystalline appearances. The swept areas on the disc were soiled with dirt and a dry black contaminant. They were also circumferentially scored and discolored to various shades of gray, blue, and bronze.

This rotor also had sections on both swept areas which were discolored darker than the surrounding surfaces. Within this same area, there were pieces of friction material bonded to the surface. There were discernible ridges about the inner and outer circumferences of the brake rotor discs, adjacent to the swept areas. A 1 1/2-inch wide section of the rotor disc was missing (Image 23). Adjacent to this area, the rotor disc was displaced outward. Centered near the start of the rotor displacement, the inner disc had a radial fracture between the inner and outer circumferences of the disc (Image 23 boxed). At the fractured end of the displaced rotor, the inner disc was dented and displaced outward (Image 23 circled).

A piece of rotor recovered from the collision scene on Thursday September 3, 2009, and identified as Item C, was matched to the fractures within the missing disc area (Image 24). The fractured surfaces of Item C and the rotor disc were silver in luster with rough crystalline appearances. The non-swept surface of the outer disc, adjacent to the fracture at the hat base, was discolored to a flat white. The remaining non-swept areas, including the cooling fins, were discolored to a reddish-orange.

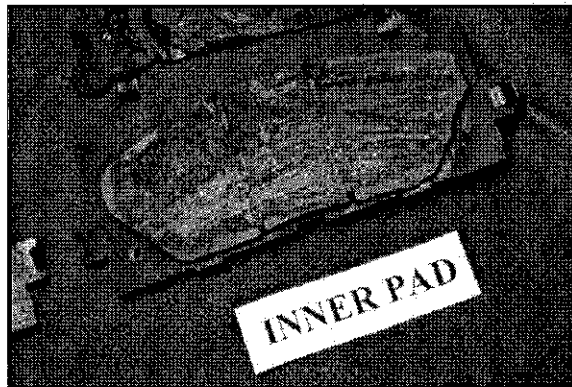
The brake pads were composed of a bonded semi-metallic friction material. The rotor contact surface of each brake pad was glazed with areas of pitted and arced scoring (Images 33 and 34). Each pad had two grooves cut into the friction material that were used as wear indicators and for cleaning and cooling. These grooves were filled with glazed friction material. The leading edge of the inner pad had a build up of glazed friction material that extended over the side. The surface of the metal support plate, adjacent to the leading edge of the friction material, had intermittent spots of glazed friction material bonded to it. The upper, lower, and trailing edges of both pads were missing material and had rough fibrous appearances. The surface of the metal anti-vibration shims that contacted the metal support plate were blistered and soiled with a glossy, black resin-like material. Pieces of the anti-vibration wire springs were bent and abraded.

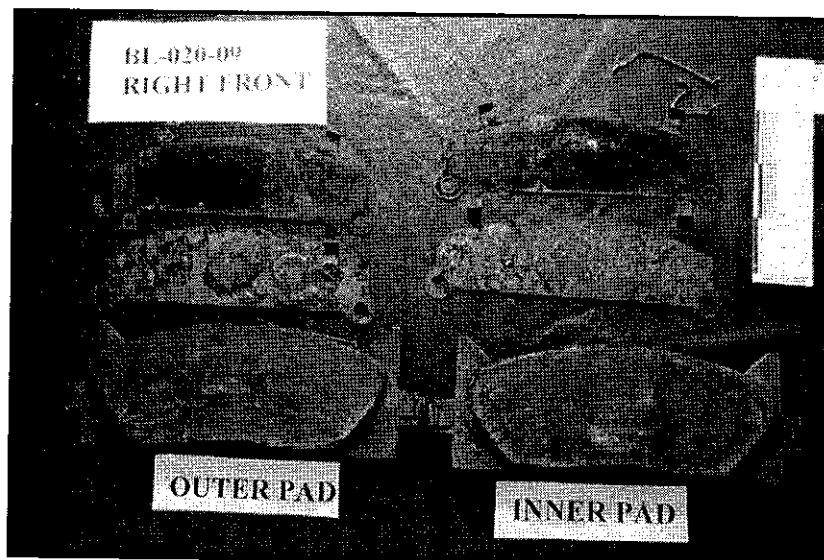
Image 35: Disc 5\DCIM\274CANON\IMG_0118.JPG

The brake pads were composed of a bonded semi-metallic friction material. The surface of the pads was glazed with areas of pitted and arced scoring (Images 35). The grooves were filled with glazed friction material. The leading edge of the inner pad had a build up of glazed friction material that extended over the side. The upper, lower, and trailing edges of both pads were missing material and had rough fibrous appearances. The surfaces of the metal anti-vibration shims were blistered and discolored to various shades of gray and black. Pieces of the anti-vibration wire springs were bent and abraded.

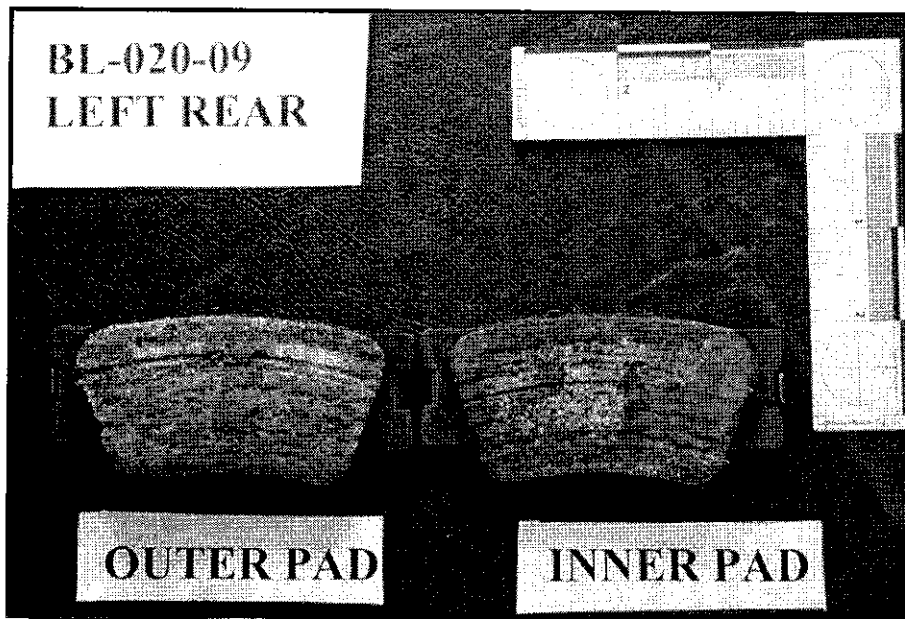
Image 13: Disc 5\DCIM\274CANON\IMG_0230.JPG

The brake pads were composed of a bonded semi-metallic friction material. The rotor contact surface of each brake pad was glazed with areas of pitted and arced scoring (Image 36). The friction material was discolored to various shades of white, gray, and yellow. The leading edge of both pads had a build up of glazed friction material. The surface of the metal support plate, adjacent to the leading and trailing edges of the friction material, had intermittent spots of glazed friction material bonded to it. Each metal anti-vibration shim was securely attached to its metal support plate.

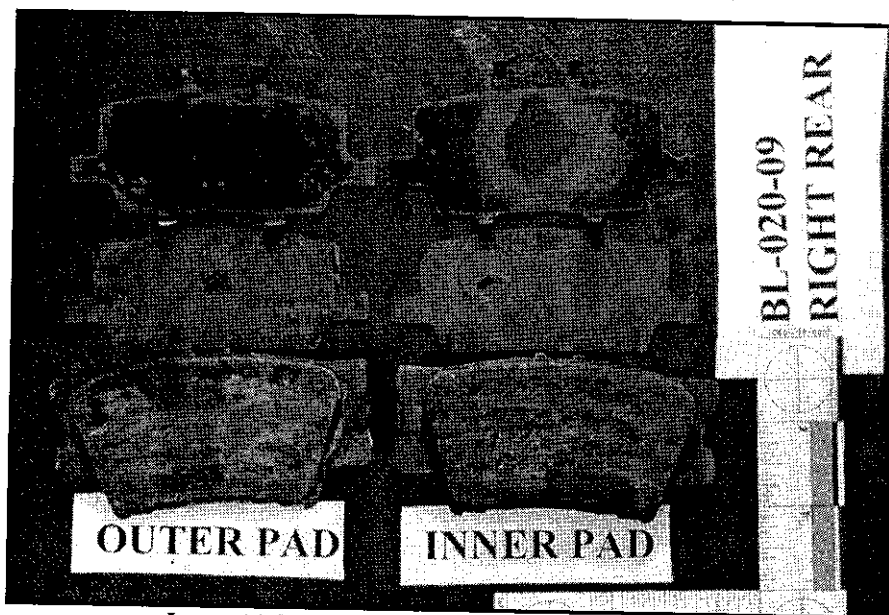
Image 14: Disc 5\DCIM\274CANON\IMG_0296.JPG

The brake pads were composed of a bonded semi-metallic friction material. The surface of the pads was glazed with areas of pitting and arced scoring (Image 37). The pitting of the inner pad measured 2/32 inch in depth. The friction material was discolored to various shades of white and gray. The surface of the metal support plate, adjacent to the edges of the friction material, had intermittent spots of glazed friction material bonded to it. The surfaces of the metal anti-vibration shims were blistered and discolored to various shades of gray and black.

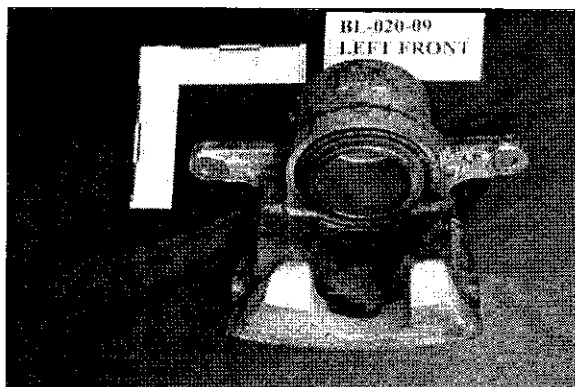
Image 15: Disc 5\DCIM\274CANON\IMG_0050.JPG

The exterior of the caliper and bracket was soiled with dirt. The caliper rubber dust boot and both bracket dust boots were complete and pliable. The surface of the caliper, adjacent to the piston and surrounding pad inspection opening, was soiled with a glossy resin-like material (Image 38). The banjo bolt on the inlet port and the bleeder screw were fractured and separated at their respective ports (Image 39). Each of the fractured surfaces had a rough crystalline appearance. Other than being soiled, the bracket and the anti-vibration springs were generally unremarkable (Images 40 and 41).

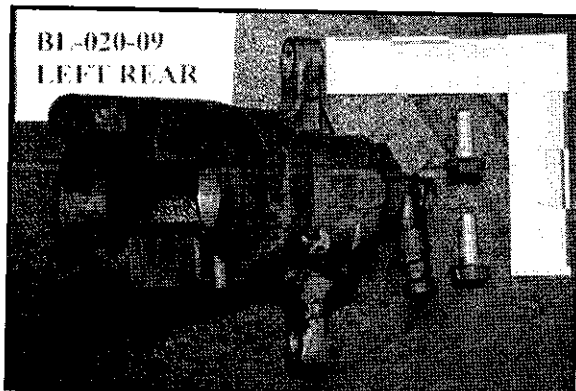
Image 18: Disc 5\DCIM\274CANON\IMG_0233.JPG

The exterior of the caliper was charred and discolored to various shades of black and brown (Image 46). The rubber dust boot, between the caliper housing and piston, was complete and pliable. The rubber brake fluid hose was fractured at the outer edge of the crimped fitting attached to the caliper (Image 47). The interior of the crimped fitting contained a charred and melted piece of rubber hose. The exterior of the bracket was charred and discolored to various shades of black and brown (Image 48). Both the rubber dust boots were melted (Image 49). The anti-vibration springs were generally unremarkable.

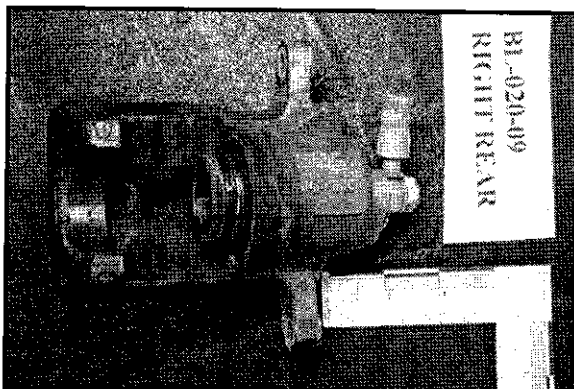
Image 50: Disc 5\DCIM\274CANON\IMG_0318.JPG

The exterior of the caliper was charred and discolored to various shades of black and brown (Image 50). Almost the entire rubber dust boot, between the caliper housing and piston, was missing. The small section remaining was charred (Image 51, arrow). The caliper piston was discolored to various shades of purple and blue. The rubber brake fluid hose was missing from the crimped fitting attached to the caliper. The interior of the crimped fitting was charred and soiled with dirt. The exterior of the bracket was charred and discolored to various shades of black and brown (Image 52). Both the rubber dust boots, which were normally attached between the sliding pins and the bracket, were missing (Image 52, circles). The anti-vibration springs were generally unremarkable.

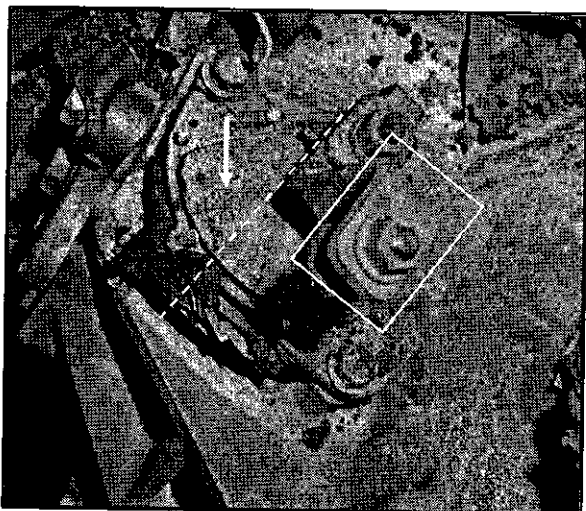
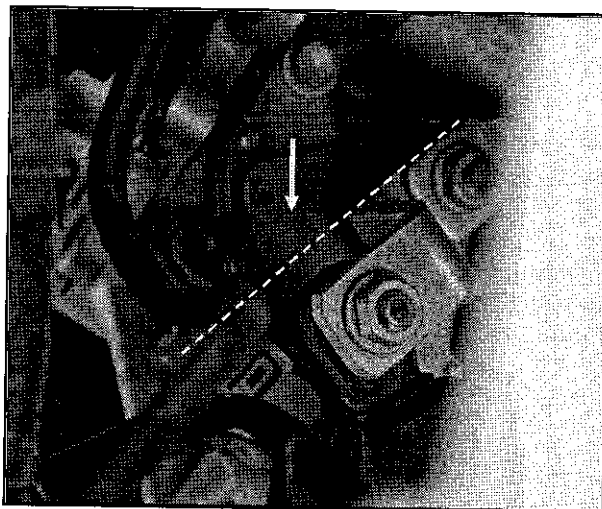
Although the upper section of the shift lever on the transmission casing of Vehicle #1 was displaced rearward (Image 57, box)¹, a comparison between the shift lever of Vehicle #1 and the shift lever of the exemplar 2008 Lexus ES 350 (Image 58) was made using the orientation of the lower arm of the shift lever. A line was extended along the prolongation of the lower arm (depicted by the dashed line in the images below) of the shift lever of each vehicle, and using a symbol cast on the surface of the transmission housing as a reference (identified by the arrow in the images below), a comparison was made.

In comparing the positions of the transmission housing shift lever on the exemplar 2008 Lexus ES 350 to the position of the transmission housing shift lever on Vehicle #1, it was determined that the transmission shift lever on Vehicle #1 was in the drive position.

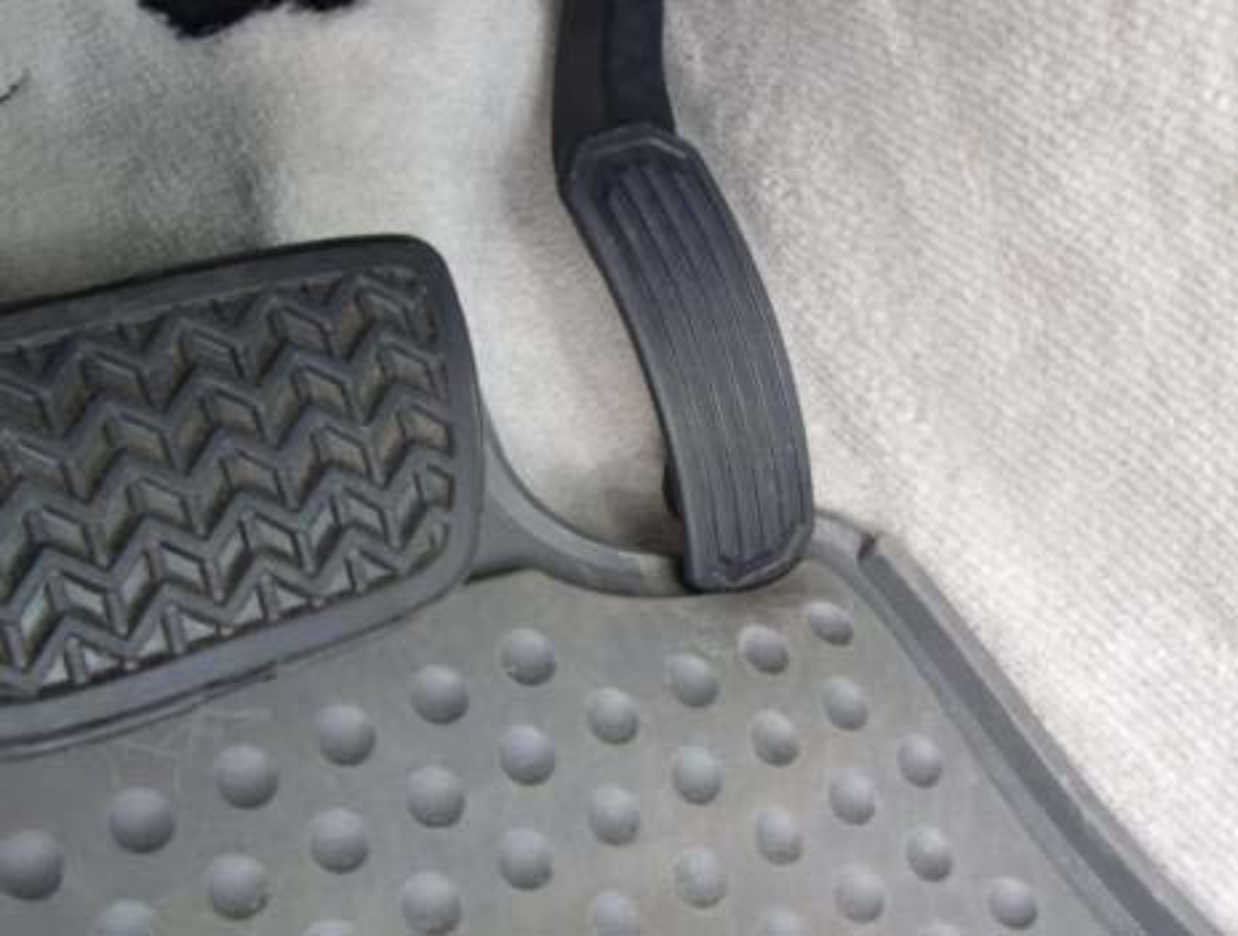
pedal trapped in AWM
