**Response 7**

### **Response 9**

### **Cause:**

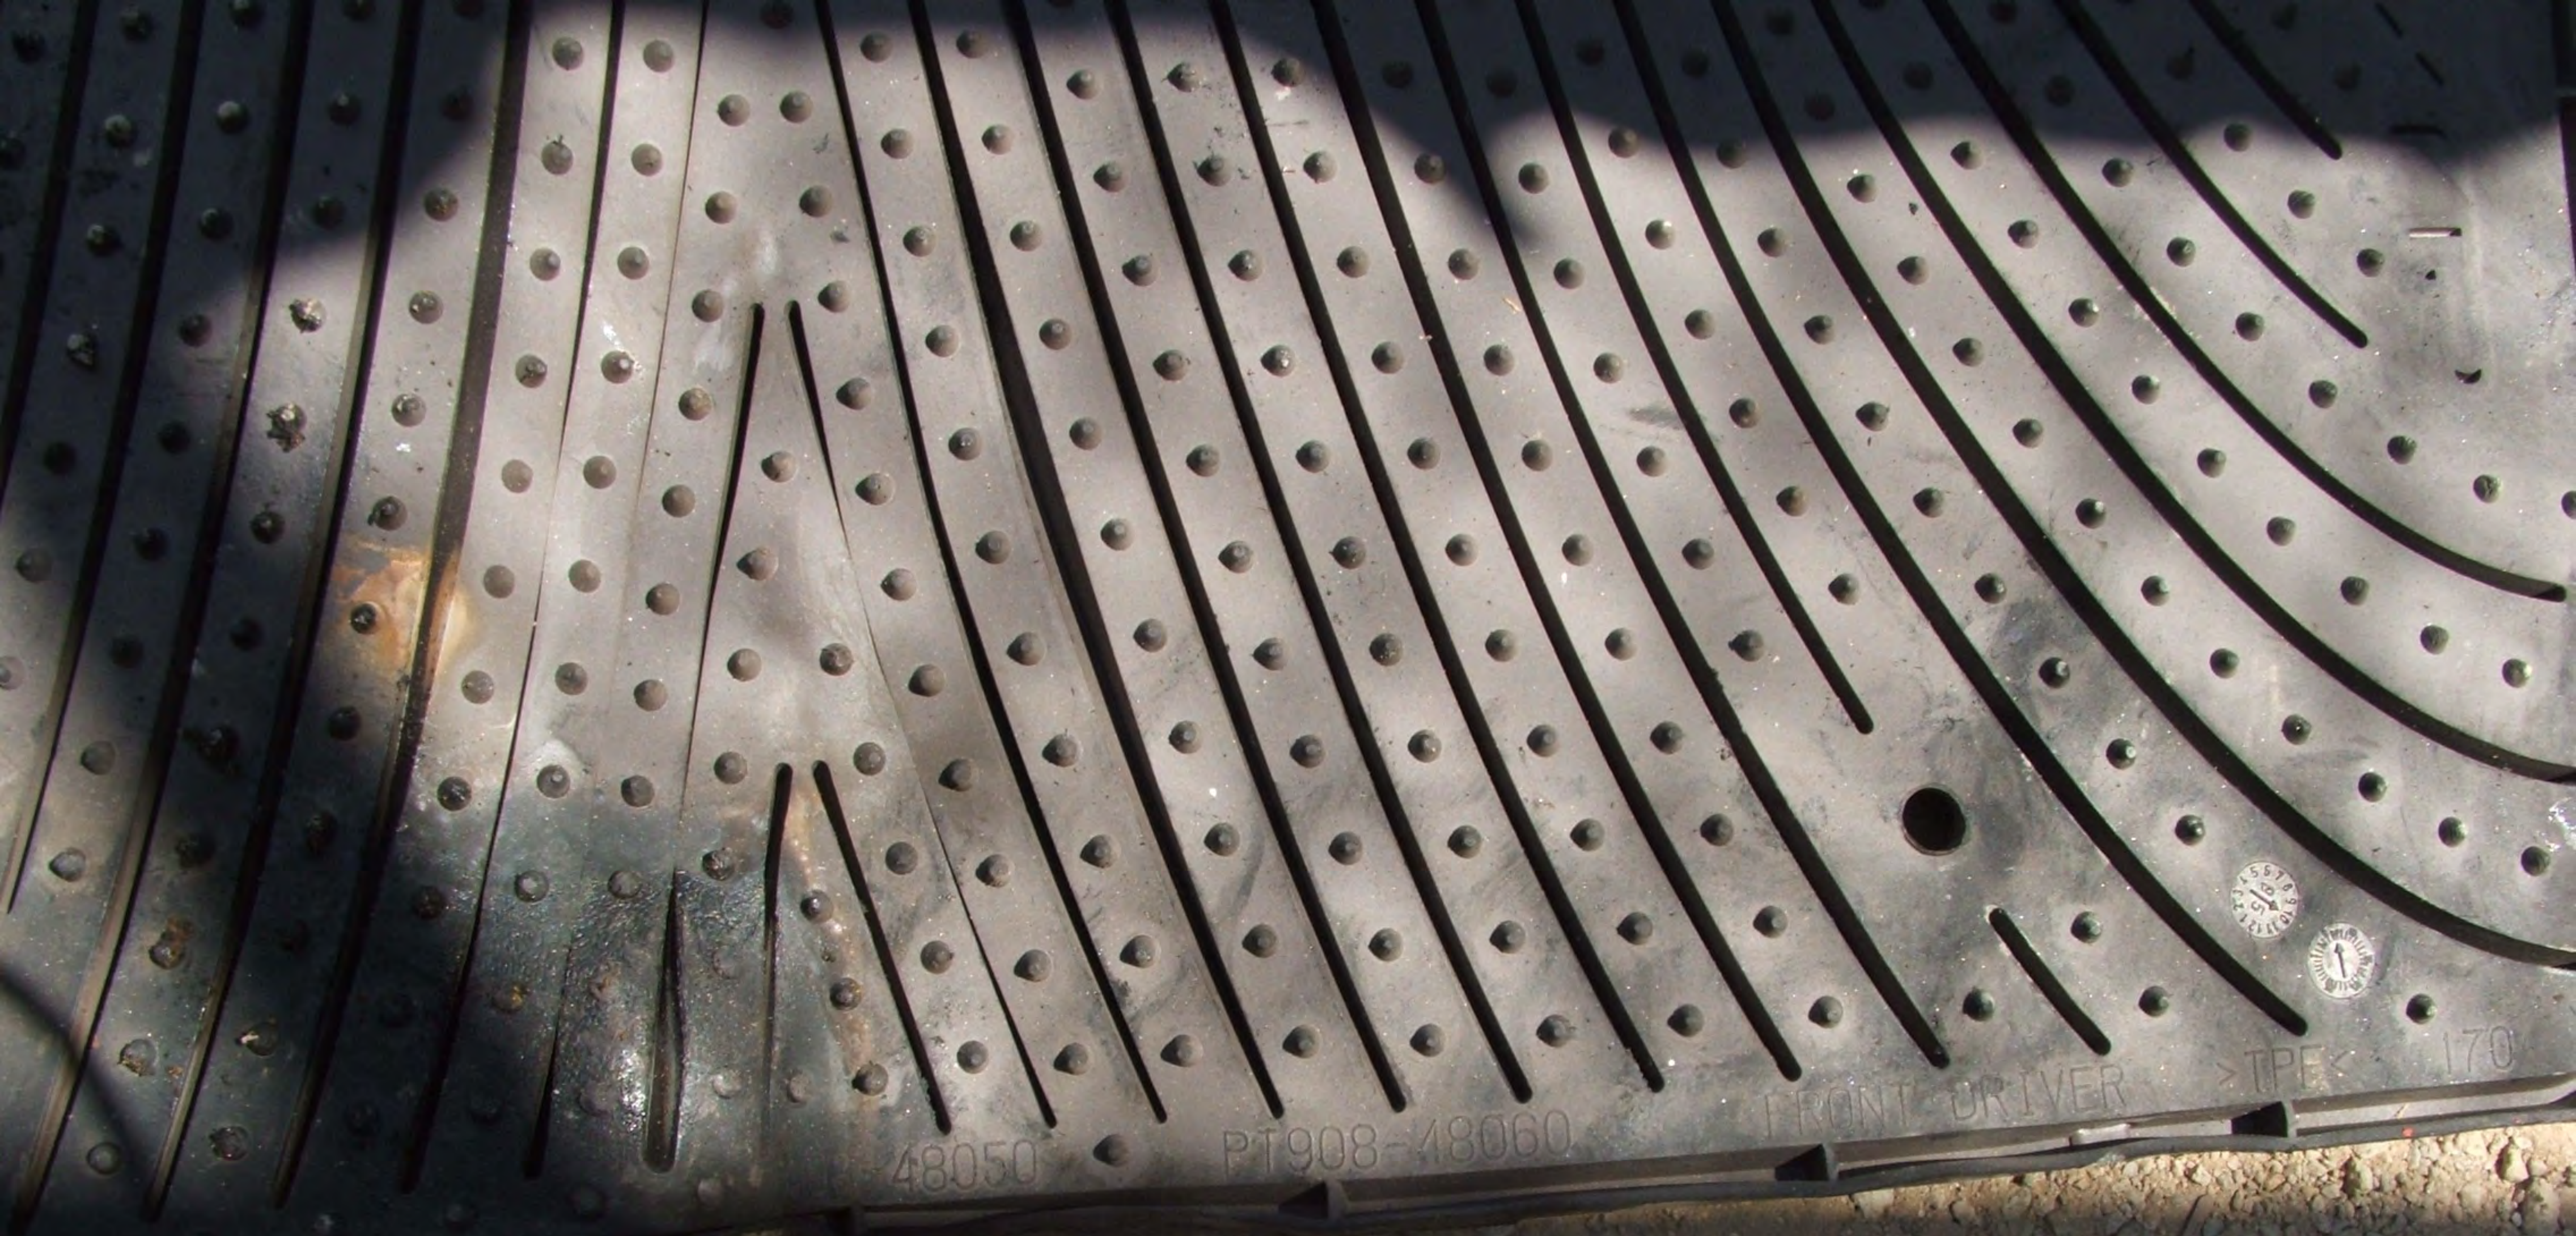
A Lexus all weather rubber floor mat (part # 48050 PT908 – 48060 Front Driver>TPF<170") is a part specific to a 2005 – 2009 Lexus RX400H sport utility vehicle. Incident to a post collision vehicle inspection of V1 (a white 2009 Lexus ES350, CA license plate 6DRT323, Vin #JTHBJ46G792[REDACTED]), a rubber mat with the above mentioned characteristics, was found in the driver side floor board of V1.

48050

PT908-48060

>TPE<

170
