U.S. Department of Transportation
National Highway Traffic Safety Administration

Investigation: EA07-010
 Prompted By: PE07-016, Consumer Complaints
 Date Opened: 08/08/2007 Date Closed: 10/11/2007
 Principal Investigator: Scott Yon
 Subject: Unwanted Acceleration, Floor Mat

Manufacturer: Toyota Motor Corporation
 Products: MY 2002 - 2008 Lexus ES350 and Toyota Camry
 Population: 55,000 (estimated)

Problem Description: The accessory all weather floor mat can entrap the throttle pedal.

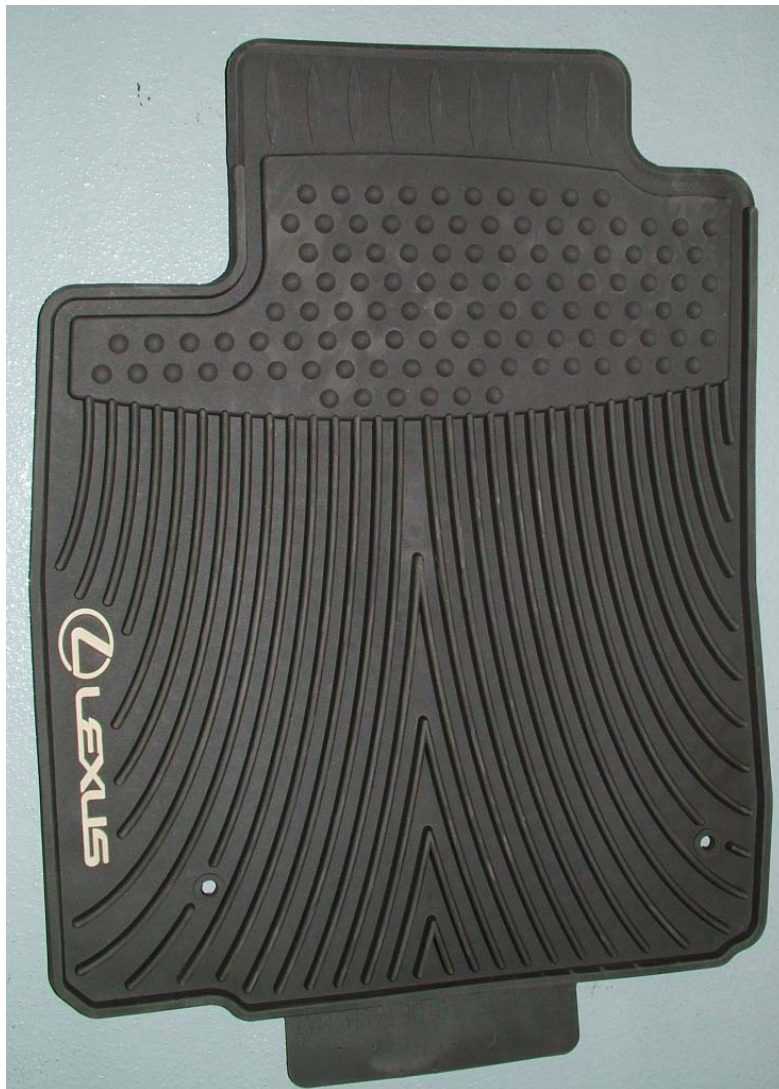
Figure 2 – Lexus All-weather Floor Mat with Retaining Hook Holes at the Bottom

pedal revealed that the one-piece, non-articulating accelerator pedal assembly was easily entrapped in the groove of the rubber all-weather floor mat (Figures 2 and 3) if the rubber mat was not properly secured with at least one of the two retaining hooks (Figure 4). In many observed ES-350's, the rubber mats were stacked on top of the existing carpeted floor mats, which prevented attachment of the rubber mats and facilitated the interference failure mode. A warning is embossed on the front of the floor mat that reads "Do not place on top of existing floor mats". Very few owners interviewed were able to find or read this warning (see Figure 5).

In a September 26, 2007 letter to NHTSA, Toyota indicated that they would conduct a safety recall to replace the all weather mat with a redesigned mat. According to Toyota, the new mat design will reduce the potential for mat interference with the throttle pedal.

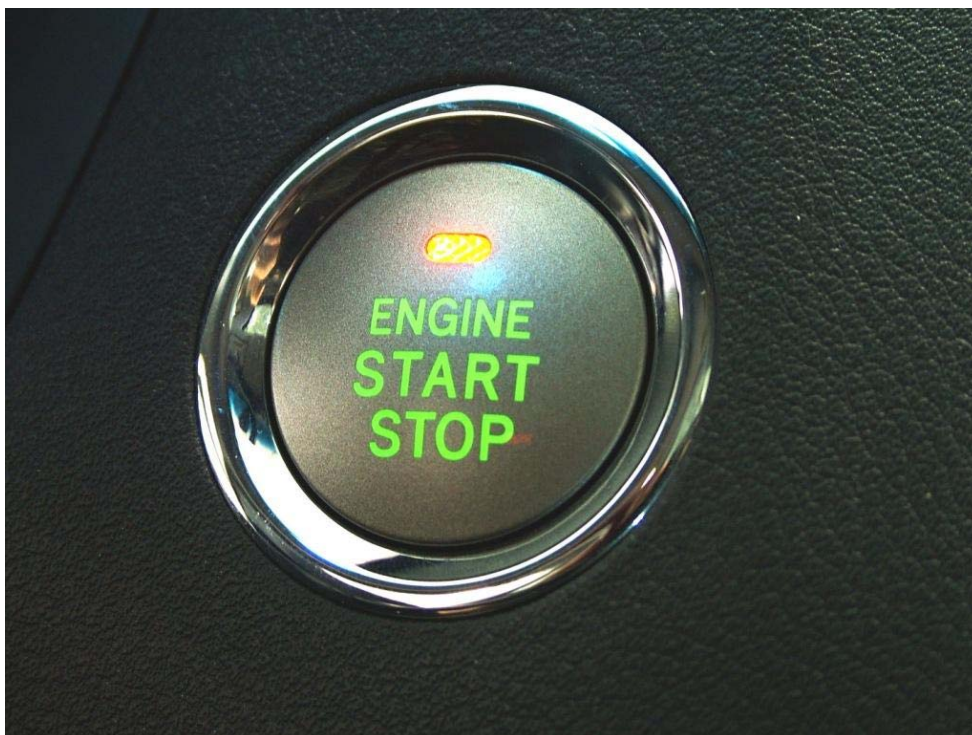
Figure 6 - Push Button Ignition Replaces Conventional Key

- 3.3.2** Turning off the ignition - In place of an ignition key, the ES-350 uses an ignition button that removes the ability to instantaneously shut off the engine in the event of an emergency while the vehicle is in motion (see Figure 6). It was found that depressing and holding the button will eventually turn off the engine after three seconds. Through the survey it was learned that the button delay operation is not widely known by owners and because of this, drivers found themselves unable to turn off the engine when the vehicle was in motion. The owner's manual makes general mention of the operation, but there is no indication of the three second hold requirement.

- The owner survey indicated the 3 second delay in the operation of the ignition button is not widely known by owners and because of this, drivers found themselves unable to turn off the engine when the vehicle was in motion.

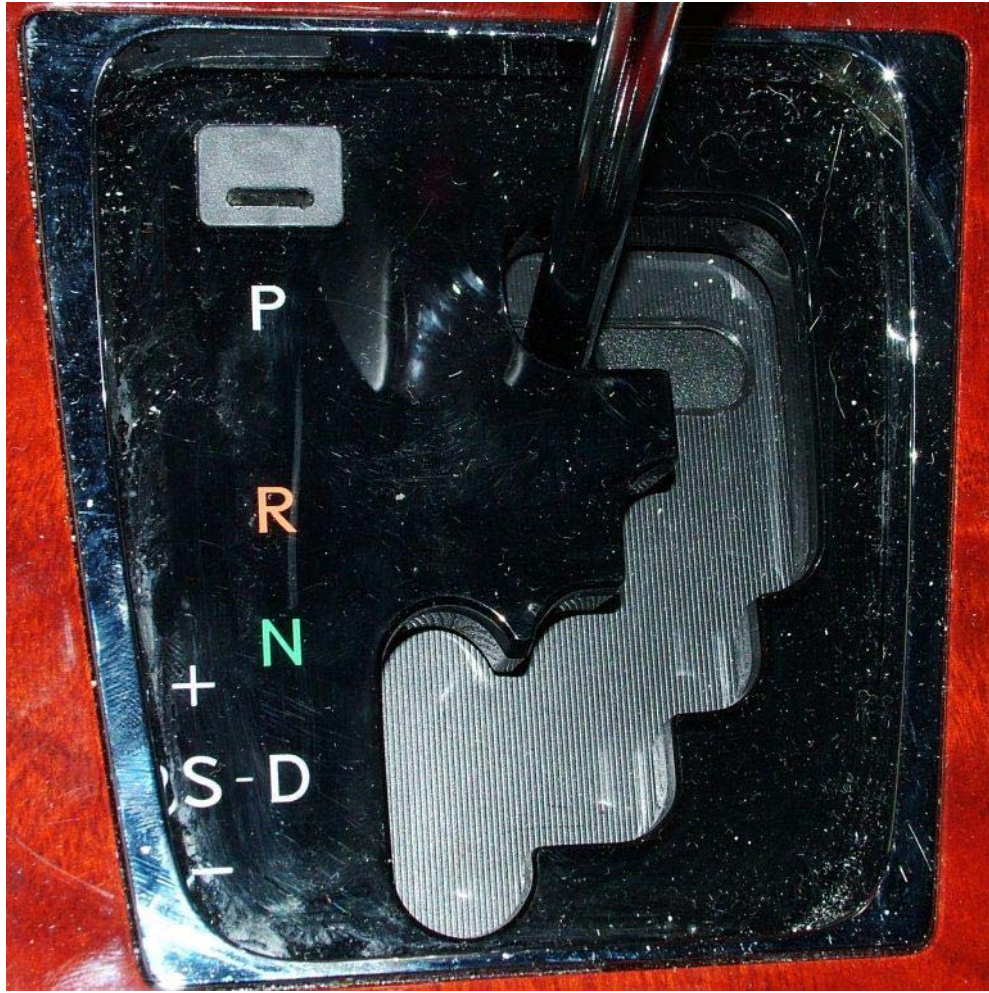
Figure 7 – Shift Gate with Diagram

- Many owners complained that the neutral gear position in the gated shift pattern was not immediately obvious, leading to unsuccessful attempts to disengage the engine from the drive wheels.
