Description: Engine/Transmission Driveability Issues

Vehicles: Windstar, Freestar, Monterey

From: Kulkarni, Arvind (A.)
Sent: Wednesday, May 25, 2005 10:49 PM
To: Fang, Andy (A.); Stodola, Robert (R.J.); Tigchelaar, Doug (D.G.)
Cc: Nasar, John (H.S.); Cordeau, Roger (T.); Hearn, Mark (E.)
Subject: Analysis of CQIS data of water leak into PCM

V229 Wipe Cowl Module – Water Leak Paths

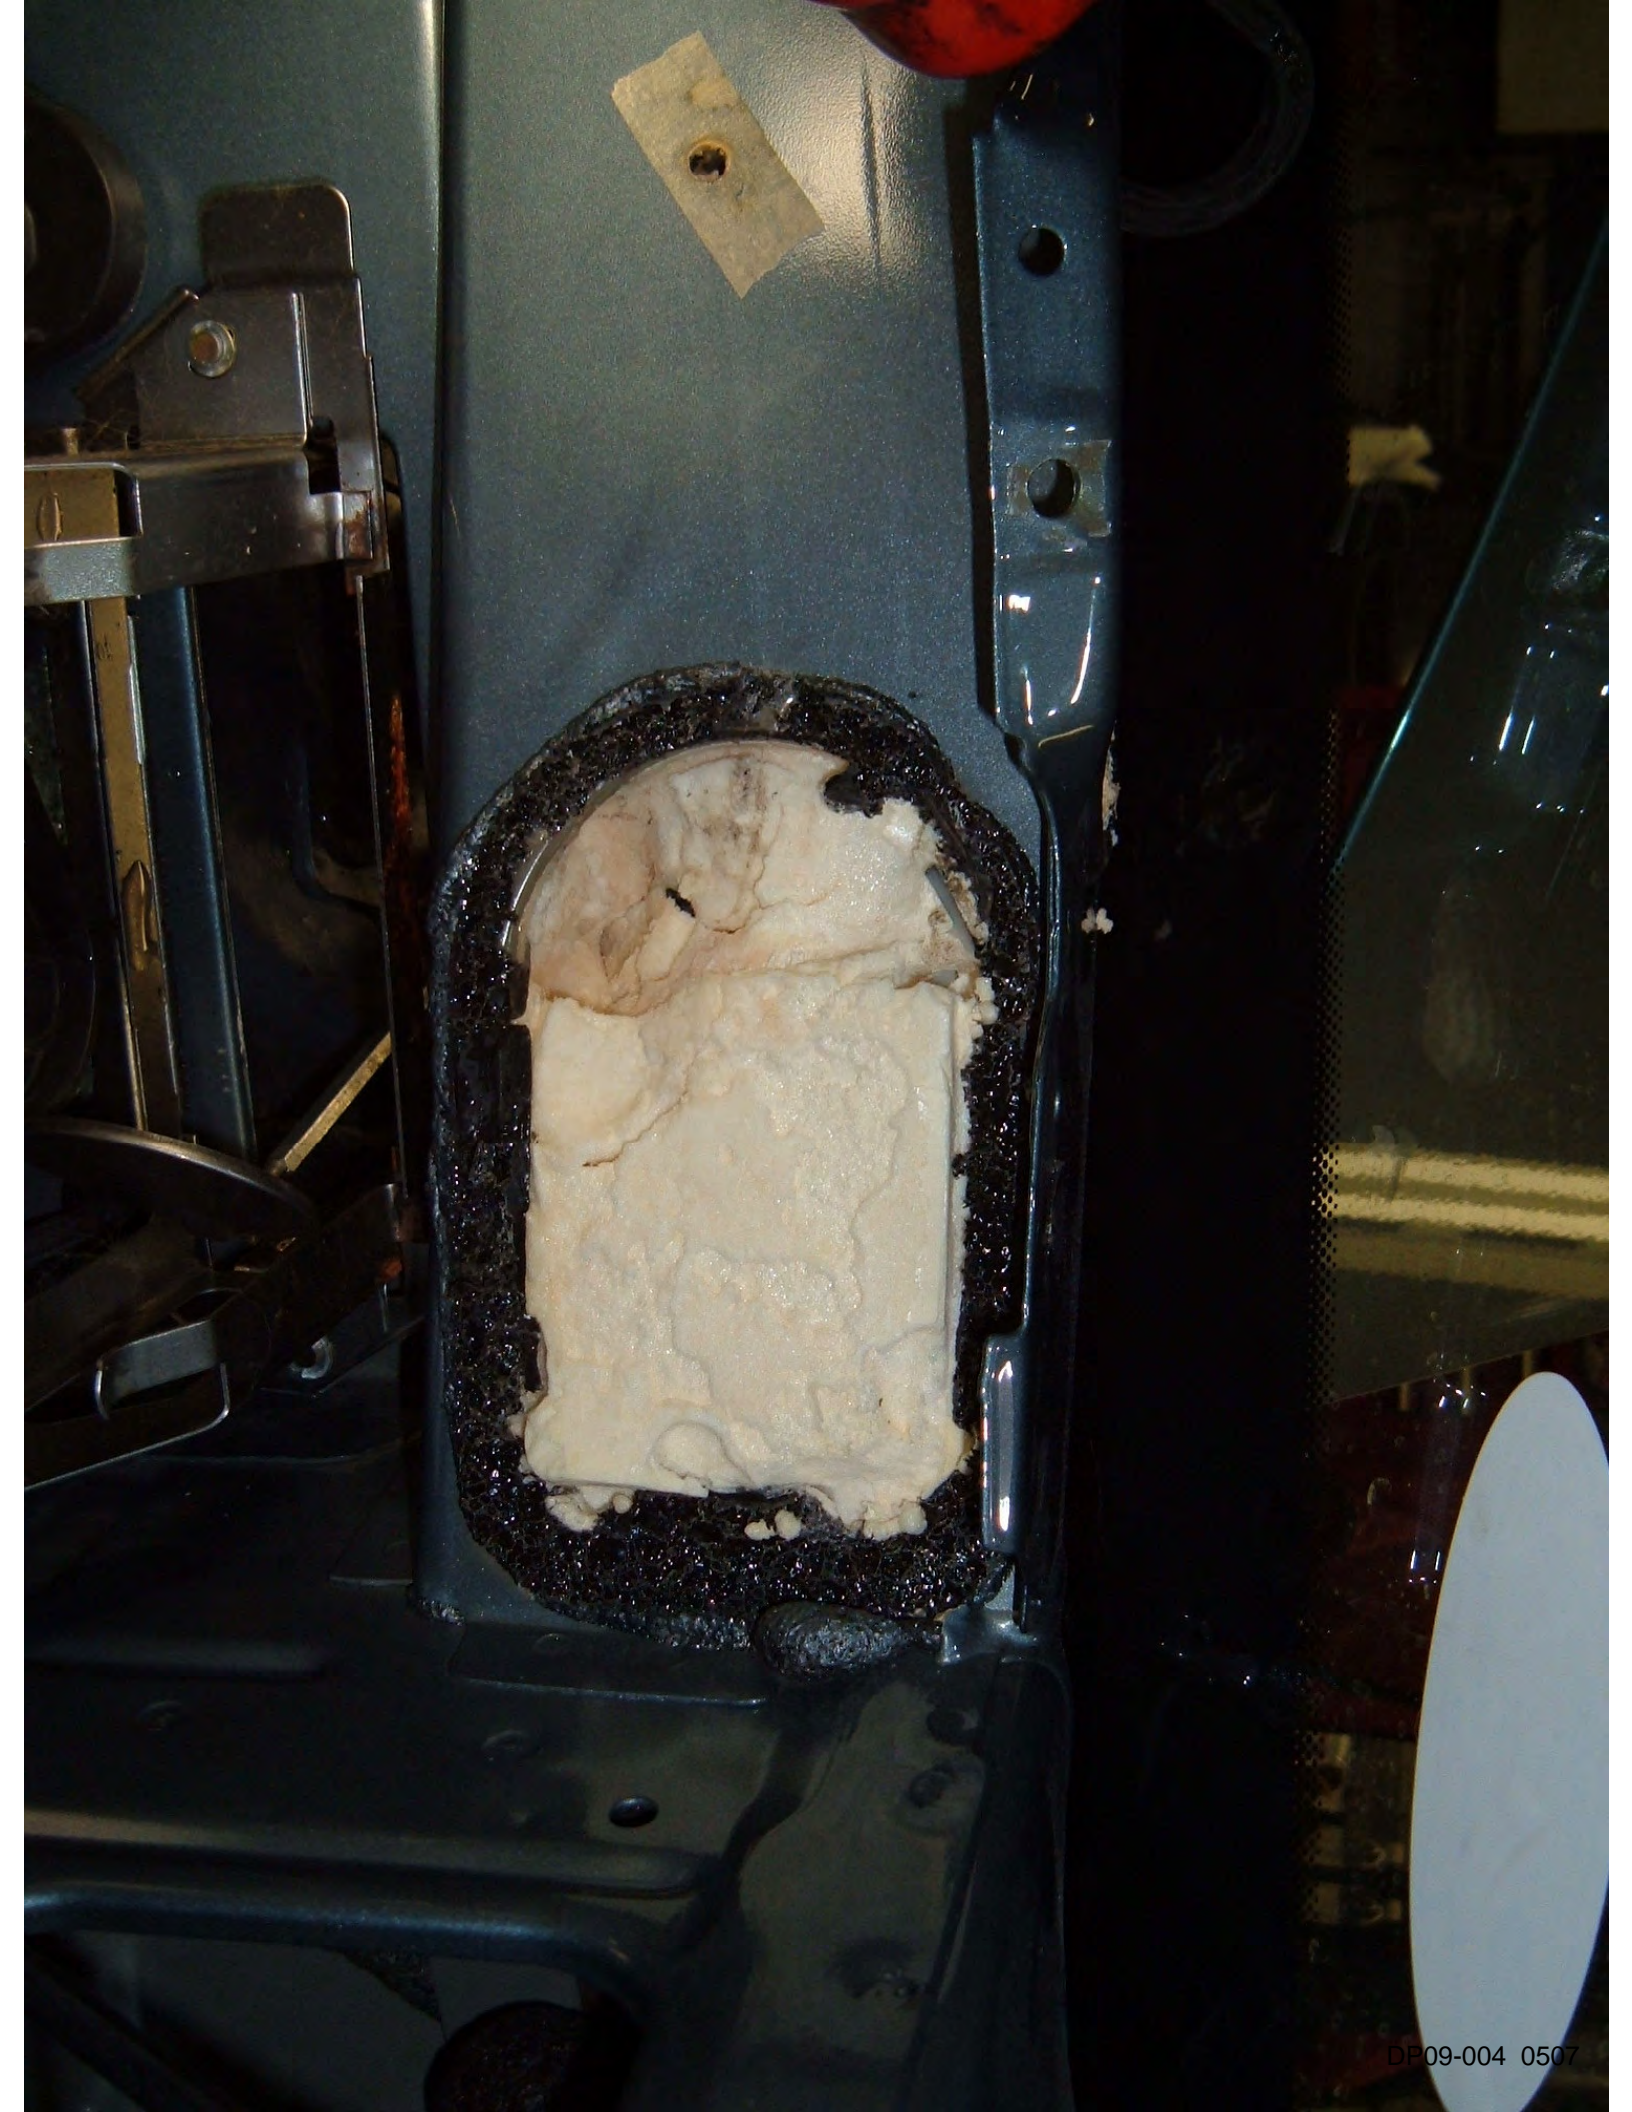
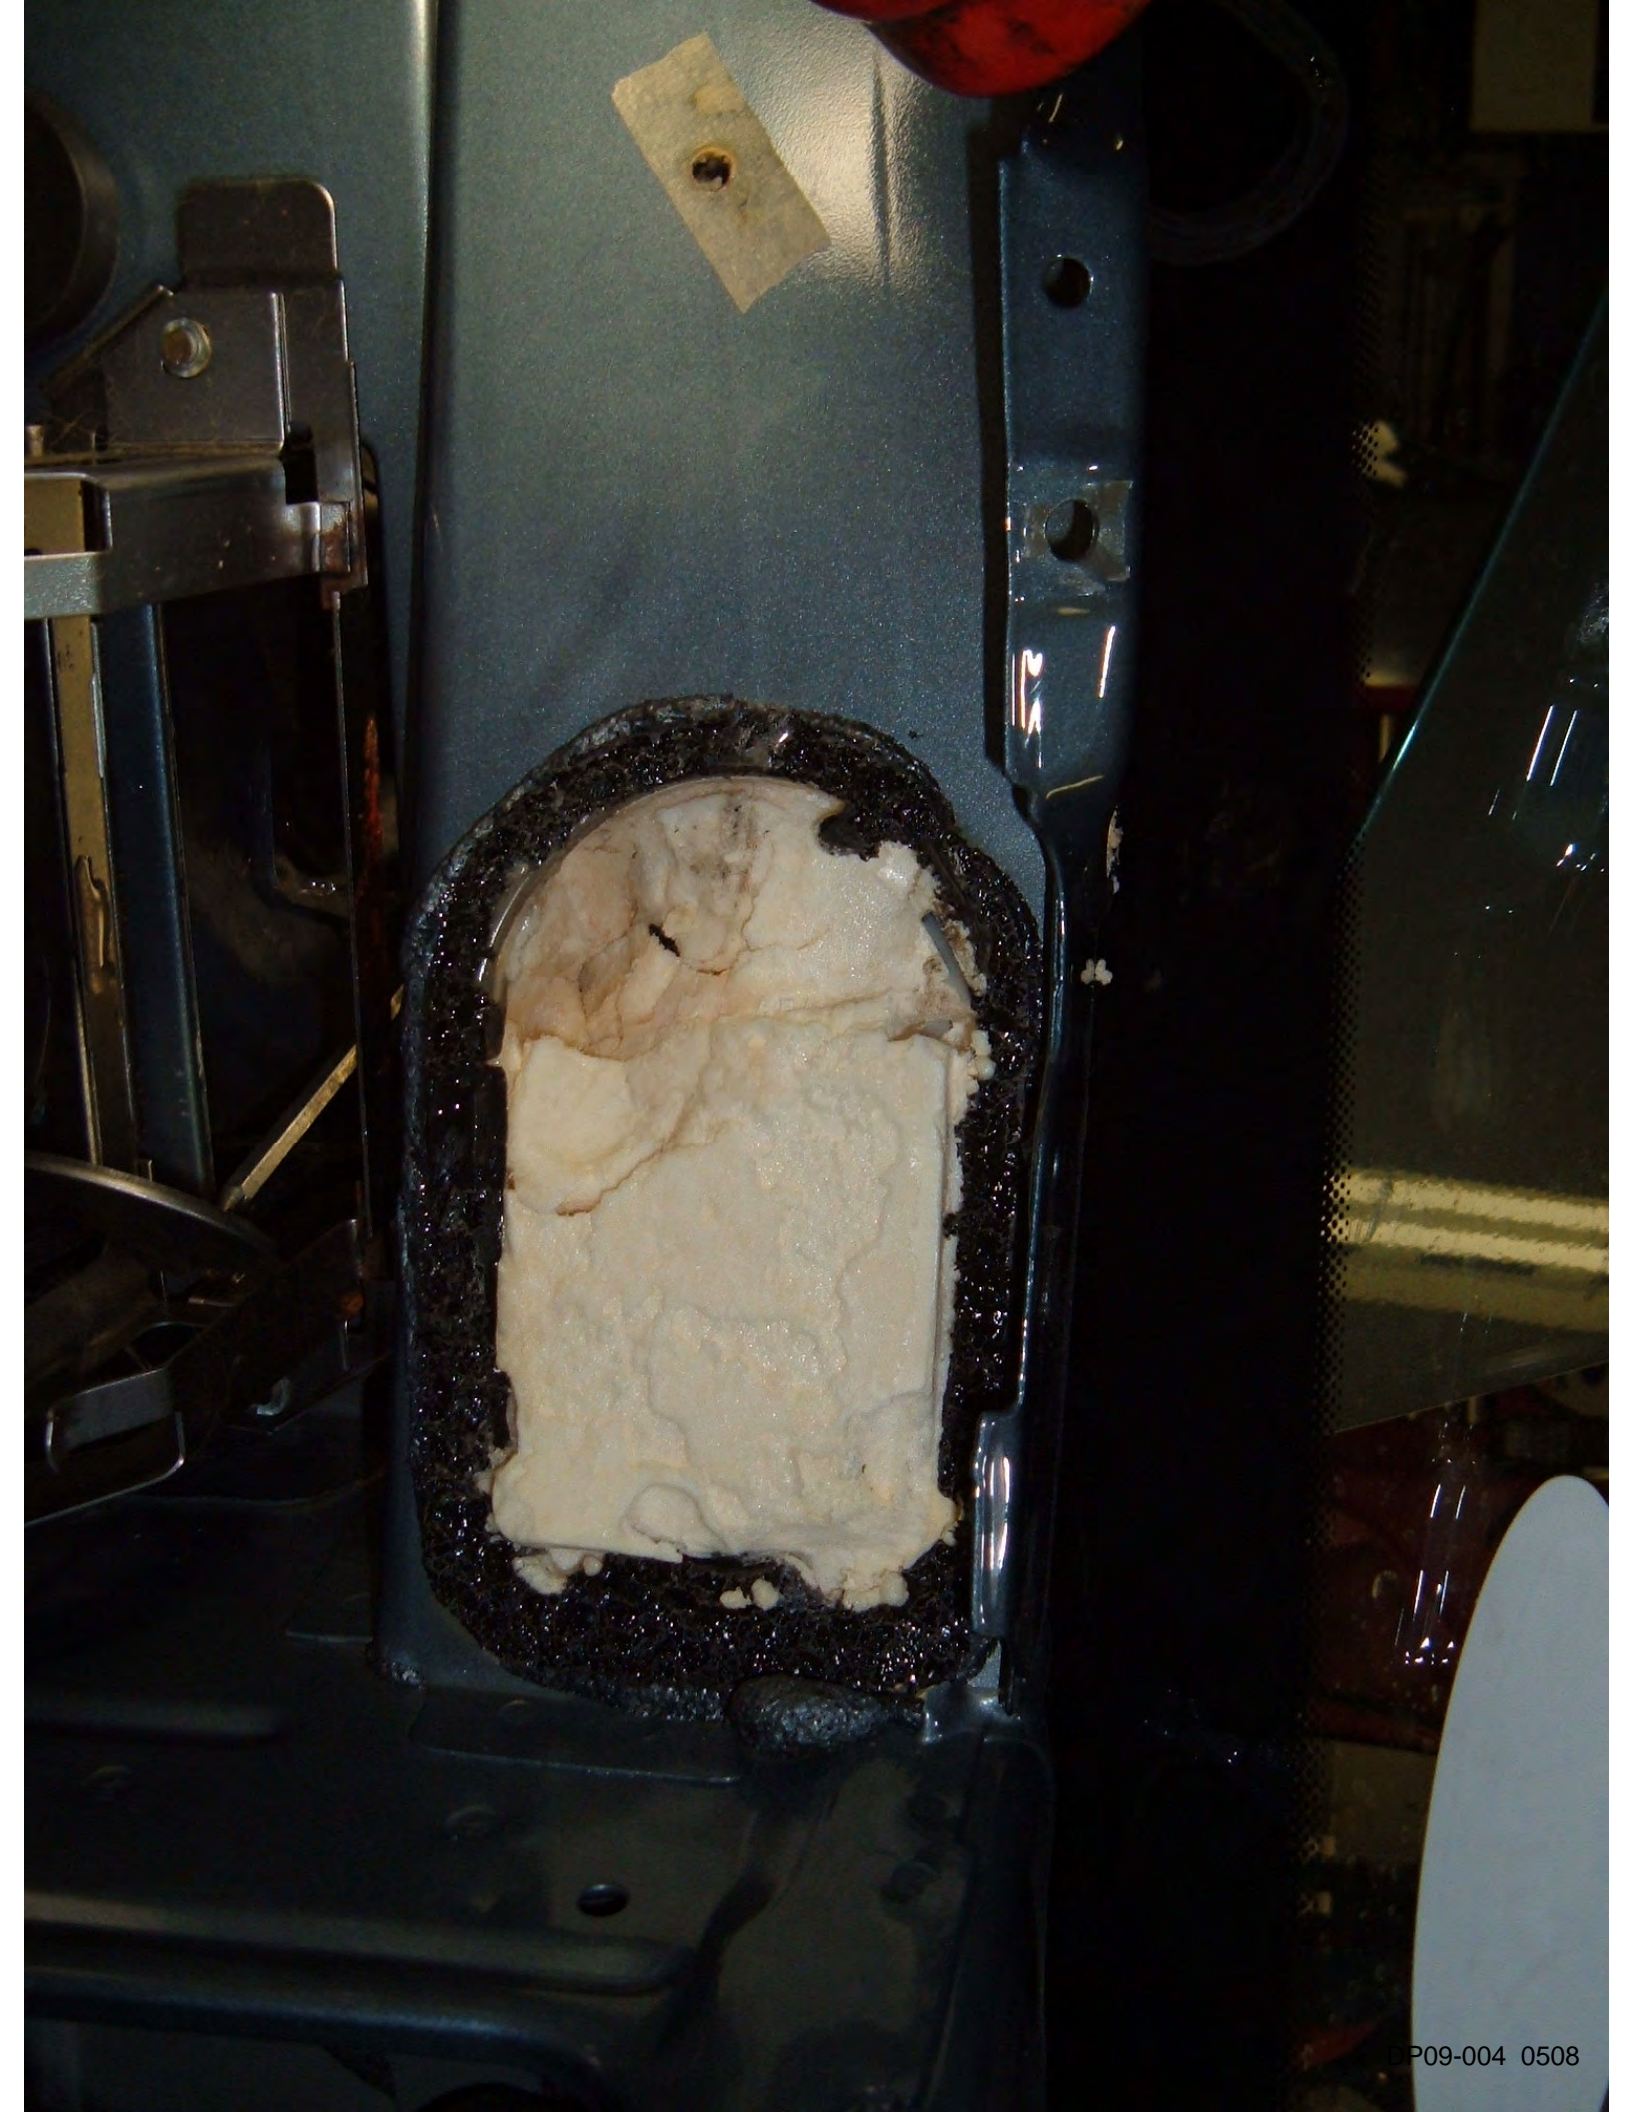
John, water in pcm....water soaked NVH foam report number 5JZCY002. Please keep me informed.

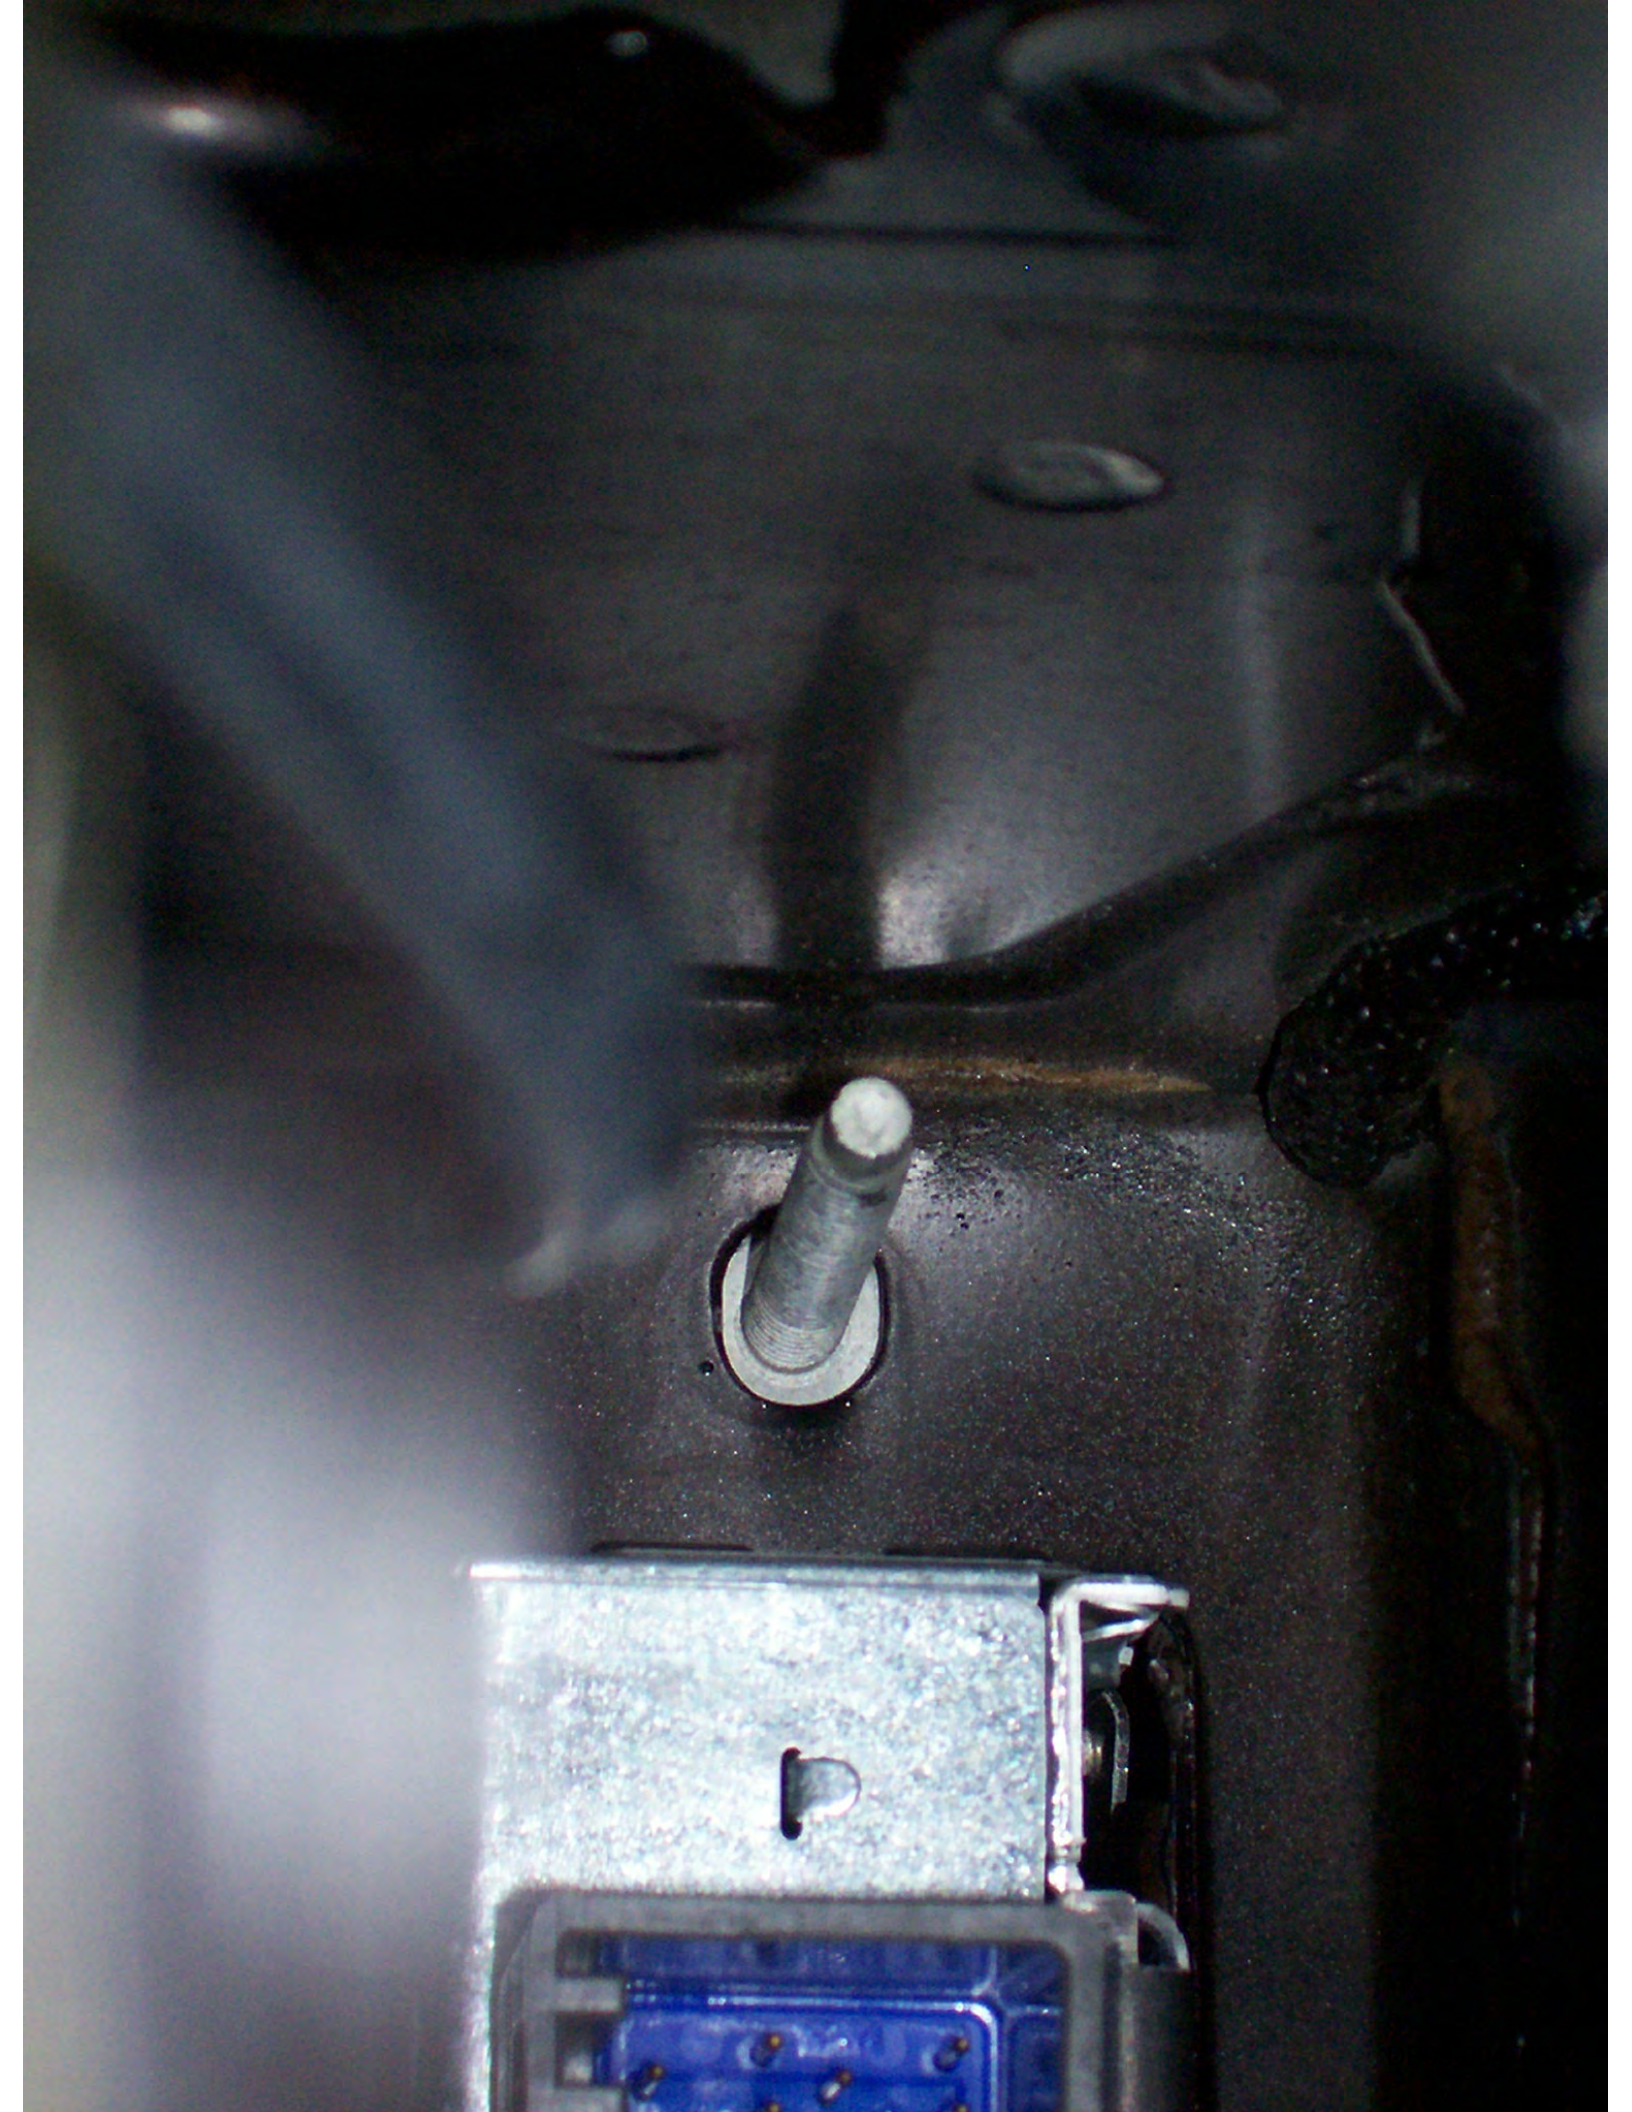
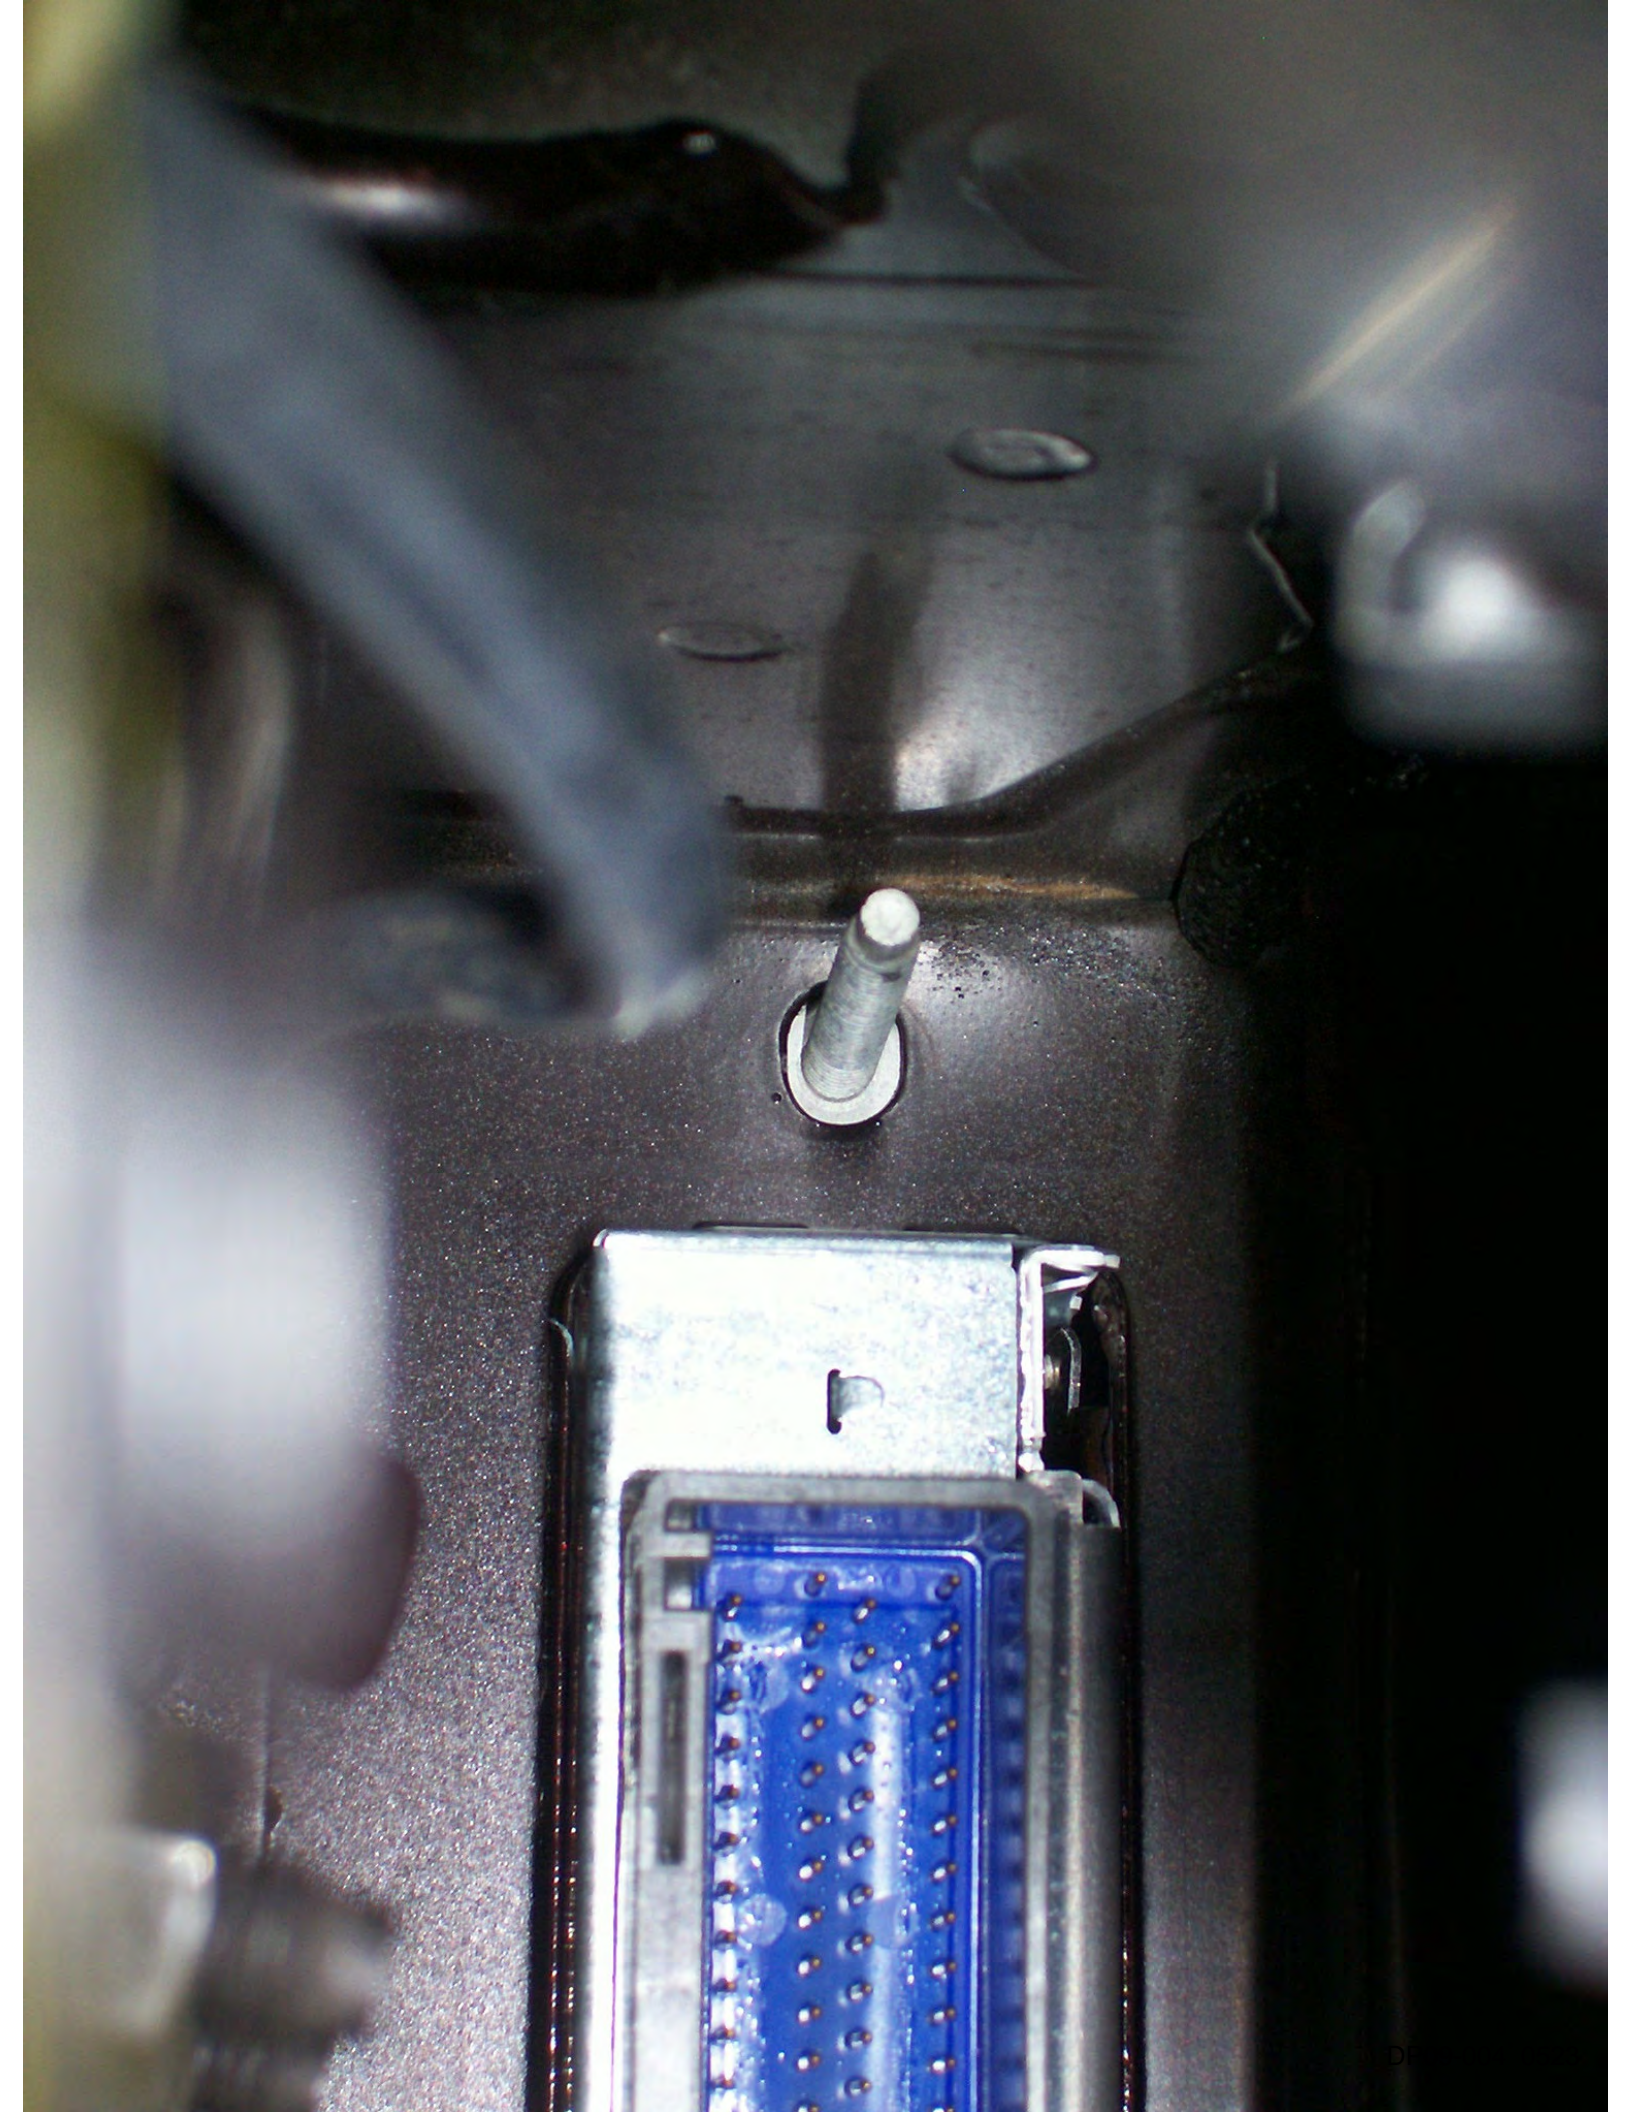
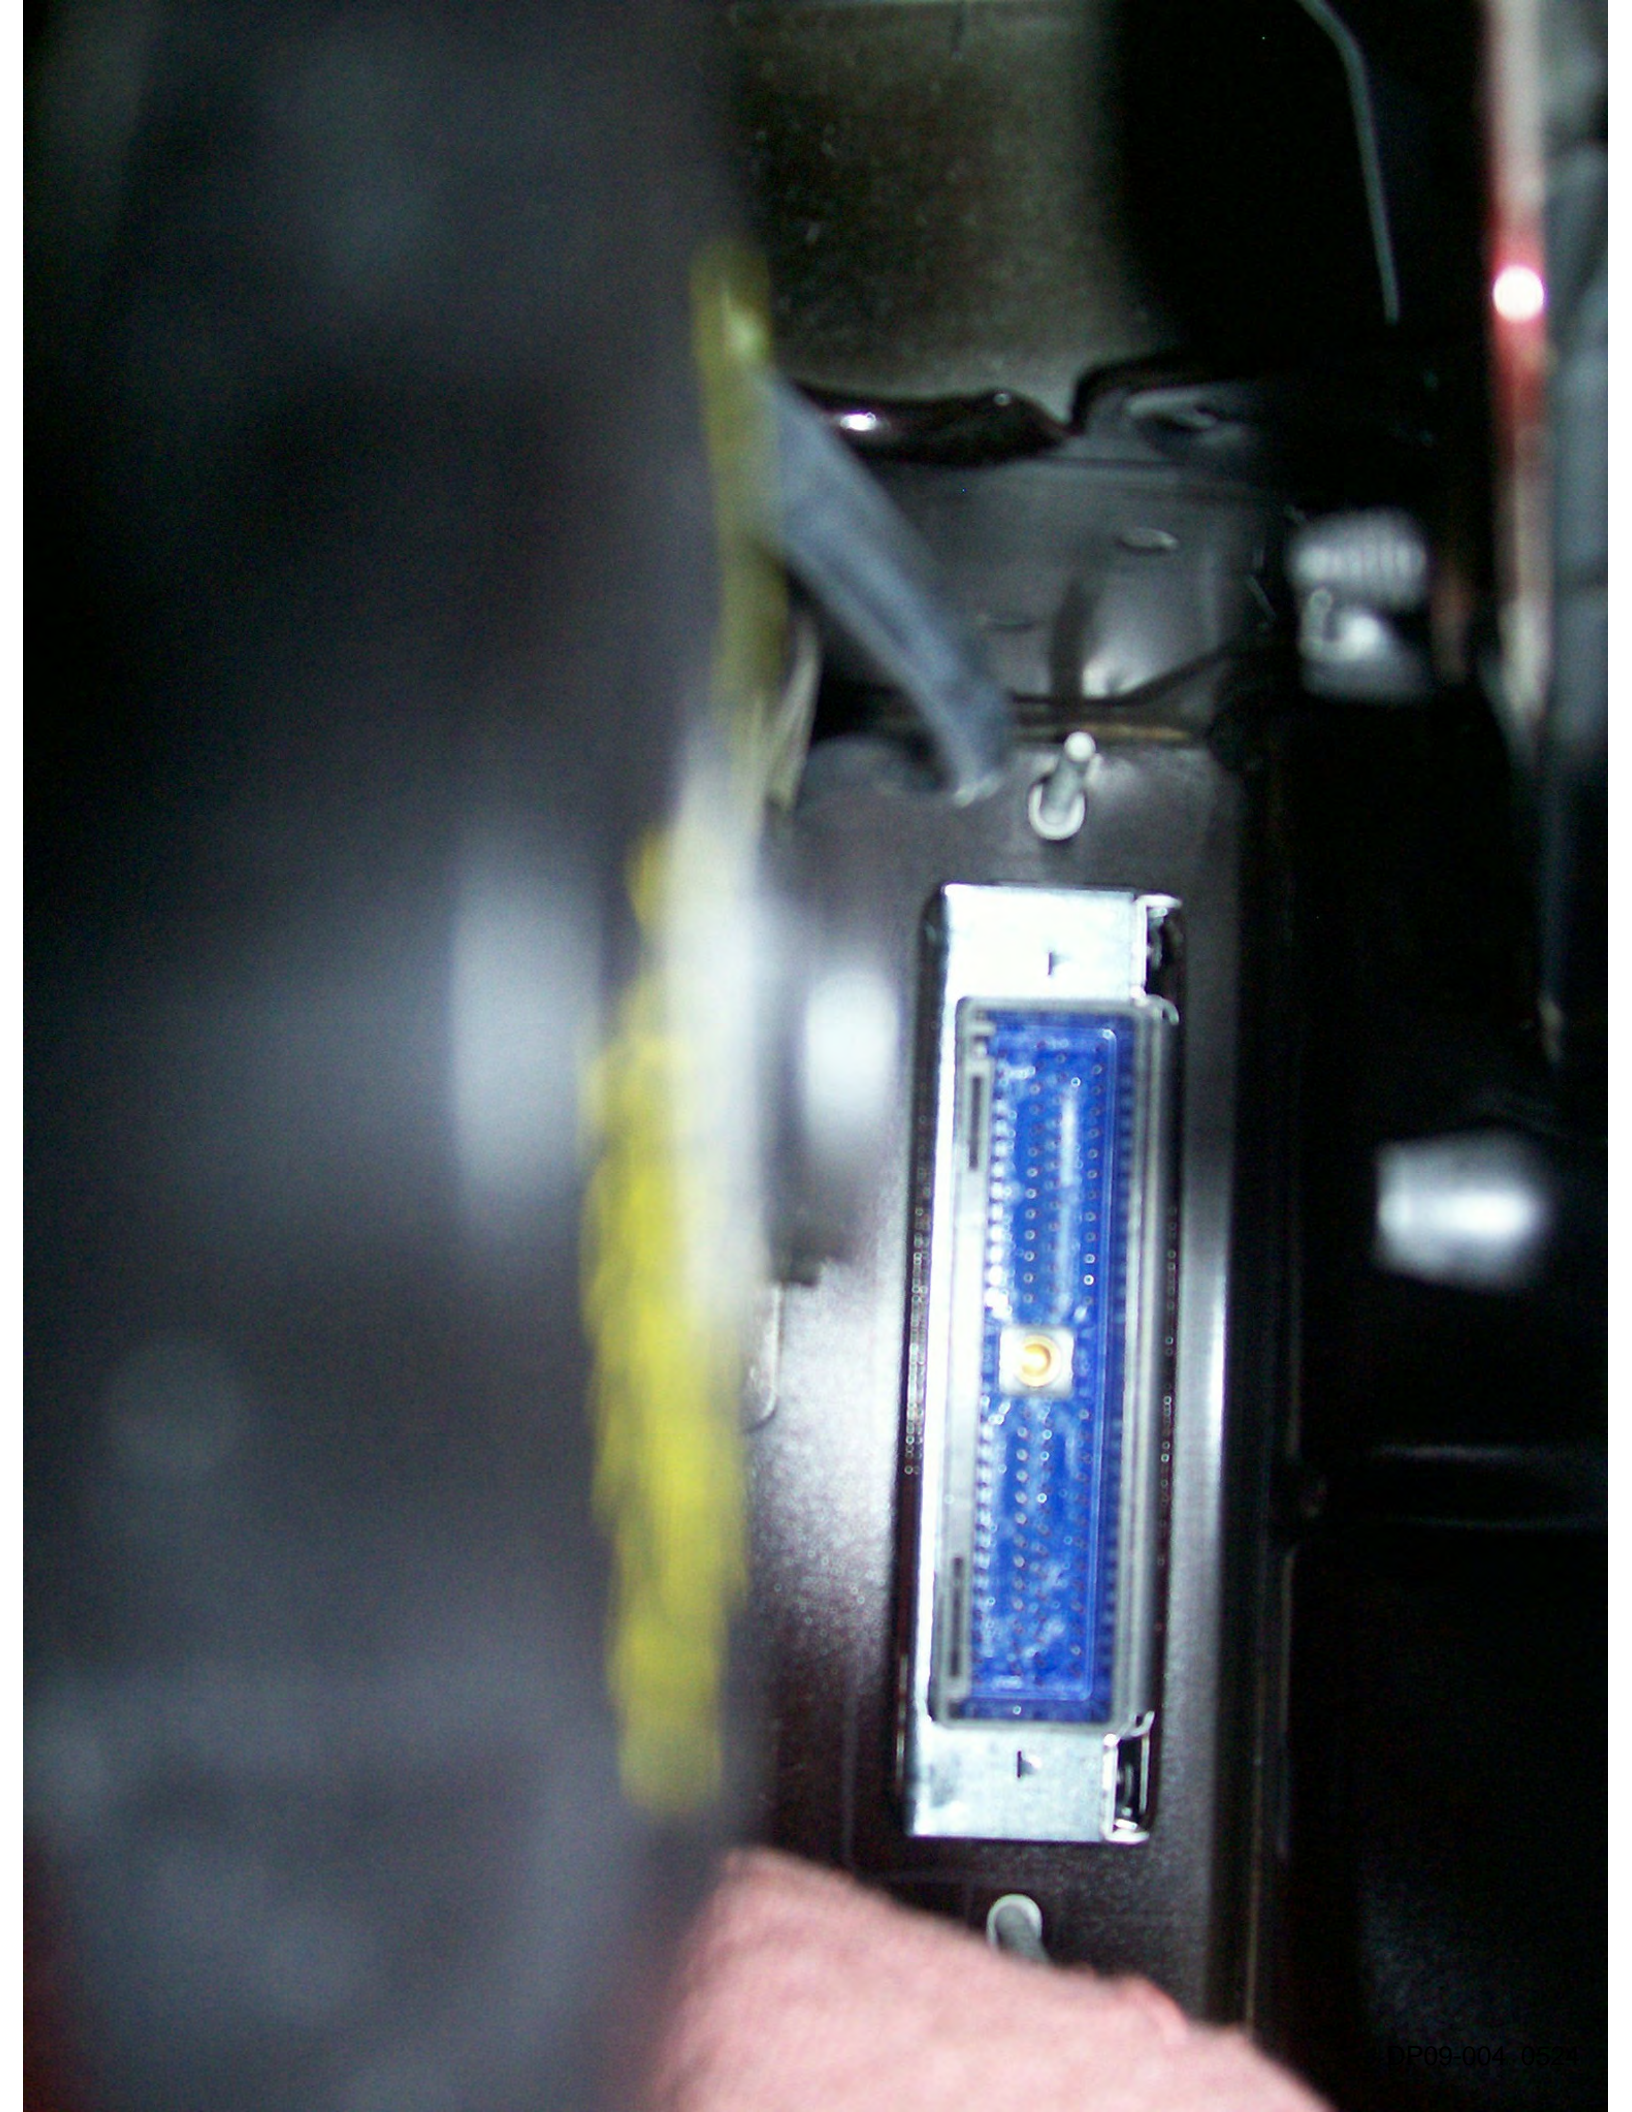
[Here are the pictures of the left side of the PCM from Bruce at Walt Sweeney Ford in Cincinnati.](#)
