Description: Engine/Transmission Driveability Issues

Vehicles: Windstar, Freestar, Monterey

From: Kulkarni, Arvind (A.)
Sent: Wednesday, May 25, 2005 10:49 PM
To: Fang, Andy (A.); Stodola, Robert (R.J.); Tigchelaar, Doug (D.G.)
Cc: Nasar, John (H.S.); Cordeau, Roger (T.); Hearn, Mark (E.)
Subject: Analysis of CQIS data of water leak into PCM

V229 Wipe Cowl Module – Water Leak Paths

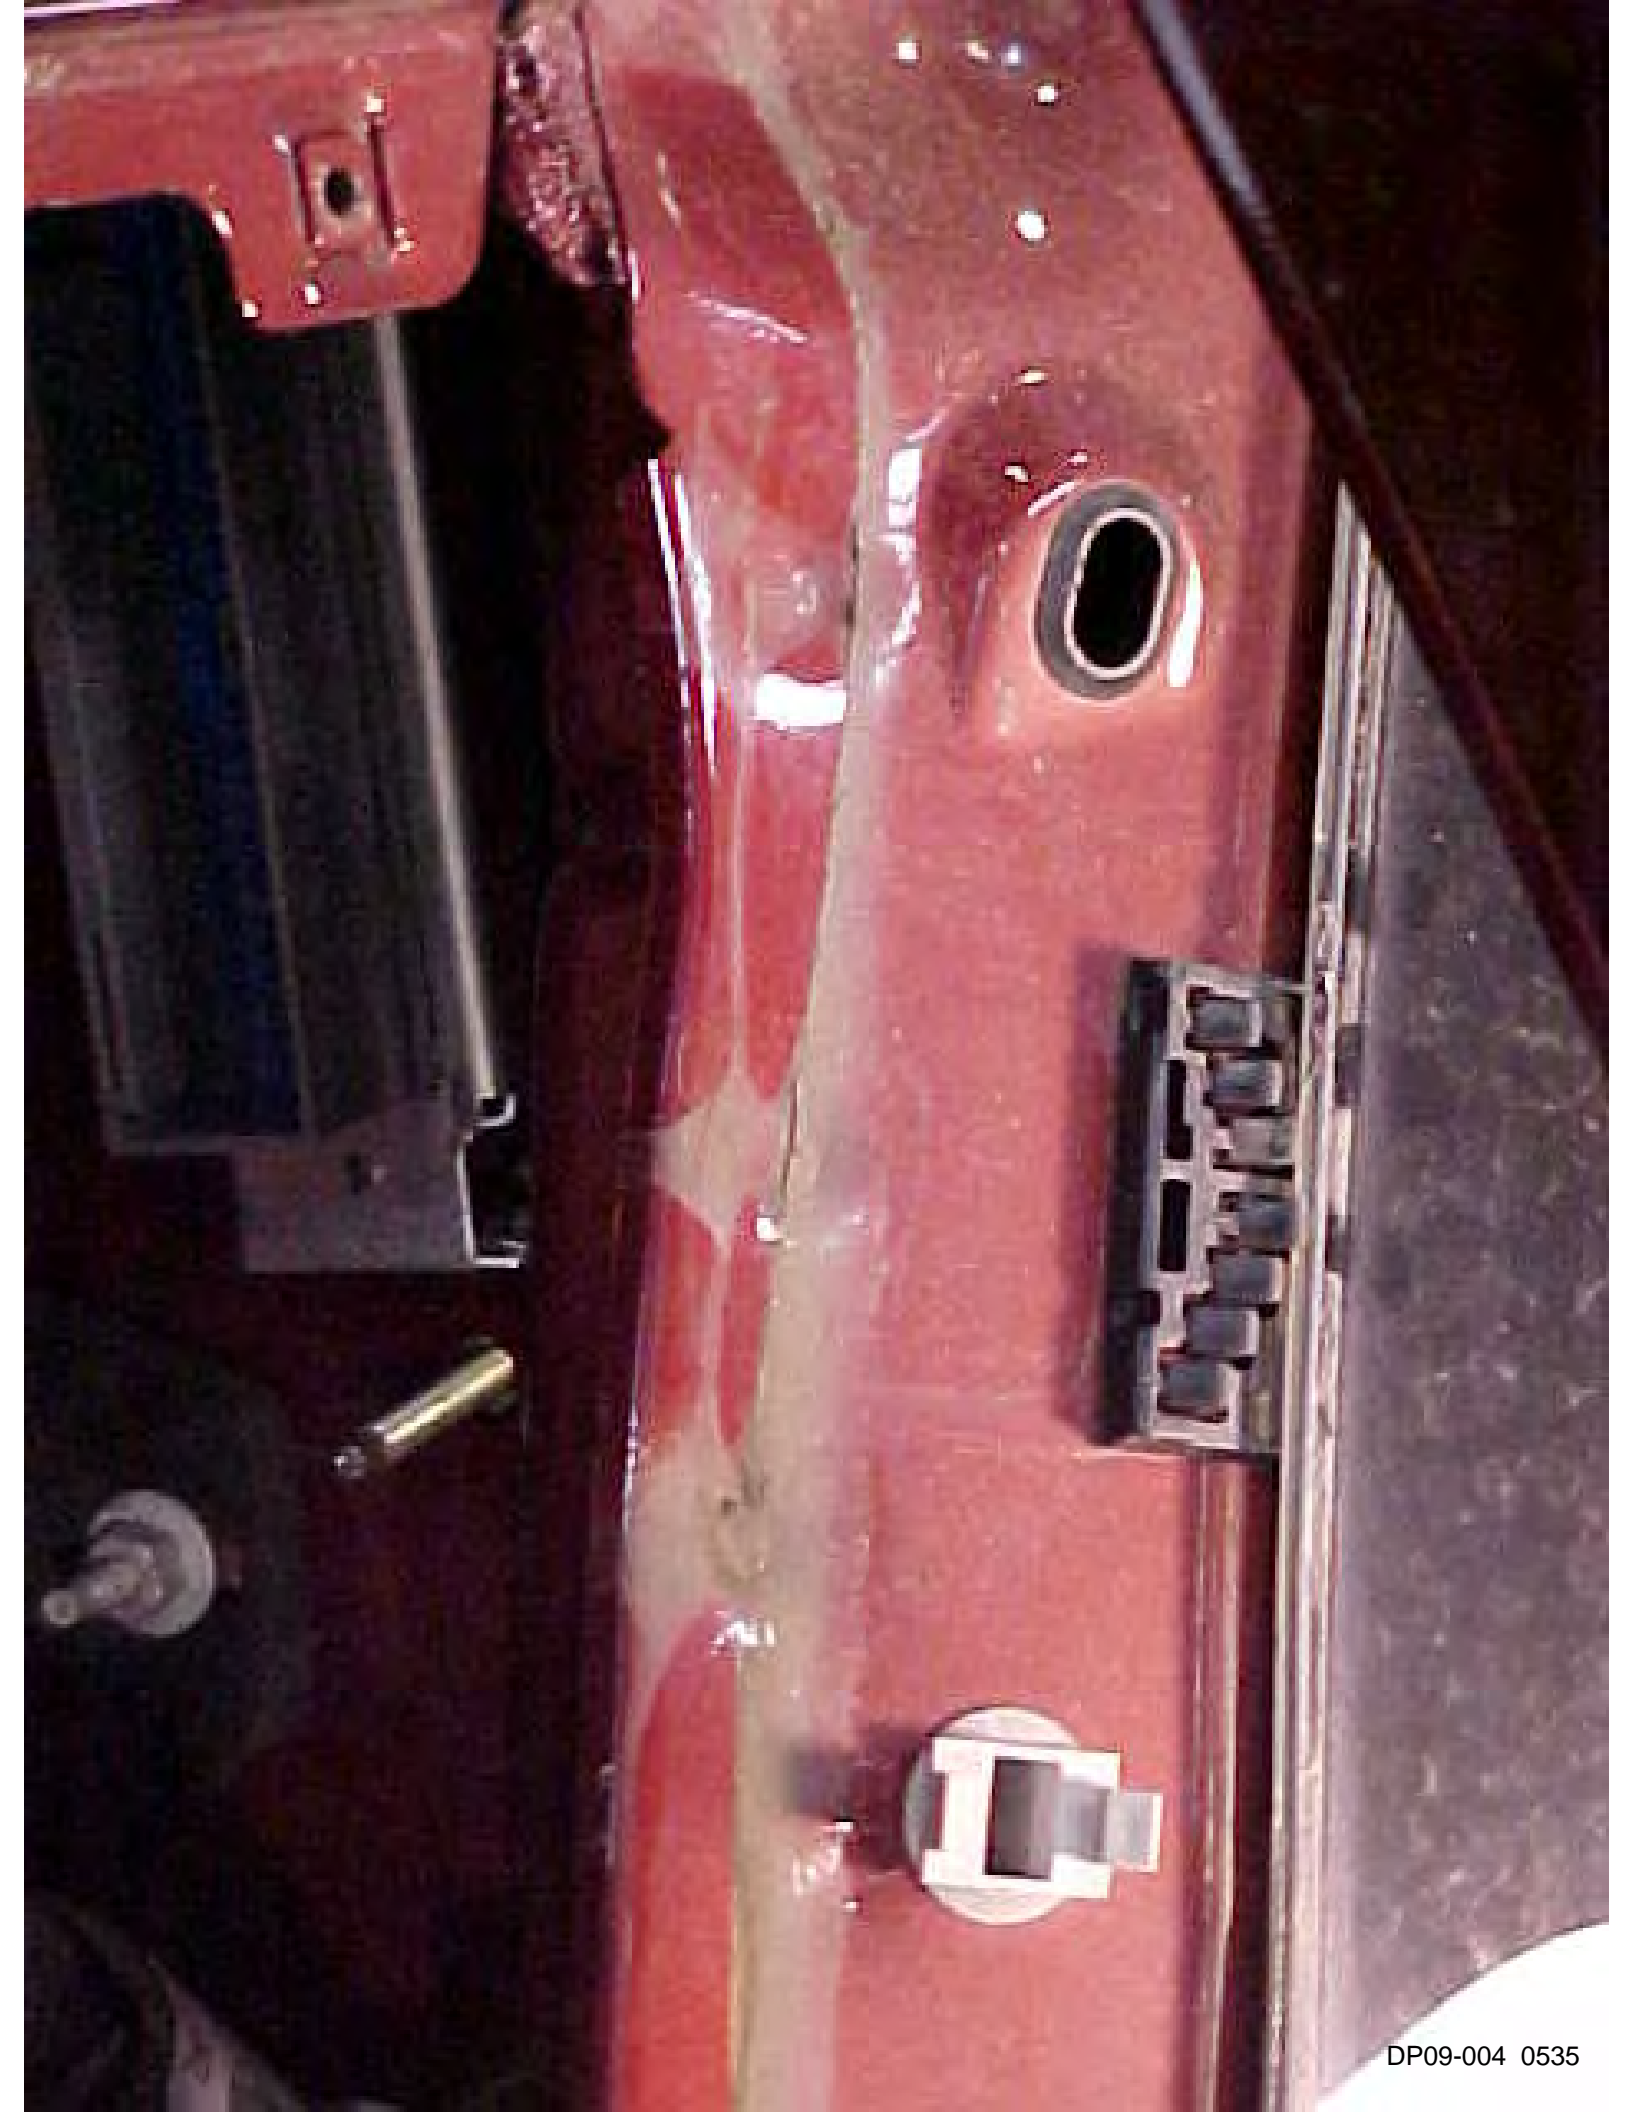
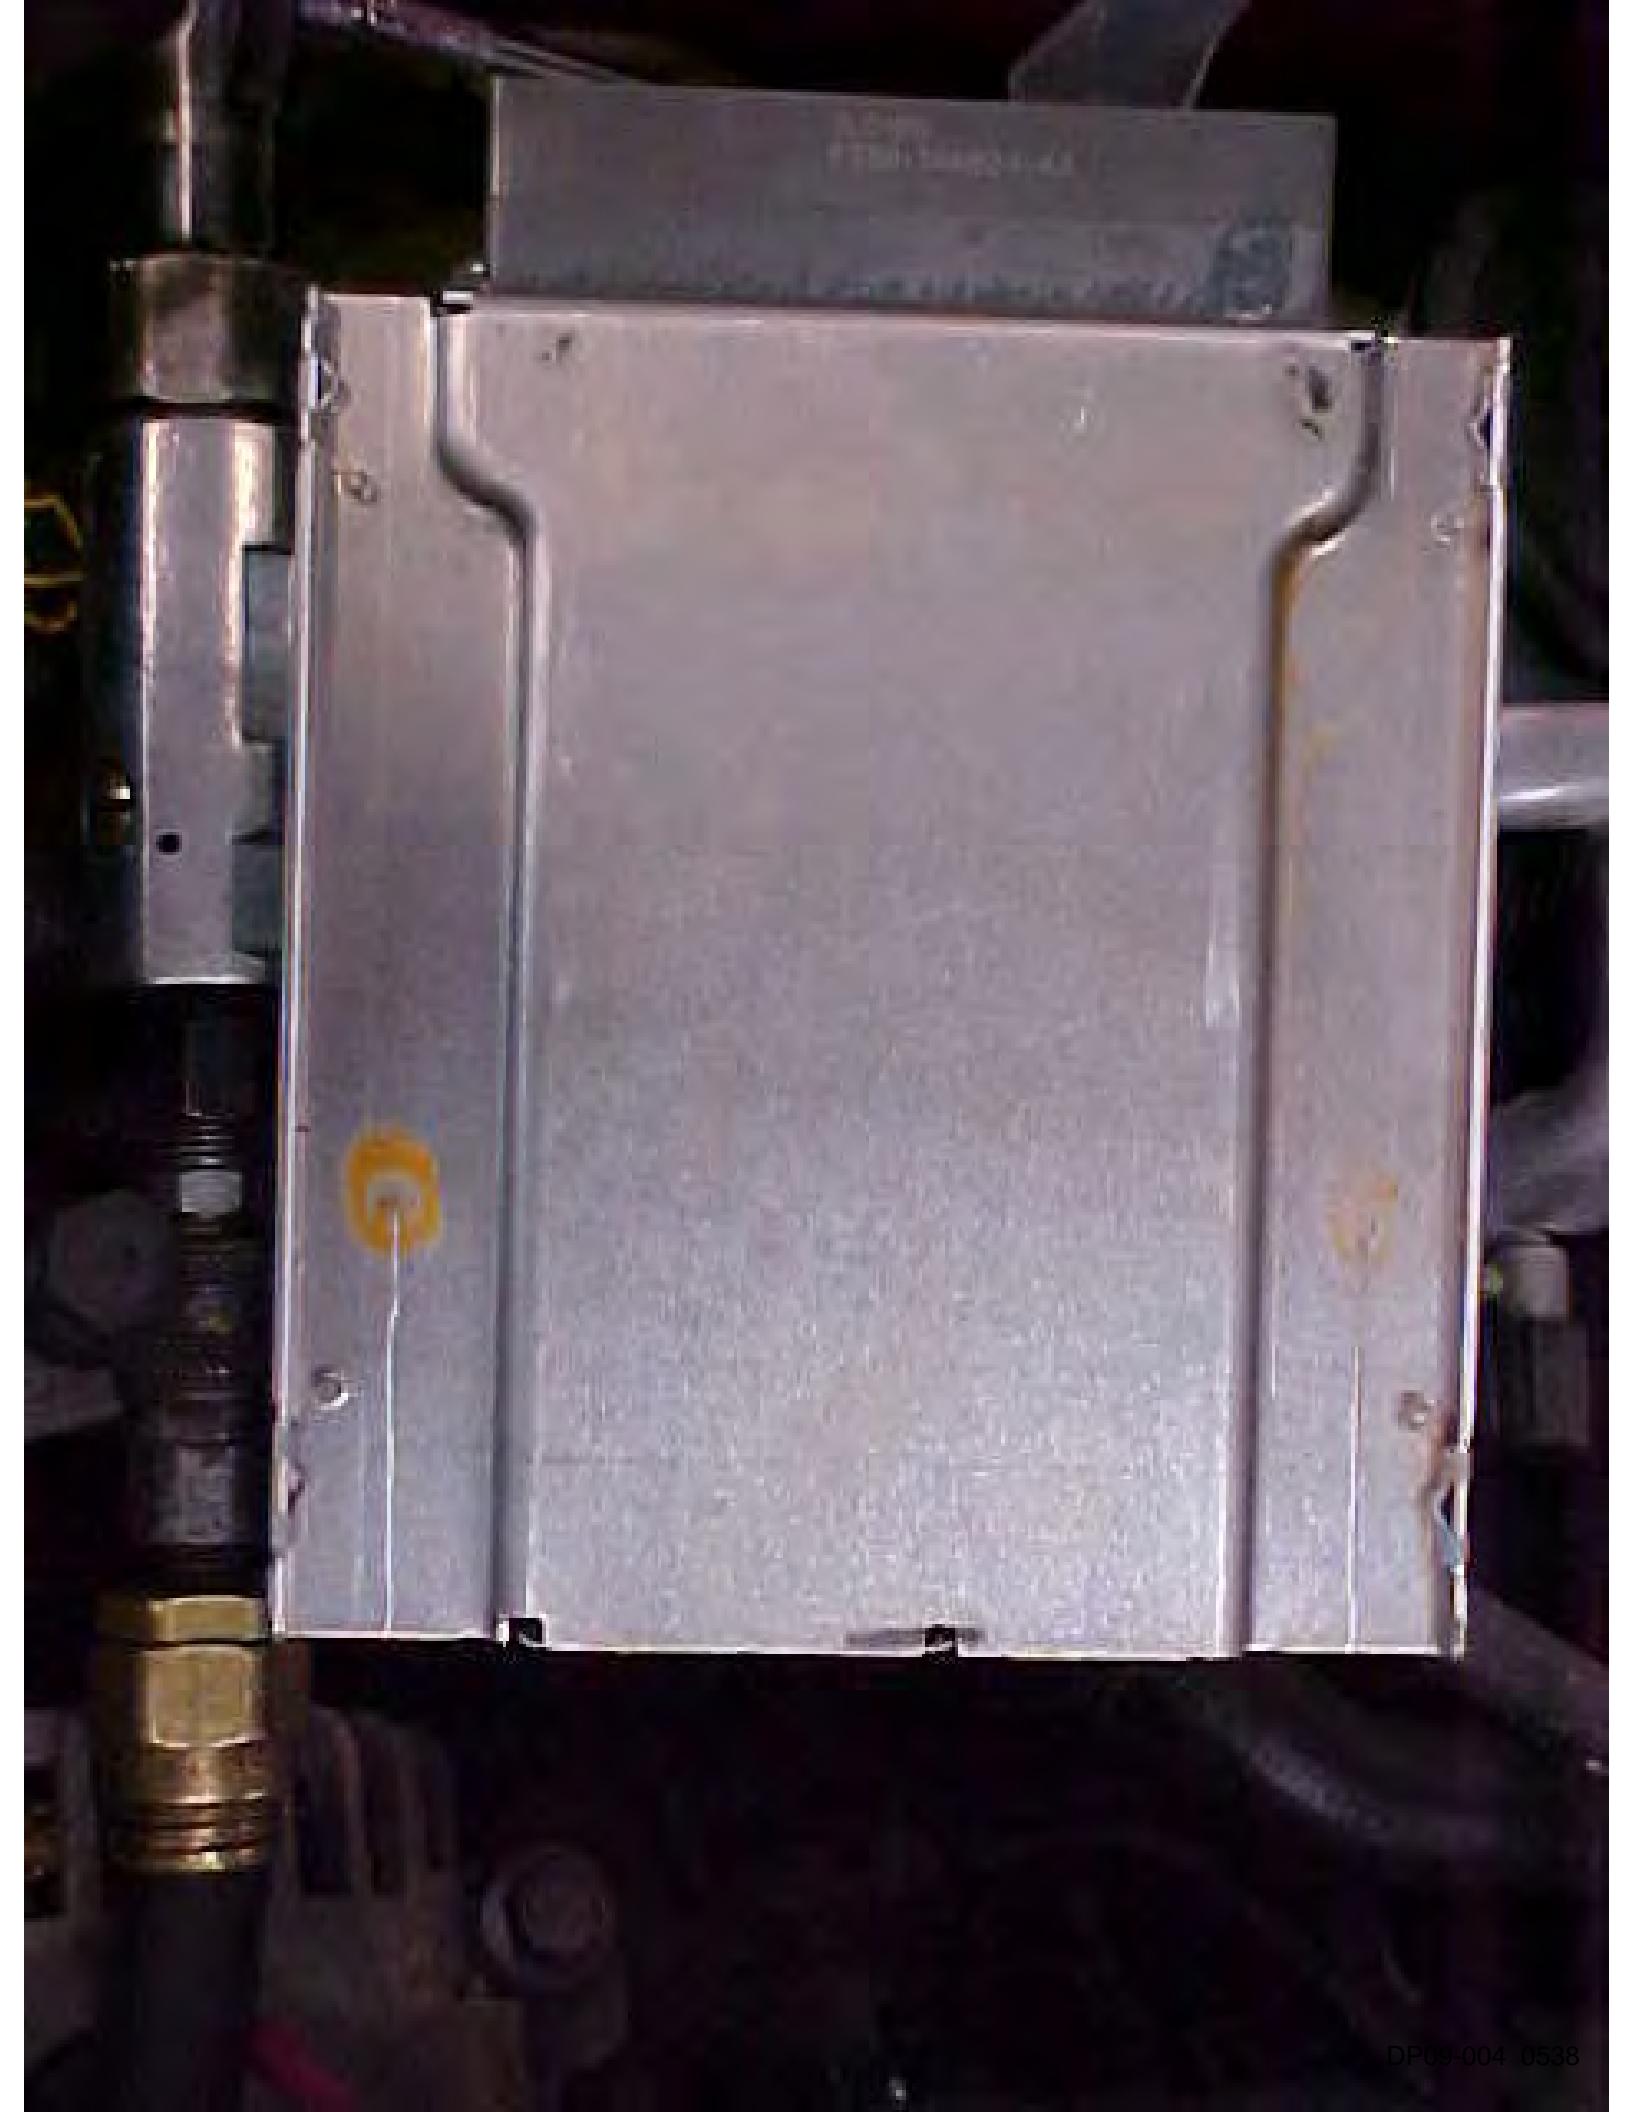
here are the attached pic on our discussion this morning tom oslick day ford 412-856-0600

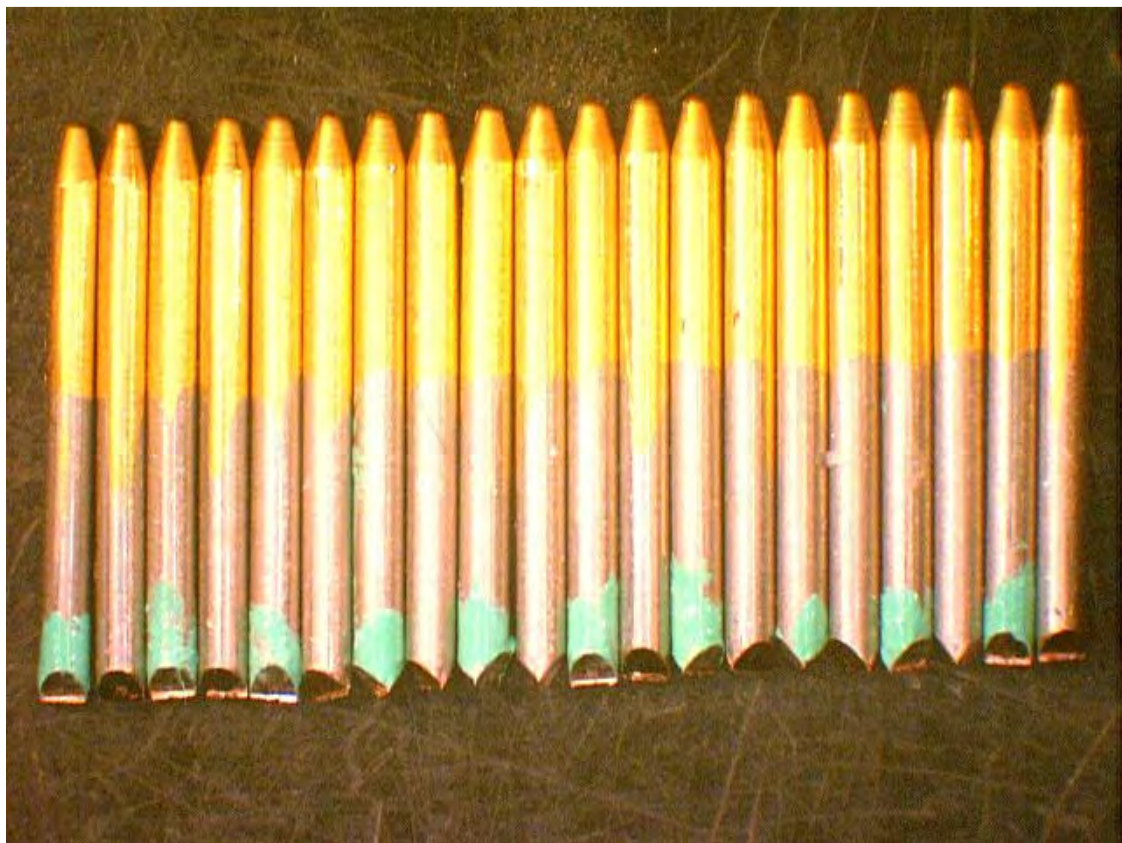
Figure 1. Field of View.

Twenty extracted pins from two PCM connectors. Pins marked with green paint were extracted from a production-ready connector. (note: production-ready pins are interspersed between pins extracted from the returned PCM.

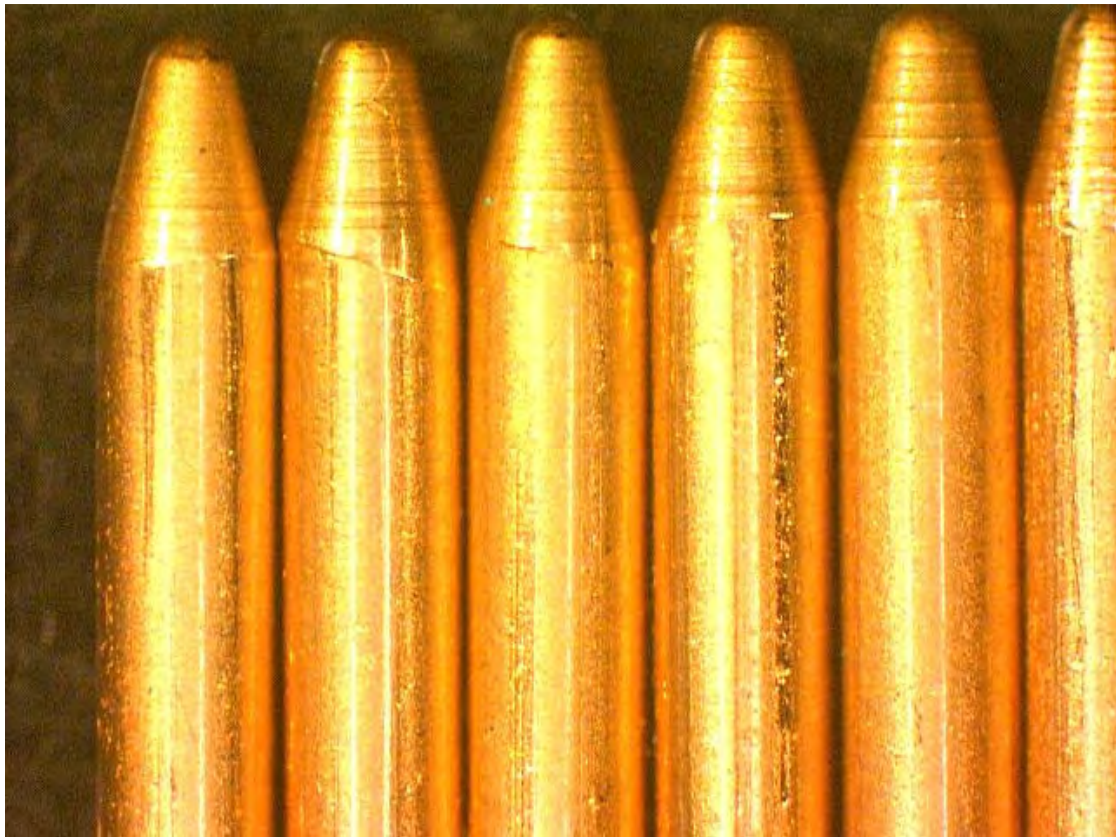
Figure 2. Left-Most Pins at 5x Magnification.

At 5x magnification, no imperfections consistent with corrosion can be seen. A small pit can be seen on the fourth pin from the left.

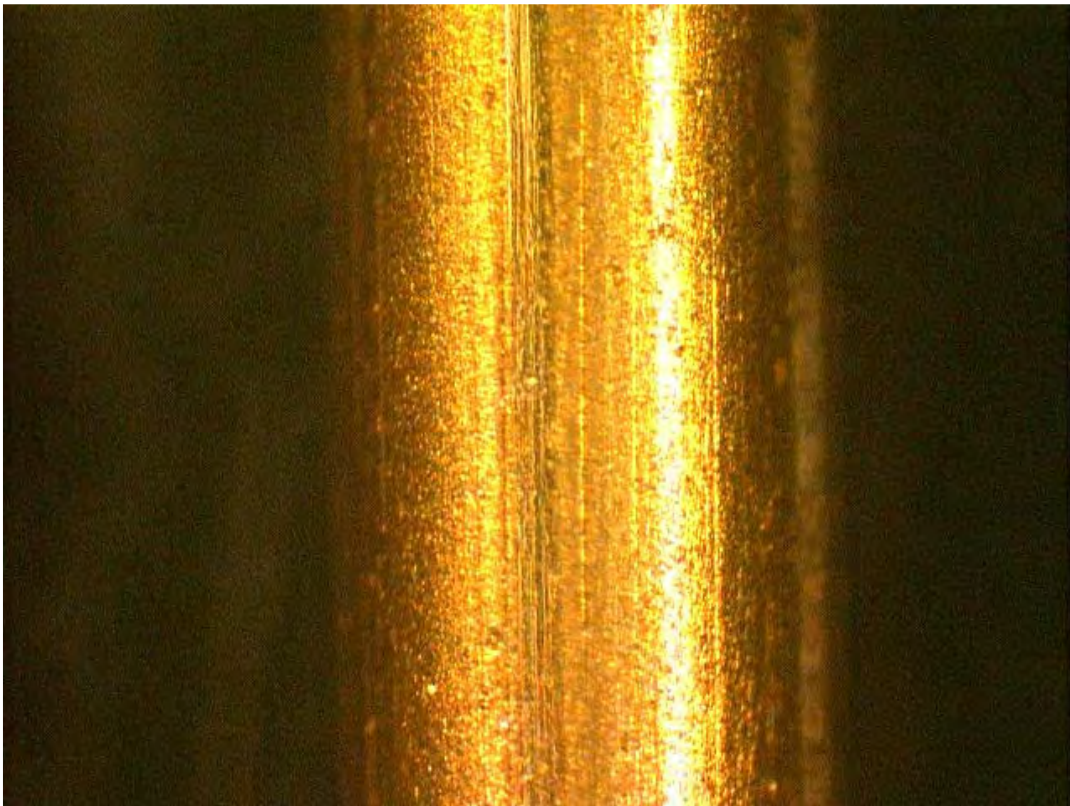
Magnification did reveal, however, some minor pitting on pins extracted from the returned PCM. Further investigation revealed the pits to be straight and approximately 180° apart. These markings are consistent with the female portion of the connector and are not deep enough to penetrate the gold plating. Each side of a sample pin can be seen in figures three and four.

Figure 3. Preliminary View of Pit at 7x.
Pit is represented by dark striations in center of pin.

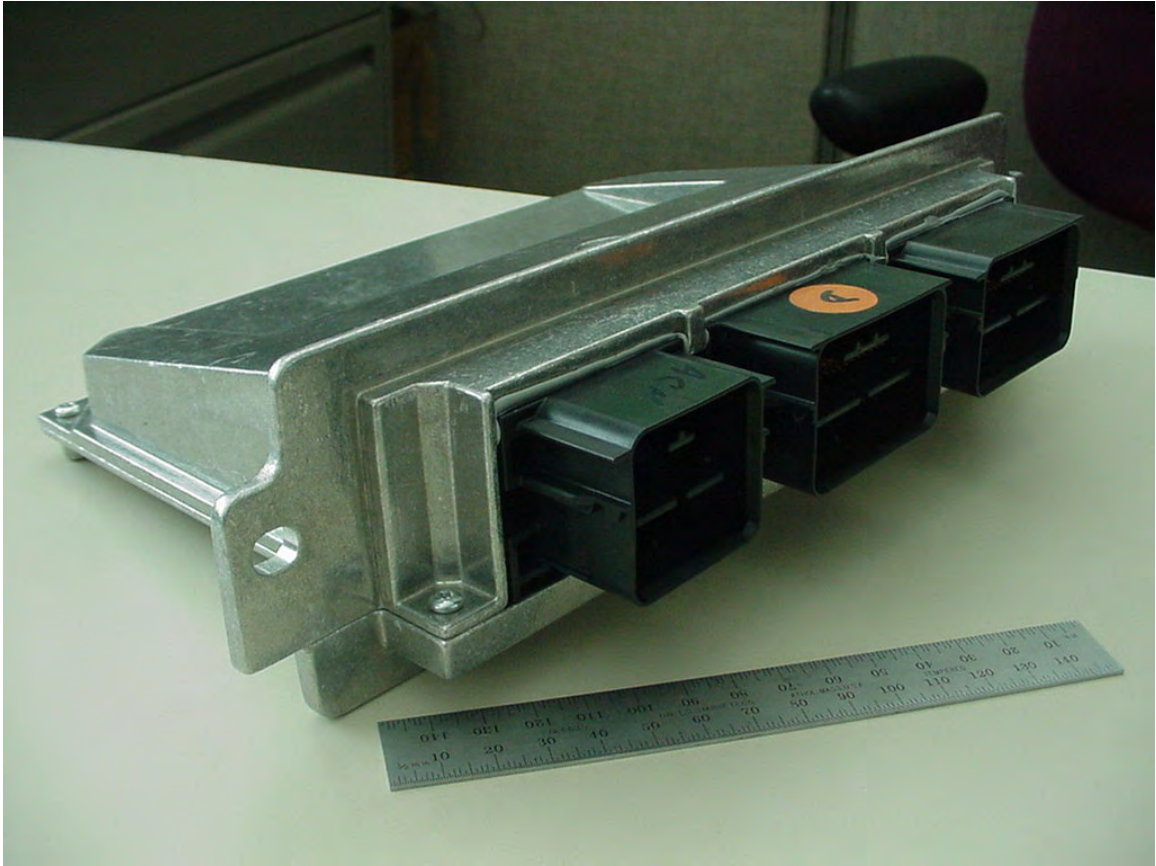
Figure 2. The U222 sealed ECU.

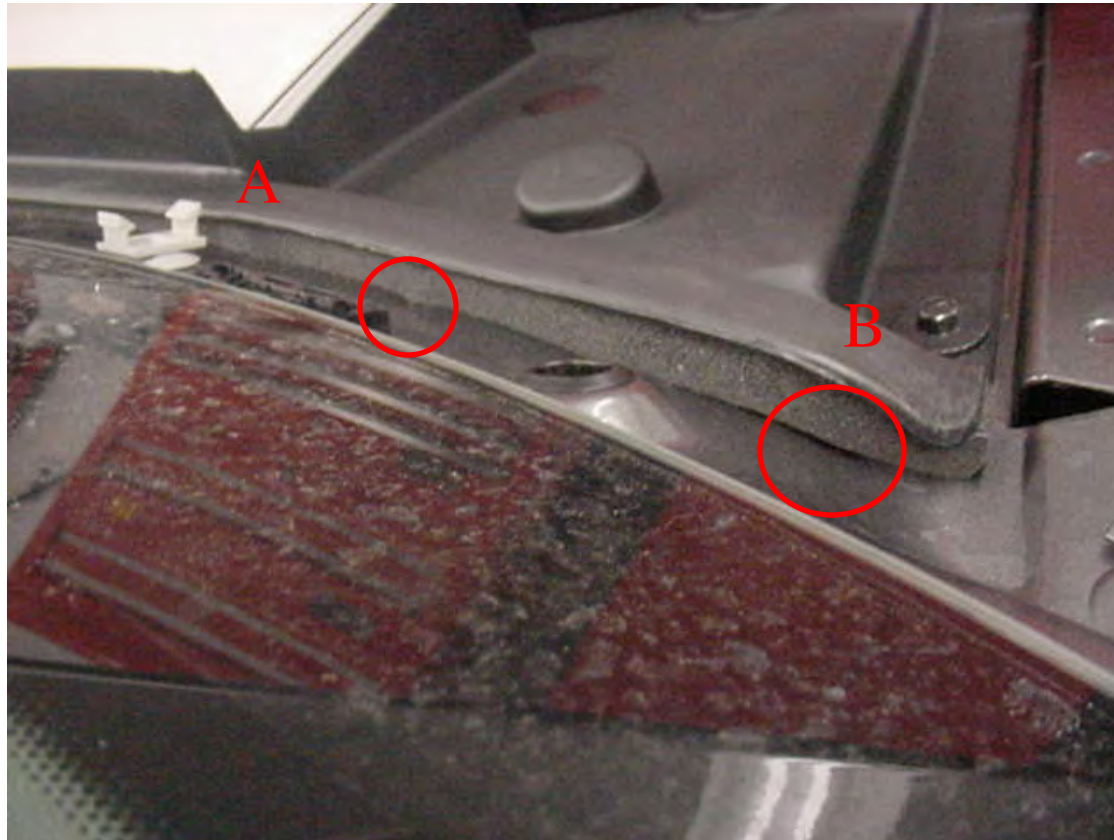
Passenger side of wiper cowl showing leak paths – Note the difference in height of the foam from point A to point B
