**Bendix Commercial Vehicle Systems LLC**  
901 Cleveland Street, Elyria, Ohio 44035  
Tel: 440.329.9000 • Fax: 440.329.9203

Re: **EA09-009**

This letter is to provide you with test findings of the Bendix valves you provided to us and requested to have inspected and tested from the field evaluation conducted the week of August 3, 2009.

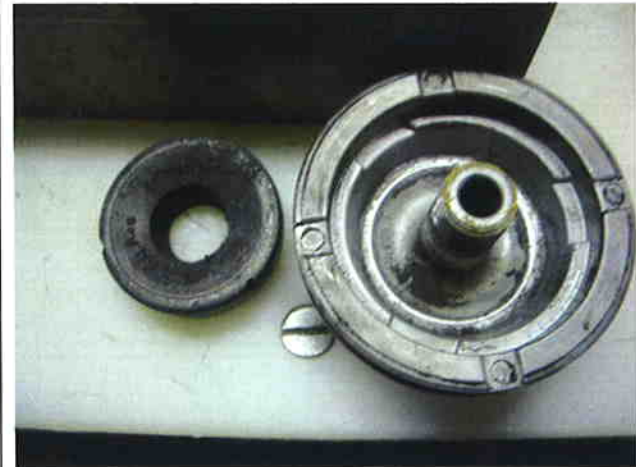
Rubber Spring

The valves were disassembled and inspected for foreign contaminants, degradation of rubber seals, or damage to internal components. The rubber springs showed compression, which may have contributed to differential spike at low pressure. There were heavy impressions on the Inlet/Exhaust valves. Durometer readings indicate minimal difference from nominal values. Some oil was present in the valves, which possibly could be heat related.

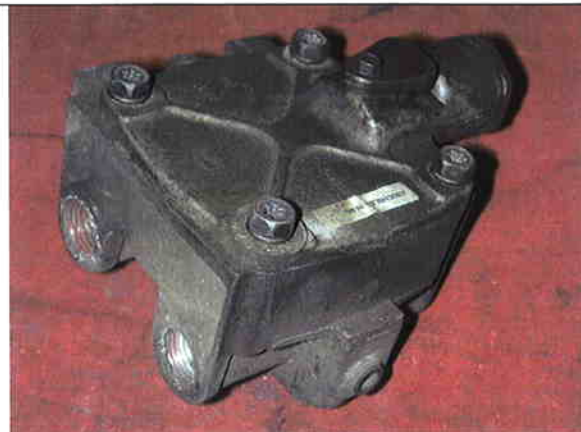
As received, found no part number or date code on body. OE label 5012296. Assembly drawing calls out a 5013270 with a 90° service port location. Photo shows the service port is 180° off location. Thus, customer may have disassembled and assembled unit.

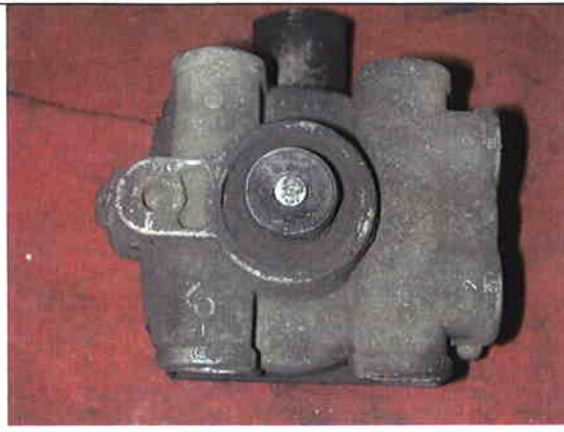
Photo shows that the exhaust cover was not disassembled.

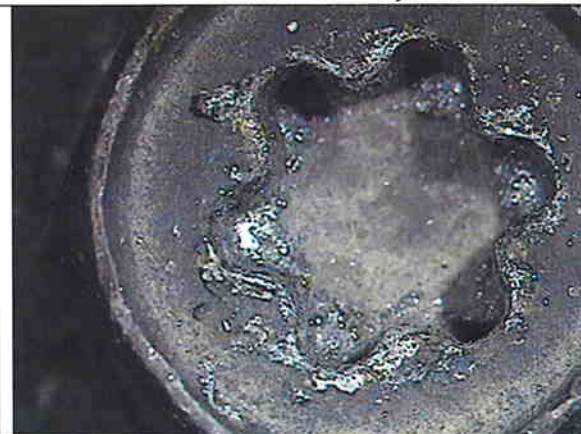
The cover bolts with fresh wrench markings indication of disassemble.

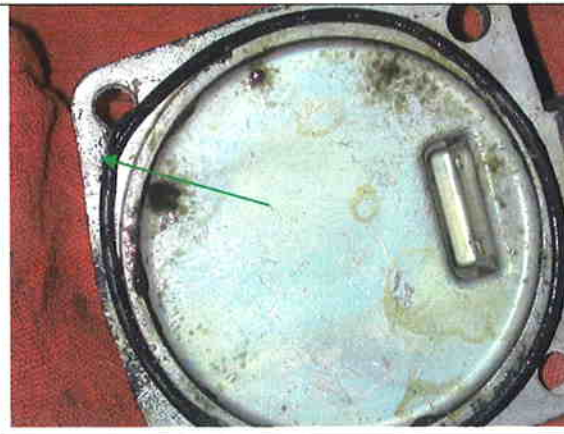
**R-14** – As noted in the table below, initial test found the valve leaking between service cover and body; the valve did not meet all the parameters of the test specification. The cover was removed and the static o-ring was found to be pinched. The customer had replaced a Haldex relay valve with the Bendix R-14 valve. It was confirmed by a Bendix representative that the cover had been removed during its installation and its removal to retrieve fittings and this is likely how the o-ring was pinched. Also the assembly drawing calls out a 90° service port location, however the part was at 180° off location. This supports that the customer disassembled and re-assembled the unit. The o-ring was replaced with a new o-ring and the valve performed within the parameters defined in the Bendix specification for new valves. Operational and differential curves show that the valve functioned satisfactorily.

Initial bench test blow leakage found static o-ring pinched. Again, indication of improper re-assembly by customer. Note that a new o-ring was installed so to complete the evaluation.

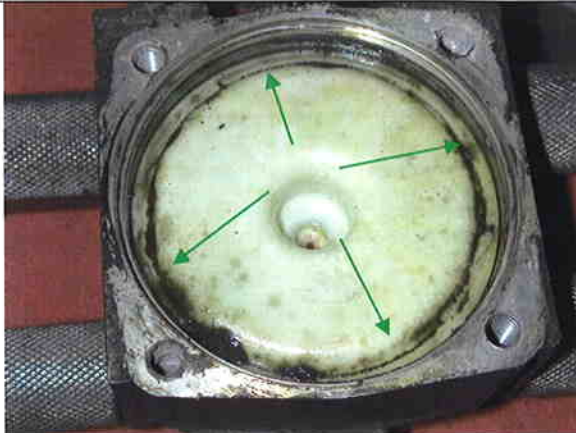
Excessive oil mix grit contamination on top of the control piston.

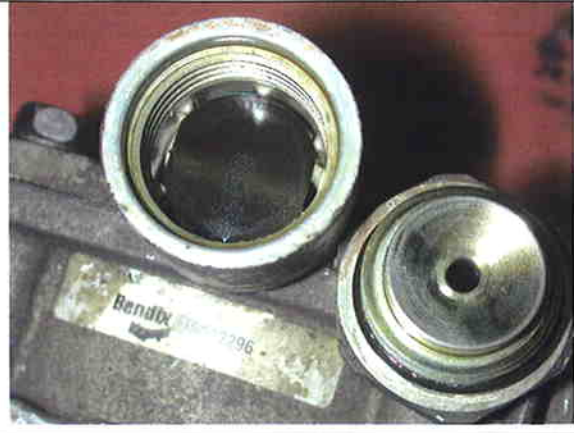
Excessive oil contamination inside the service quick release cavity

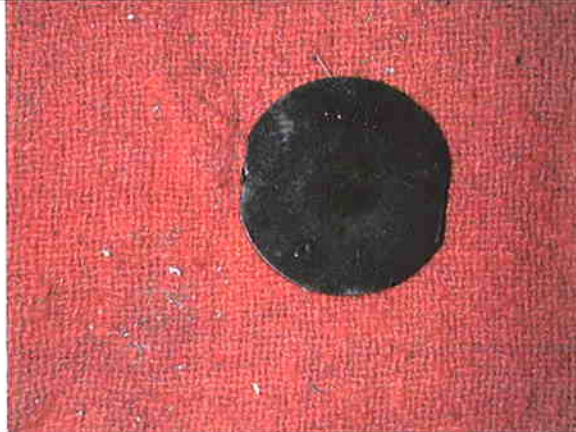
The quick release diaphragm appears normal. Light cupping.

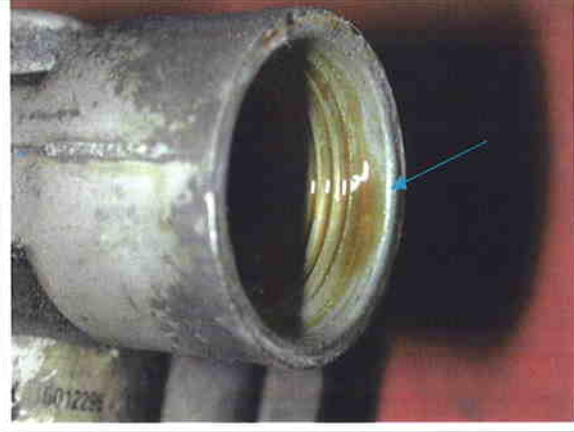
Excess oil residue inside service cap port area.

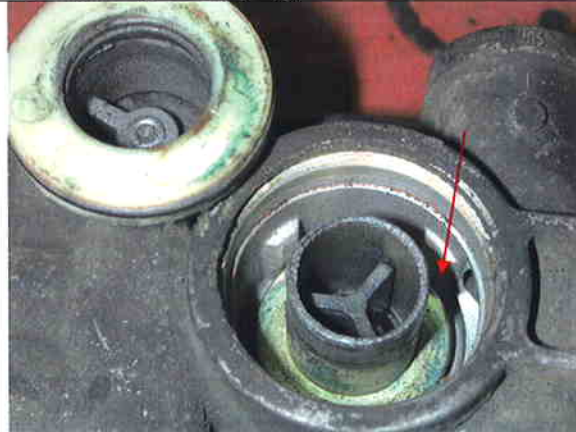
Exhaust inlet cavity shows less contaminates. Lacking grease.

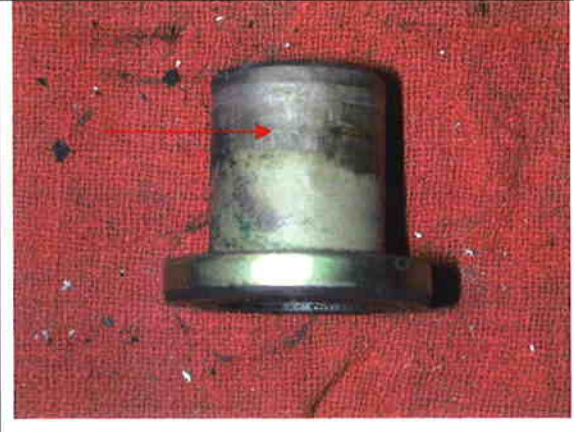
I/E valve OD surface lacks grease.

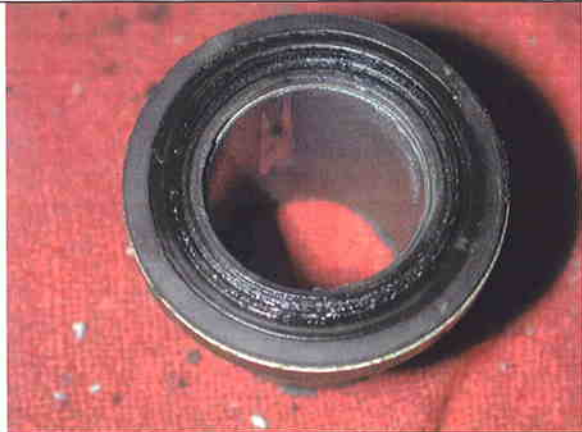
The valves were disassembled and inspected for foreign contaminants, degradation of rubber seals, or damage to internal components. There was heavy oil and grit contamination. The inlet/exhaust seat showed wear from the oil mix contamination.

I/E valve seat shows excessive wear from oil mix grit contaminates.

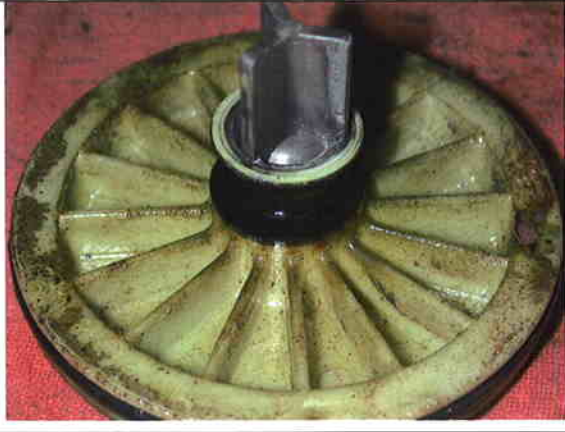
Control piston's delivery side shows excessive oil and grit contaminates.

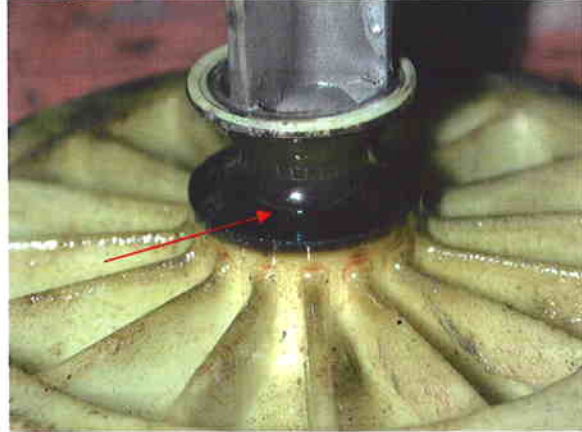
The control piston's delivery side, below the seat, has a tacky like oil residue.

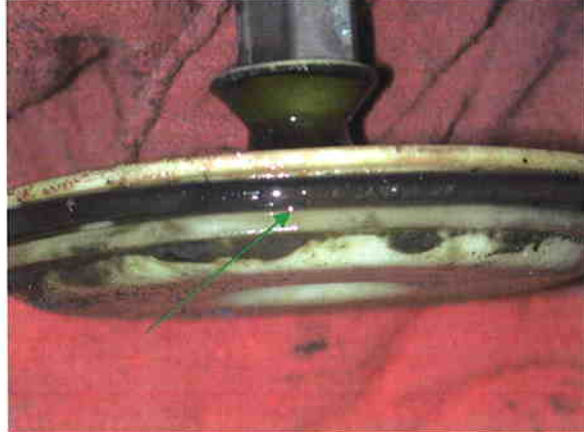
The piston o-ring groove area shows oil contaminates residue.

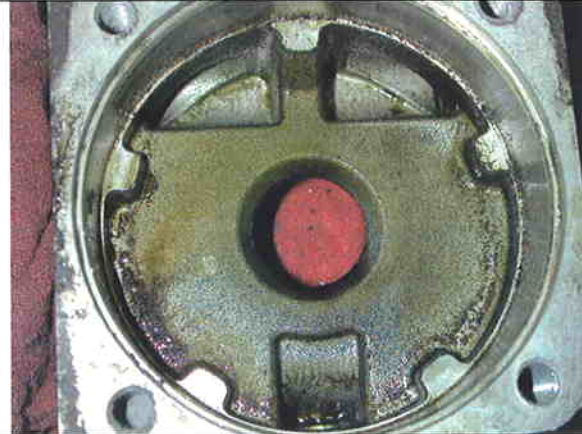
The body's delivery cavity shows oil grit contaminates.

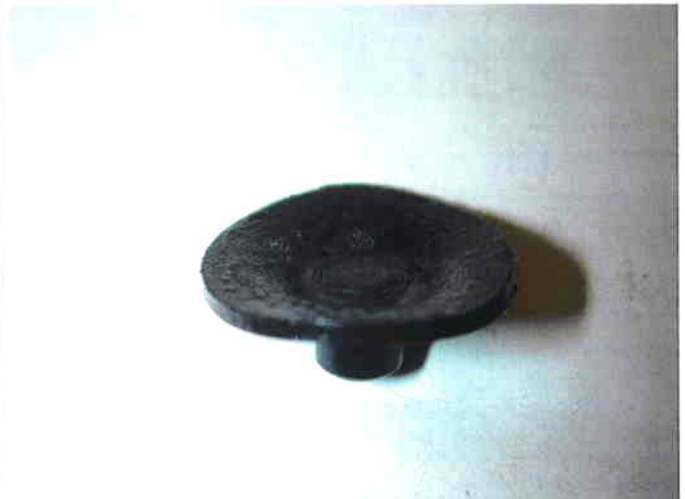
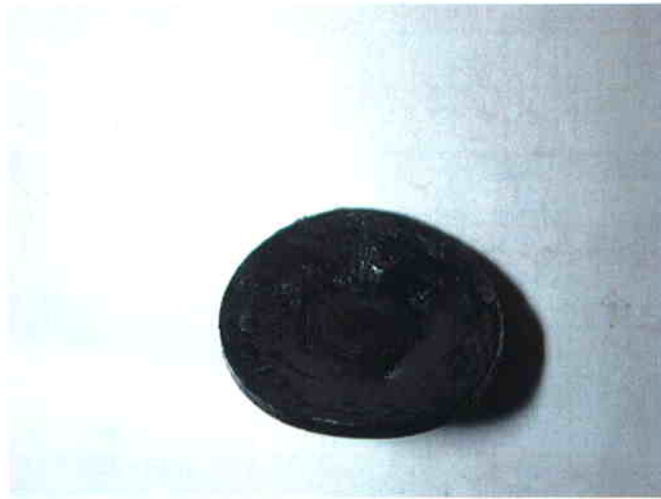
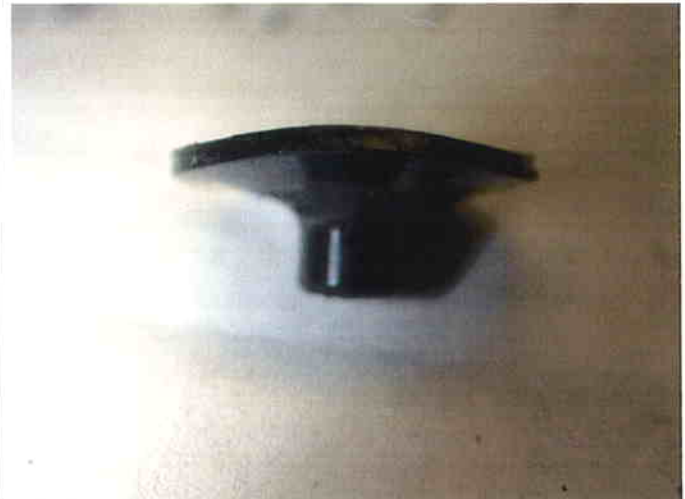
Double Check Valve

The valves were disassembled and inspected for foreign contaminants, degradation of rubber seals, or damage to internal components. The double check valve on all three valves were contaminated with oil and damaged in one valve (...1696). This caused the leakage in the “buttons in” test. When the damaged double check valve was replaced in the one valve (...1696), the valve passed all performance requirements. The exhaust seal of the tractor plunger was contaminated and damaged in two of the valves (...4367 & 4366). Material analysis determined that the substance found on the o-rings and exhaust seal was a mixture of the standard Bendix grease, water and an alcohol. The durometer of several o-rings was found to be under specification, which may have contributed to the Buttons In leakage results.

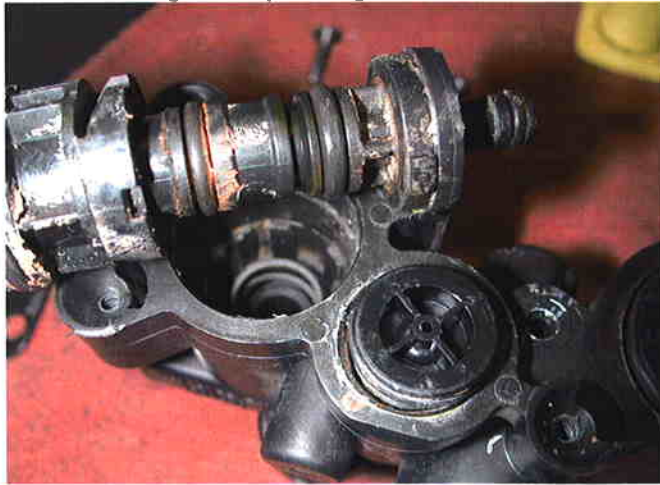
Tractor Plunger – dry o-ring

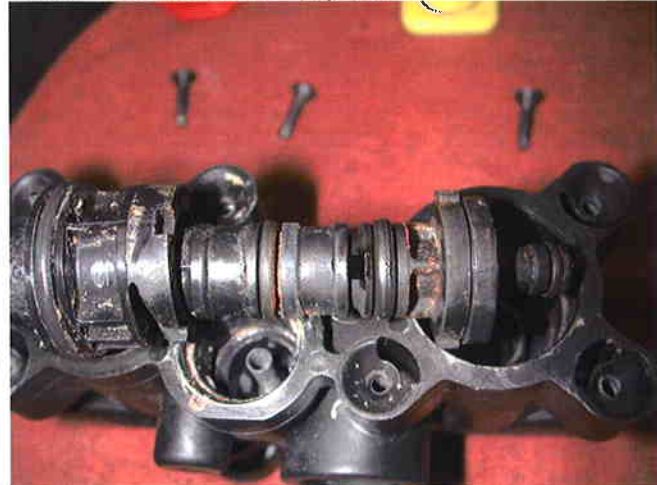
Tractor exhaust seal – dry o-ring

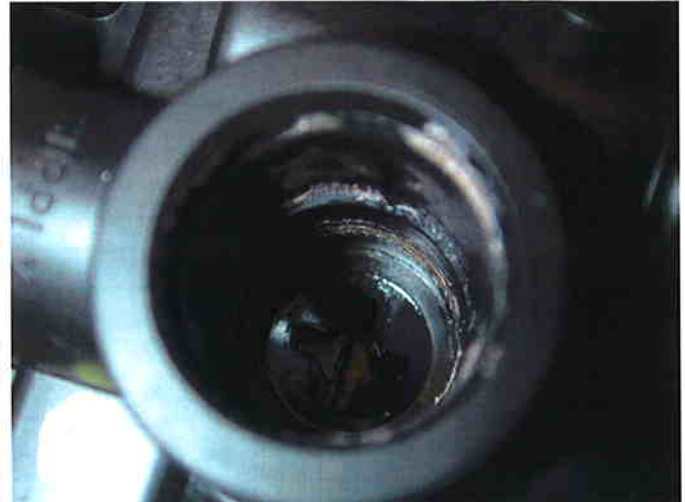
Double check valve bore – oil
