## **NHTSA ODI – EA09-009**

- The information that follows was prepared to supplement the Mack Trucks presentation and technical discussions on the subject during a review meeting December 17, 2009
- Attendees were from NHTSA, Mack Trucks, Haldex and Meritor WABCO
- For further information, see individual vehicle and product reports to be submitted to NHTSA in January, 2010.

NHTSA EA09-009 Review – December 17,2009

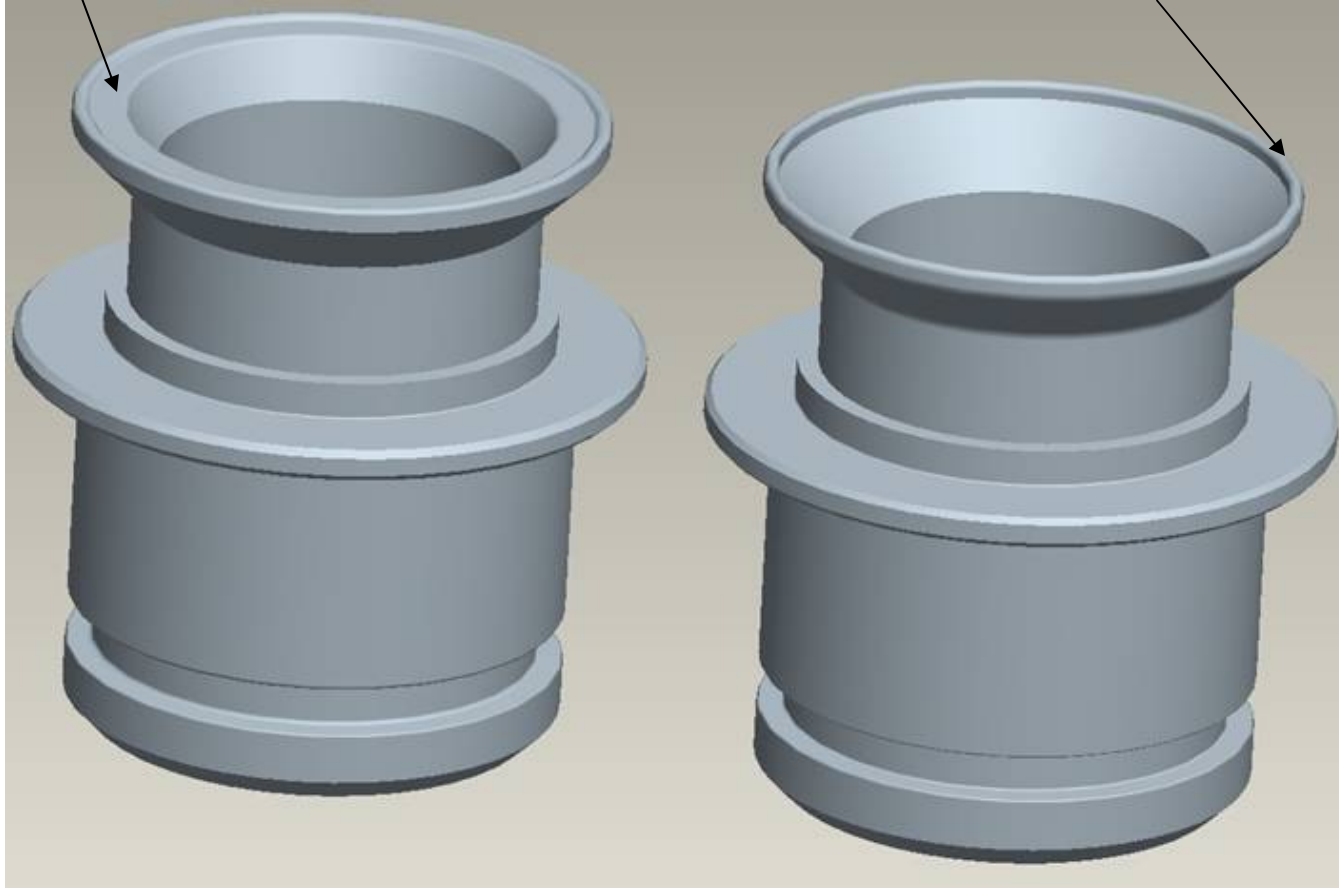
## Relay Valve Exhaust Seat / Modulation Tube Design Change – Phase I

Phase 1 Implemented Jan 2009

(Additional metal to reduce rubber deflection)

Original Design

(No metal stop other than seat – results in more rubber deflection)

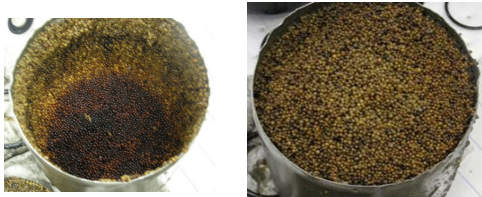
| | Vehicle Identification | | |
|---|---|---|---|
| Dryer Cartridge Inlet / Outlet | | | |

| | Vehicle Identification | | |
|---|---|---|---|
| System Status | Dryer cartridge not serviced | Dryer cartridge replaced @ 100K | Dryer replaced @ 566,245. Incorrect installation – not enough purge |

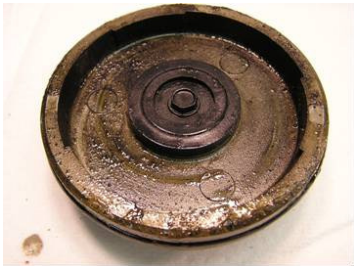
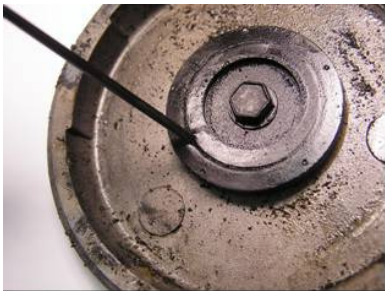
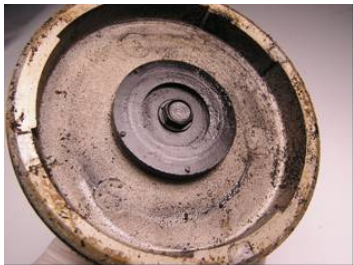
| | Vehicle Identification | | |
|---|---|---|---|
| Relay Valve – Exhaust | | | |

| | Vehicle Identification | | |
|---|---|---|---|
| Vehicle Performance | Reported – leakage found on site | SS121 apply .23 sec, drive OK | SS121 apply .21 sec |

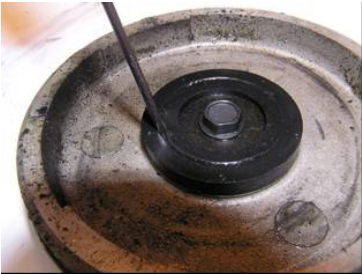
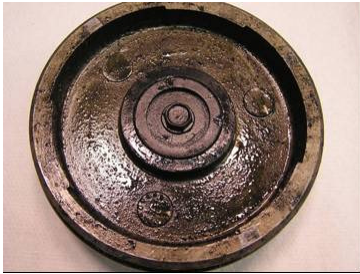
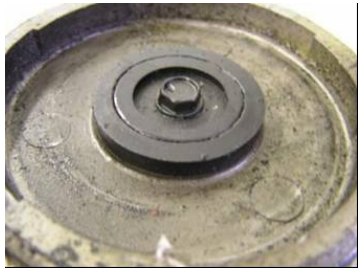
| | Vehicle Identification | | | MERITOR WABCO |
|---|---|---|---|---|
| Relay Valve – Exhaust | | | | |

| | Vehicle Identification | | | MERITOR WABCO |
|---|---|---|---|---|
| System Status | Dryer cartridge not serviced | Excessive bio fuel | Assume same as PA/NJ2 | |
| Vehicle Performance | PBBT OK – 0.53 brake force ratio | Reported problem | Reported problem PBBT on different vehicle OK – 0.60 brake force ratio | |
