**EA09-009**

**December 17, 2009**

**Mack Trucks, Inc.**

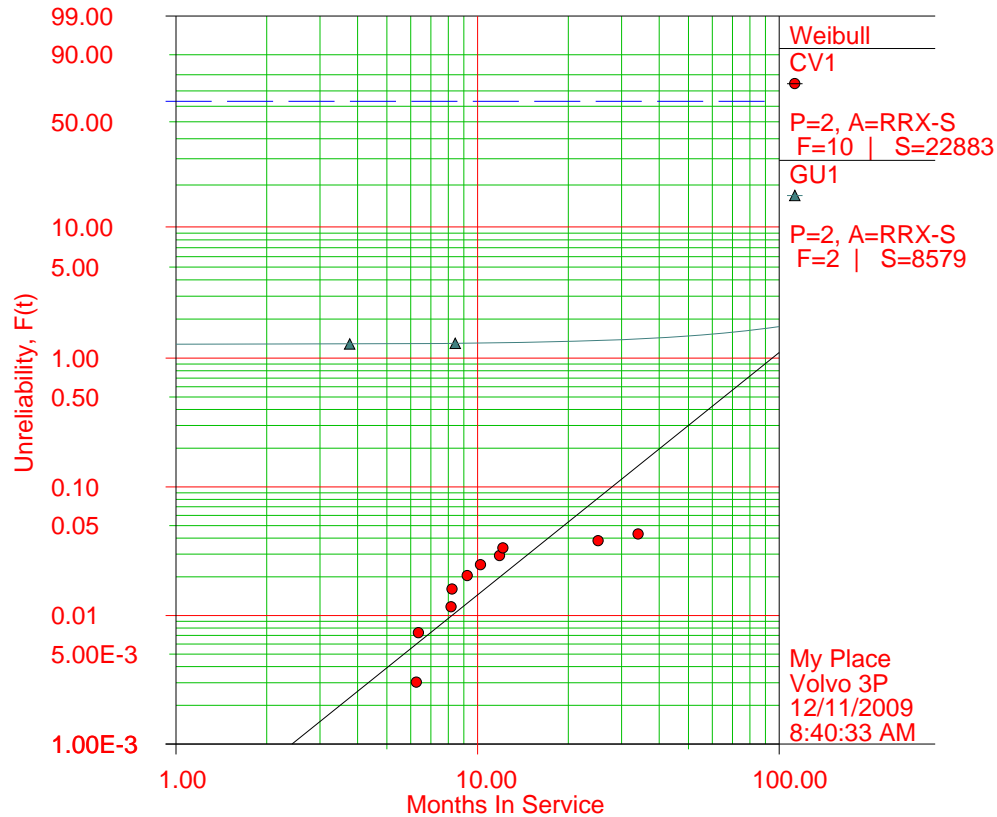
Mack Construction Models

$\beta_1=1.89, \eta_1=1088.84, \rho=0.79$   
 $\beta_2=1.22, \eta_2=8049.71, \rho=1.00$

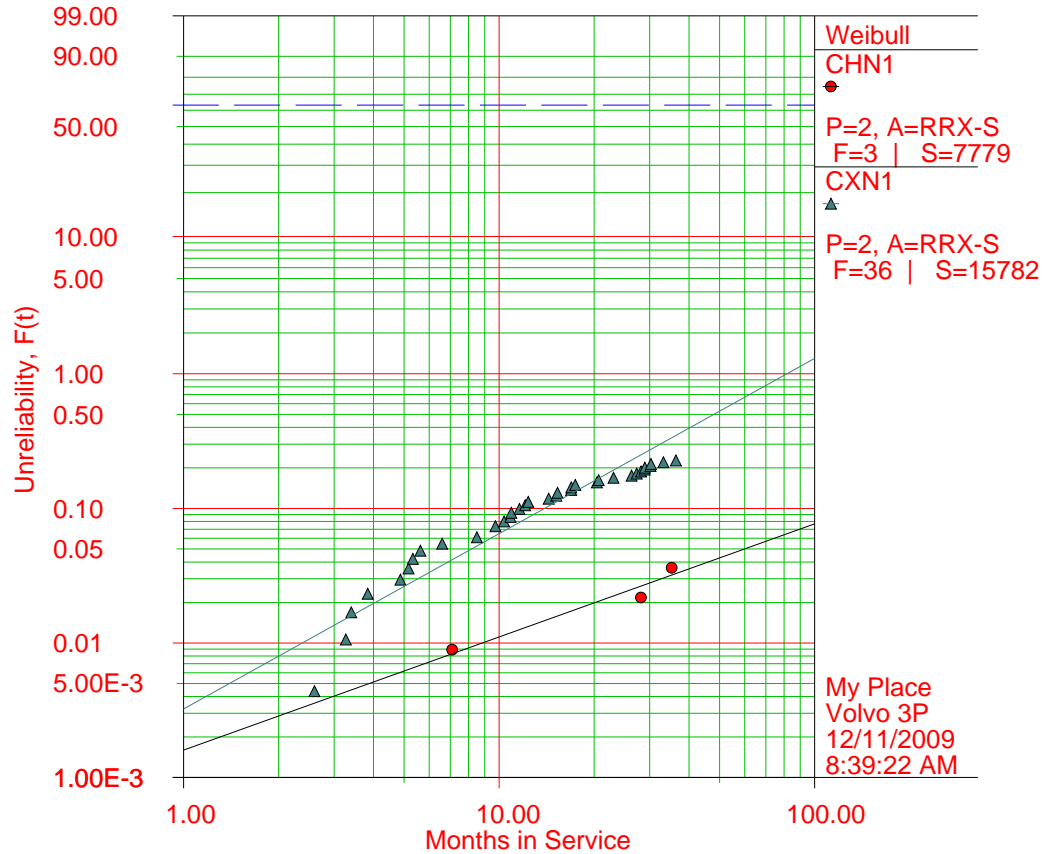
Mack Highway Models

$\beta_1=0.84, \eta_1=5.03E+5, \rho=0.97$   
 $\beta_2=1.30, \eta_2=2786.82, \rho=0.95$
