# FSE Report

2007 CM SANTA FE - ESC WARNING LIGHT ON

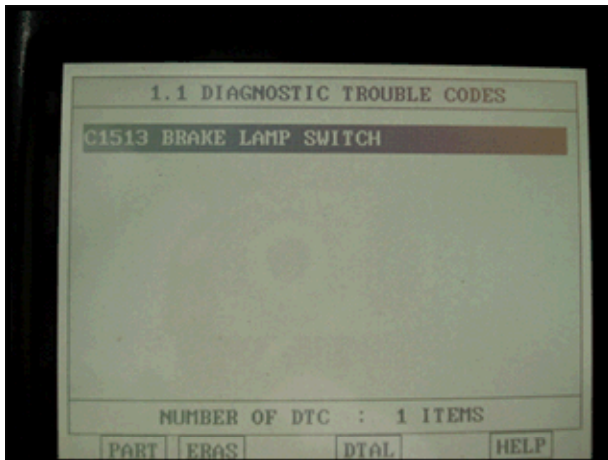
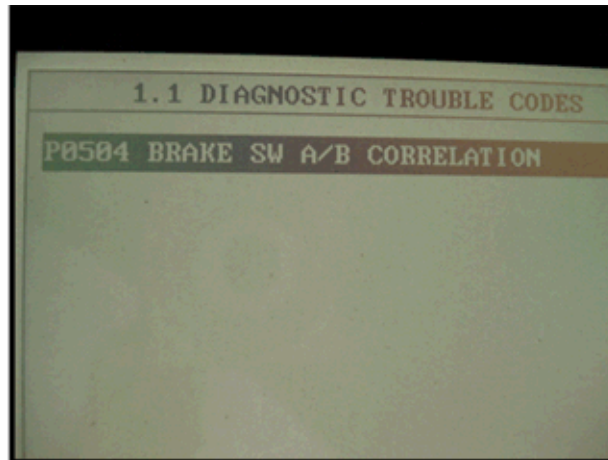
- Retrieved codes C1513 from ABS module and P0504 from PCM.

- Replaced brake switch and condition is no longer present.

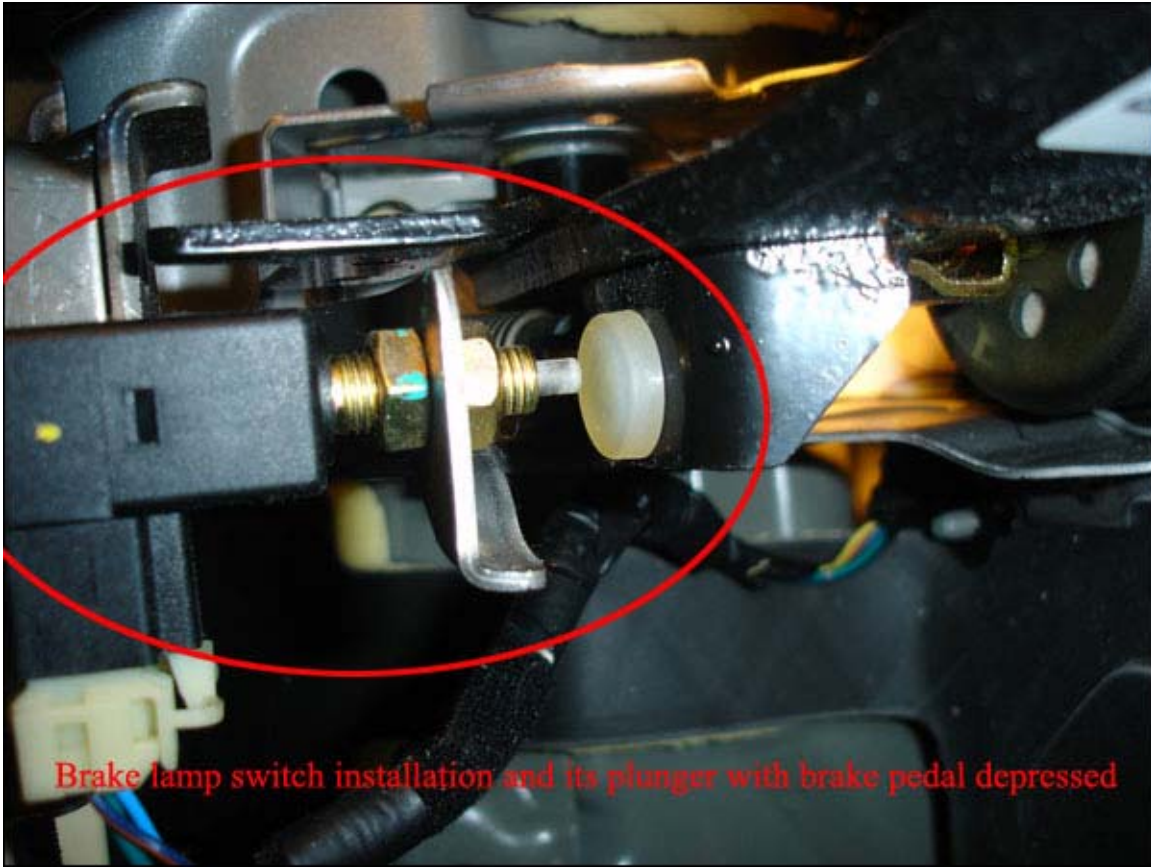
**Root Cause Analysis\*:**  
Brake lamp switch appears to be intermittently inoperative/poor contact.

Brake lamp switch installation and its plunger with brake pedal depressed

**Corrective Action\*:**  
Replaced brake lamp switch assembly.

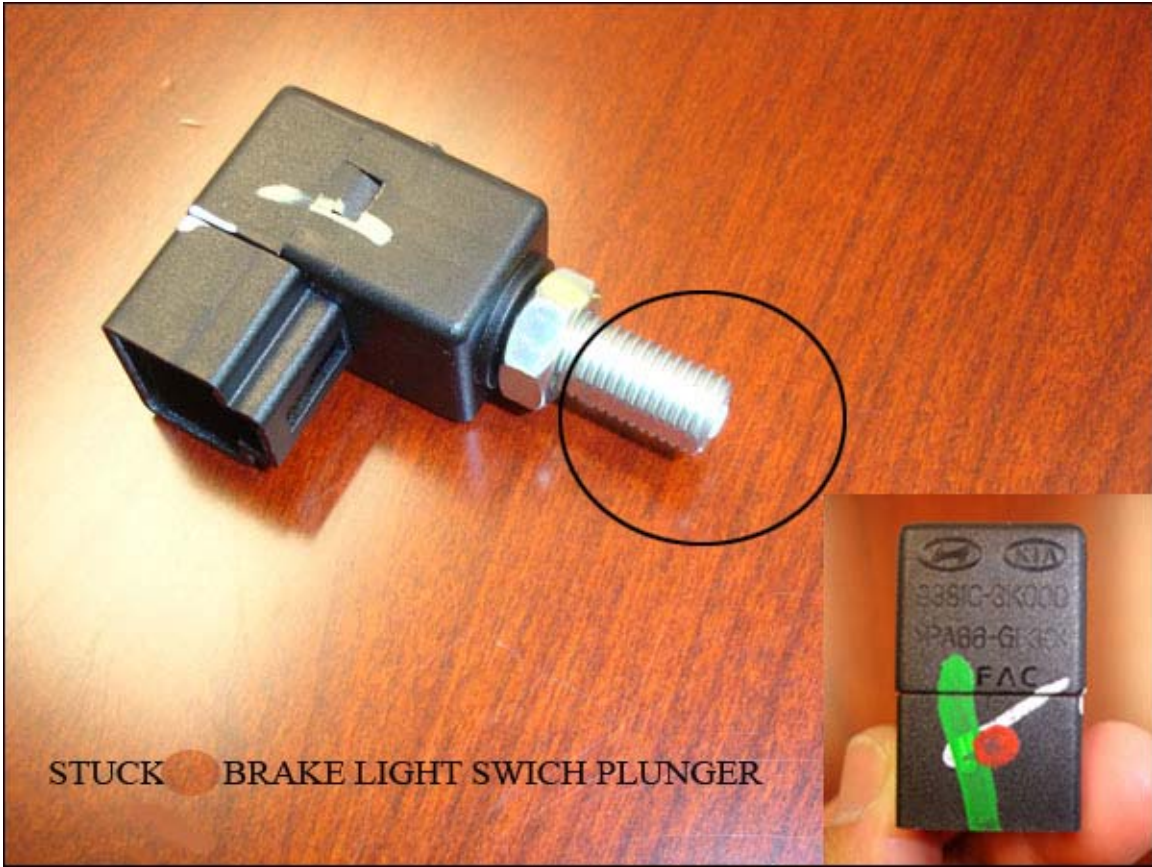
- ESC warning light is on and gear selector is difficult to shift during PDI.
- DTC C1513 - brake light switch error was found in the system and plunger was found to be intermittently stuck in its housing.

STUCK  BRAKE LIGHT SWITCH PLUNGER

- Replaced brake light switch.

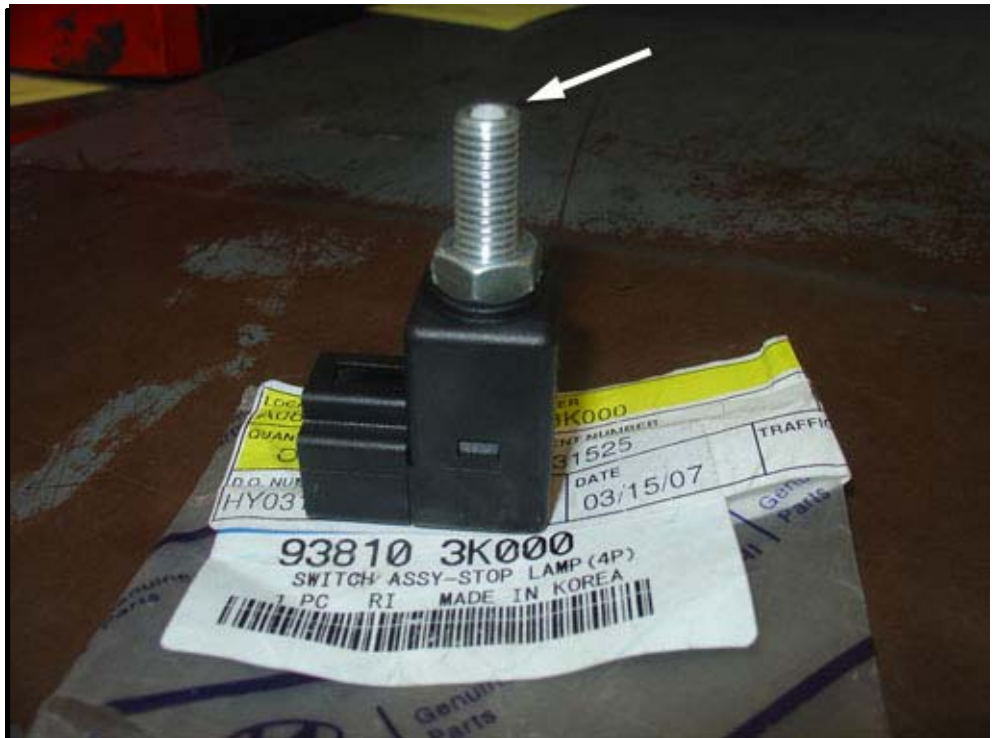
The picture to the right shows the incident stop light switch plunger stuck in the IN position. If the plunger does not extend when the brake pedal is pressed the brake lights do not light and the shifter shift lock does not release.

The plunger sticks in the switch bore.

Replaced stop light switch.

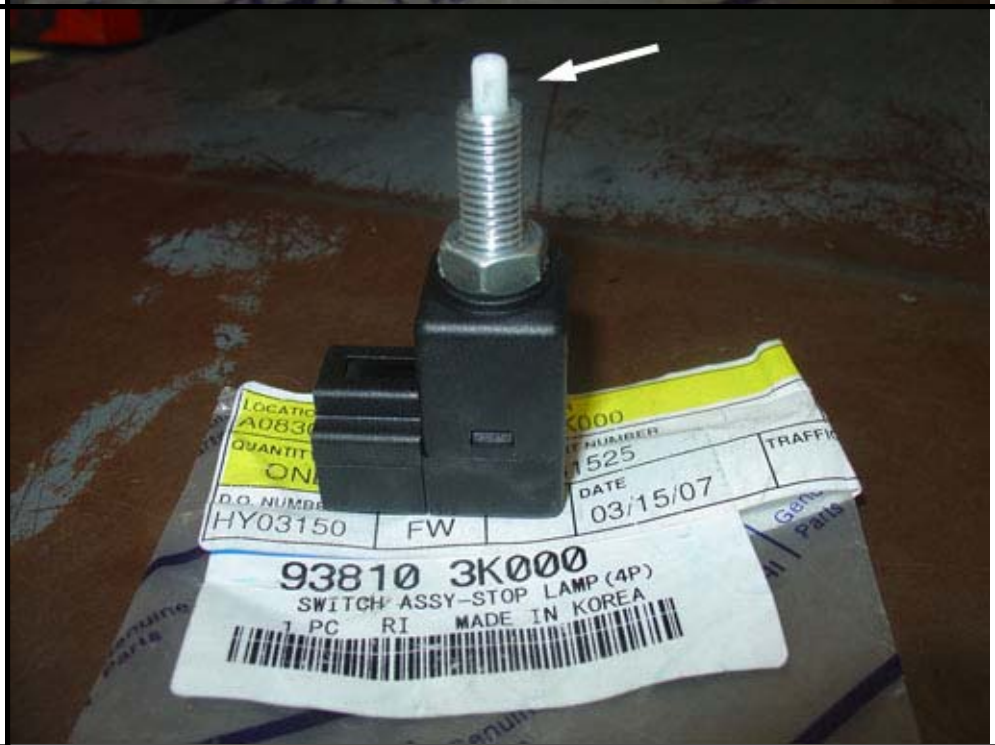
The picture to the right shows the incident stop light switch with the plunger extended.

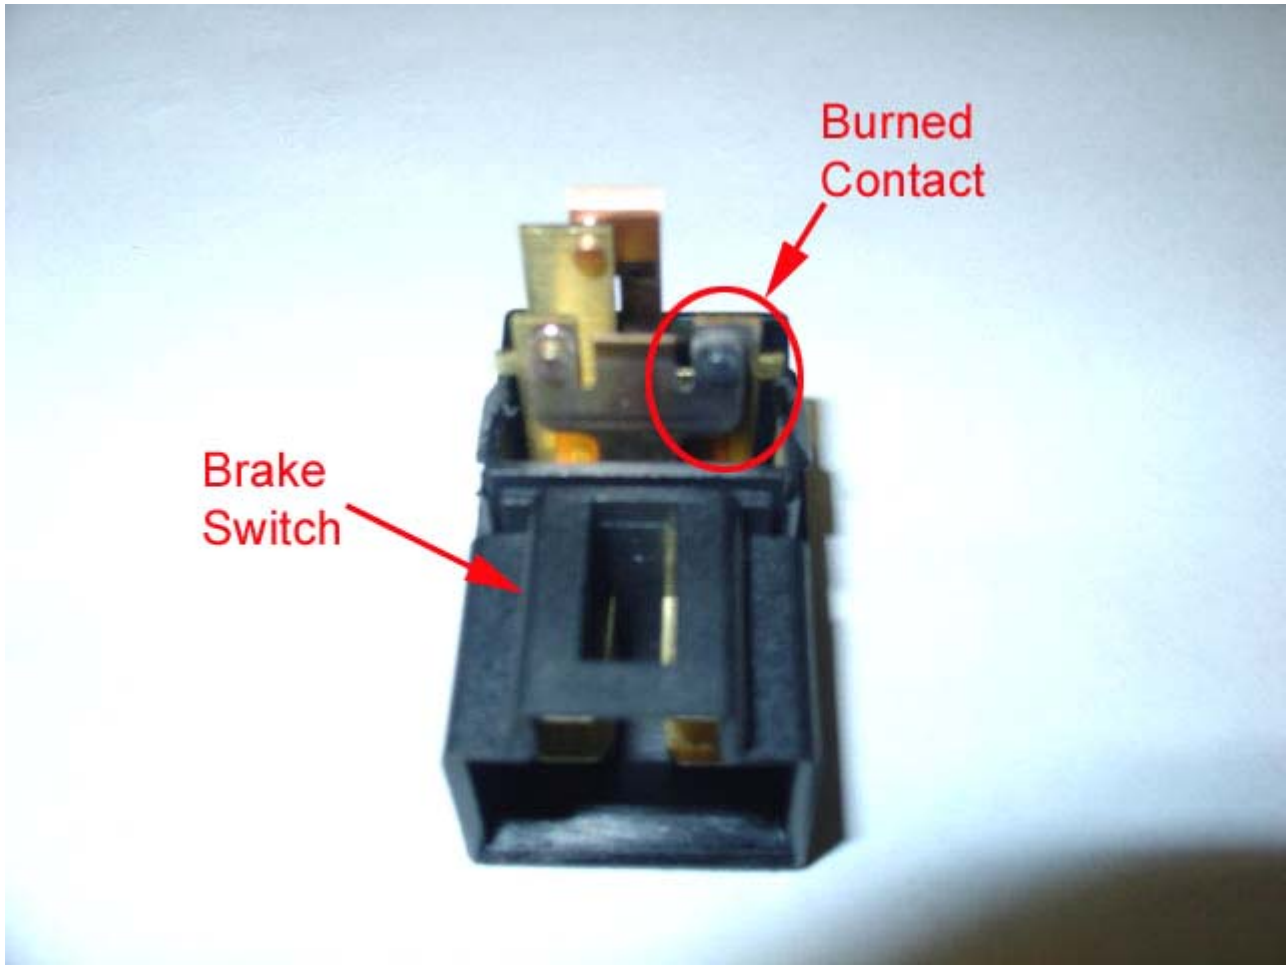
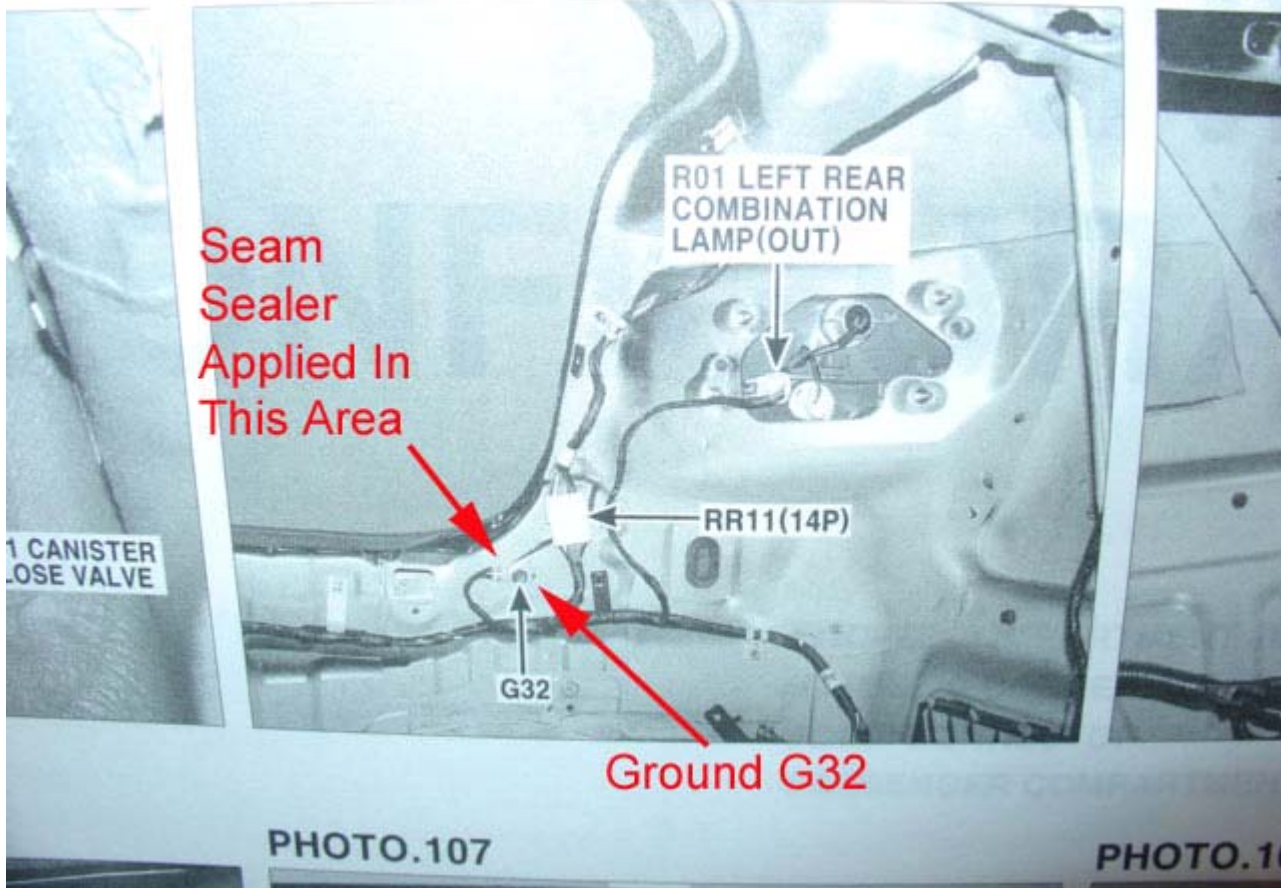
PHOTO.104

Technician found brake switch contact to be over heated and the brake lights not illuminating when he steps on the brakes.

Technician found seam sealer covering ground G32 as well as the ground bolt.

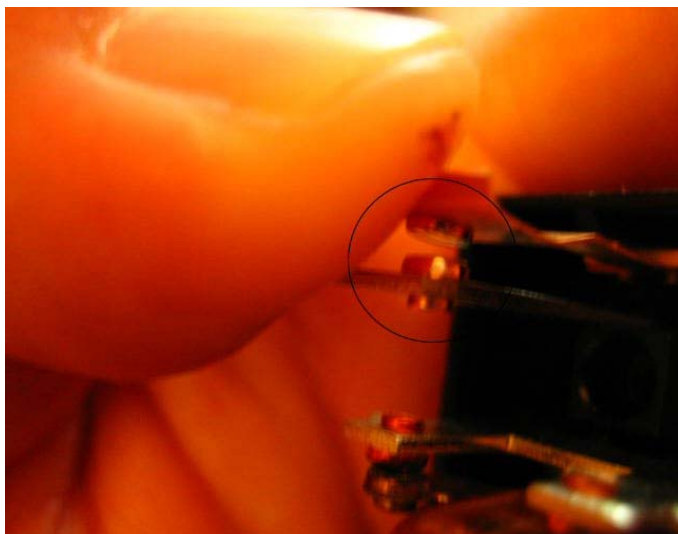
One side contact point is OK (no heat spots)

The other side of contact has heat spots

Replaced brake lamp switch

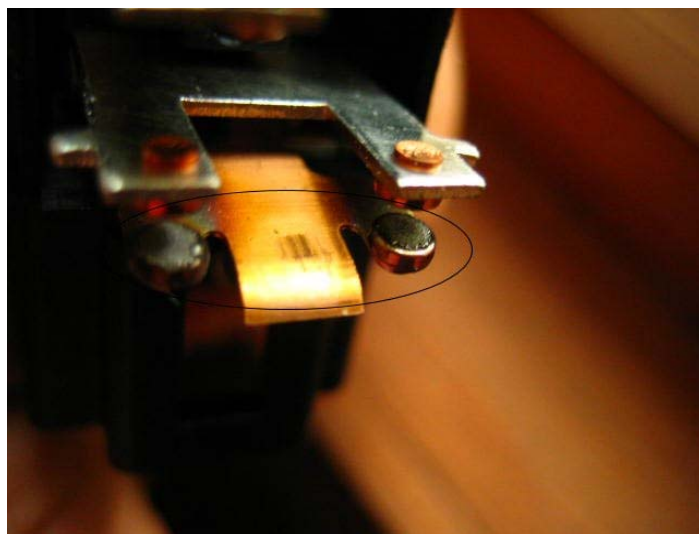
Code didn't set right away when clearing it - checked brake switch functions and works OK - Opened housing and found one side of bridge connection points have heat spots when the other side is OK - It is necessary to find out if this heat spot interfere with switch signal and how long it takes to set the code again.

Heat spot

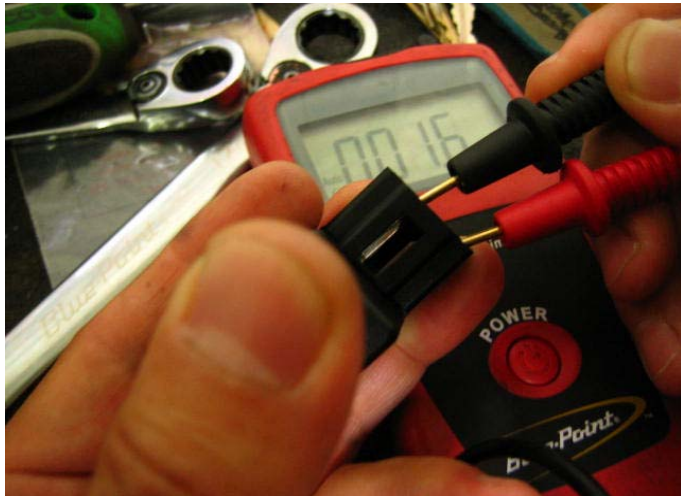
At this time pin 1, 2 (input to PCM) was OK

But RH side of prong 1, 2 has heat spots

Replaced brake lamp switch

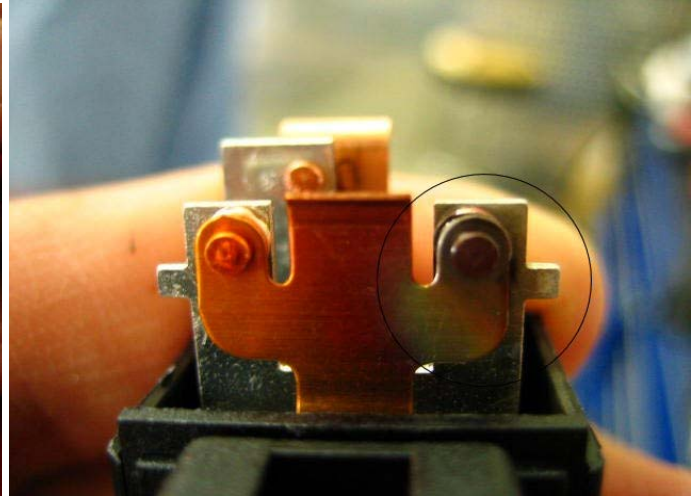
Found one of the prong (input to PCM) has heat spot - Heated prong surface intermittently doesn't allow secure connection - Customer says that ESC light was flashing (not staying on) and turned off by the time the vehicle arrived at dealer - But C1513 was set in ABS module

Prong 1, 2 heat spots

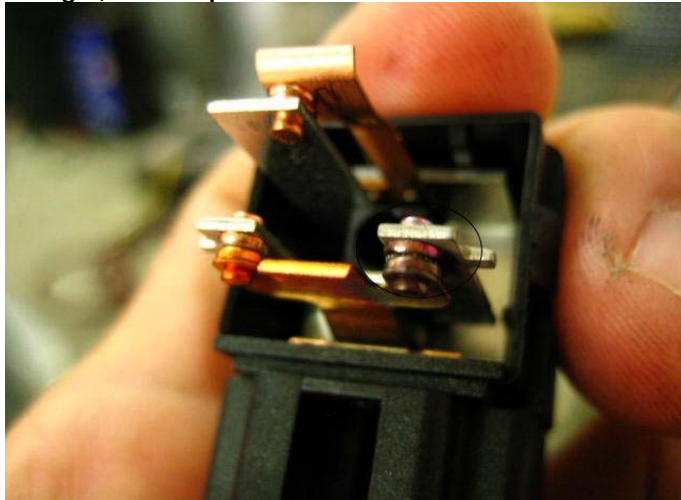
Heated prong surface

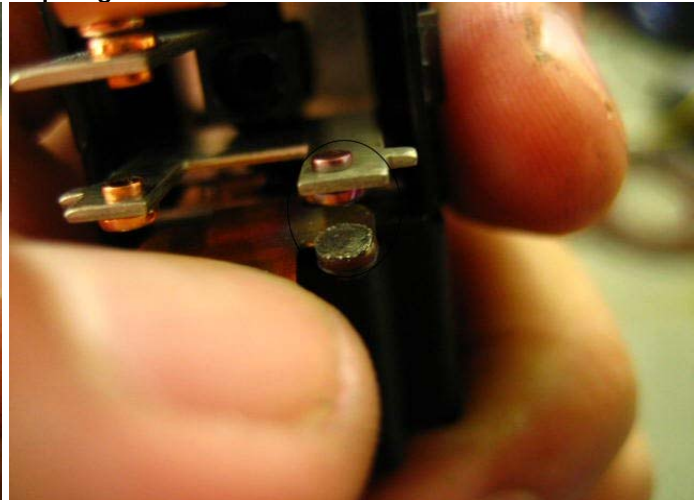
Heated surface doesn't allow secure contact

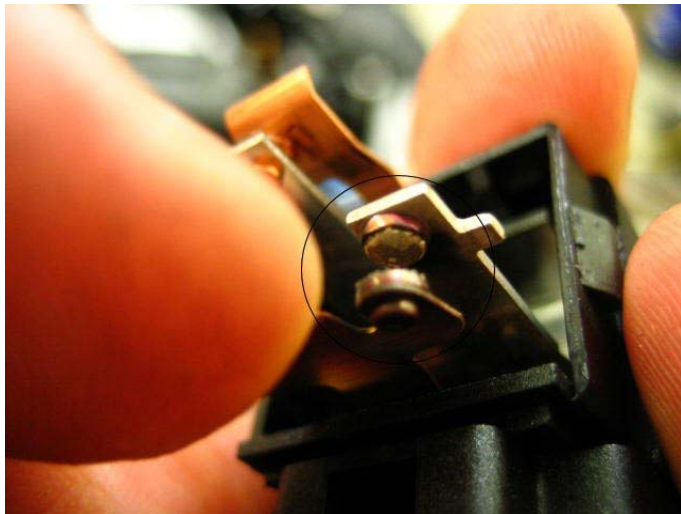
LH side prong still OK

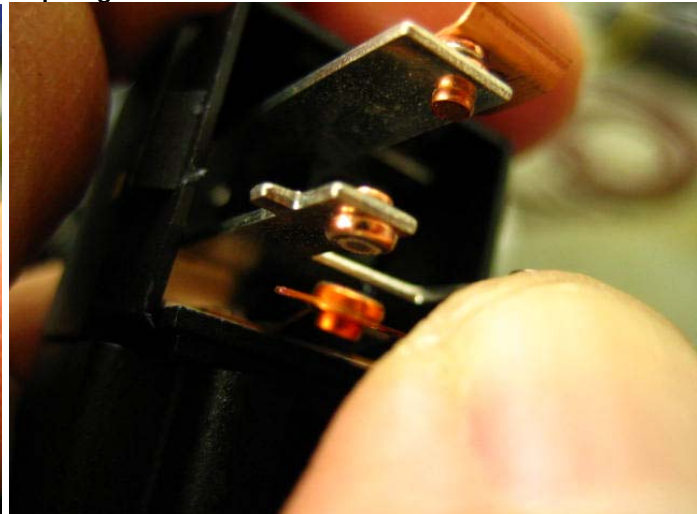
Prong 1, 2 got heated (input to PCM)

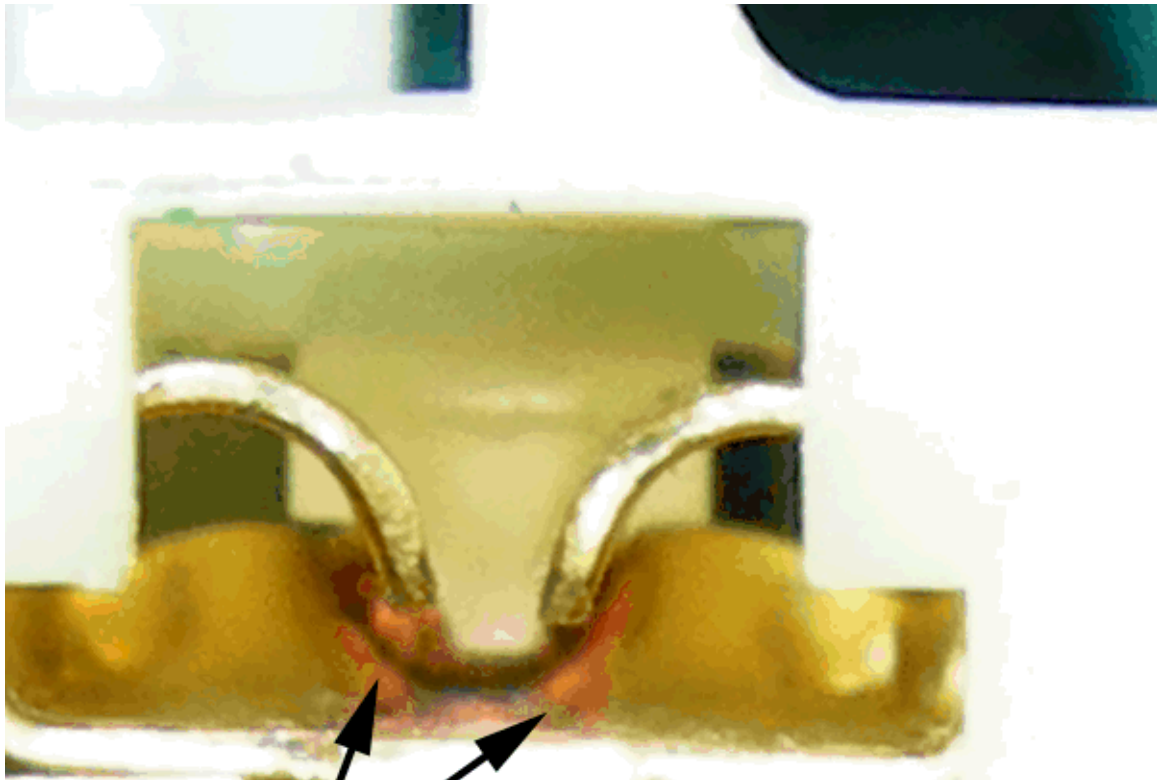
- Loose pins on brake light switch connector E62.
- FSE checked all other connector pin fit in the brake light circuit and found all others to be good.

**Burn marks on Brake light switch connector terminals.**

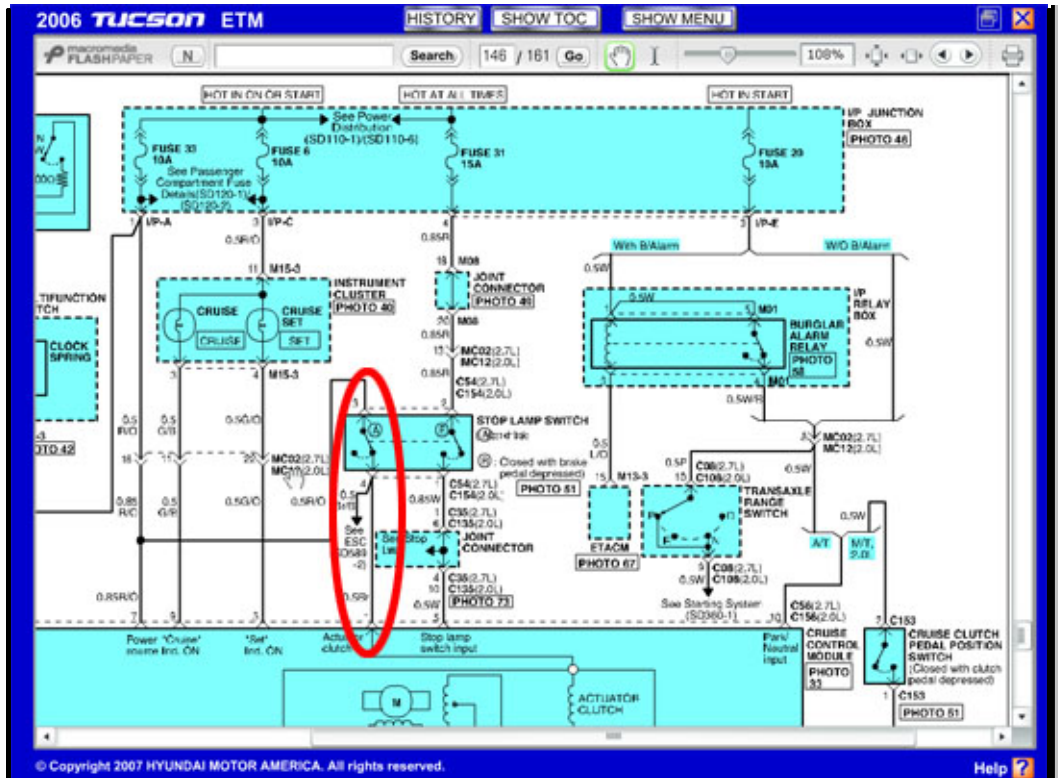
- The picture to the right shows brake switch interface with the cruise control module.
- With the brake pedal depressed 0 volts was observed at pin 1 of C56 cruise control module connector (connector connected or disconnected).
- After the brake pedal was depressed for greater than 30 minutes continuously and DTCs C1513 and C1237 set.
- Cruise control connector C56 was disconnected and a voltage measurement was taken at C56 pin 1 with the brake pedal still depressed. Battery voltage was observed.
- The voltage present at C56 pin 1 was generated from within the ESC control module and is the root cause of the DTCs.

- Replace brake light switch with post counter measure switch.

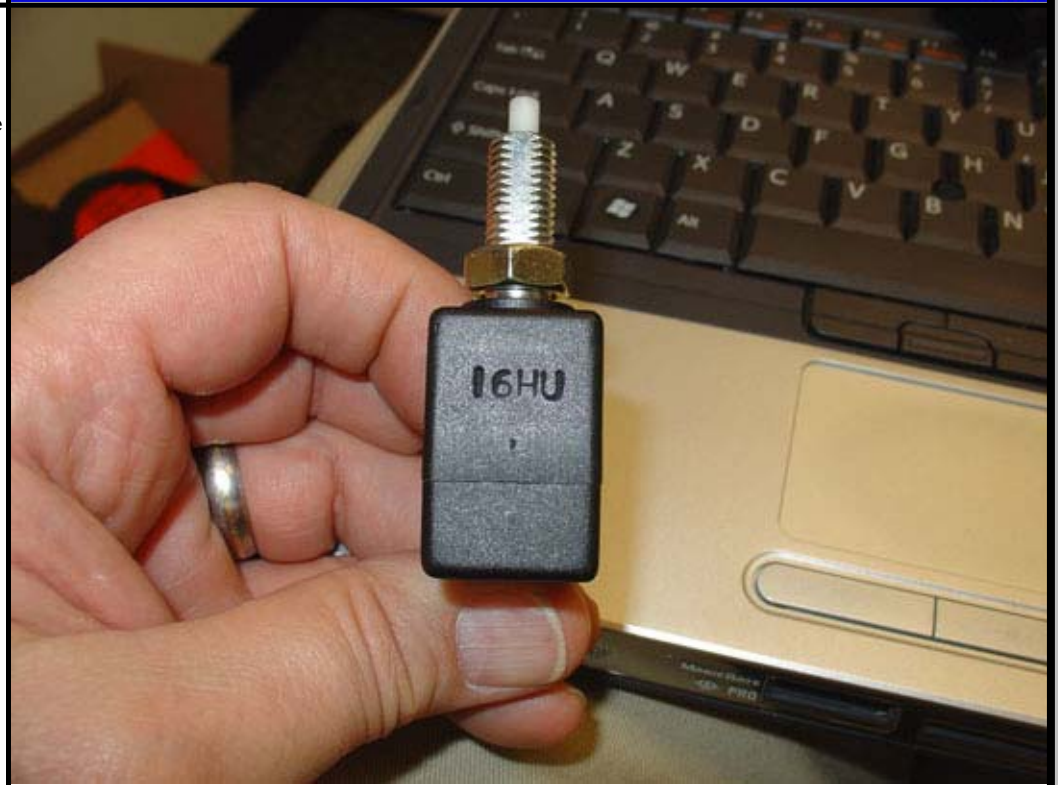
- The picture to the right shows the brake light switch from the incident vehicle.
- The date code stamped on the switch indicates a before counter measure switch.

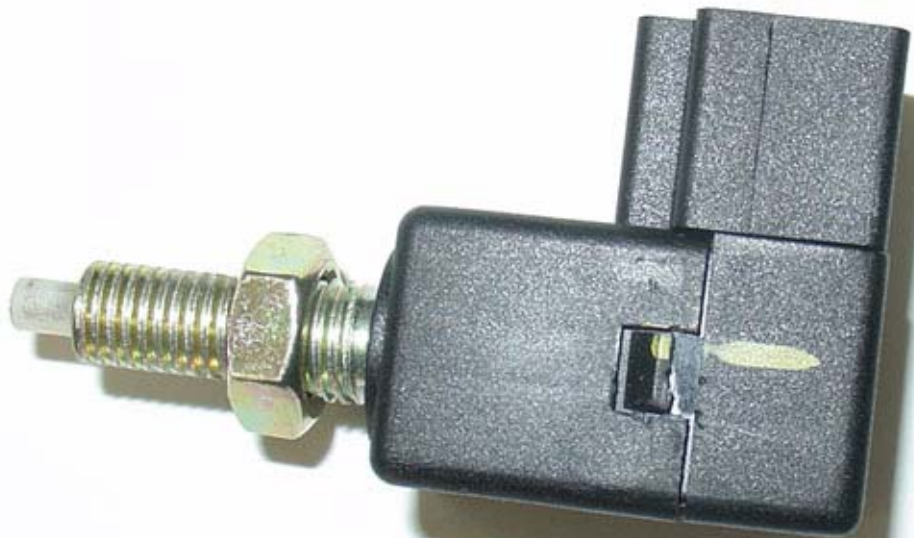
- Interrogated vehicle fault memory and observed diagnostic trouble code C1513 (Brake switch error) present. Brake lights worked normally.

- The picture to the right shows the incident vehicle brake light switch.

Replaced brake light switch and advised the customer not to hold the brake pedal for extended periods when the vehicle is parked with

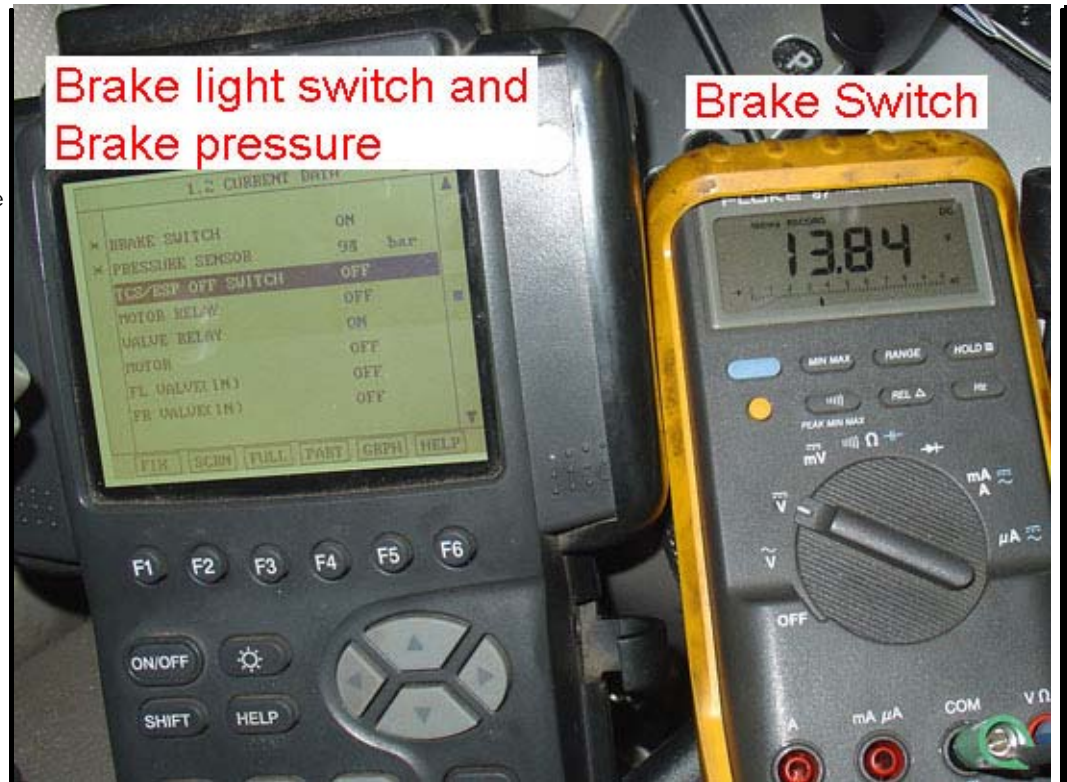
- The picture to the right shows the event that set C1513. The

brake light switch is on, the brake switch is on and the brake pressure is >20 bar.

- The brake lights were on during the event.

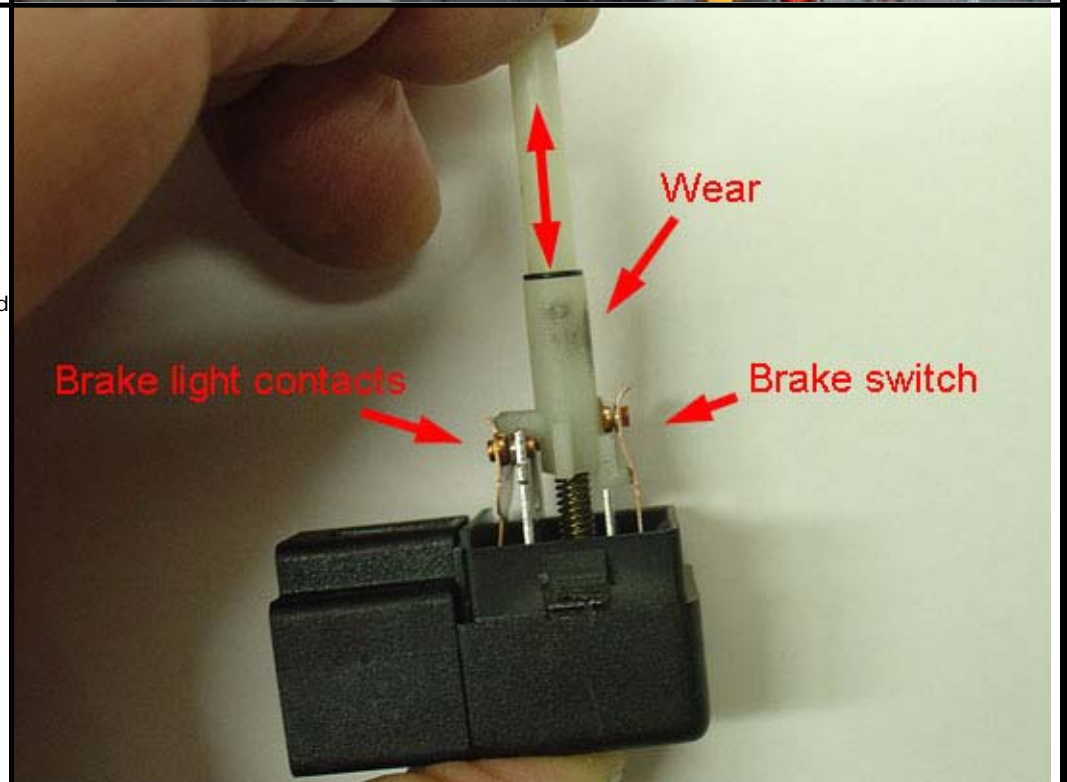
- The picture to the right shows the internal components of the brake light switch.
- After extended operation the "Brake Switch" contacts closed with, brake pressure present and the brake lights on, causing the DTC to set.

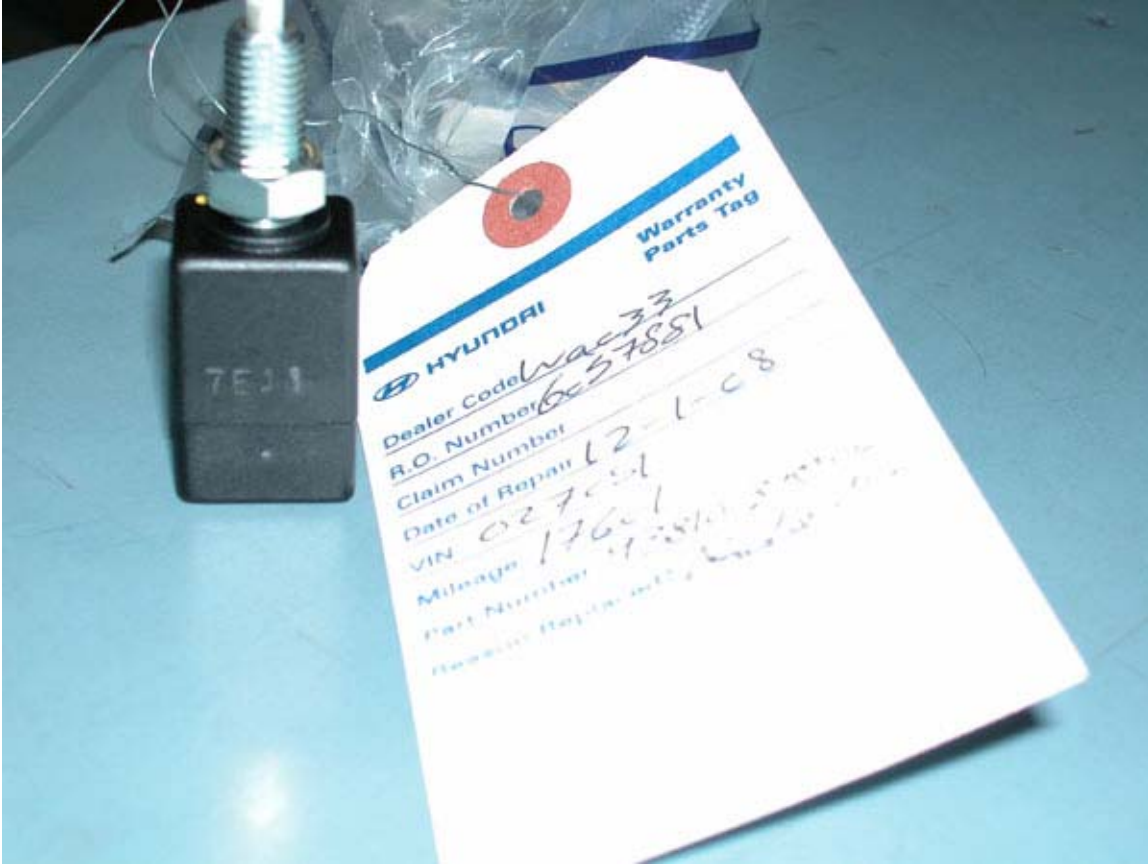
- Technician interrogated vehicle fault memory and observed diagnostic trouble code (DTC) P0504 (Brake Switch "A" / "B" Correlation) was present.
- The picture below shows the front side of the brake light switch.

- Replaced brake light switch.
- Incident part forwarded to VDS engineer RC.

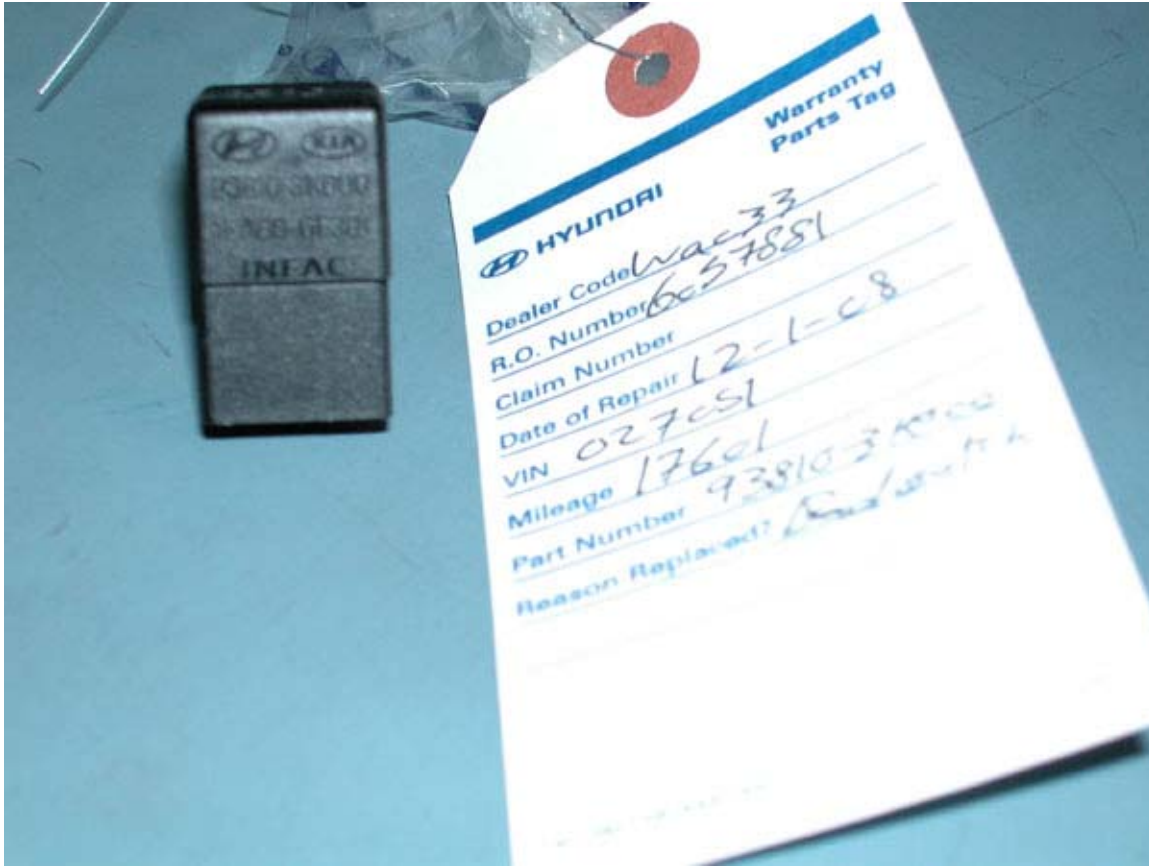
- The picture below shows the back side of the brake light switch.

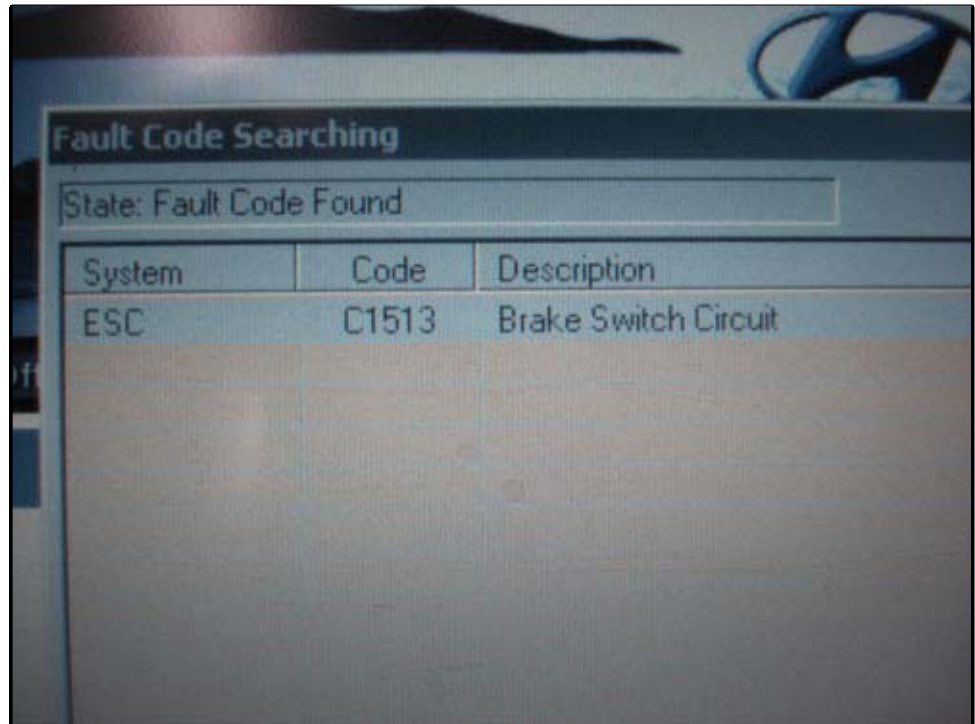
- Code stored in ESC module C1513

Replace brake light switch assembly

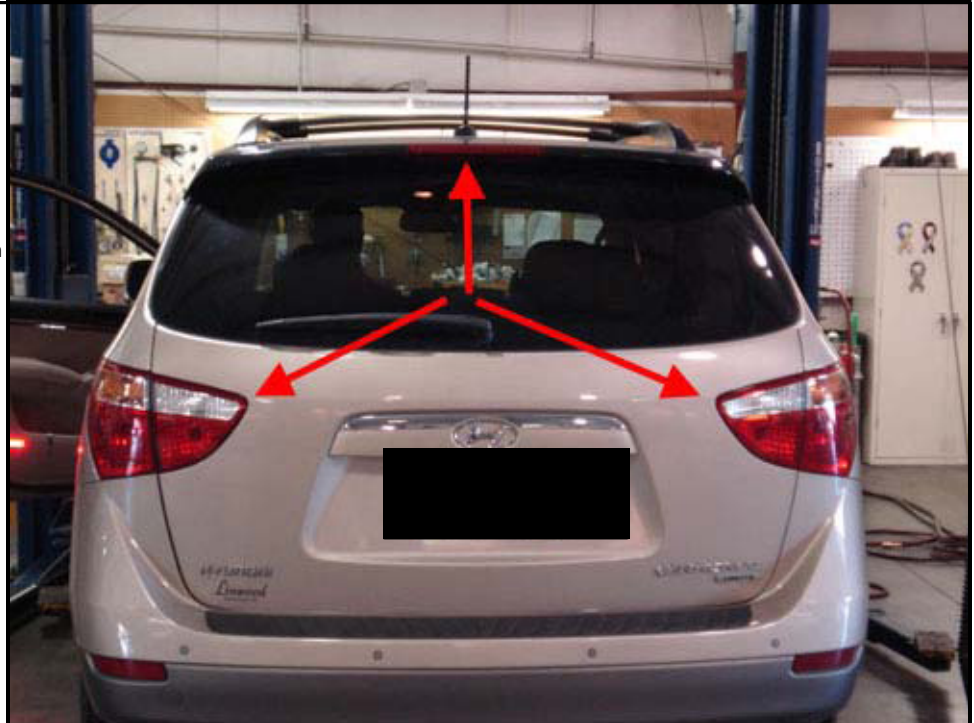
- Brake lights are not coming on

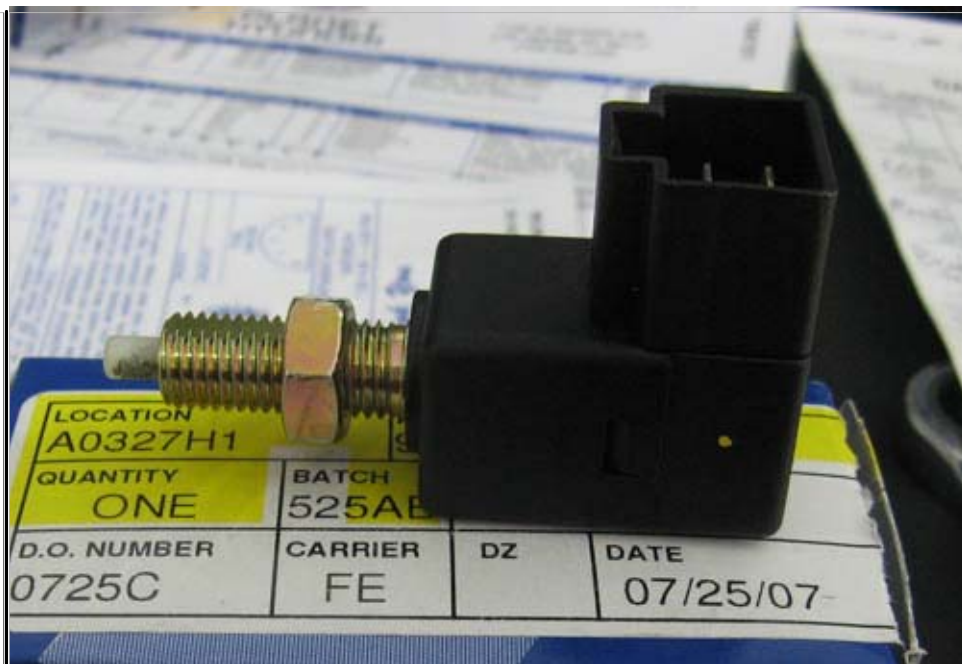
BRAKE SWITCH, CUSTOMER CLAIMED THE BRAKE LIGHTS STAYED ON AT TIMES AND DISCHARGED THE BATTERY. THIS MAY HAVE CONTRIBUTED TO THE BATTERY REPLACEMENT.

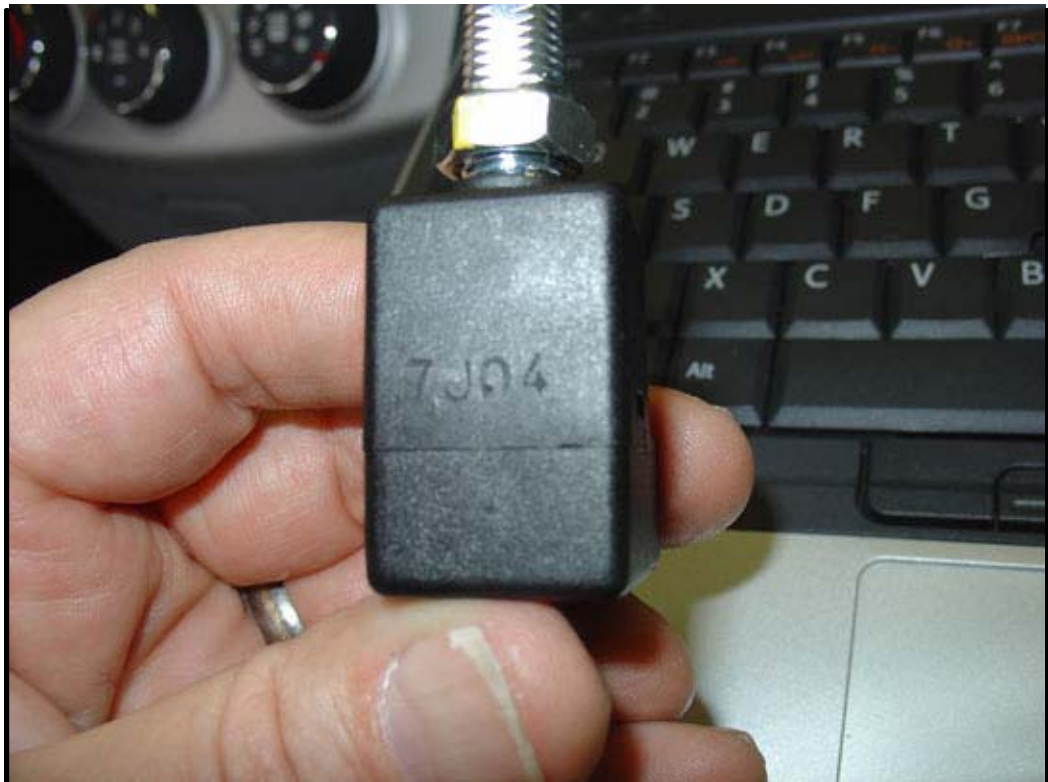
- Interrogated vehicle fault memory and observed diagnostic trouble code (DTC) C1513 (Brake Switch Error) present in the antilock brake (ABS) system.

- The picture to the right shows the incident brake light switch.

Replace brake light switch.

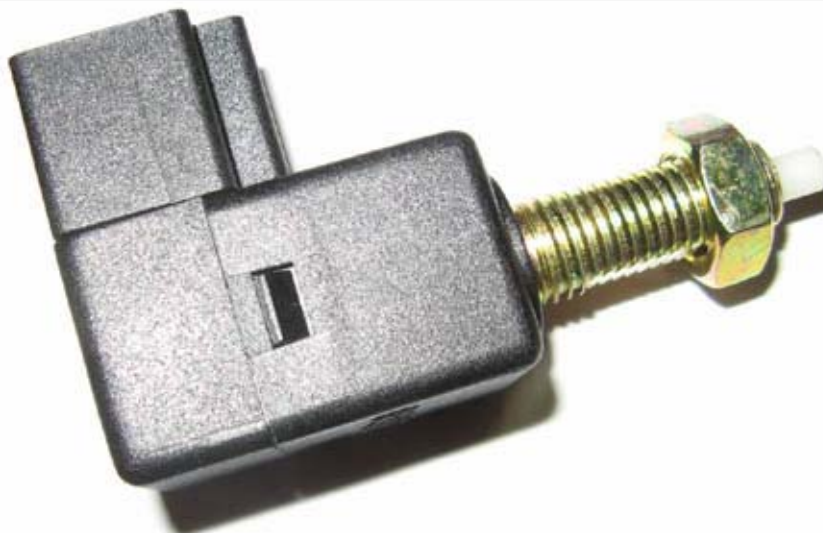
BRAKE SWITCH DATA SHOWS OFF,  
WHEN BRAKE PEDAL IS PRESSED.
