PE09-024

HONDA

ATTACHMENT Q8

QUALITY IMPROVEMENT SHEET (Q.I.S.)

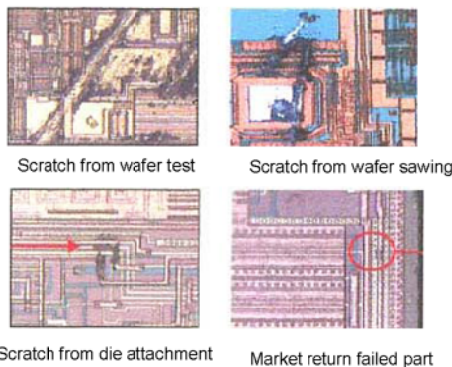
Scratch recreation test was carried out with equipments, and found that both the size and configuration differed from that of the market return parts (See photos on right.)

Scratch from wafer test

Scratch from wafer sawing

Scratch from die attachment

Market return failed part

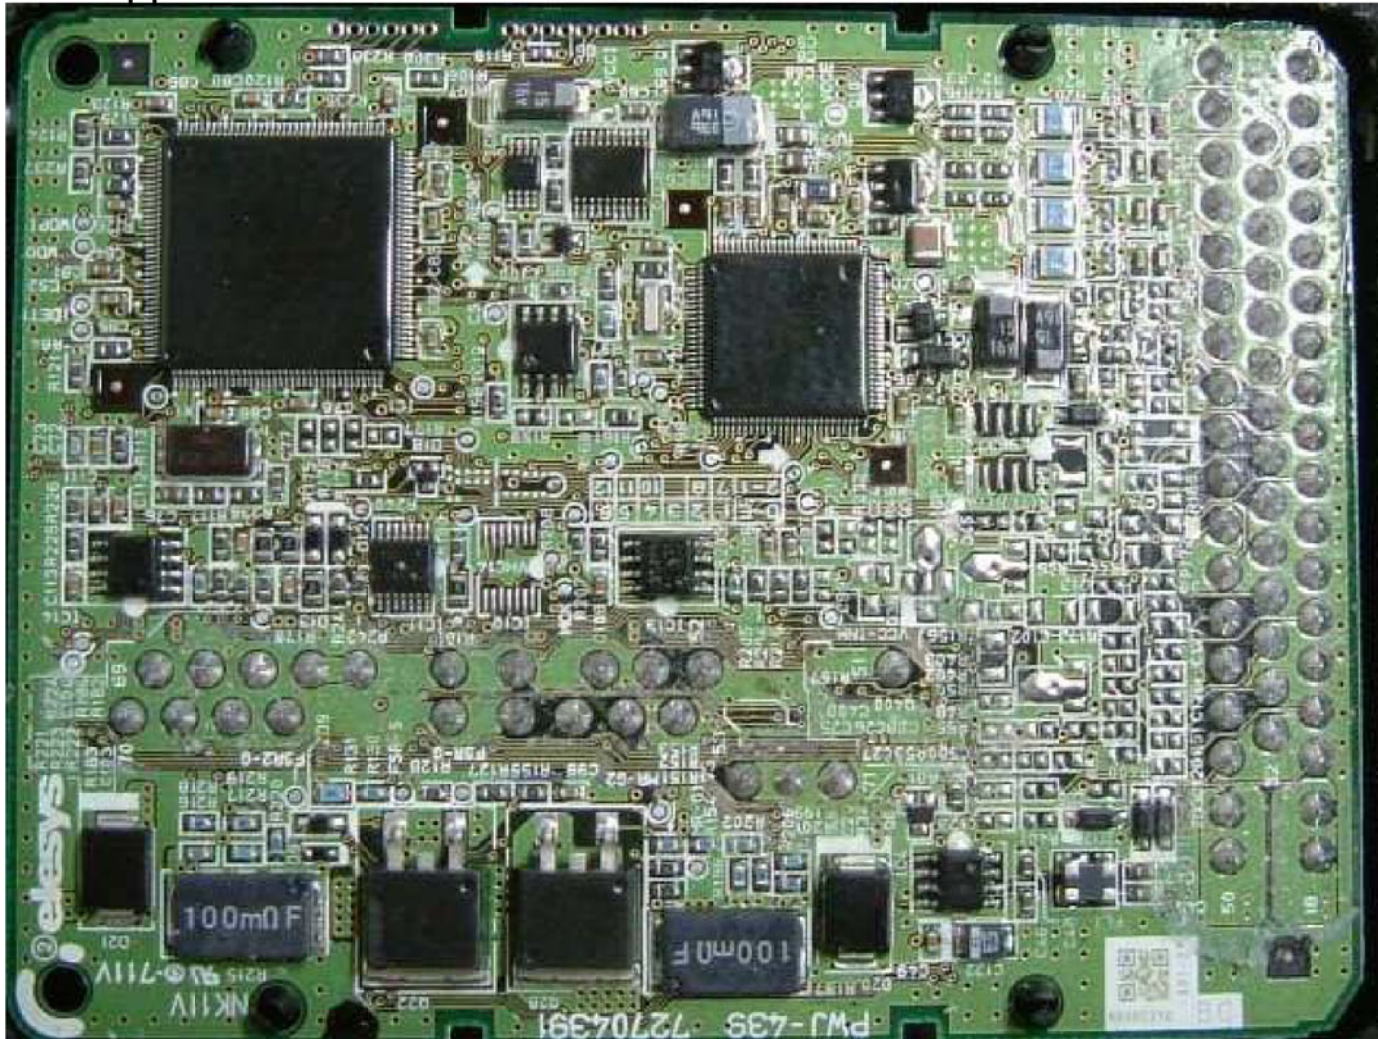
Separate sheet 2

Board's outer appearance confirmation result

- Board's outer appearance has no abnormality such as contaminant adhesion, disconnection of pattern.
- Soldering condition of terminals has no abnormality.
