**Document ID: 1870206**

## **#06-02-32-014: Power Steering Fluid Leak (Replace Hose and Clamps or Pipe/Hose Assembly) - (Nov 1, 2006)**

# #06072: Customer Satisfaction - Power Steering Hose Leak - (Oct 17, 2006)

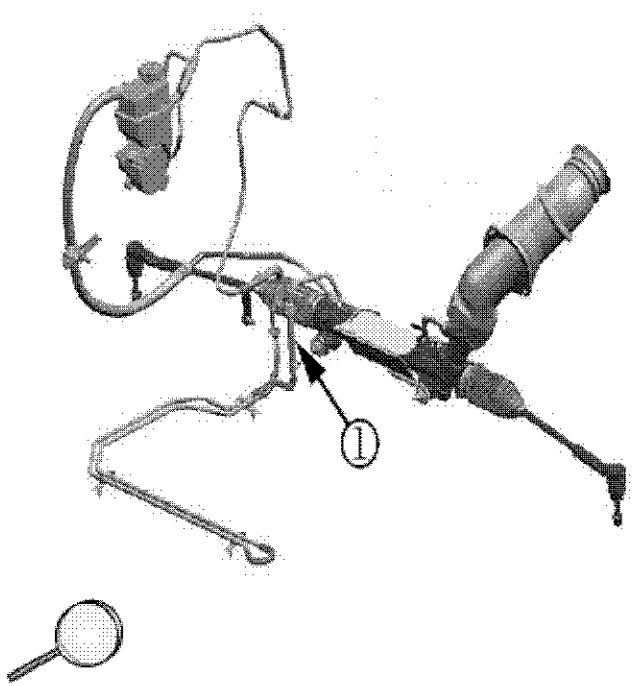
Some customers may comment on a fluid leak. Upon investigation, the technician may find that the power steering cooler pipe/hose assembly is either split or leaking around the clamps. The leak generally occurs during cold start conditions.

The cause of this leak may be due to the higher pressures generated in cold temperatures. These pressures may exceed the strength of the hose or clamps.

The hose section (1) where the leak can occur is shown above. On V6 applications, the hose fittings are constant tension clamps, therefore, the hose and clamps can be replaced. Use the procedure listed below.

1. Raise and support the vehicle.
2. Place a drain pan under the vehicle.
3. Remove the hose clamps.
4. Remove the section of hose from the power steering cooler pipe/hose assembly.
5. Slide the new clamps onto the new section of hose.
6. Install the new section of hose with clamps to the power steering cooler pipe/hose assembly.
7. Position the new clamps and tighten until the torque caps break off.
8. Clean any fluid residue from under the vehicle.
9. Lower the vehicle.
10. Check the power steering fluid level and bleed the system. Refer to Power Steering System Bleeding in SI.

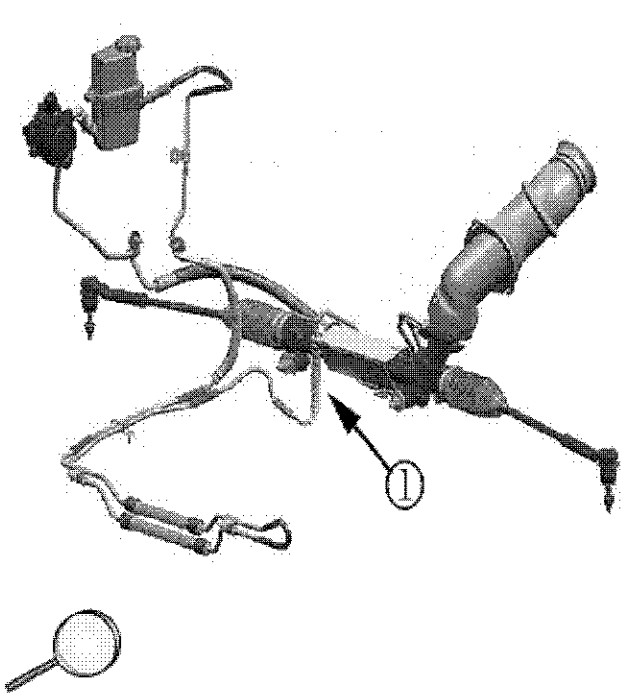
The hose section (1) where the leak can occur is shown above. On V8 applications, the fittings are crimped, therefore, the power steering cooler pipe/hose assembly must be replaced. Use the procedure listed below.

1. Raise and support the vehicle.
2. Place a drain pan under the vehicle.
3. Remove the power steering cooler pipe/hose from the retaining clips on the frame.

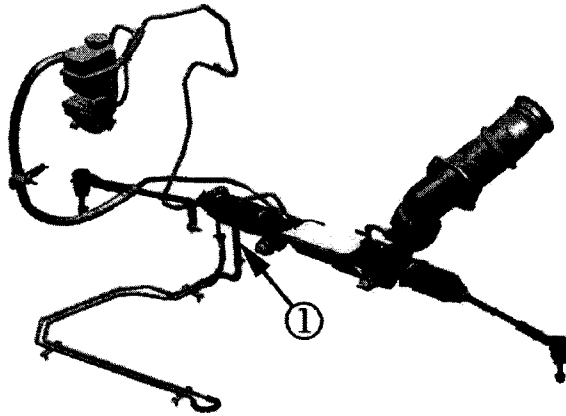
1854948

Customers in Canada, Alaska, Maine, Minnesota, Montana, New Hampshire, North Dakota, South Dakota, Vermont, Wisconsin, and Wyoming have reported an unusual number of power steering fluid leaks involving the power steering fluid return line in certain 2006 Chevrolet Impala and Monte Carlo vehicles equipped with a V6 or V8 engine, and 2005-2006 Pontiac Grand Prix vehicles equipped with a V8 engine. When these vehicles are started at temperatures of -20°C (-4°F) or below, the pressure on the hose is substantially higher than in warmer conditions and may exceed the strength of the power steering hose or clamps. If this were to occur, the driver would likely notice fluid spotting under the vehicle when the vehicle is parked and a decrease in power steering assist. If enough fluid is lost, damage to the power steering pump could occur.

**Important:** The location of the leak (1) is shown above. The power steering cooler hose may leak from the hose clamp.

1. Raise and support the vehicle. Refer to the *Lifting and Jacking the Vehicle* procedure in SI.
2. Place a drain pan under the repair area.
3. Remove the power steering hose clamps.
4. Remove the power steering hose from the vehicle.
5. Slide the new clamps onto the new power steering hose.
6. Install the new power steering hose.
7. Position the power steering hose clamps.

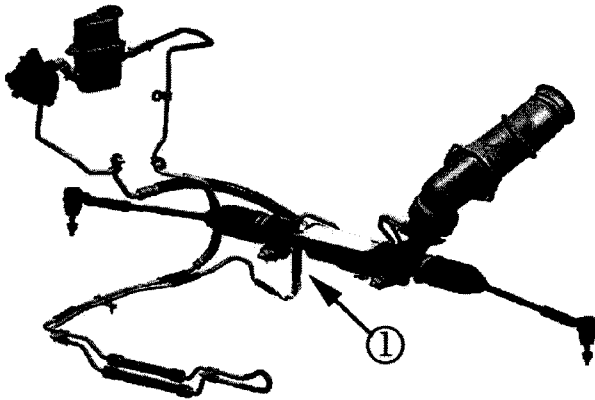
1854947

**Important:** The location of the leak (1) is shown above. Fittings on the hose are crimped socket and are not likely to leak.

1. Raise and support the vehicle. Refer to the *Lifting and Jacking the Vehicle* procedure in SI.
2. Place a drain pan under the vehicle.
3. Remove the power steering cooler pipe/hose from the retaining clips on the frame.
