Statistical Engineering Summary Report

Chevy Impala Power Steering Cooling Line Hose Rupture

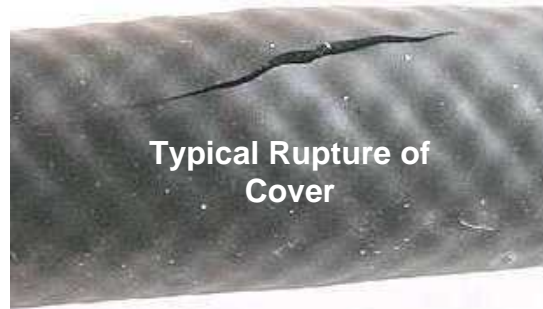
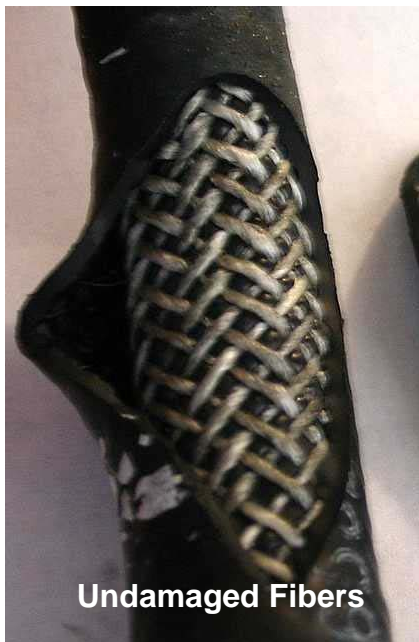
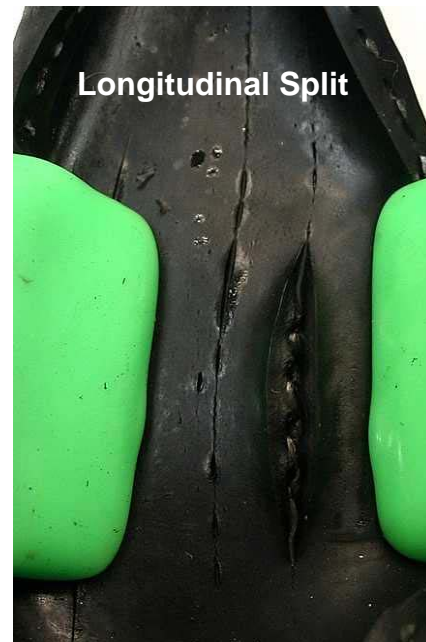
Characteristics of Failure

A hose in the power steering return line is rupturing in service causing warranty claims for loss of power steering assist. This is only happening in northern climates in the winter on 2006 V6 Chevy Impala.

Initially followed a Region to Region Same Hose Strategy to understand why the hose was failing in some areas and not others. Features on the interior surface of the inner tube, caused by the flexible mandrel used in the extrusion process, create a straight path along the length of the tube that a longitudinal split was using to propagate along. This mark is present in all hoses produced in the process and is not specific to just failing hoses. Currently utilizing a vehicle to vehicle strategy same model because of the concentration of failures in northern climates in winter.
