SERVICE BULLETIN 00-030

Safety Recall: Passport Rear Suspension

SERVICE BULLETIN 00-036

Product Update: 2000 Passport Rear Suspension

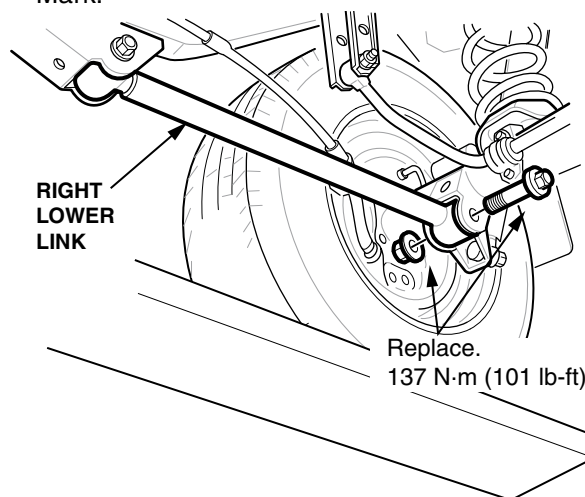
Excessive paint thickness on certain rear suspension components may cause the lower link bolts and nuts to loosen and make noise. Over time, the nut and bolt could fall out, allowing the lower link to separate from the axle.

1. Park the vehicle on level ground. If you need more room underneath, park the vehicle on a wheel alignment rack. Do not raise the vehicle on a hoist, the full weight of the vehicle must be sitting on the suspension during this procedure.
2. Replace the nut and bolt mounting the right lower link to the rear axle. Torque the new nut to 137 N-m (101 lb-ft). Mark the nut and bolt with the Brite-Mark.

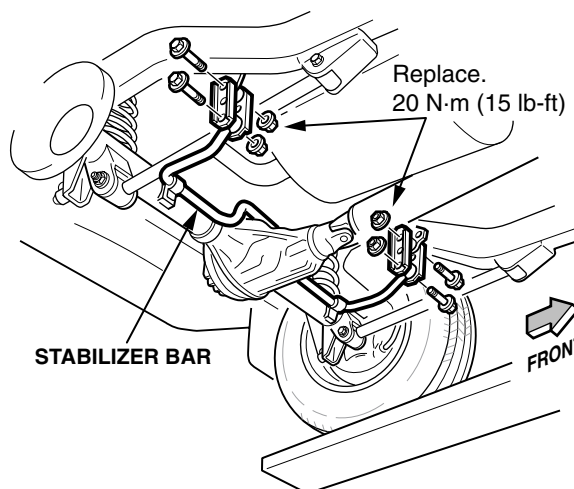
Additionally, the rear stabilizer shackles, lateral link, and rear damper mounting nuts and bolts could loosen, causing abnormal noise.

3. Repeat step 2 on the left side.
4. Replace the four nuts and bolts connecting the ends of the stabilizer bar to the frame. Torque the nuts to 20 N-m (15 lb-ft). Mark the nuts and bolts with Brite-Mark.

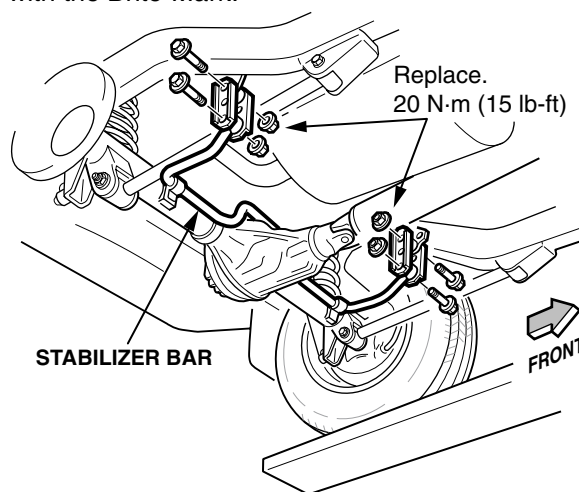
Excessive paint thickness on certain rear suspension components may cause certain nuts and bolts to loosen. This would cause an abnormal noise.

1. Park the vehicle on level ground. If you need more room underneath, park the vehicle on a wheel alignment rack. Do not raise the vehicle on a hoist, the full weight of the vehicle must be sitting on the suspension during this procedure.
2. Replace the four nuts and bolts connecting the ends of the stabilizer bar to the frame. Torque the nuts to 20 N-m (15 lb-ft). Mark the nuts and bolts with the Brite-Mark.
