From: Jimmy Lee [JimmyL@DDCC.COM]
Sent: Friday, October 03, 2003 11:19 AM
To: Placha, Diana (D.B.)
Cc: David Faeth; Iarsumi@exedy-us.com; Jeff Cline; KusamizuK; Sean Kawamura; Koji Akita; Mike Berry
Subject: MPI investigation 1991

Re: Ford P/N: E6SP-7F466-AA, Insert-Trans. Converter Cover (MPI P/N: W1818)
Response to QR 925305.

Re: C11578386 G8D#35881 4F50N Differential Failure in Vehicle Durability

Re: C11565485 G8D#34605 4F50N Pump Drive Plate Failure

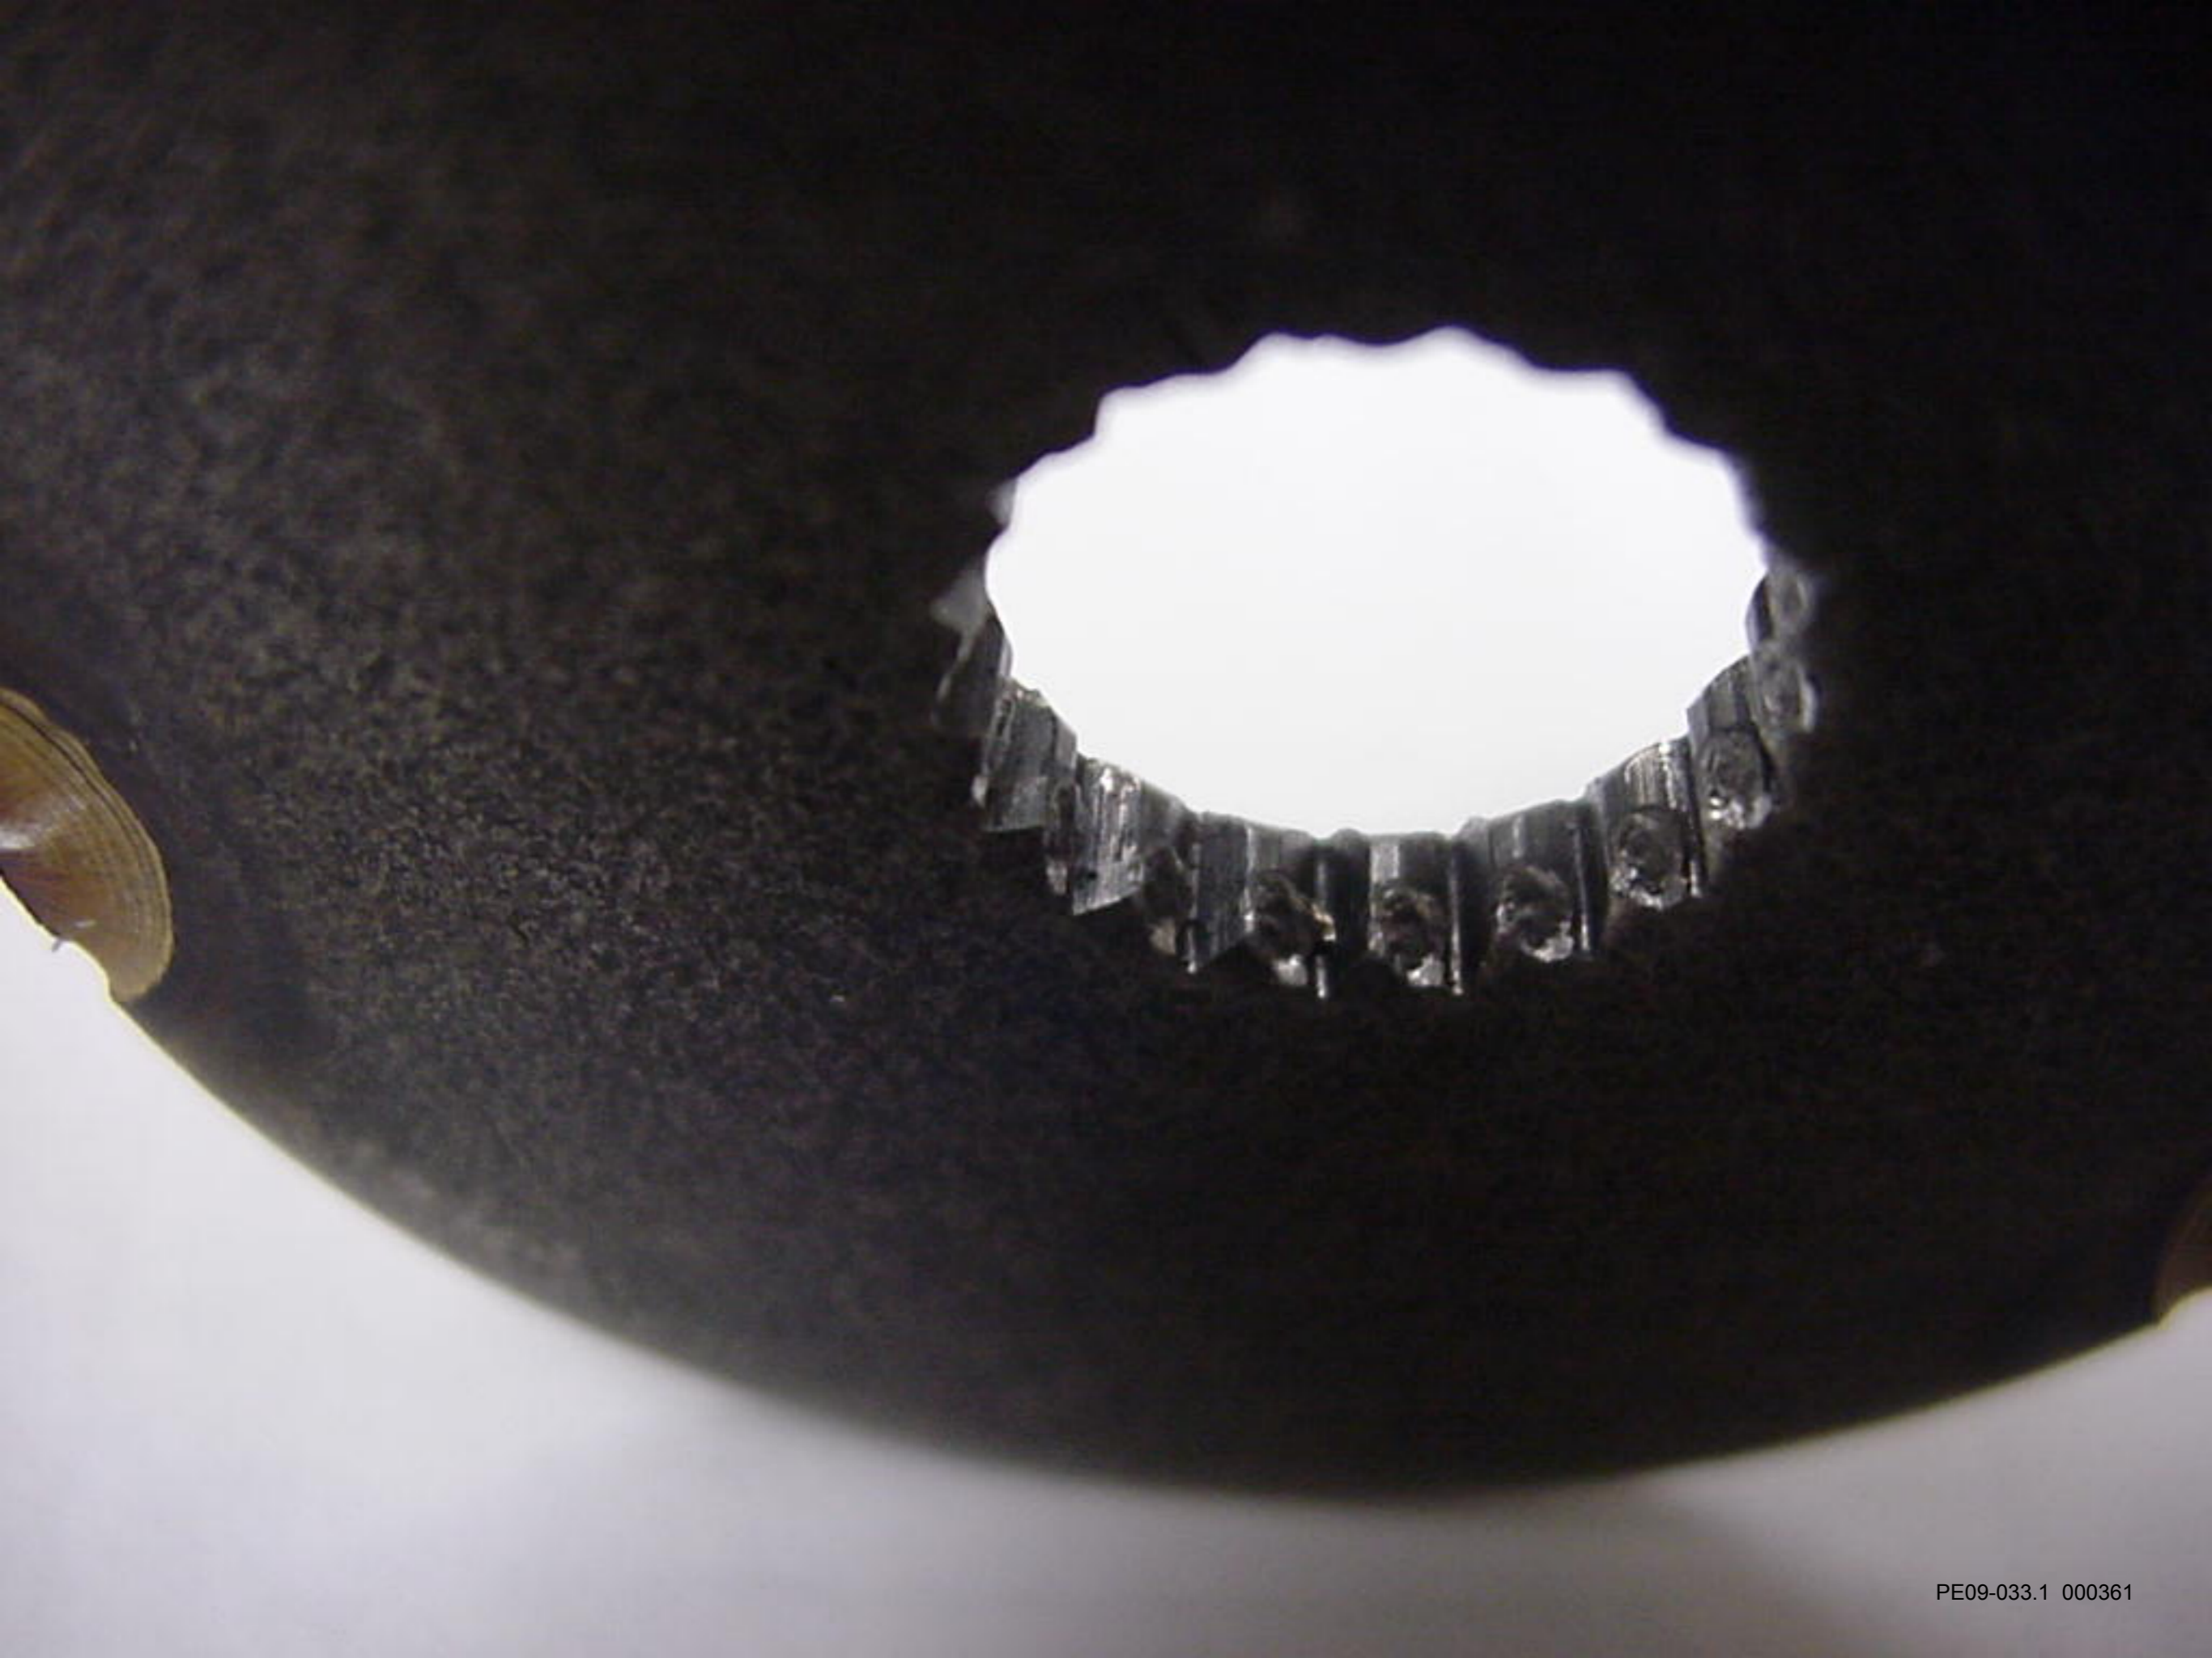
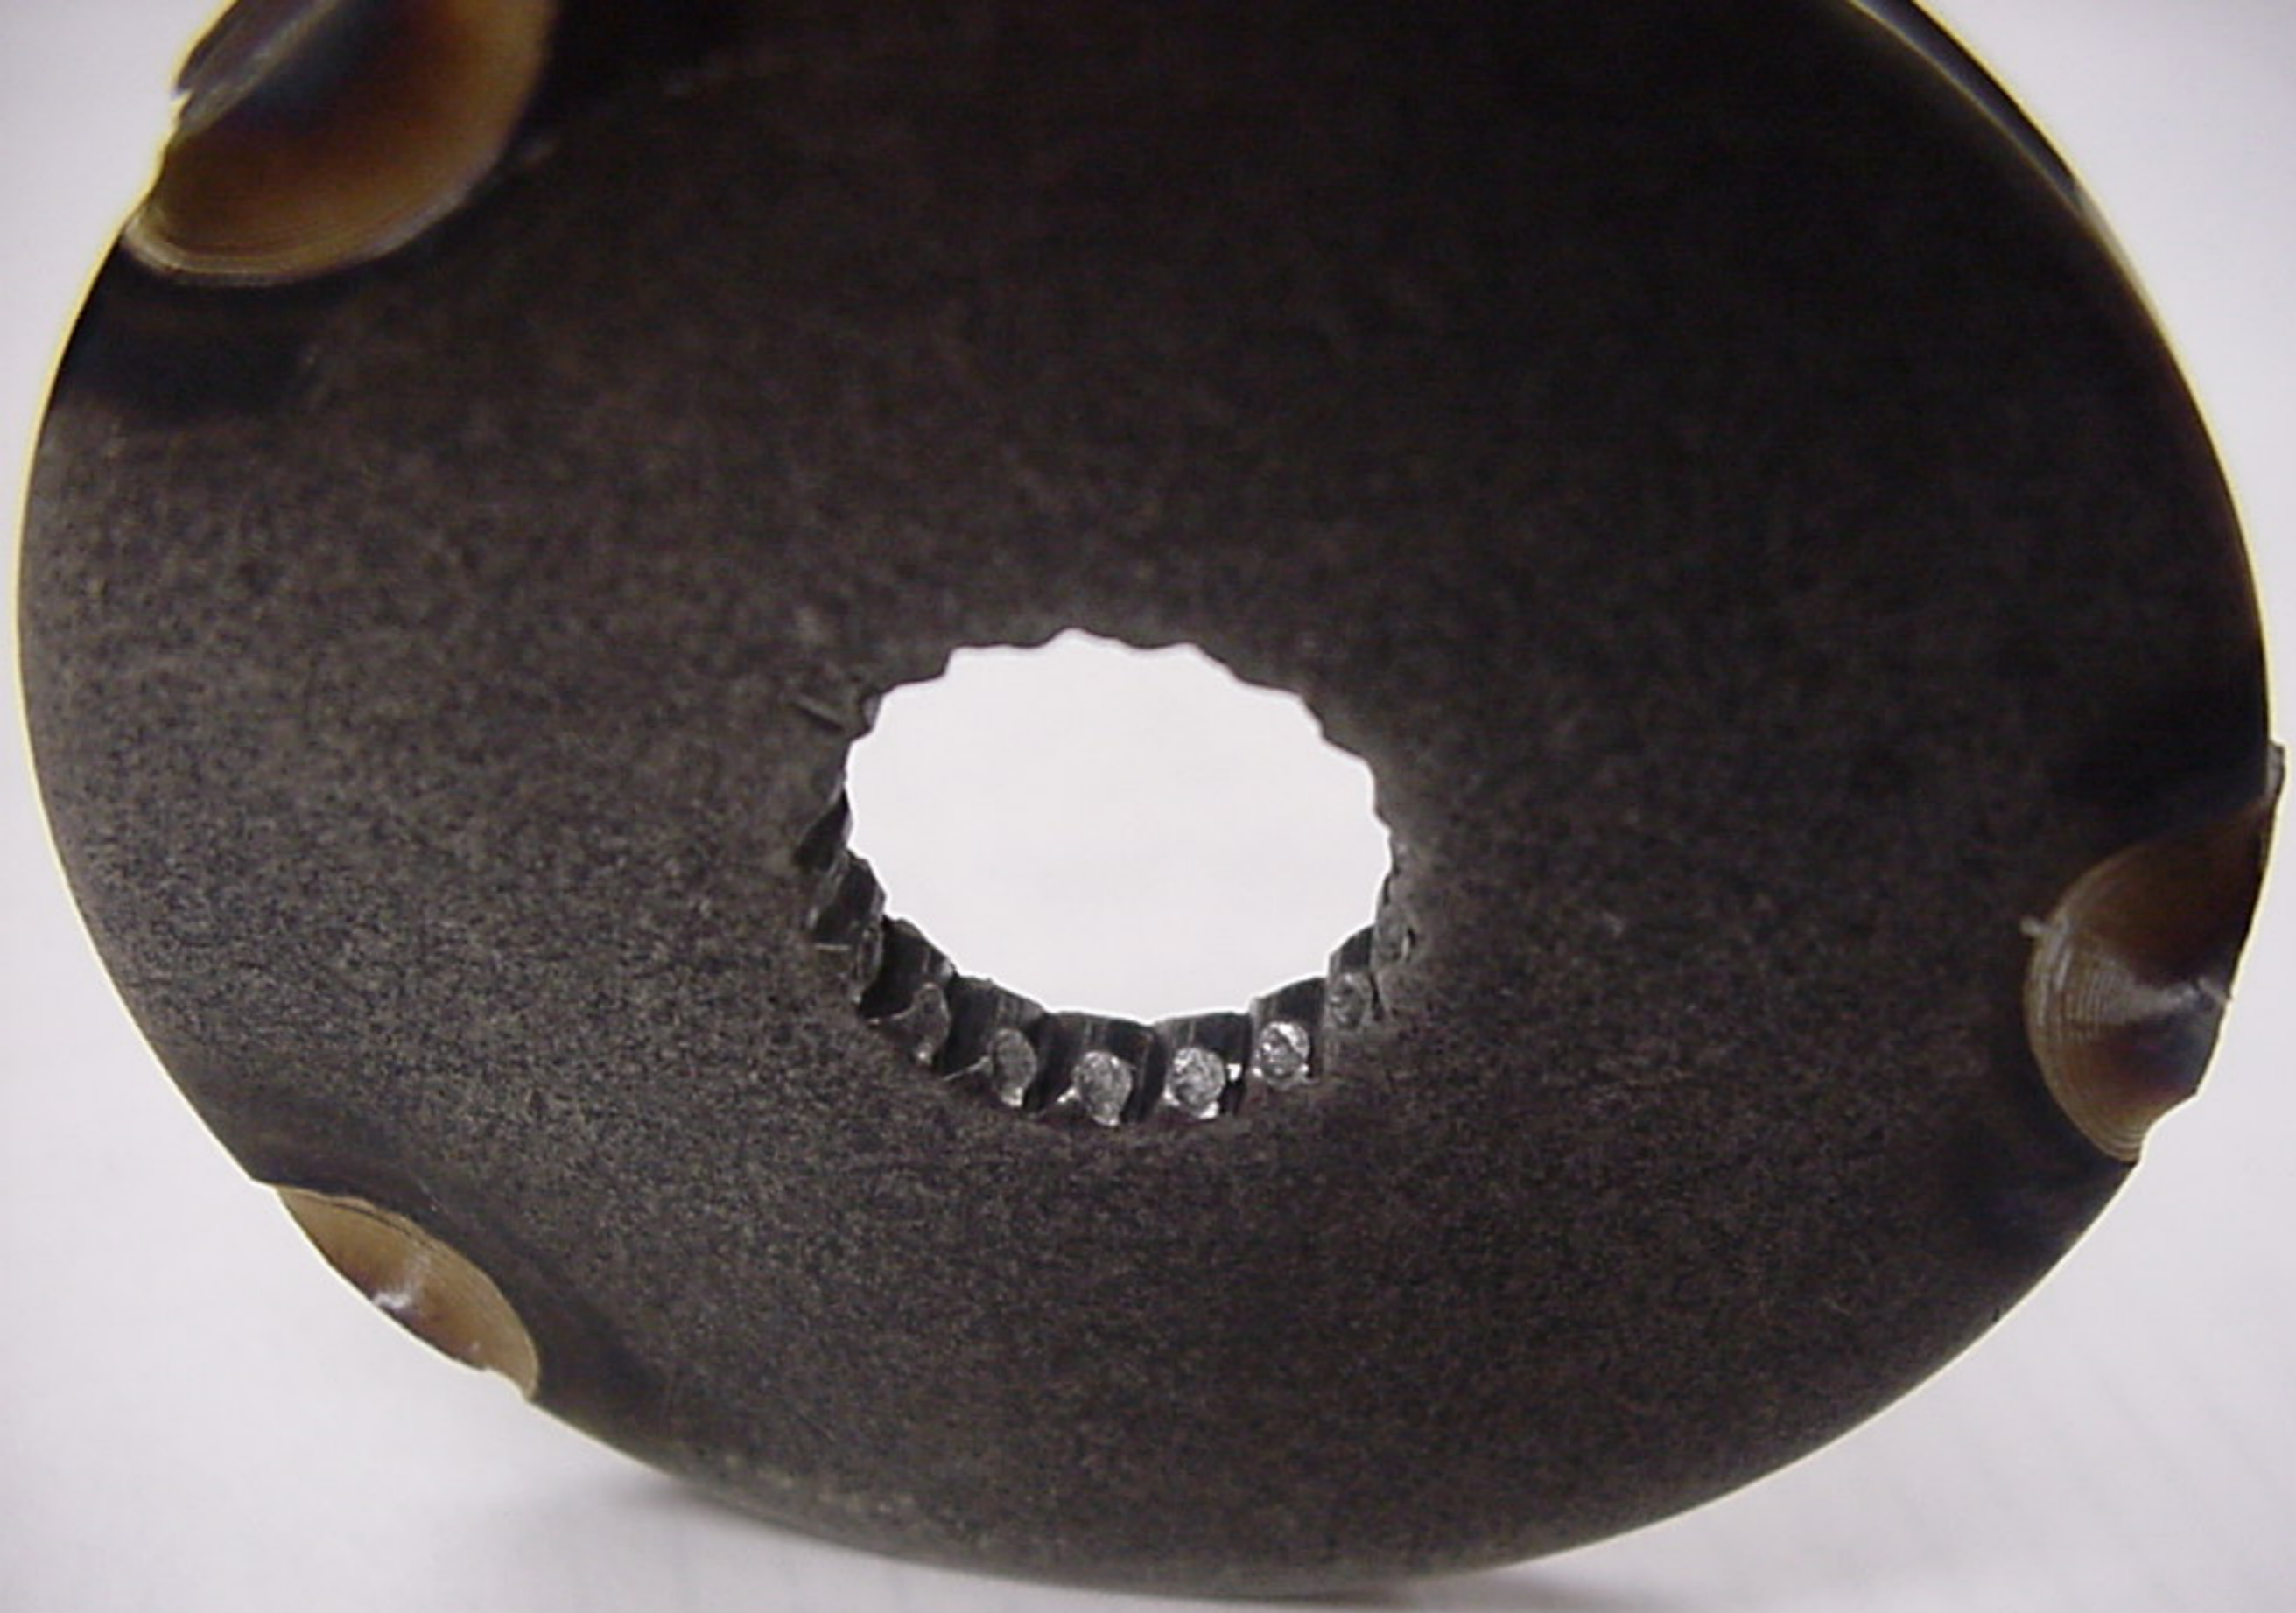
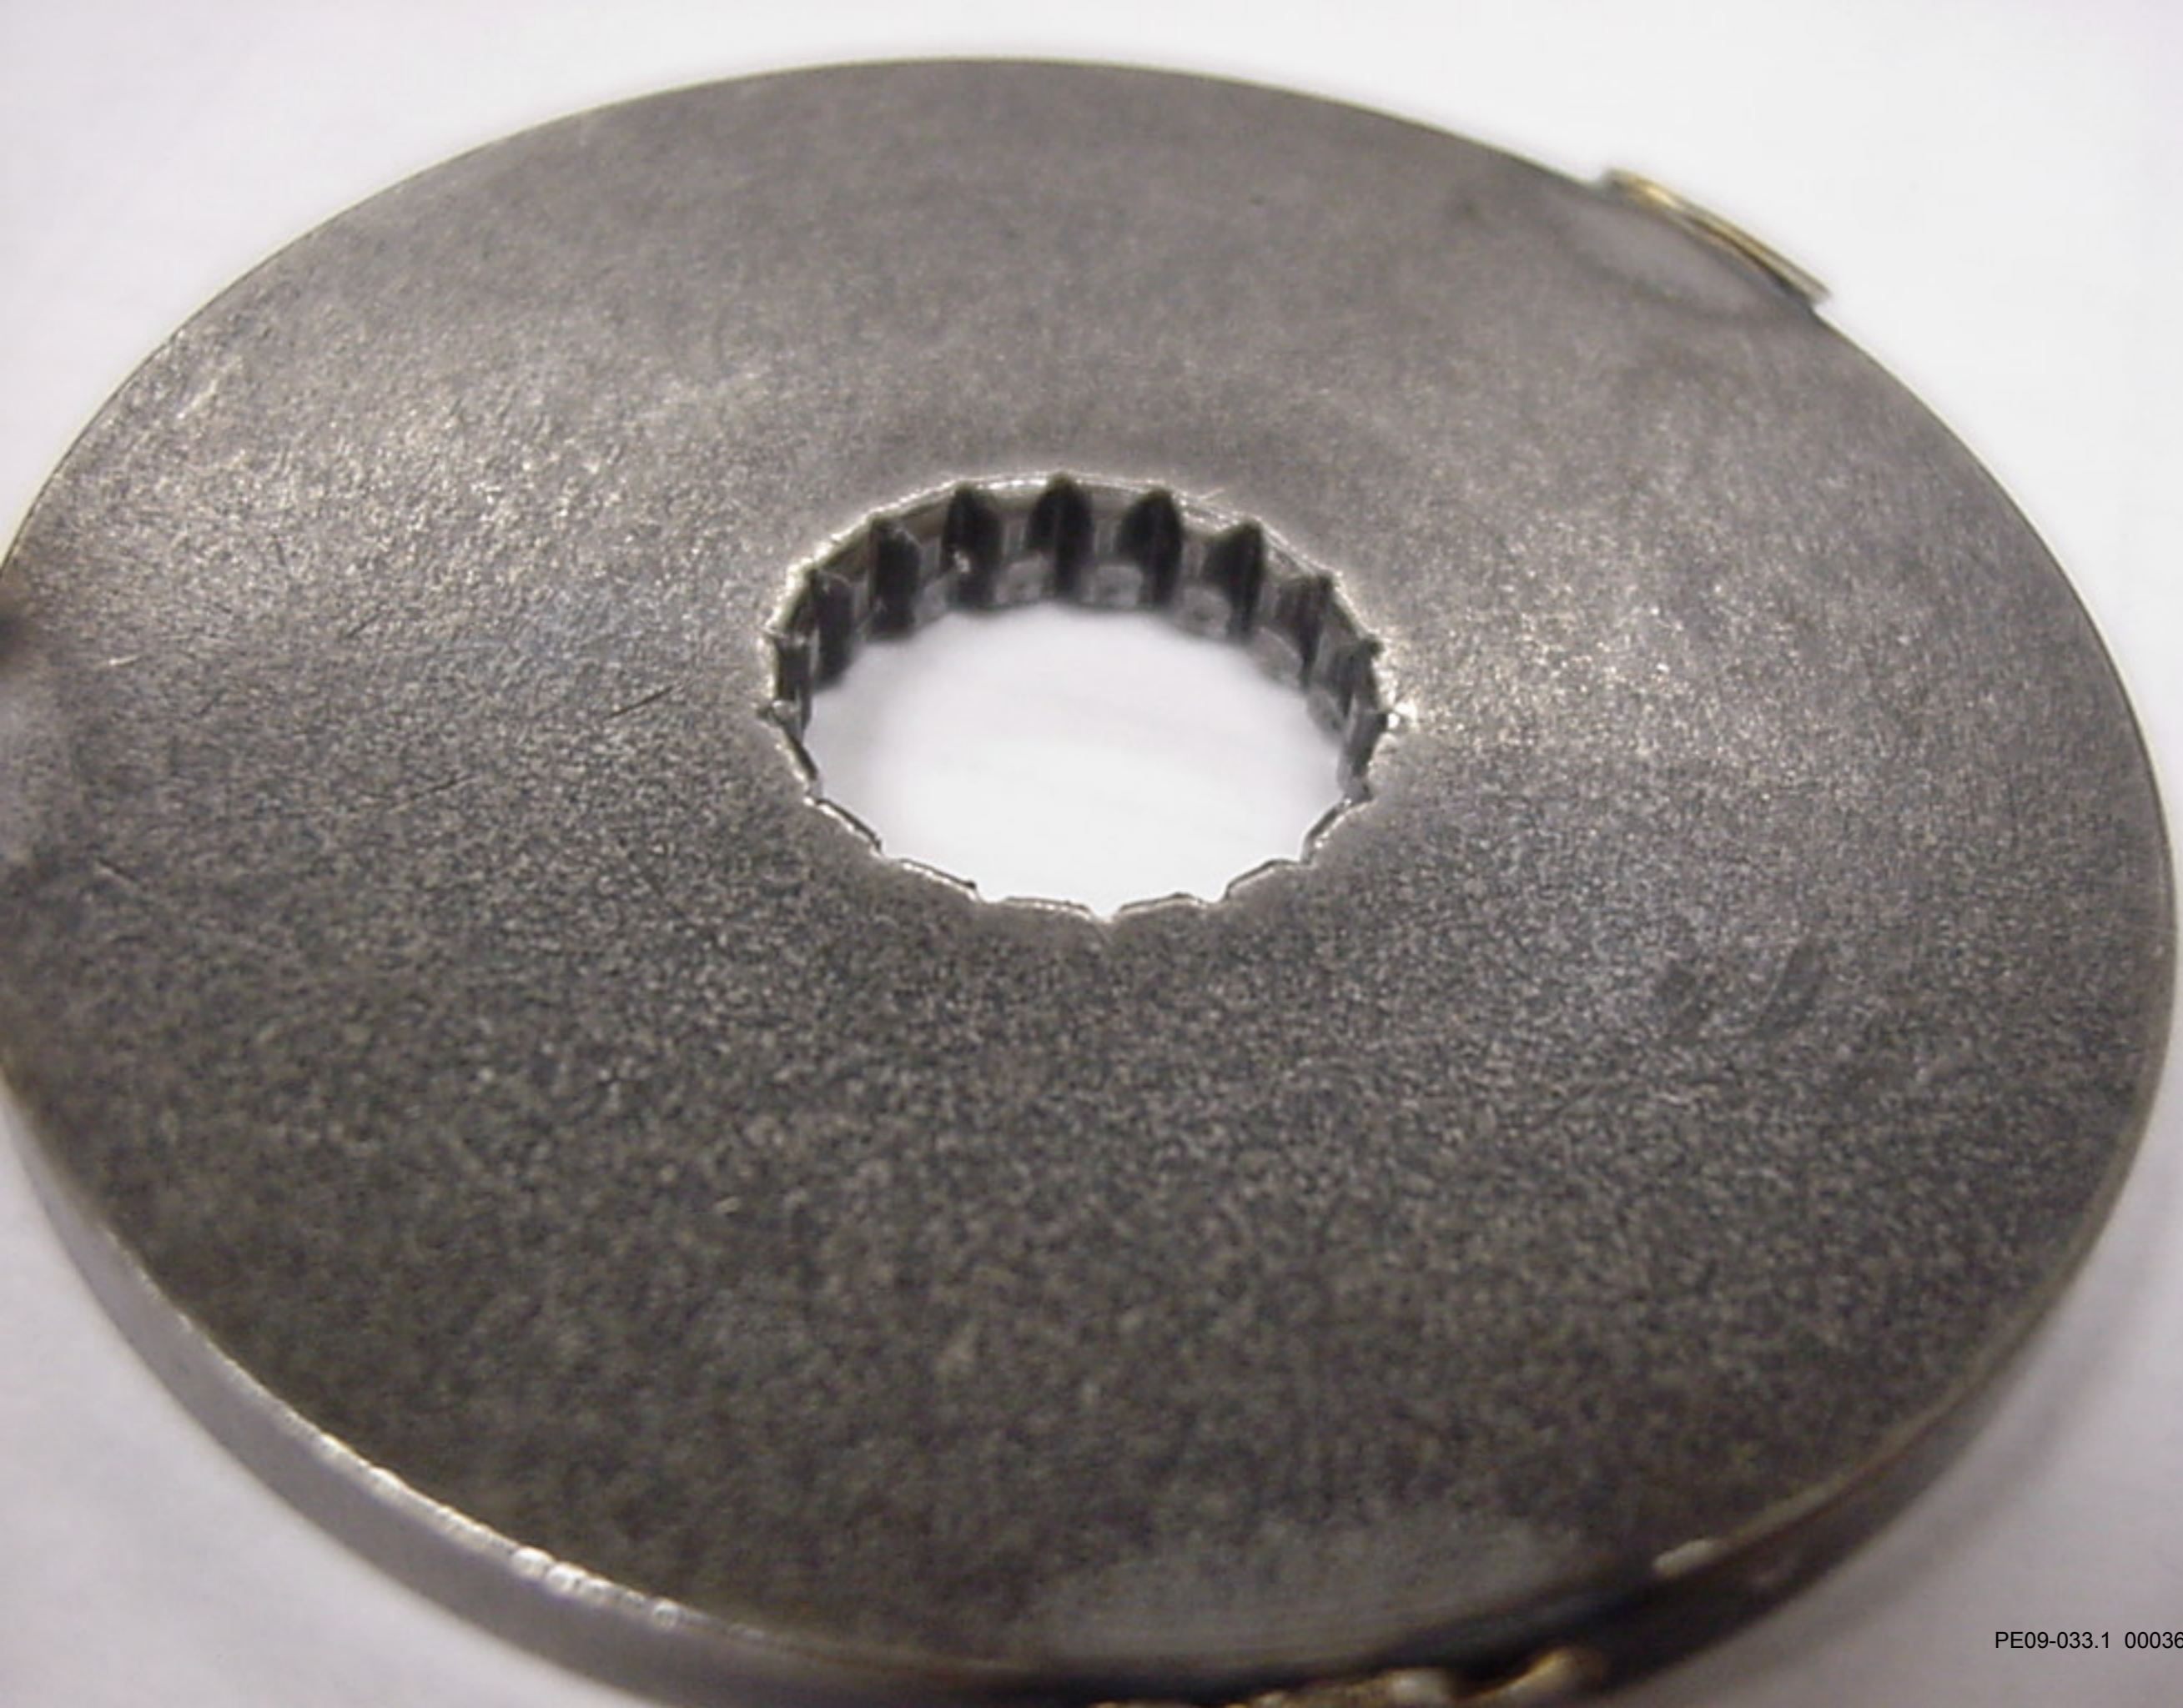
Here is some information about a previous spline damage occurrence.
Another possible cause to investigate.
Jimmy

We have finished our investigation into the failed converter cover insert, which was returned due to a damaged spline. Based on the following information, we have concluded that this failure is not our responsibility.

- The spline was damaged after the part was welded into the converter.
 - Deformation of the insert face matches the configuration of the radiused hole in the converter cover. See attached photos for details. Reference also QR notices 924966 and 924967 from February, where there was even greater deformation caused by the shaft insertion force.

We believe the insert was probably damaged by misalignment of the converter cover and the pump shaft at assembly. We ask that QR 925305 be removed from our record. If you desire we will return the insert and converter cover to you so you may continue your investigation.

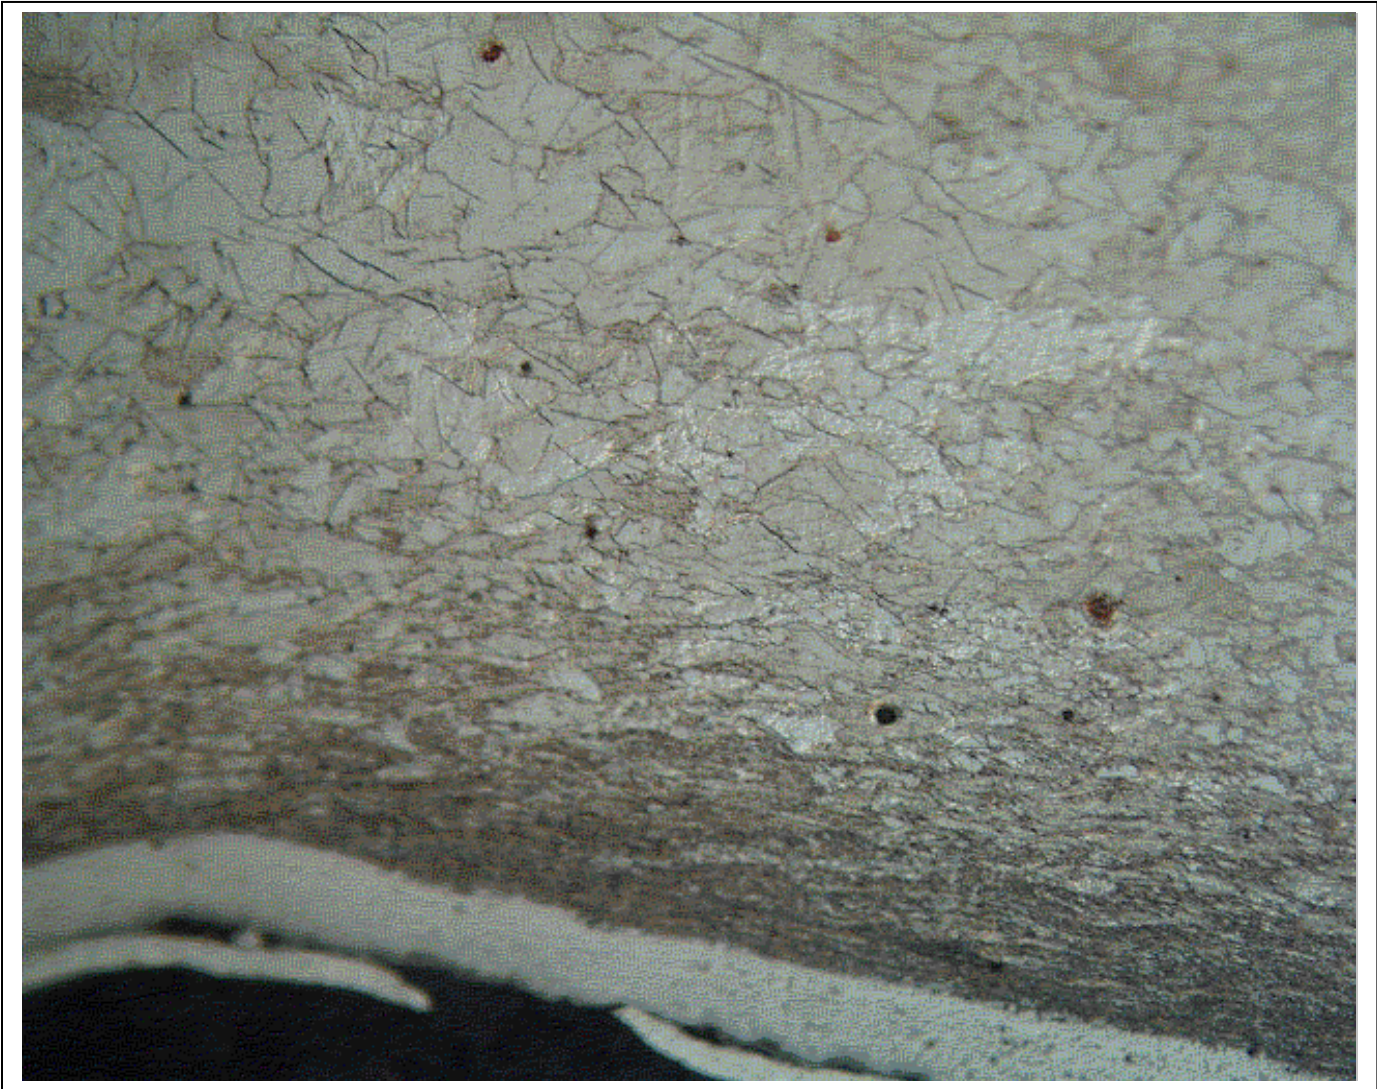
MPI Pic #8 Failed at 28,593 miles 200X

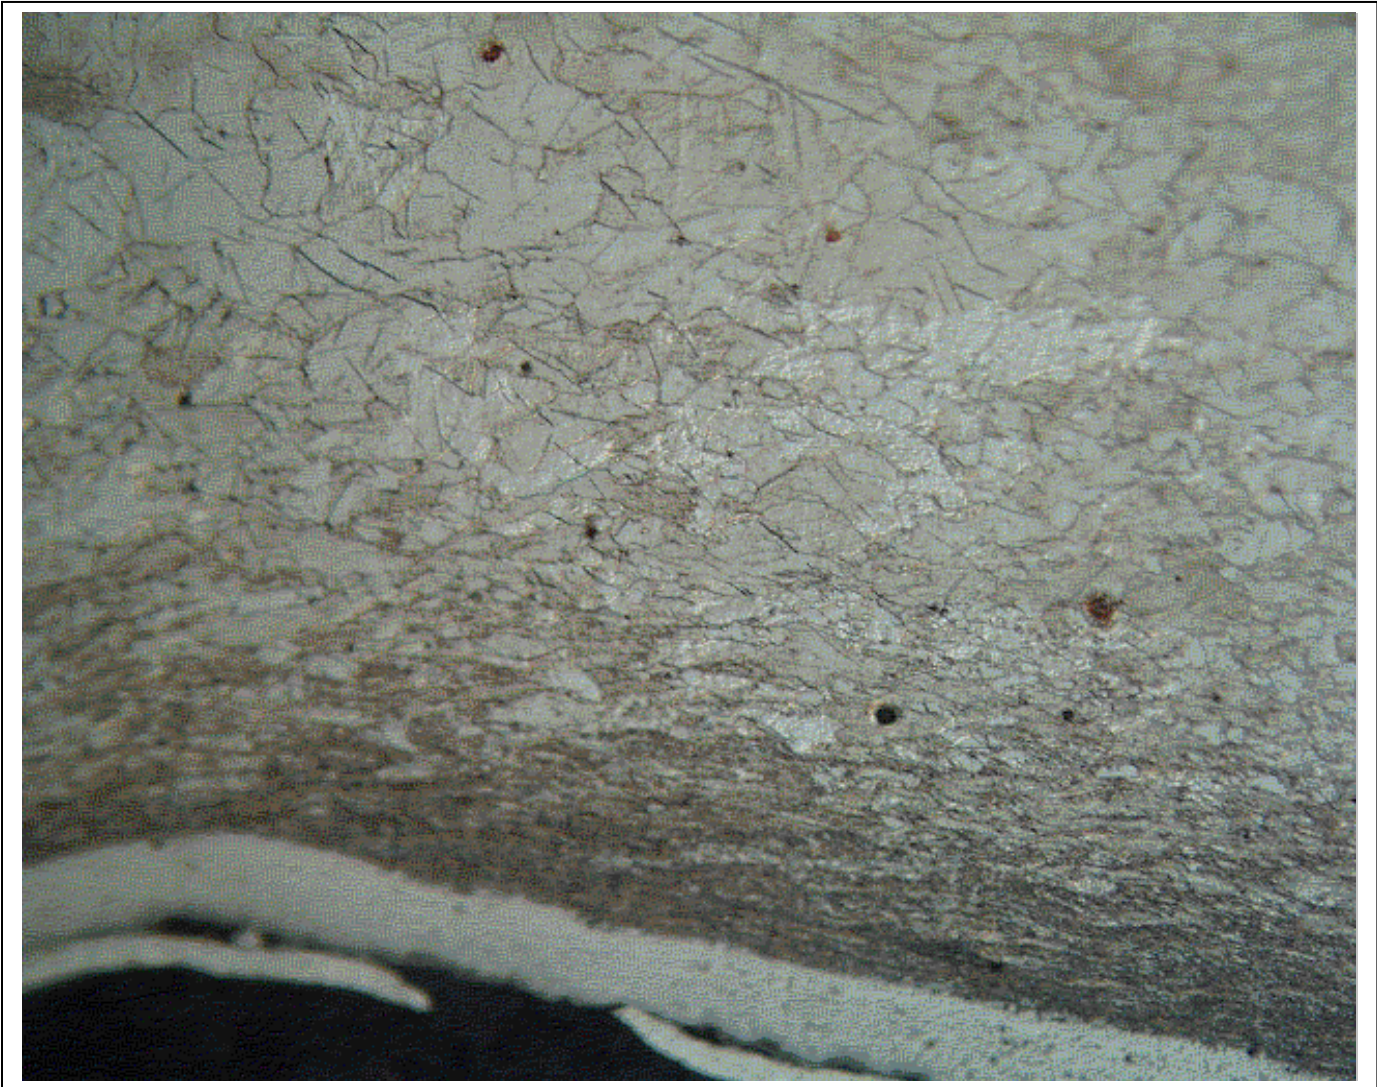
MPI Pic #8 Failed at 28,593 miles 200X
