From: Ruth, Richard (R.R.)
Sent: Thursday, August 17, 2006 10:54 AM
To: Clement, Charles (C.A.)
Subject: FW: 04 F150 Airbag deployment

From: Ruth, Richard (R.R.)
Sent: Tuesday, July 25, 2006 9:54 AM
To: Clement, Charles (C.A.); Oswald, Greg (G.G.)
Cc: Fonseca, Lourdes (L.C.)
Subject: 04 F150 Airbag deployment

04 F150, VIN 1FTPW14574KB03029, Build date 10/09/03, 90000miles, Durand Auto Group, Svc Mgr James McDonald in Vermont 802 463 3300. Dealer says customer described event as pulled in gas station to refuel, turned key off, driver airbag allegedly deployed as he was exiting the driver door. Dealer took codes and got B2293 only, took PIDS and both DAB1 and DAB2 were 25.5 ohms. Dealer installed simulators and both DAB1 and DAB2 read 3.2 ohms (normal). Dealer did not find any visible signs of impact. Customer stated he is a physician and needed the use of his vehicle, at customer request Dealer installed a new driver airbag so customer would have a horn and no airbag sticking out, but did not connect new airbag pending results of investigation in to root cause. Customer is currently driving the vehicle.

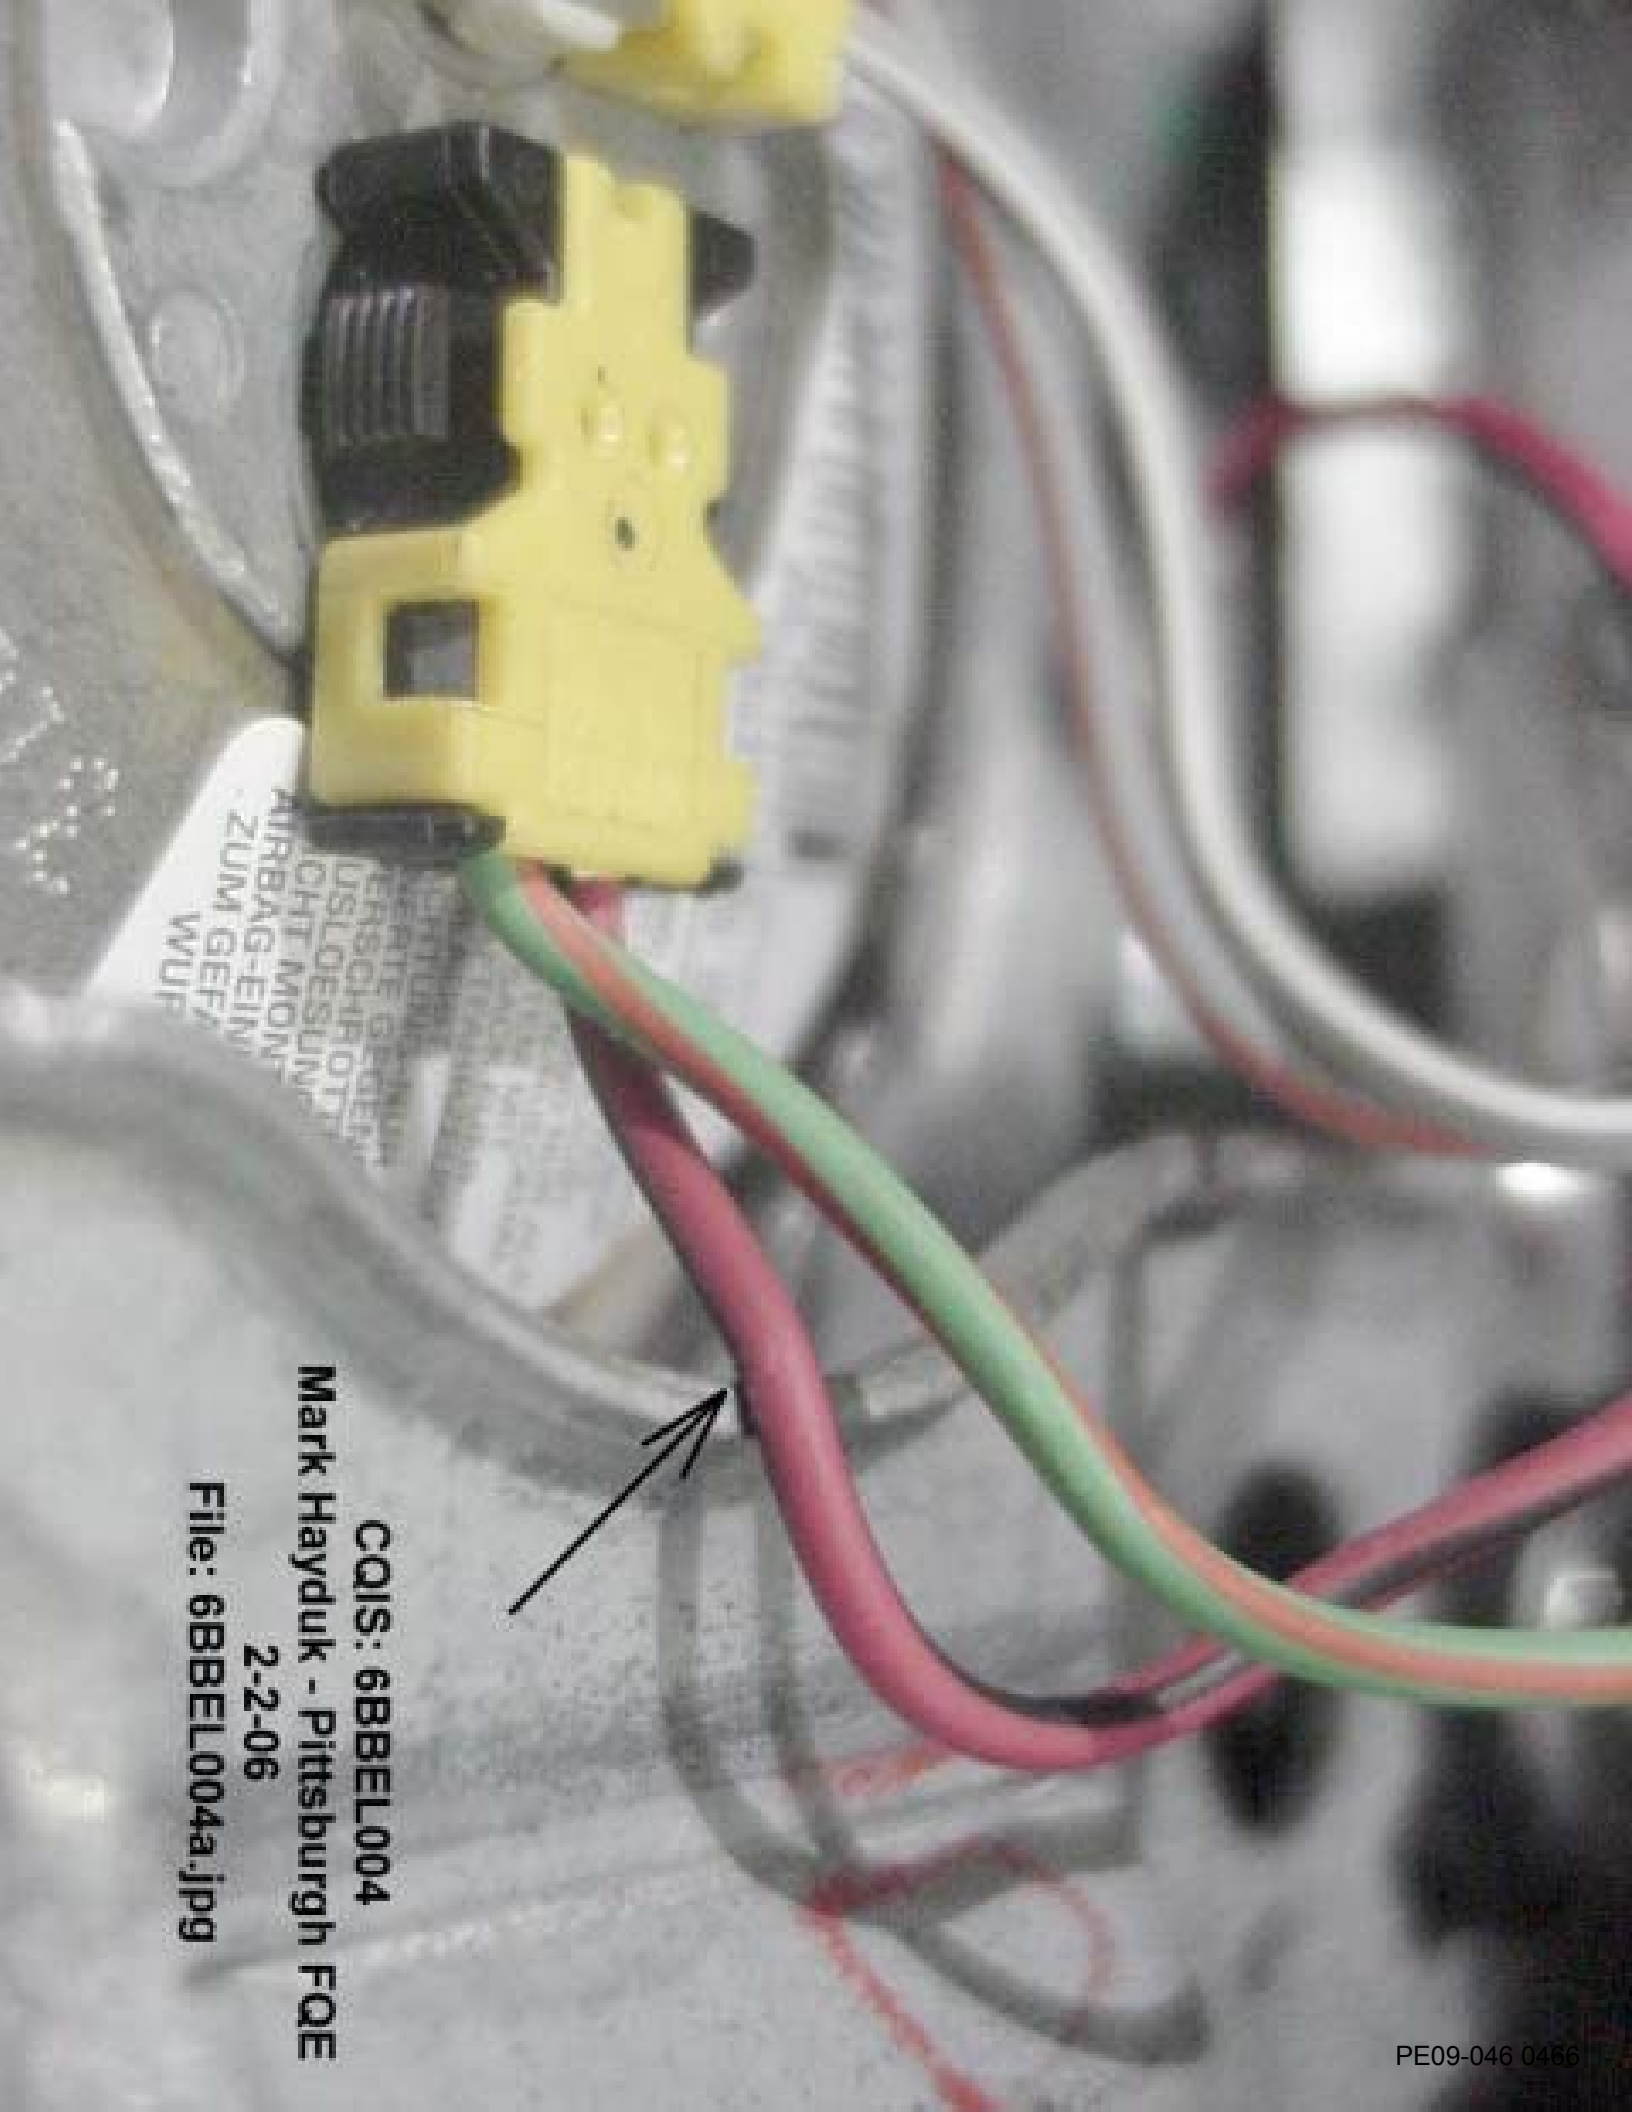
COIS: 6BBEL004
Mark Hayduk - Pittsburgh FOE
2-2-06
File: 6BBEL004a.jpg

TECH/C 02/02/2006 02:04PM MARK HAYDUK MSS - FCSD - CQD - FQE
TECH. FOUND P0581 (CRUISE CONTROL MULTI-FUNCTION INPUT CIRCUIT HIGH.)
AND B2293 (AIR BAG FAULT.). RESTRAINT SYSTEM PID DATA SHOWS FAULTS
FOR: 2293_29_CM, 2293_29_OD, 2293_21_CM AND 2293_21_OD. RESISTANCE
VALUES MEASURED WITH WDS FOR BOTH THE 1ST STAGE AND 2ND STAGE CIRCUITS
OF THE AIR BAG RANGED FROM 3.2 OHMS TO 7.1 OHMS WHEN TURNING THE WHEEL
AND OCCASIONALLY THE 1ST STAGE AND/OR 2ND STAGE RESISTANCE WOULD GO TO

25.5 OHMS. ALSO FOUND THE RED WITH BLACK STRIPED WIRE, GOING TO THE
BLACK CONNECTOR ON THE BACK OF THE STEERING WHEEL AIR BAG, TO BE
AGAINST THE EDGE OF THE STEEL BRACKET. THE WIRE COVER WAS DAMAGED BUT
DID NOT PENETRATE TO THE COPPER WIRES. THE BLACK COVER OF THE WIRES
PLUGGED INTO THE CLOCK SPRING CONNECTION ON THE PASS. SIDE OF THE
CLOCK SPRING SHOWED A WITNESS MARK FROM THE STEEL BRACKET PUSHING ON
IT, BUT THE COVER WAS NOT CUT THROUGH. TECH. INSTALLED A NEW CLOCK
SPRING, CLEARED CODES AND THE CONCERN WAS RESOLVED. PHOTOS ARE
ATTACHED TO THIS REPORT. CLOCK SPRING IS BEING RETURNED TO DEAN
MCCLLENAGHAN. MARK HAYDUK - PITTSBURGH FQE - 724-413-9113.

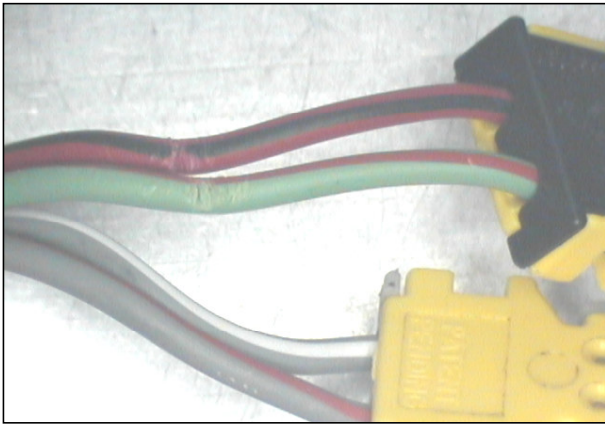
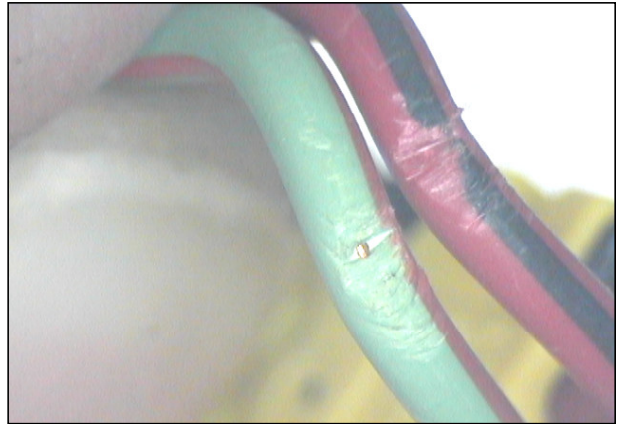
1. VIN NA74168, Pinched wires near FCI connector on red/black and green/orange wires.

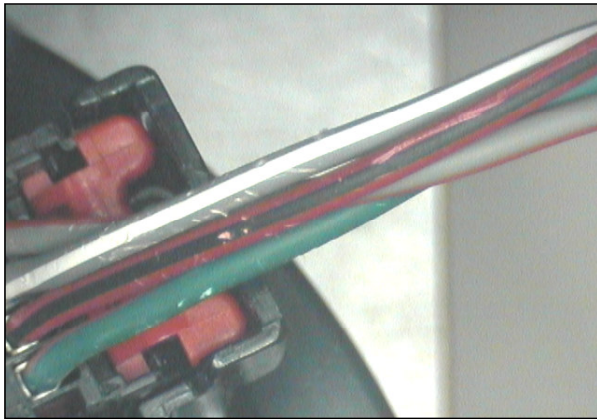
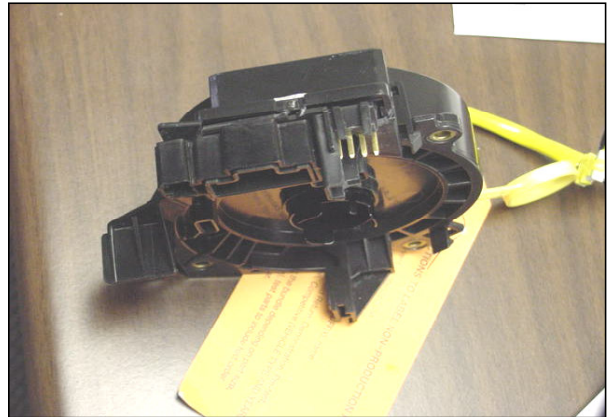
2. Part labeled unknown VIN - abrasions on harness near clockspring side of harness - left picture. Download connector area (plastic) is badly damaged/broken - right picture.

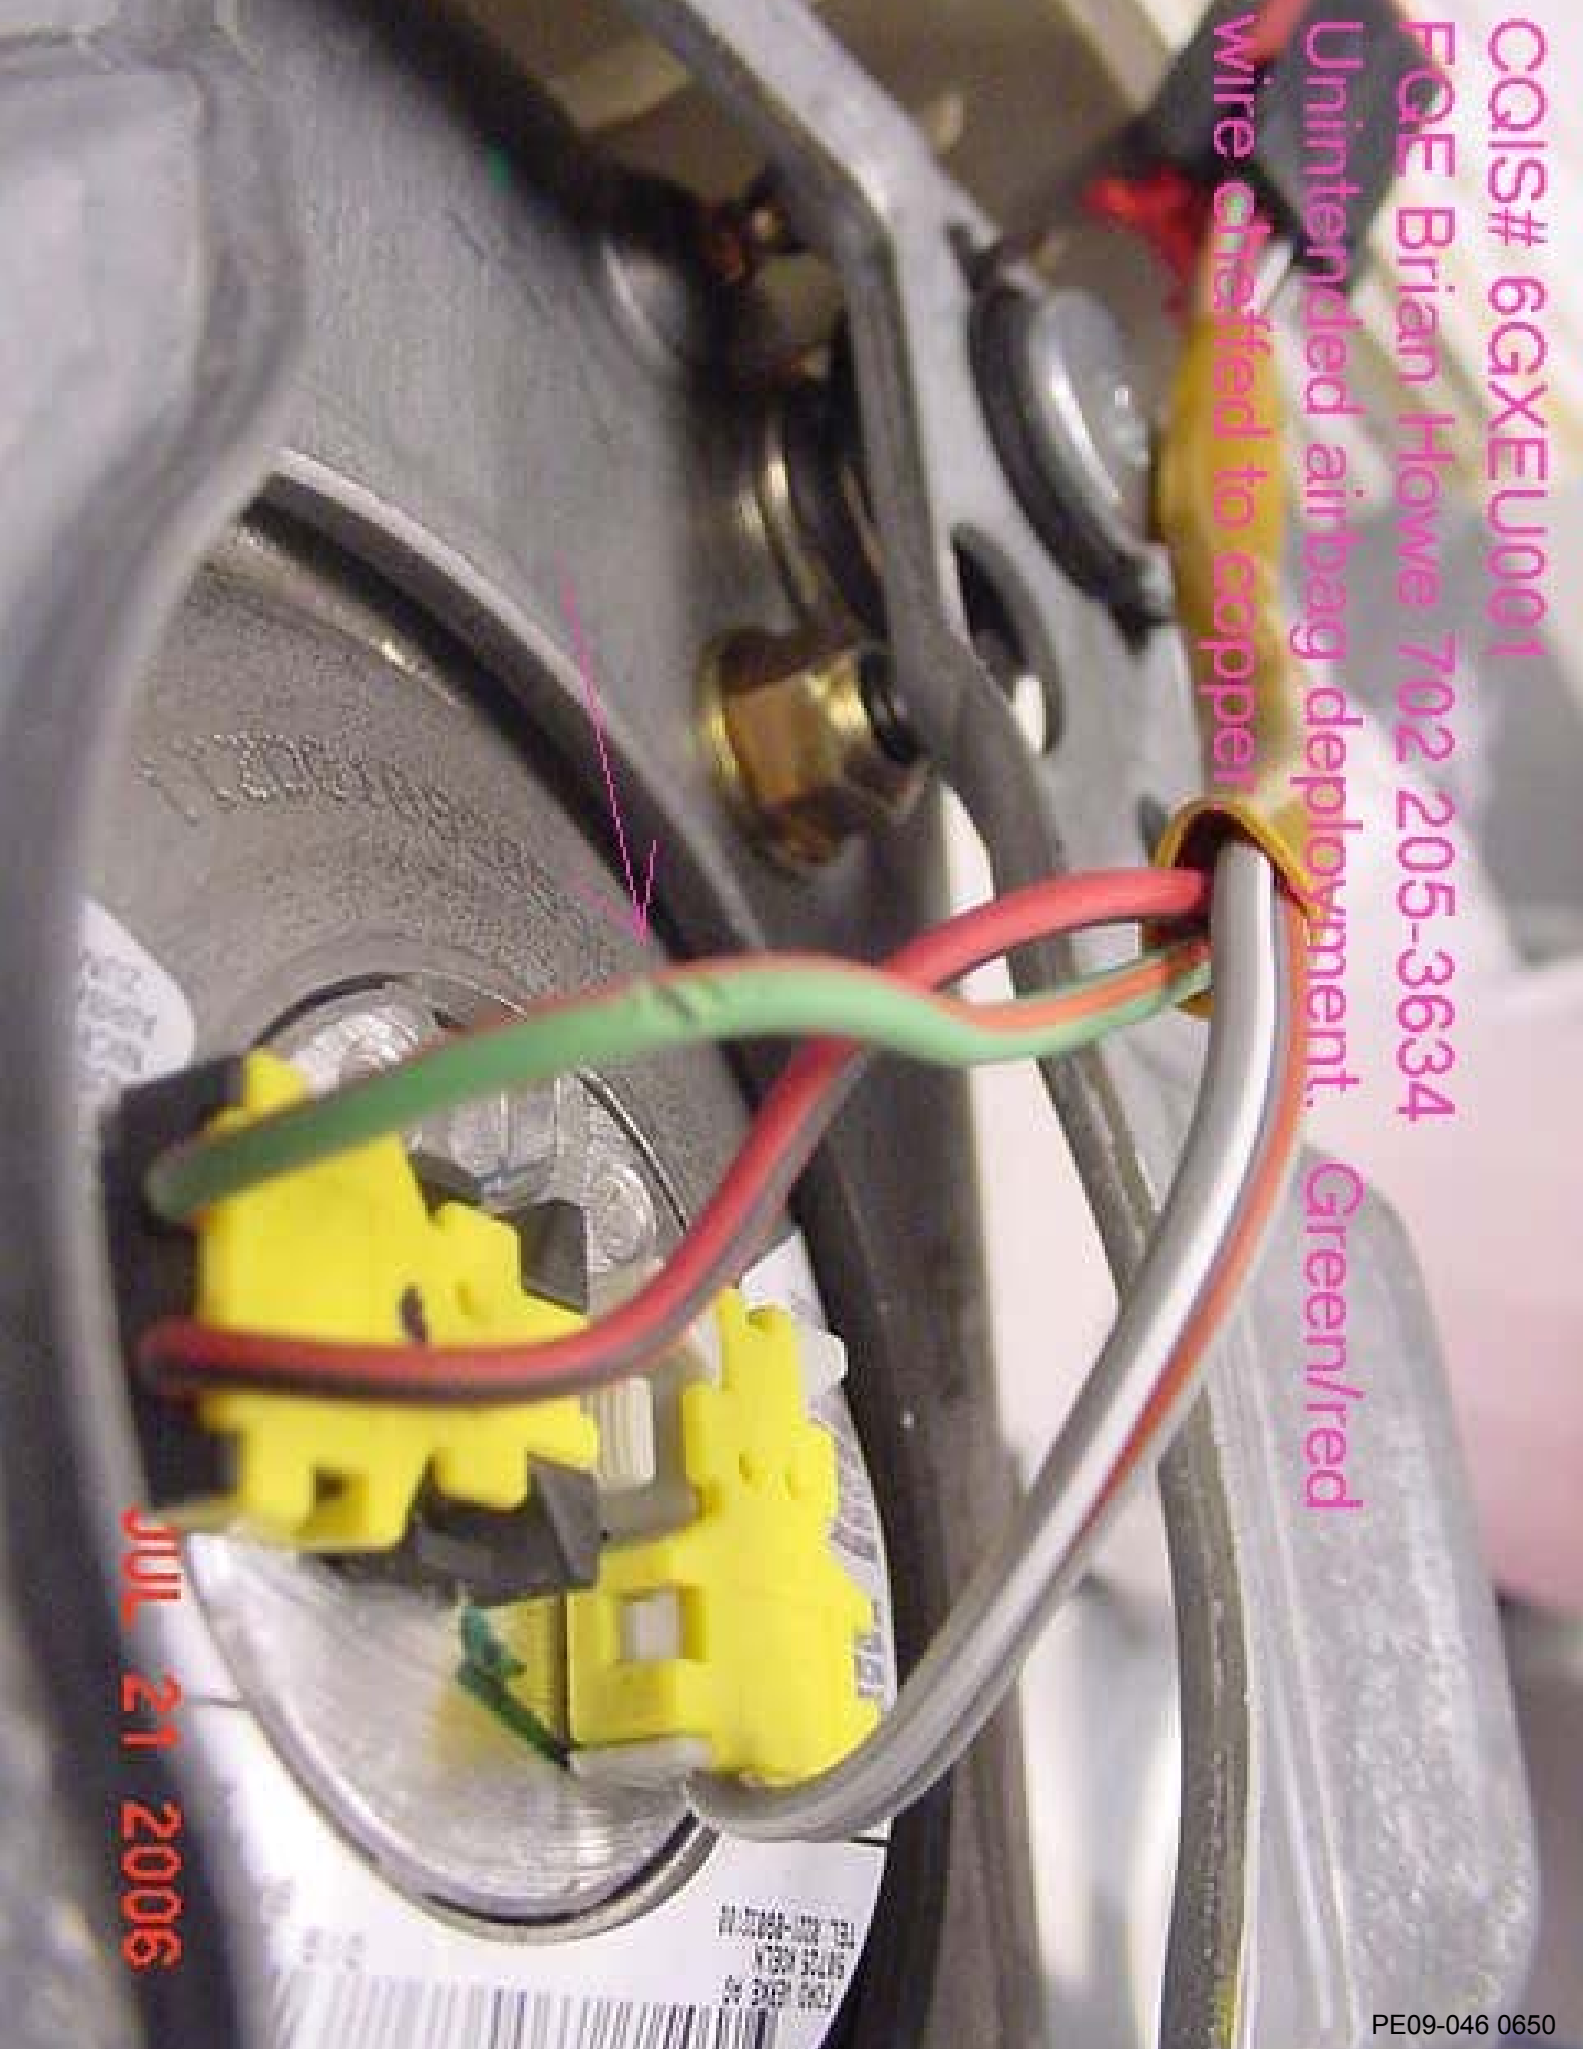
COIS# 6GXEU001
FOE Brian Howe 702 205-3634
Unintended airbag deployment
Wire chafed to copper
Green/red

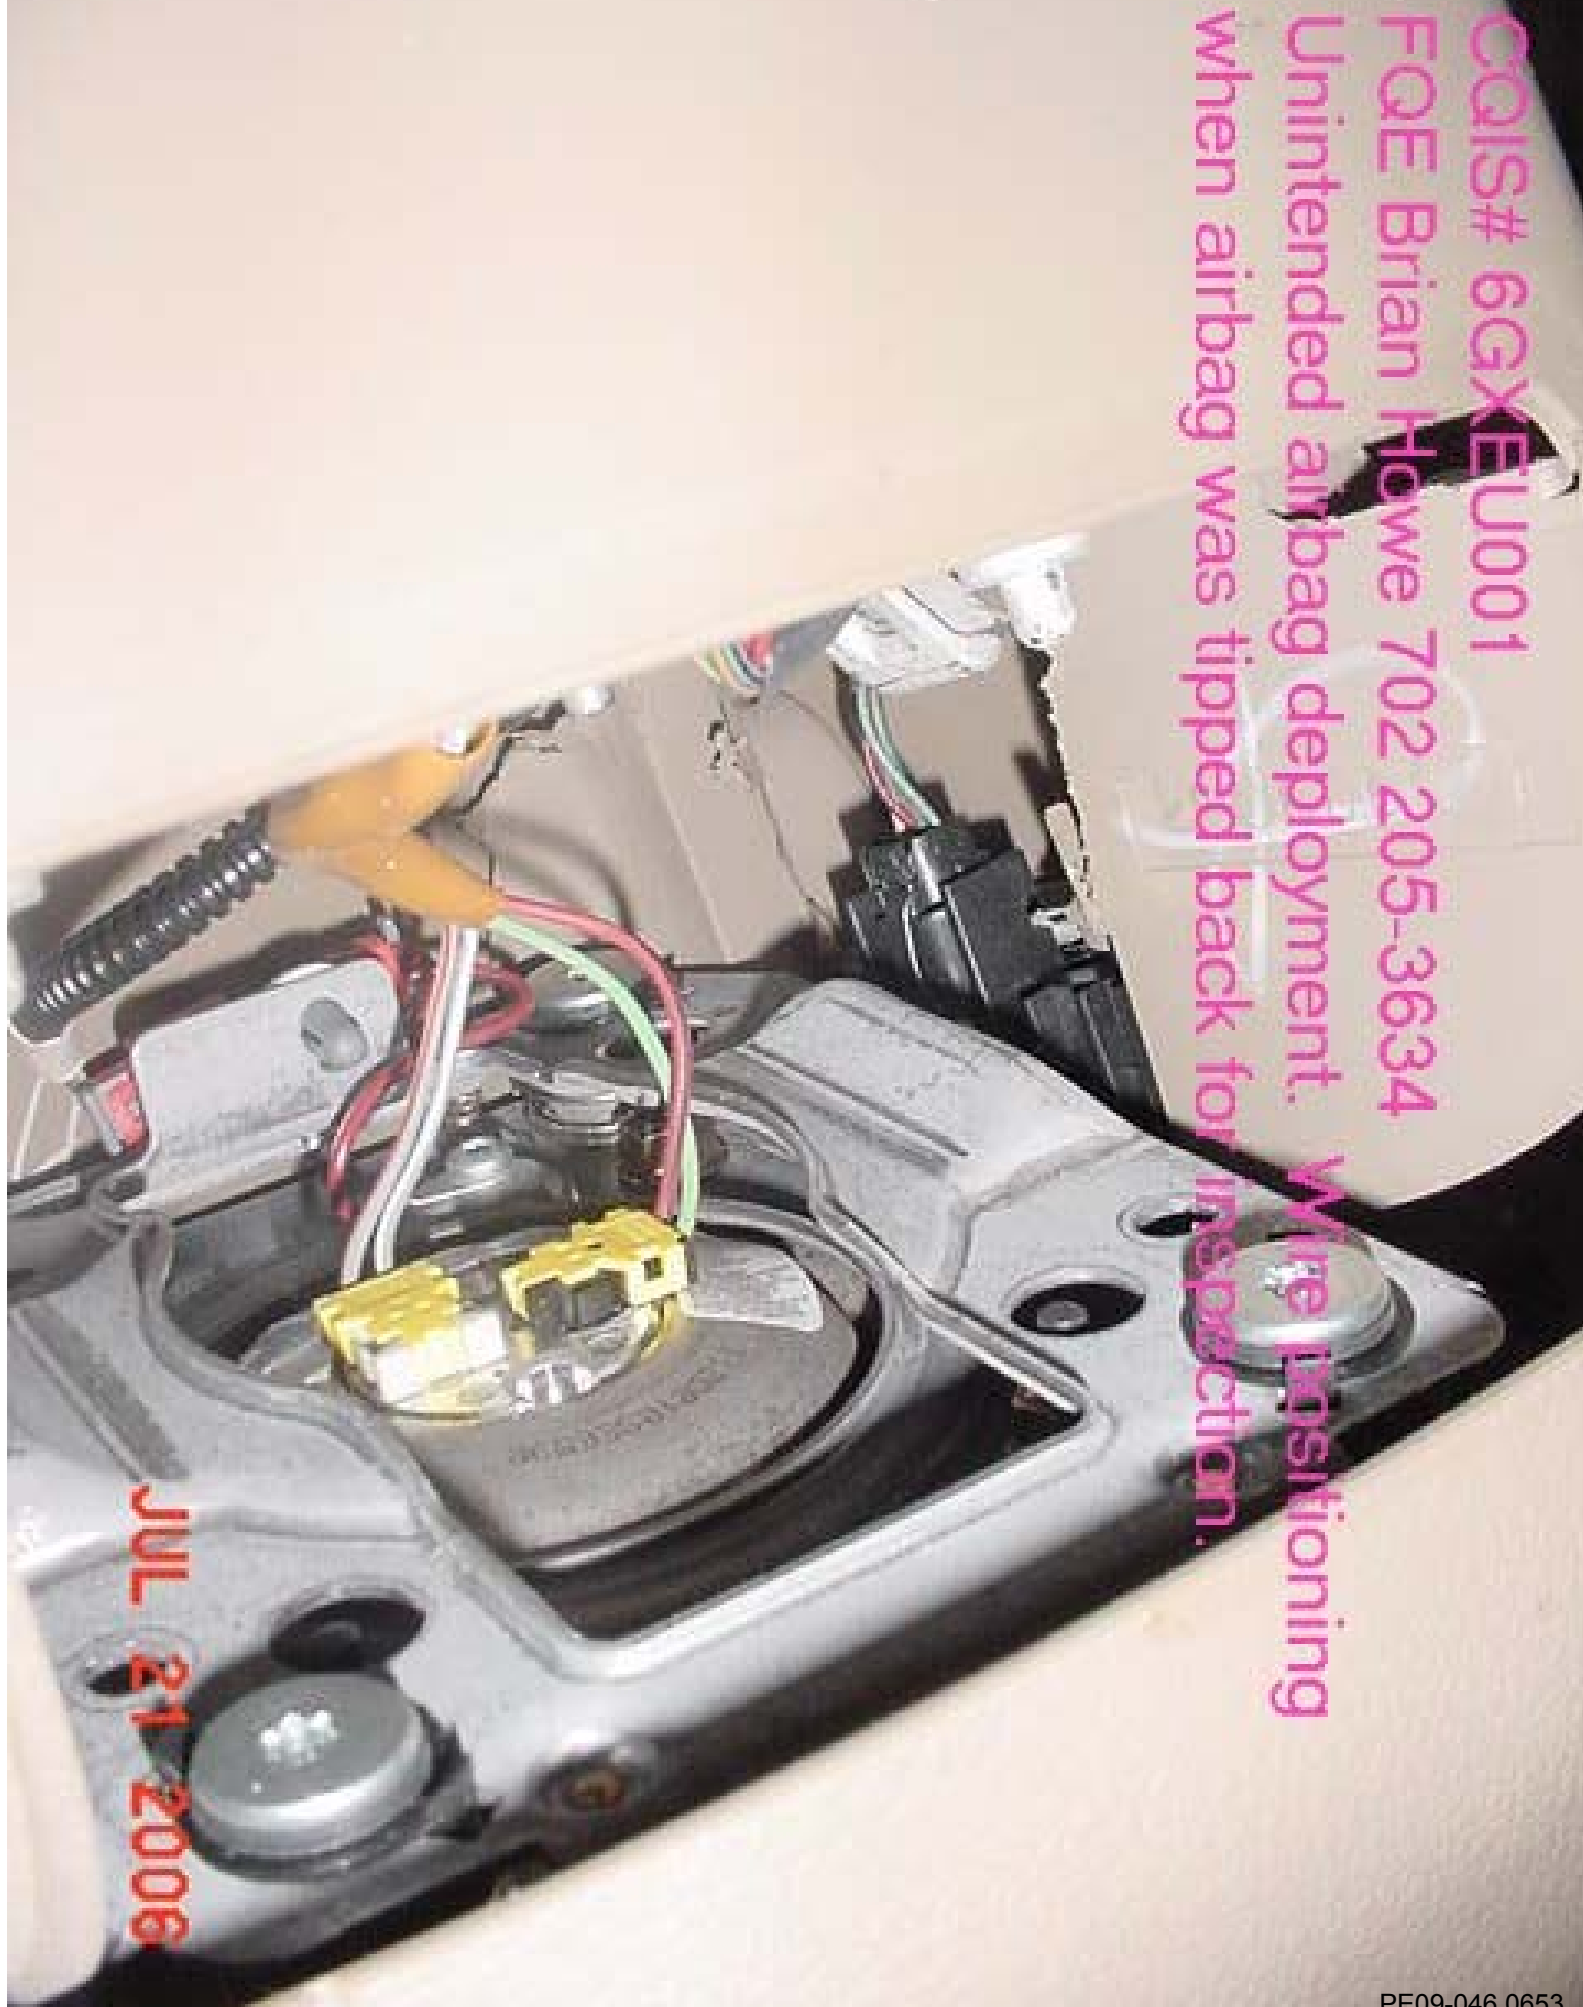
Unintended airbag deployment. Wire positioning when airbag was tipped back for inspection.
