**PE09-049
TOYOTA
12/4/2009
RESPONSE 4
FIELD REPORT
AND LEGAL CLAIMS**

FIELD TECHNICAL REPORT

TQCN DOC# TQCN_FTR-083220017		Affiliate TMS	Dept. QABody		Date 11/18/2008
Primary Model Tundra	Model Year 2000	Production Date 2000-06-23	Odometer 91504	VIN (confirm 17 characters): 5TBBT4419YS [REDACTED]	
Source FTS	Location REG-BOS	Problem Area Base Vehicle		Repair Date 11/13/2008	
Part # 1: N/A	Part # 2:	Part # 3:	Parts Destination: CQE	Parts Available: No Part(s) Available	
Condition Title Rust Appearing on Frame					Ref 83237972

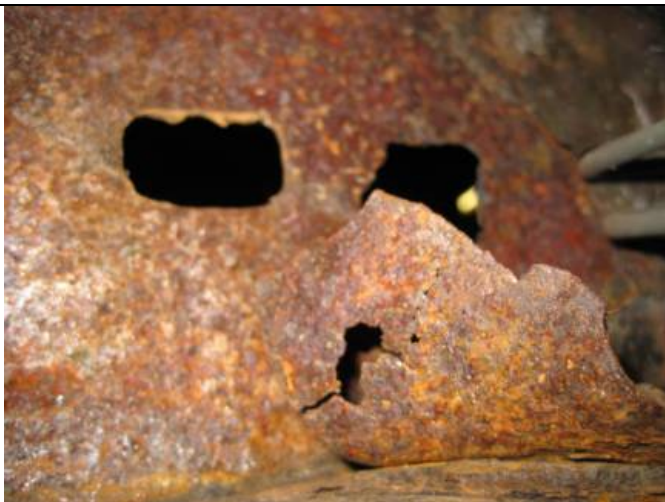
- Placed vehicle on alignment rack. Inspected frame.
- Vehicle has a perforated hole in the left rear wheel well.
- The spare tire carrier has separated from the frame rails.
- The left rear shock upper mount has become detached and the shock absorber is penetrating the bed.

Environmental corrosion

This is a photo of the left rear of the frame from the inside of the C-channel

No repairs were made at this time.

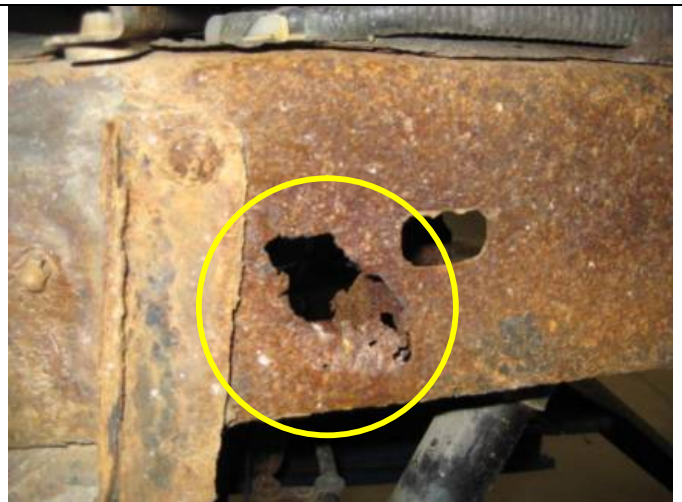
This photo is taken from the wheel well. Note the perforation through the metal.

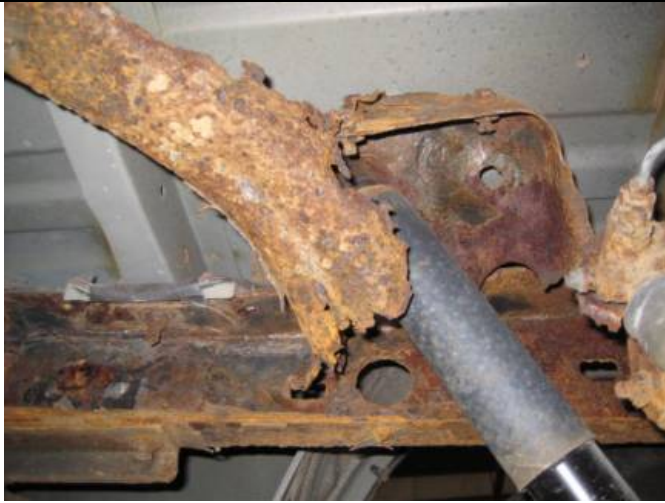
This is a photo of the shock absorber mount

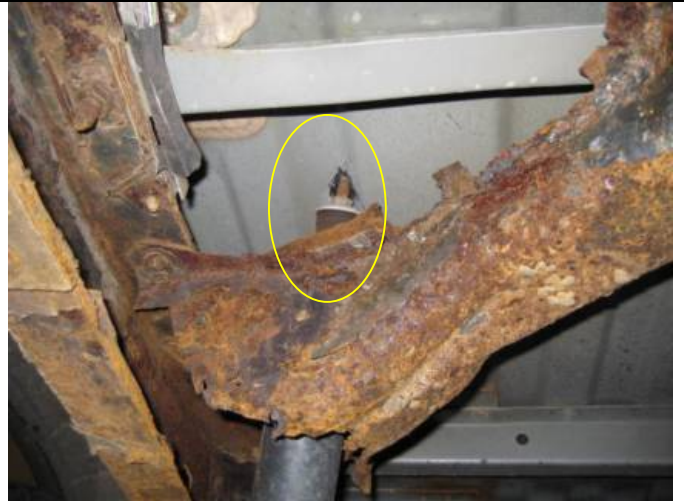
This photo is of the mount from a different angle. Here the shock can be seen penetrating the bed.

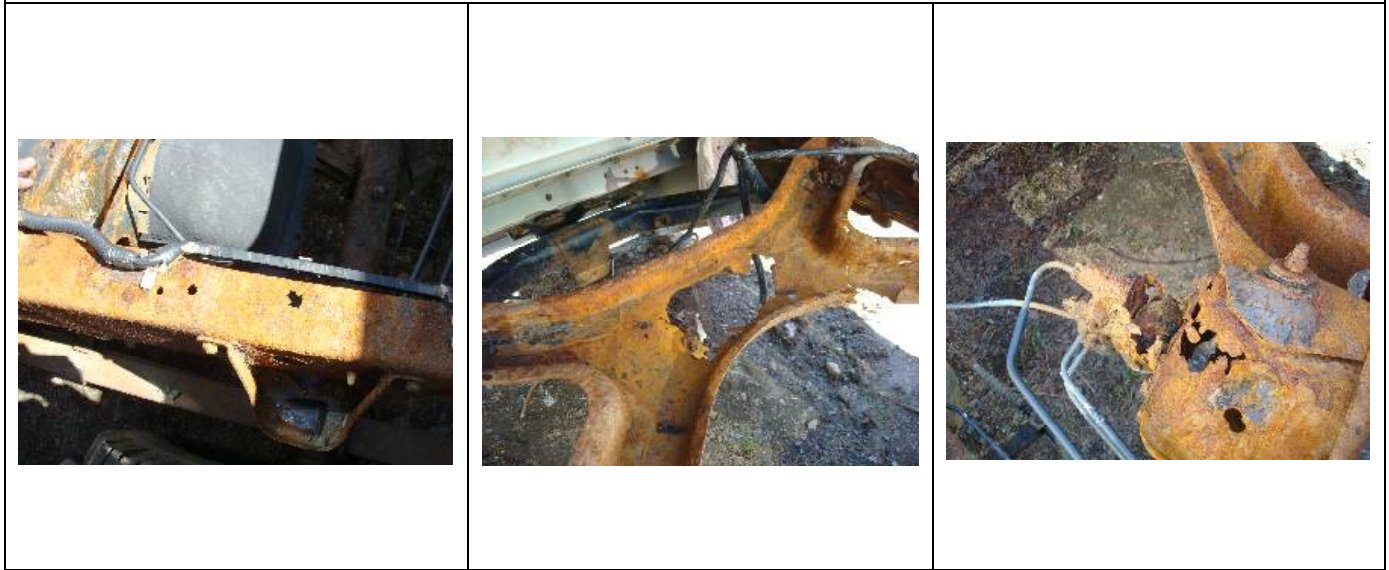
Customer is concerned with frame integrity

removed bed, verify rust perforation

Environmental

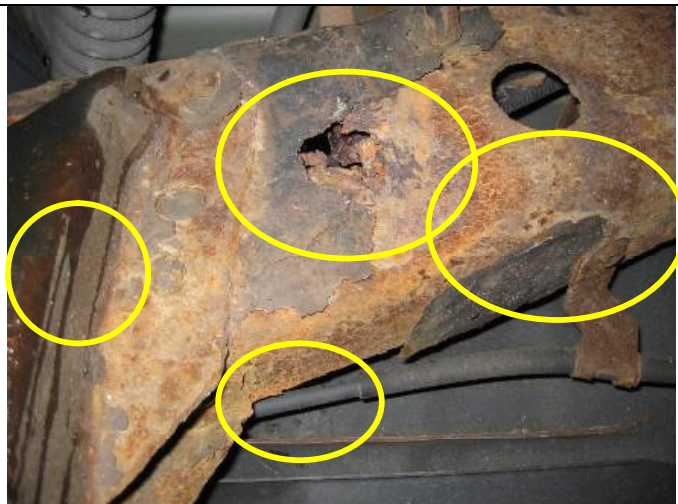
- Raise vehicle on lift
- Moderately tap, using peen of hammer, frame assembly
- Perforation established on drivers side, outer rail above rear leaf spring front mounting bracket
- Perforation established on rear cross member above spare tire

This is perforation found on drivers side above the rear leaf spring front mounting bracket

None at this time. To repair would have to remove and replace frame assembly

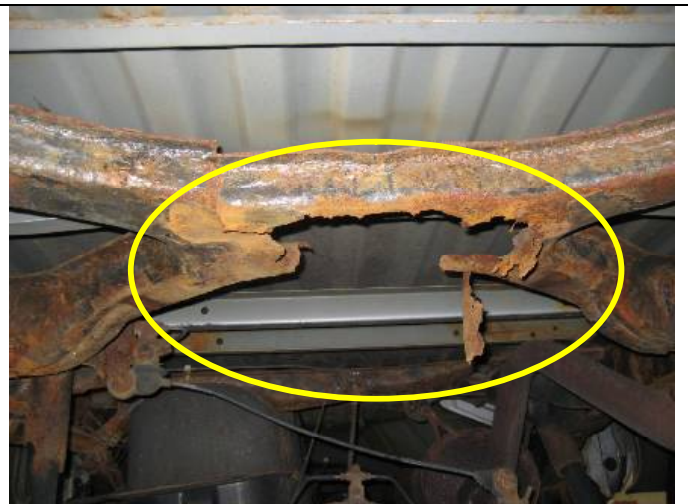
This is the rear cross member

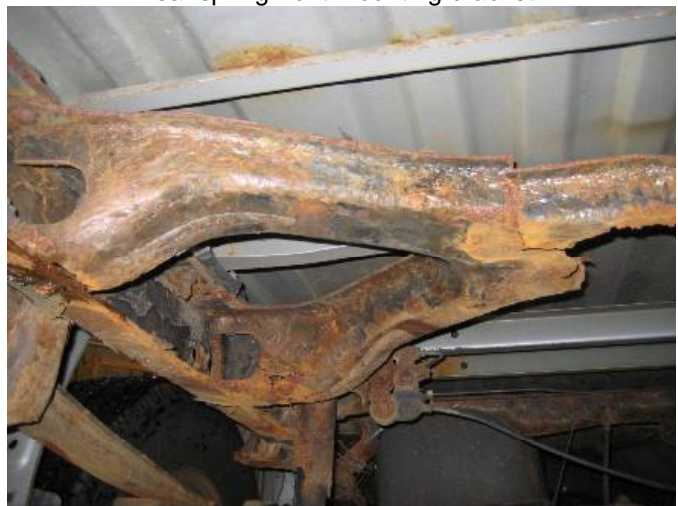
This is the rear cross member

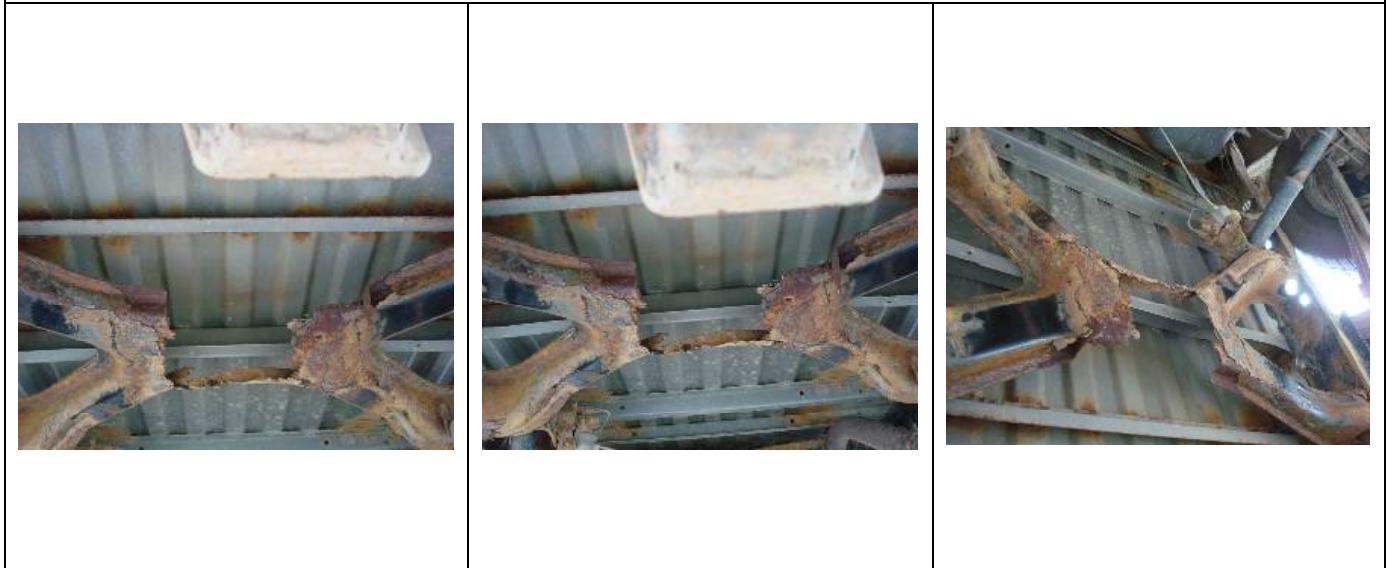
Customer stated a piece of his vehicle's rear cross member and spare tire, where spare tire hoist mounts shows signs of perforation.

Environmental.

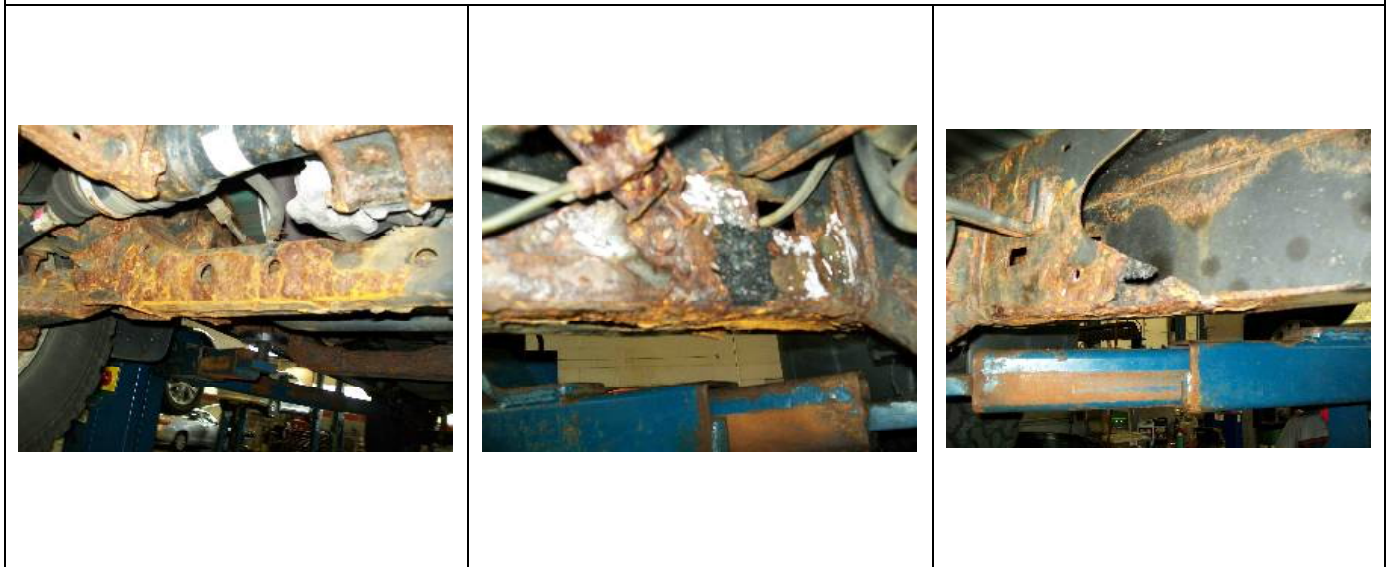
Spare Tire and Carrier missing from vehicle and frame rusted

Took pictures and advised customer to call toyota 800 relations number

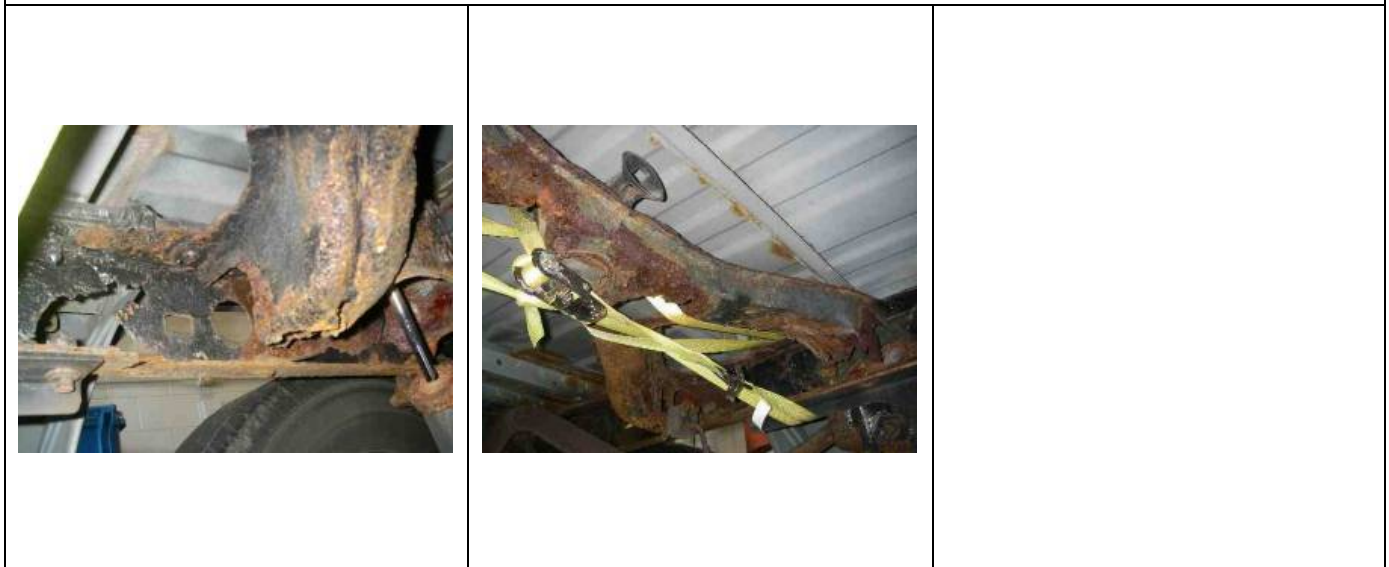
Performed visual inspection, confirmed customers stated concern
The frame rails at the rear of the bed are perforated. Spare tire carrier has fallen off. Customer is using tie down straps to keep frame from separating

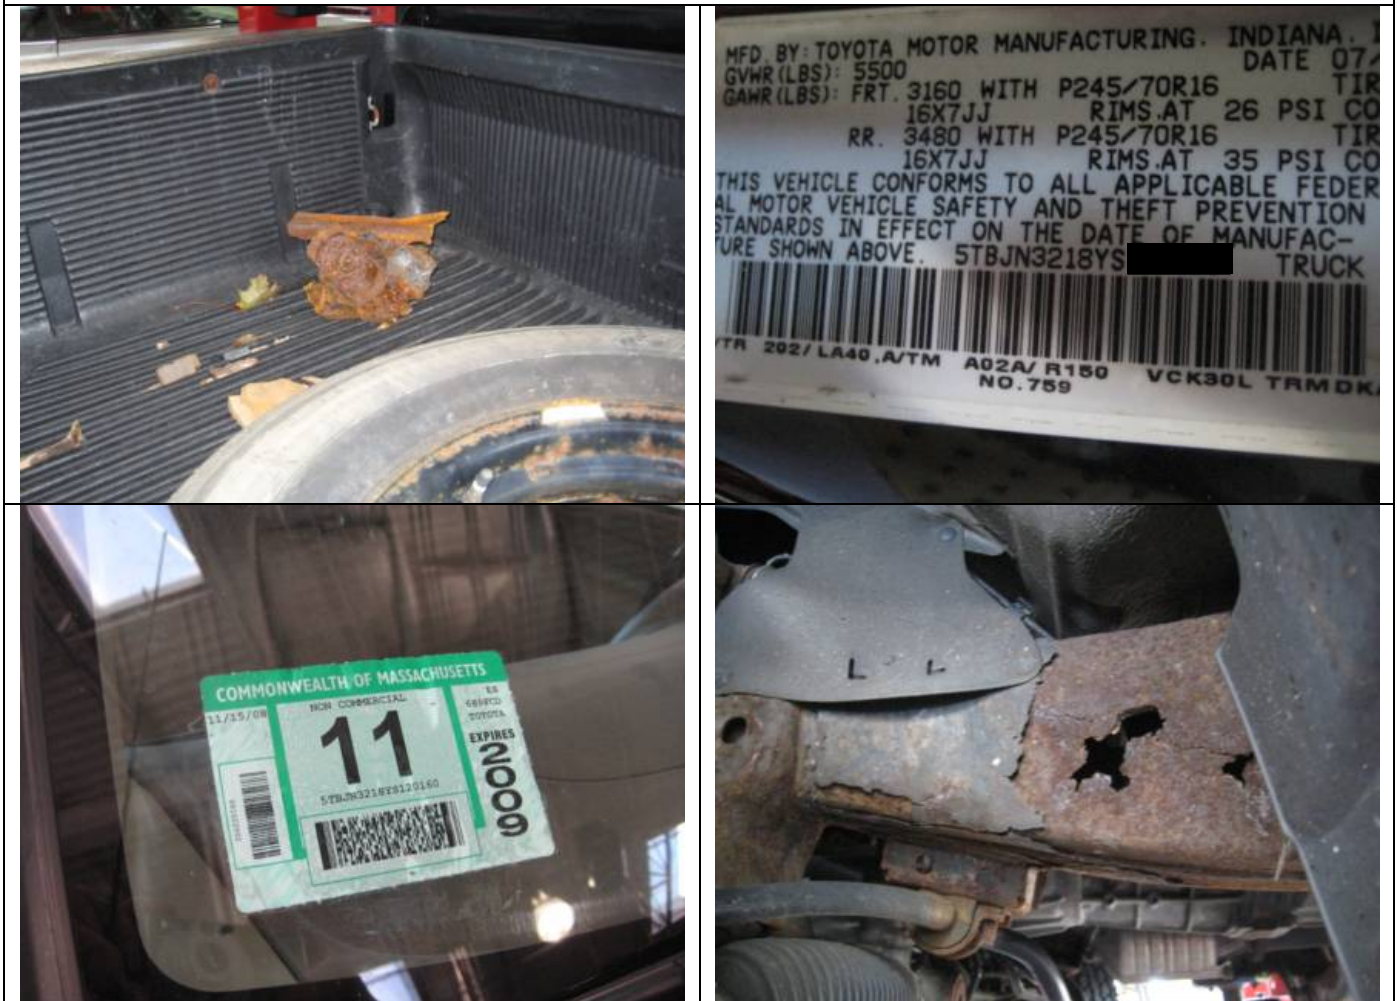
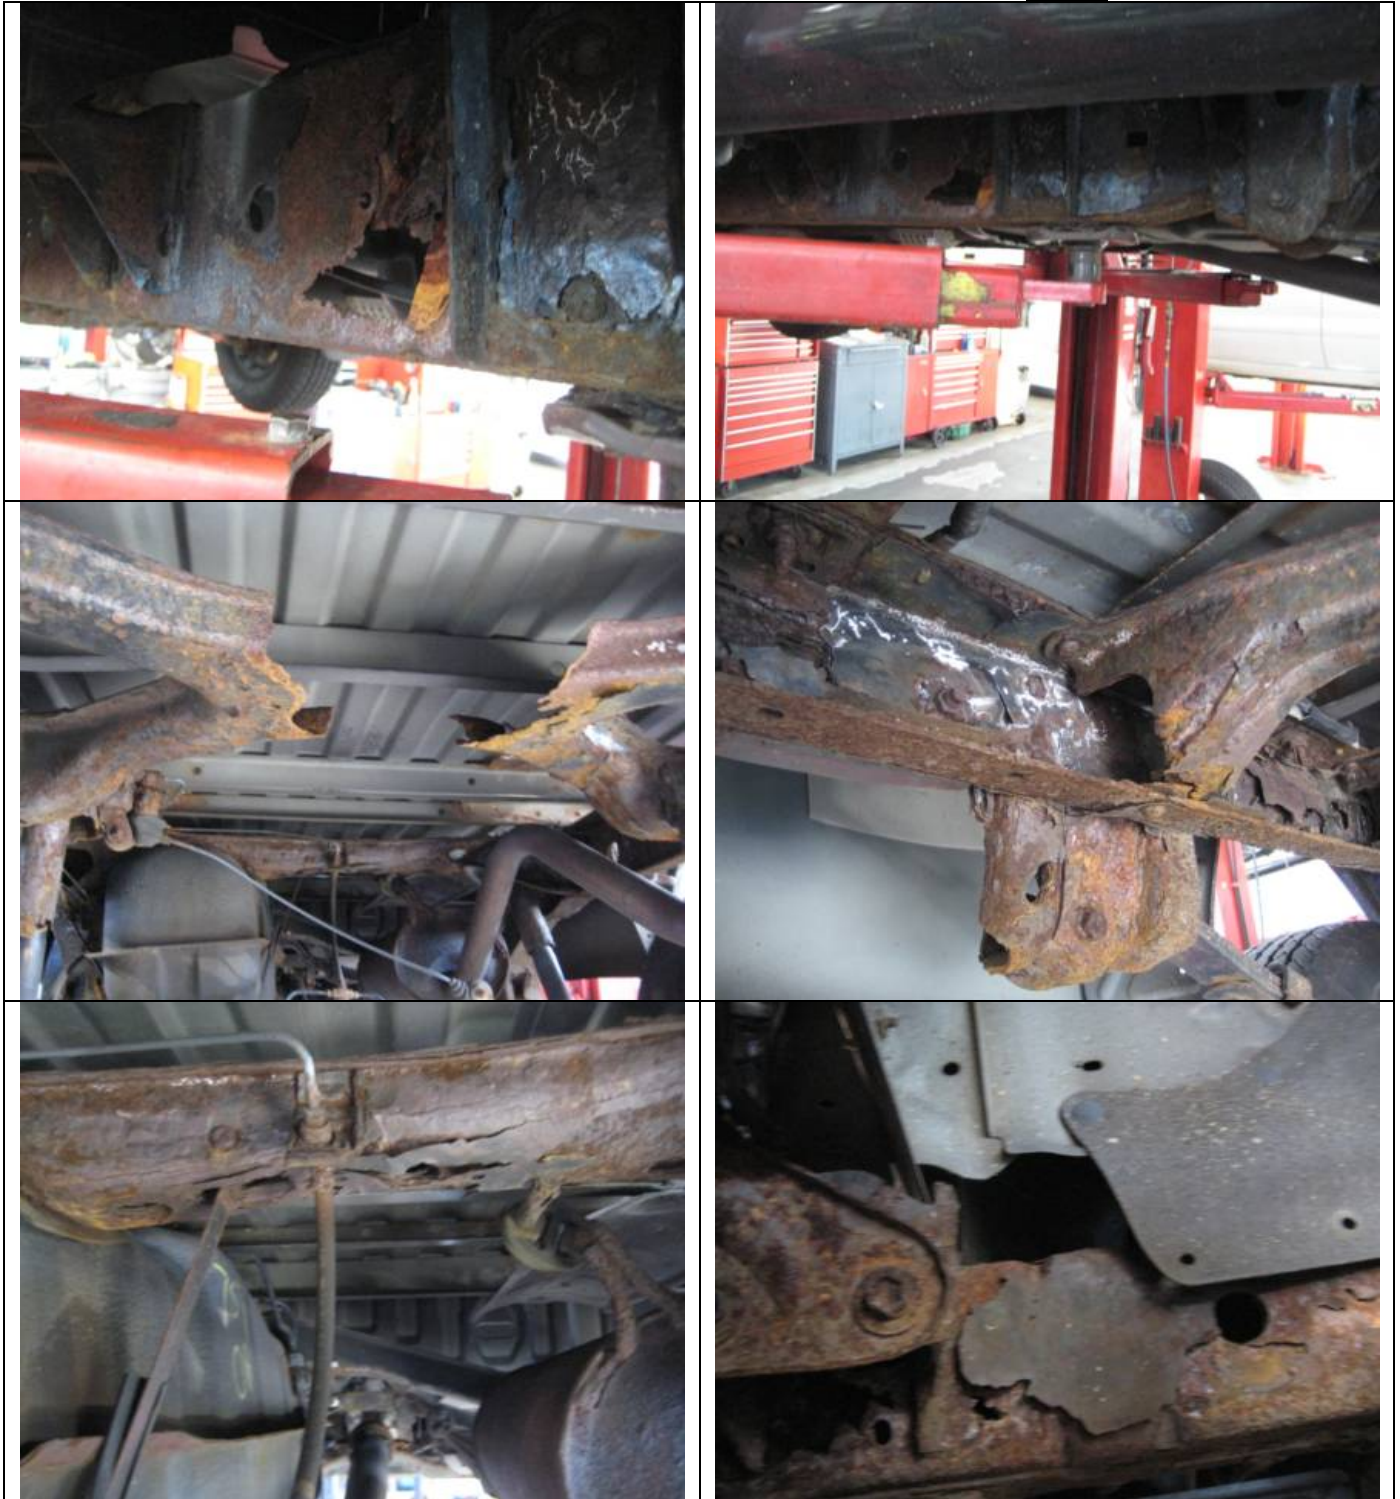
- The rear tire carrier mount had rotted off the vehicle
- There were 3 major holes in the frame
- Large amounts of surface rust were falling off

- New England type weather

None at this time, The customer was informed the vehicle was not safe to drive on the roads and they should either park the vehicle or repair it.
