Mazda's response: NHTSA Inquiry NVS-213kmb, RQ09-002

Mazda records indicate that the approximate total number of 2001 – 2004 Model Year Mazda Tribute vehicles subject to NHTSA recall number 07V-157 sold in the United States (the 50 states and the District of Columbia) and its protectorates and territories (American Samoa, Guam, Northern Mariana Islands, Puerto Rico, US Minor Outlying Islands, and Virgin Islands) is 95,349.

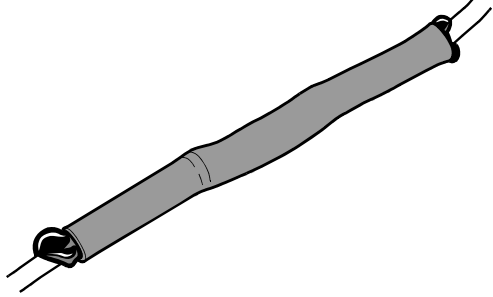
<p>INADEQUATE CRIMP USING IMPROPER TOOL</p> <ul style="list-style-type: none"> • Broken splice connector. • Possible loose connection.

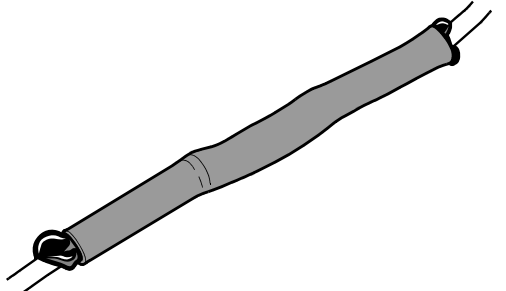
<p>INADEQUATE CRIMP USING IMPROPER TOOL</p> <ul style="list-style-type: none"> • Broken splice connector. • Possible loose connection.

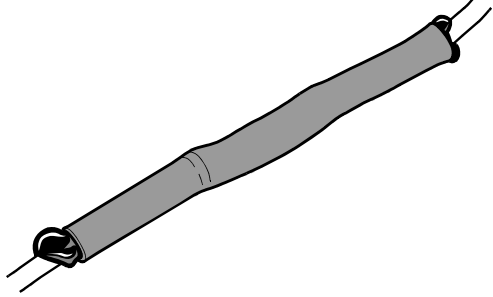
<p>INADEQUATE CRIMP USING IMPROPER TOOL</p> <ul style="list-style-type: none"> • Broken splice connector. • Possible loose connection.

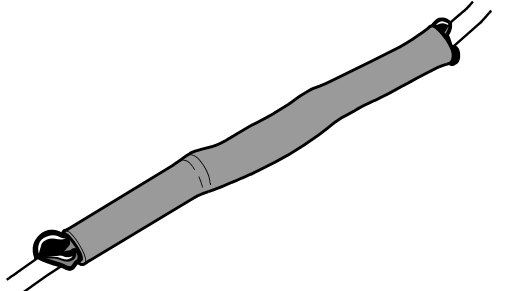
<p>INADEQUATE CRIMP USING IMPROPER TOOL</p> <ul style="list-style-type: none"> • Broken splice connector. • Possible loose connection.
