RQ09-002

FORD

c39371 grease over corrosion

**From:** Murphy, Gregory [mailto:MurphyG1@autonation.com]  
**Sent:** Thursday, September 06, 2007 8:21 PM  
**To:** sssc@renkim.com  
**Subject:** 2001 escape fire at abs control module pig tail

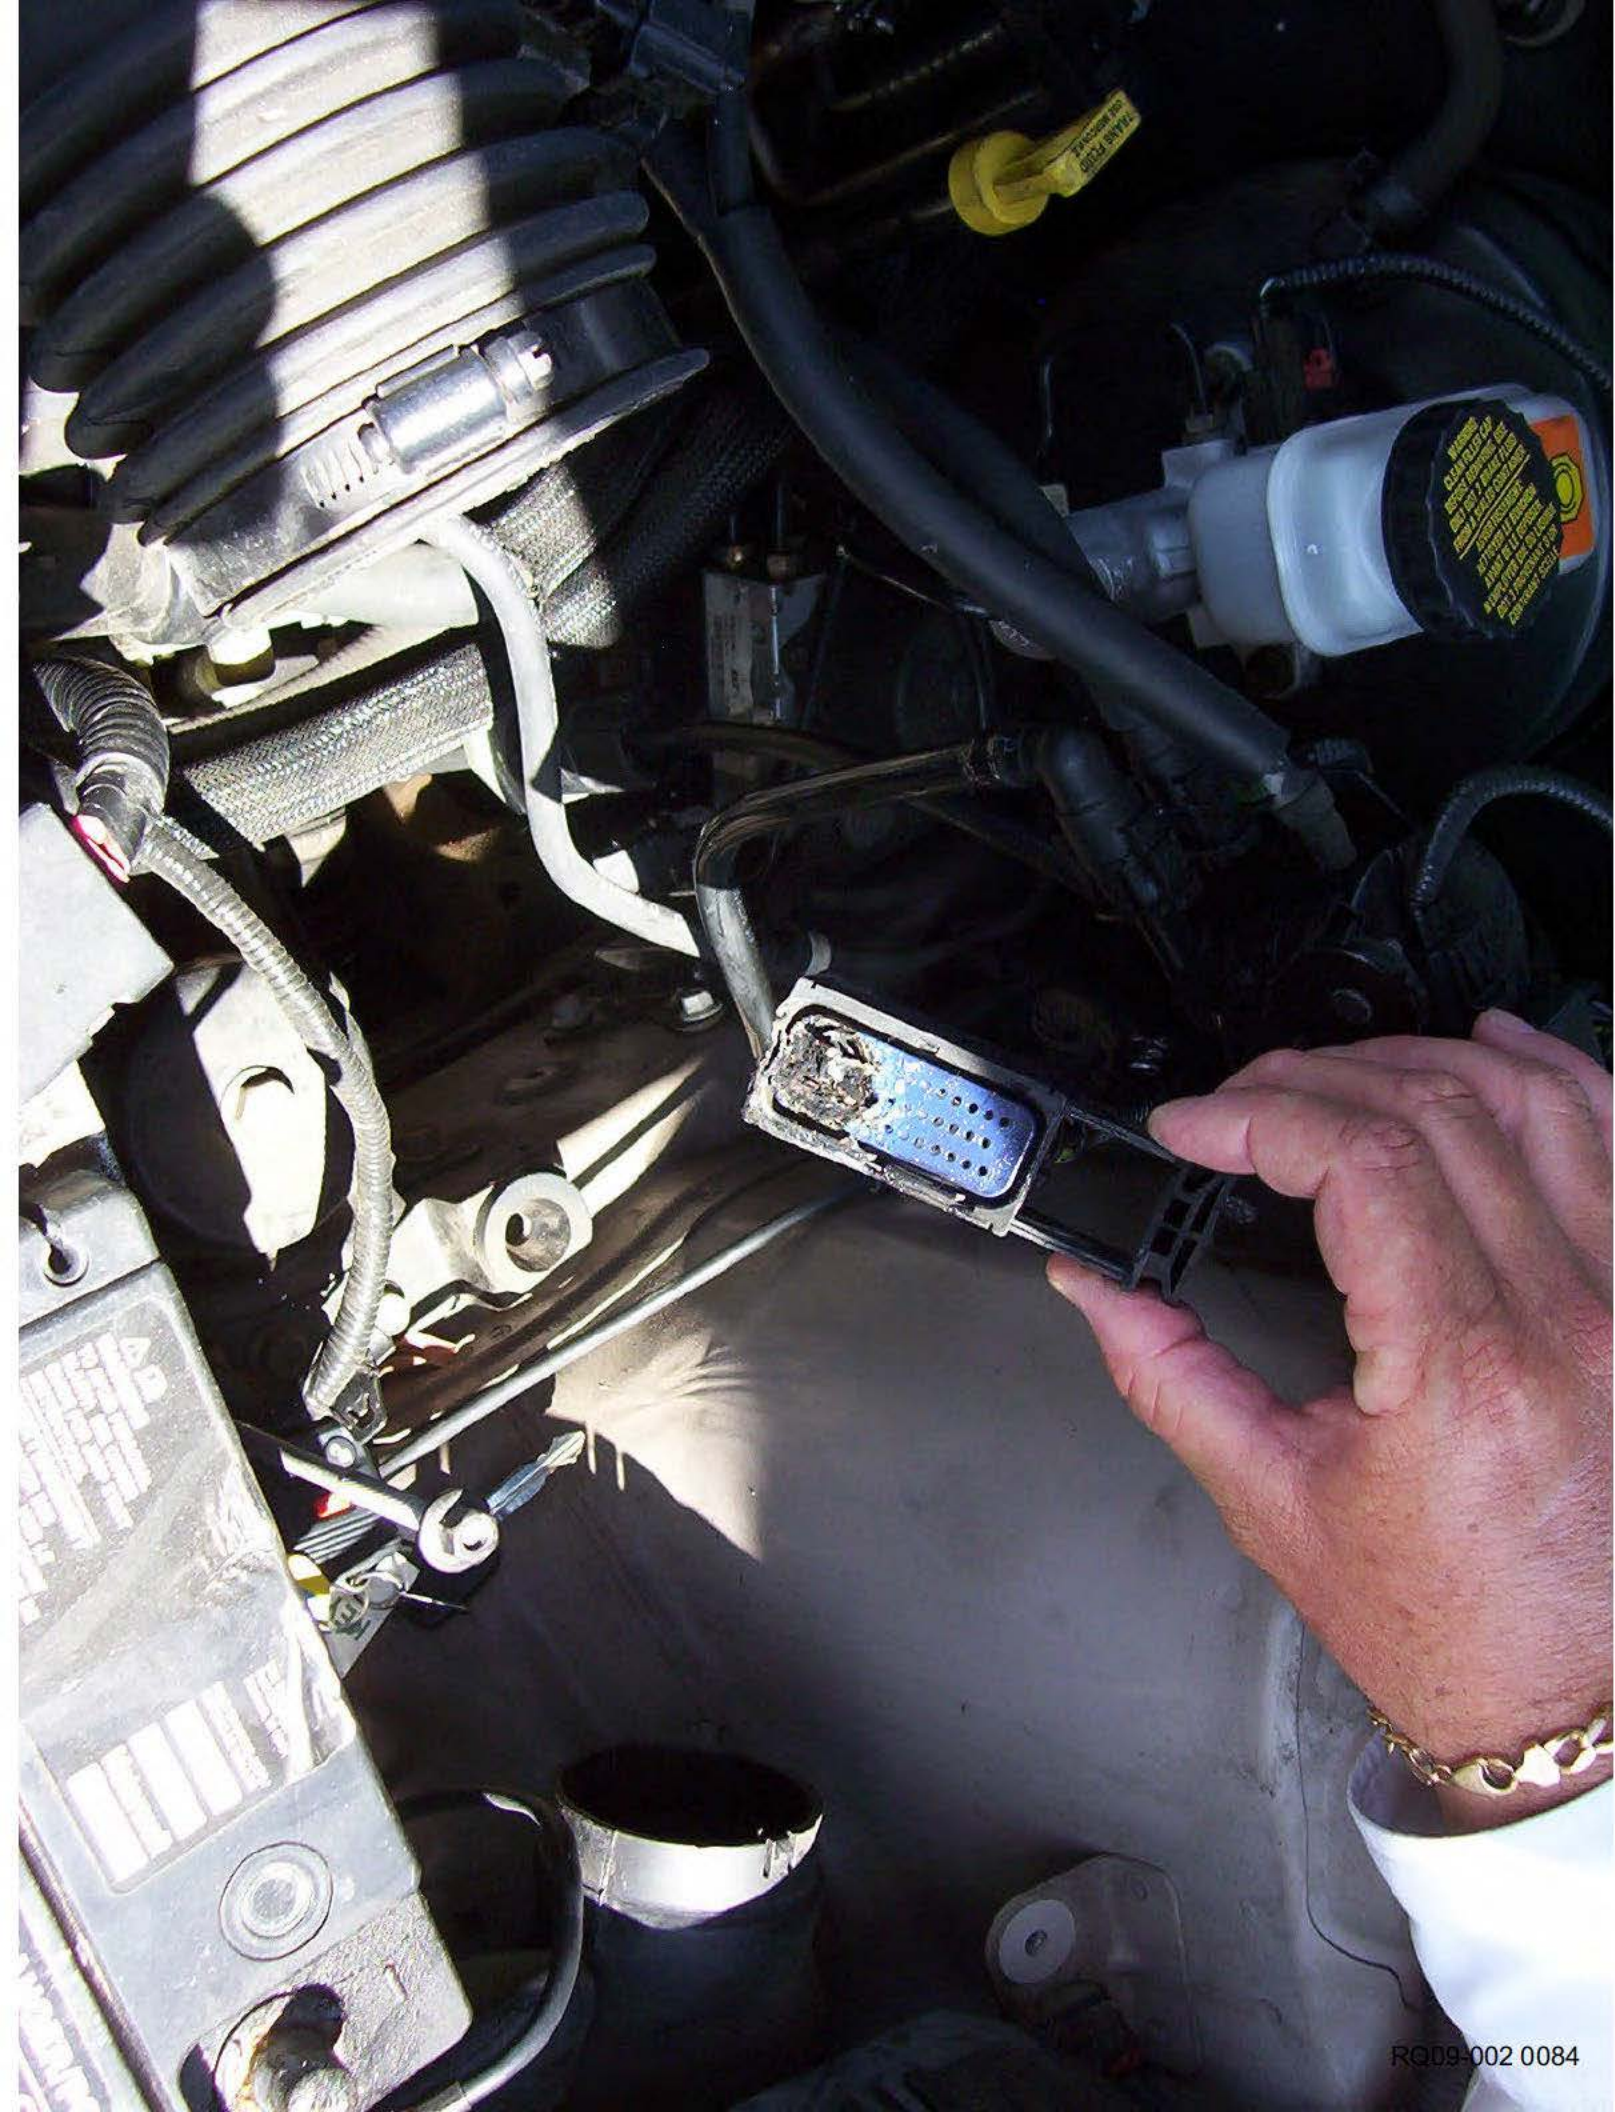
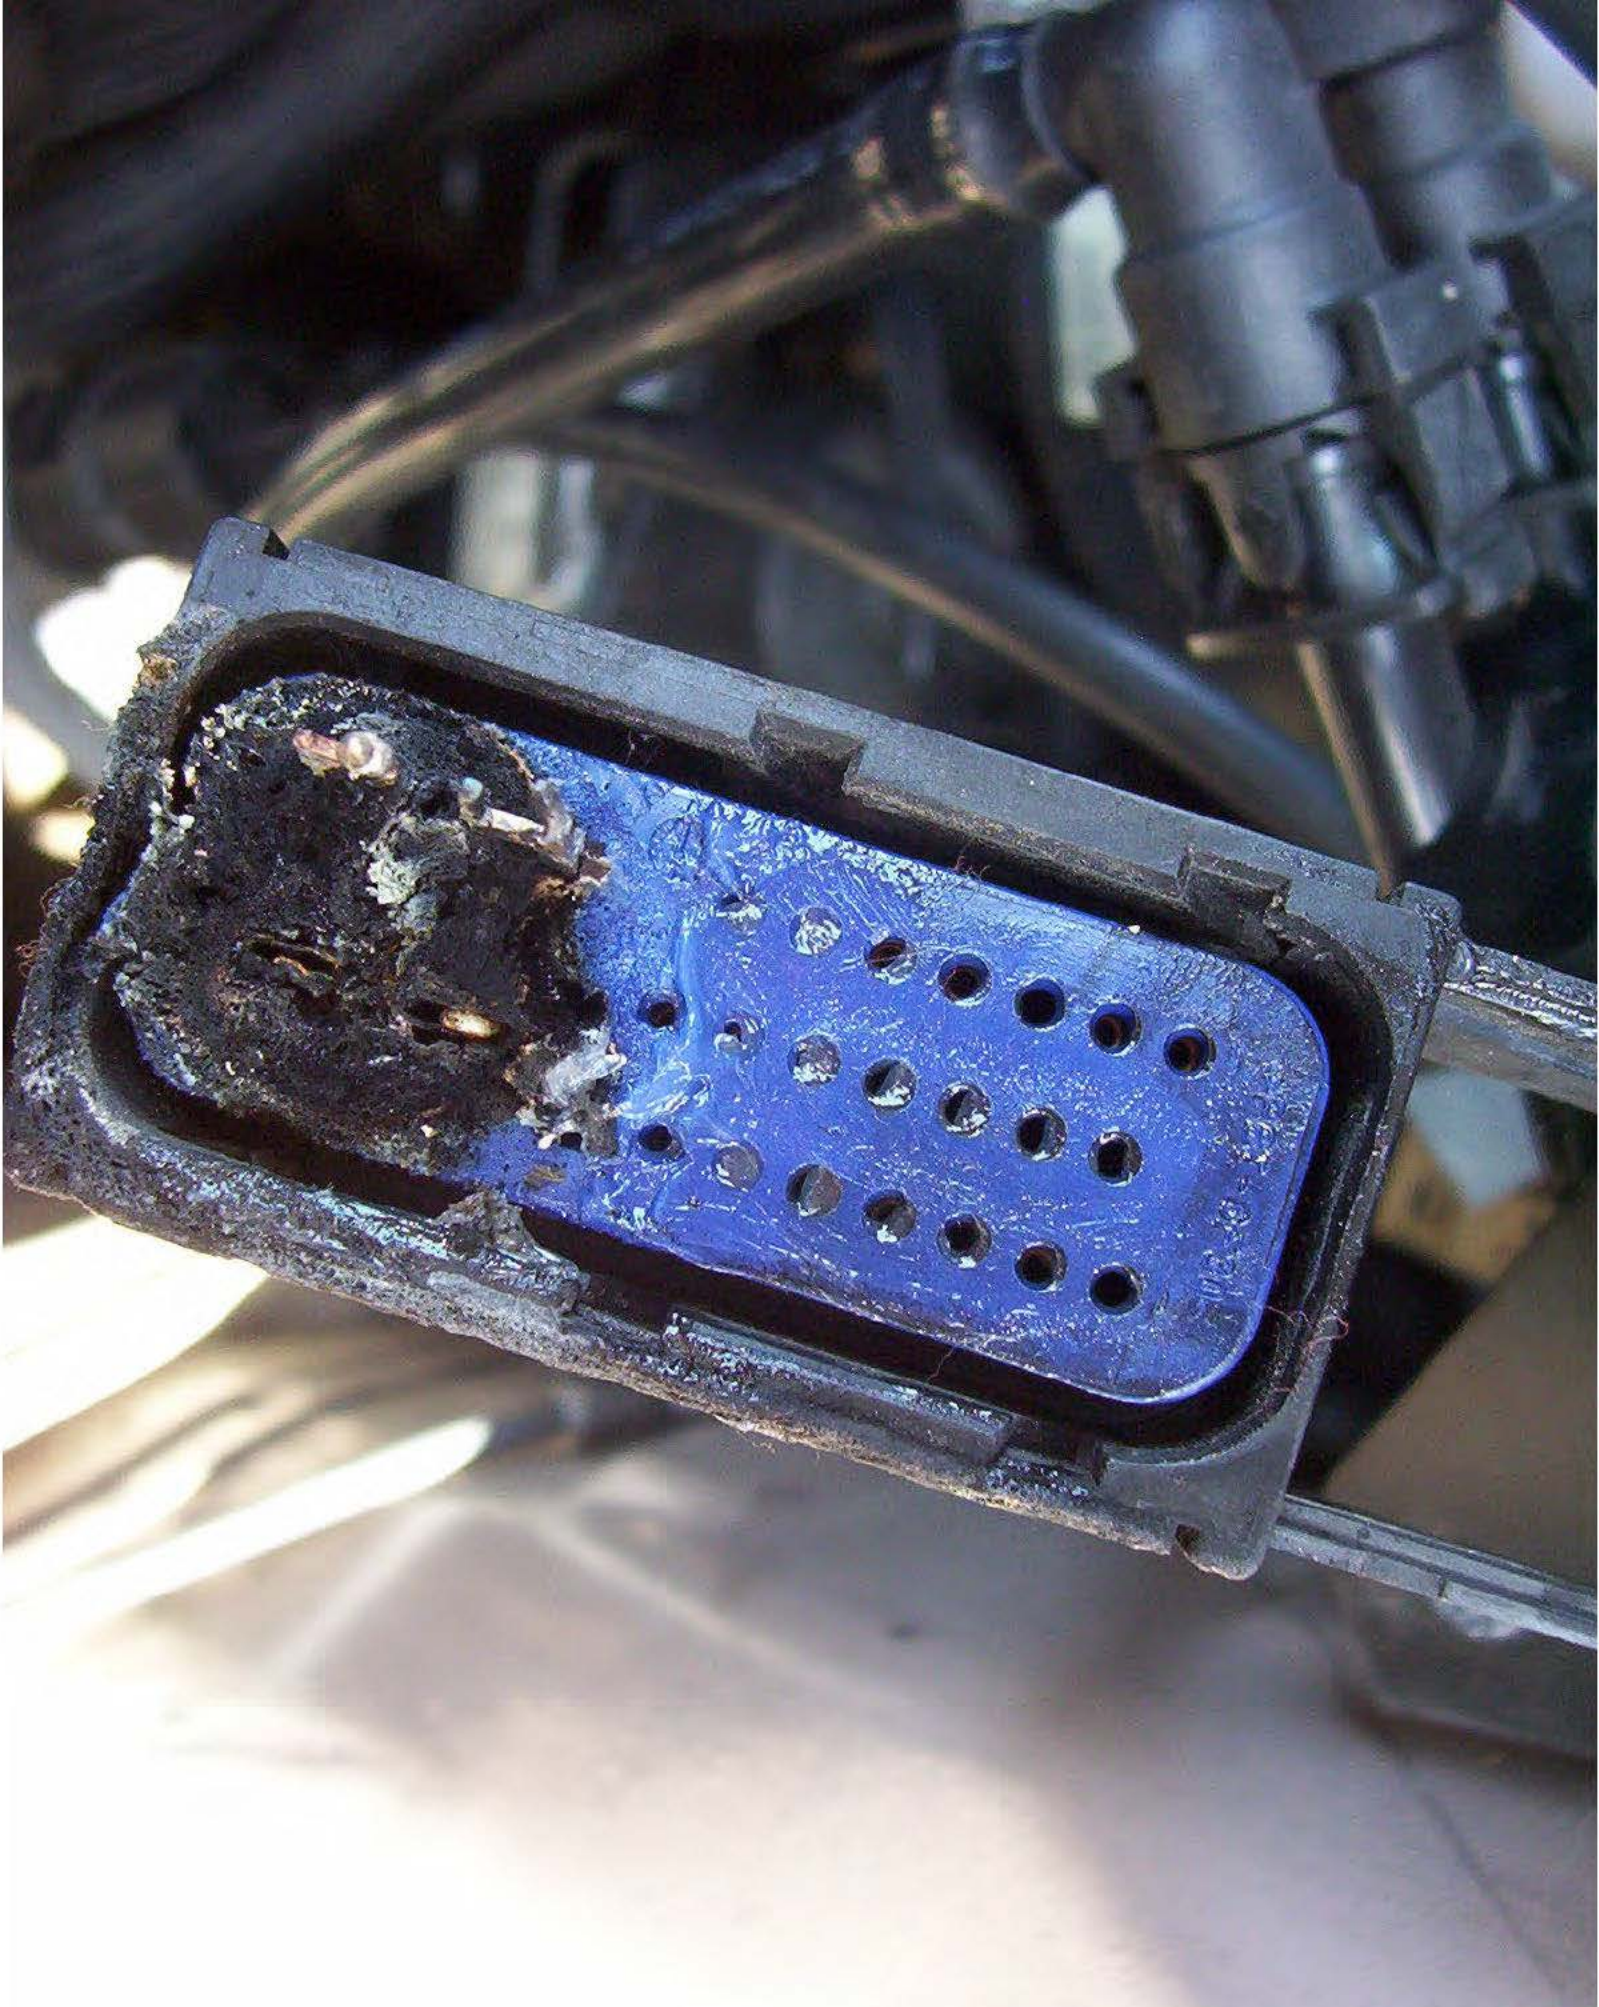
This one to me appears that they installed grease in a corroded pigtail. I am basing that on the fact that it got hot, but there are no pins left in the module at all. I can see some green corrosion on the smaller pins that did not get any grease on the extreme left of the picture.

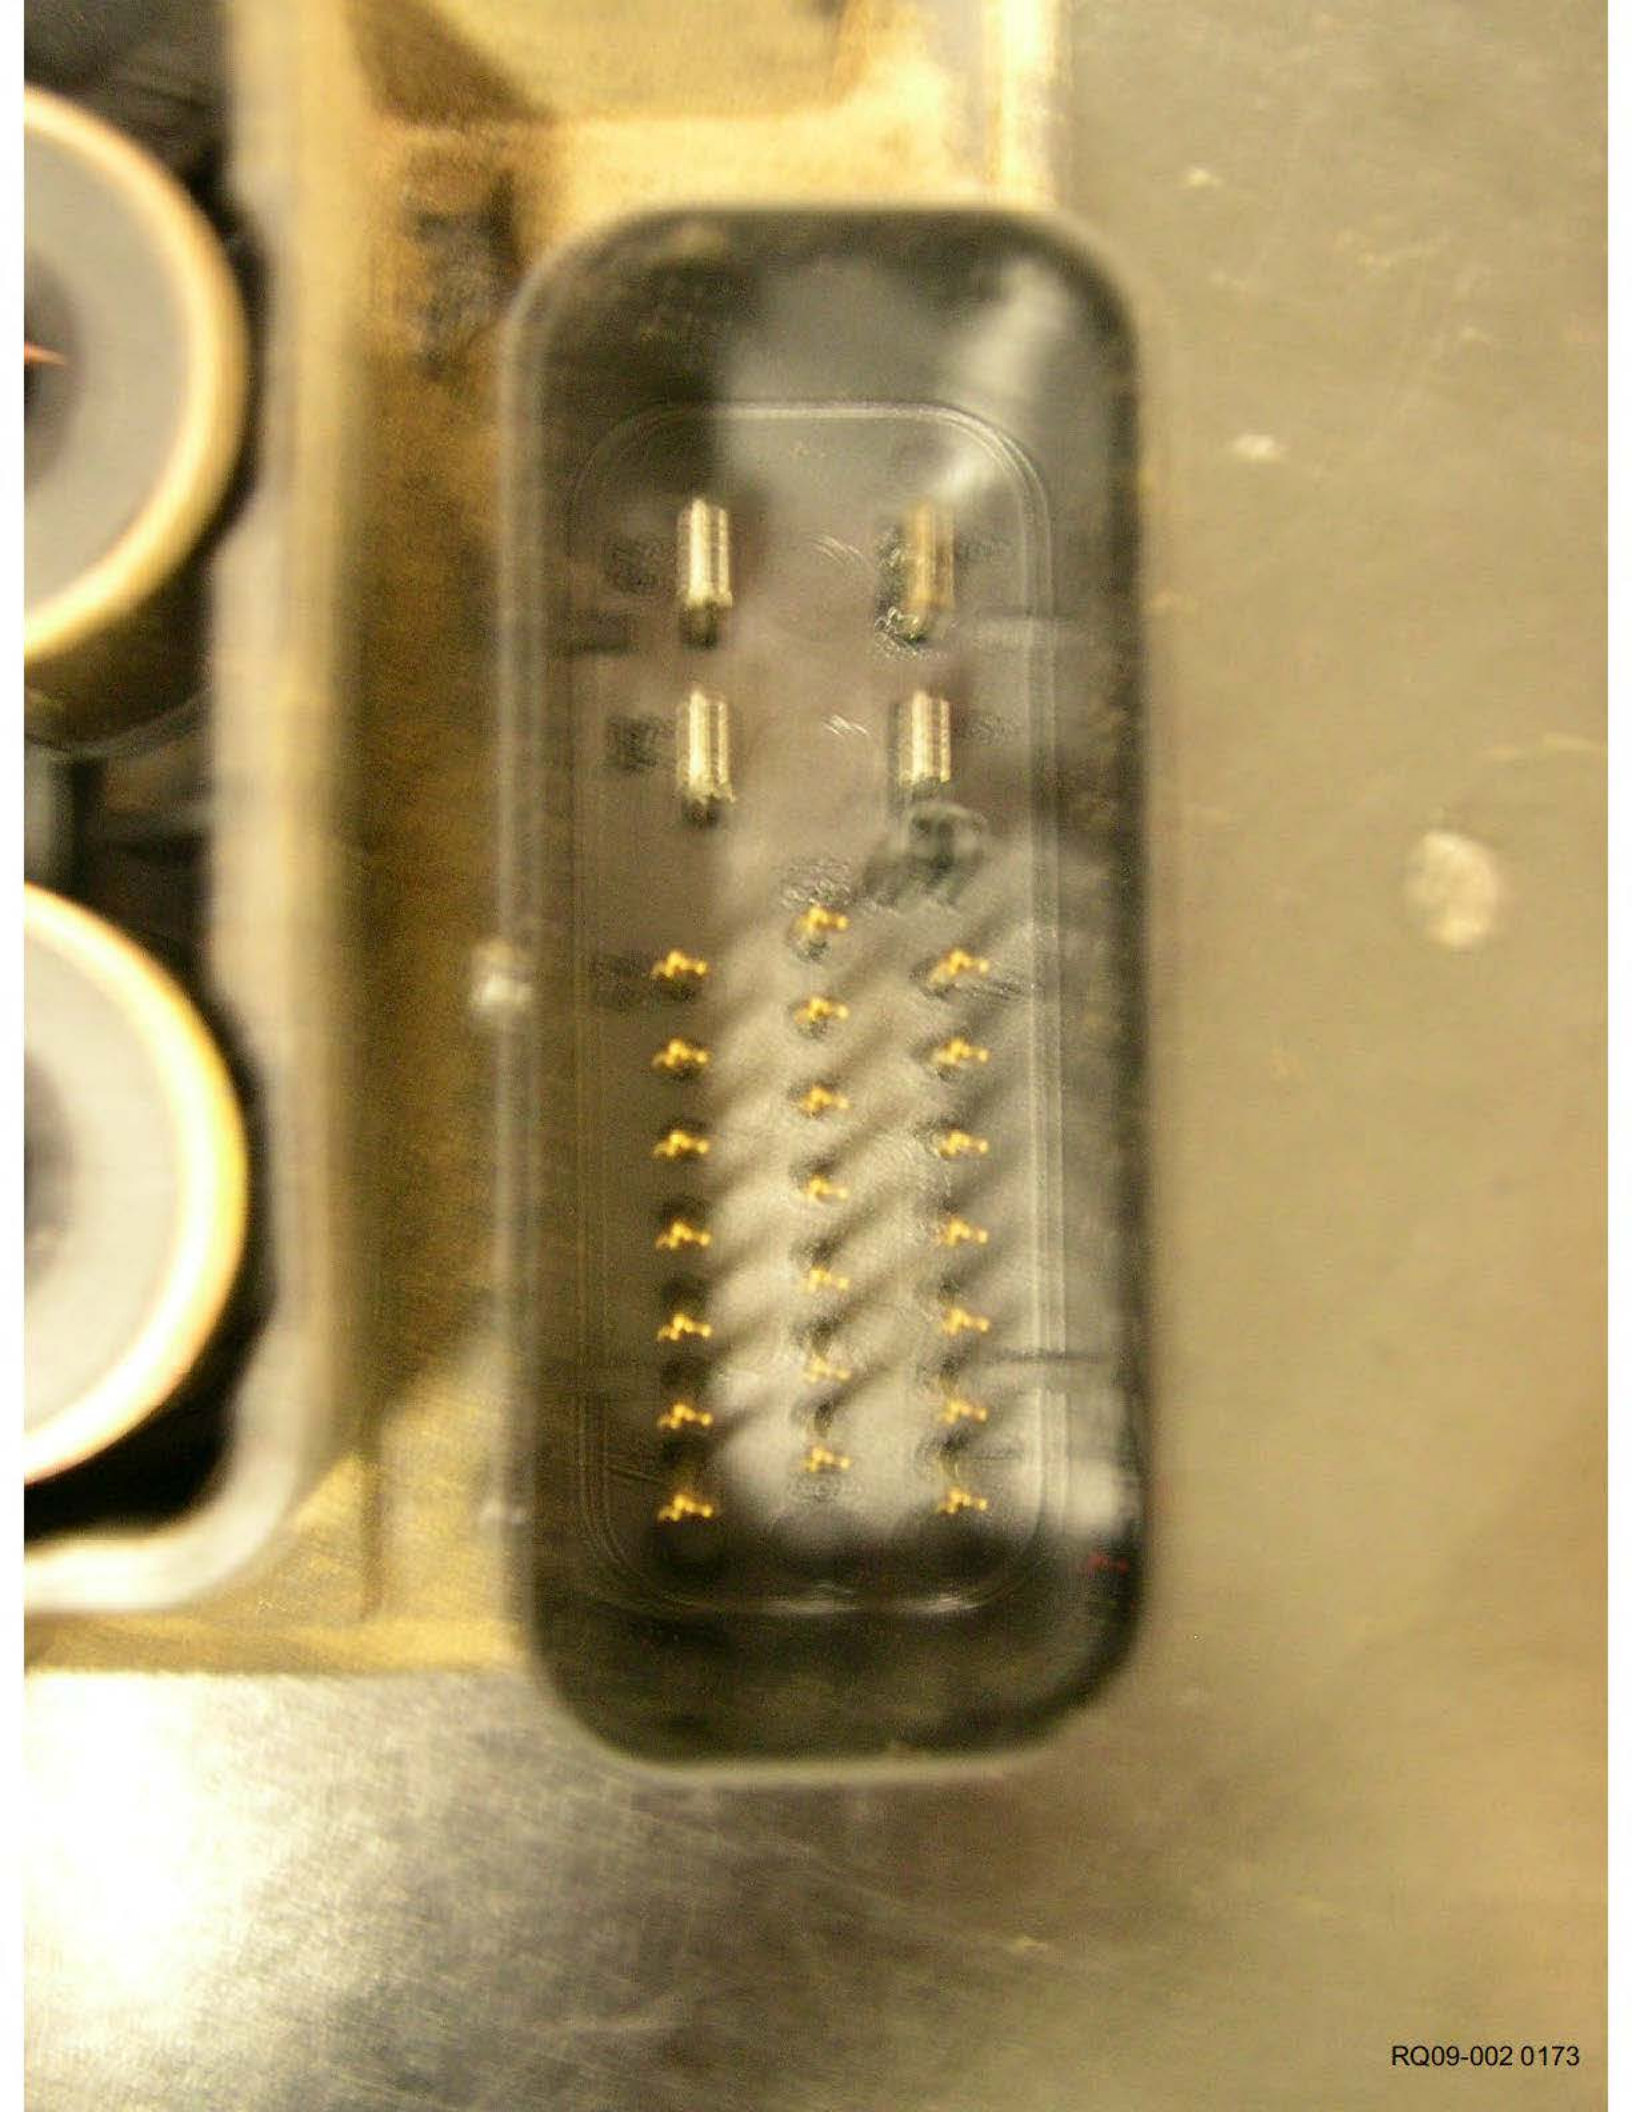
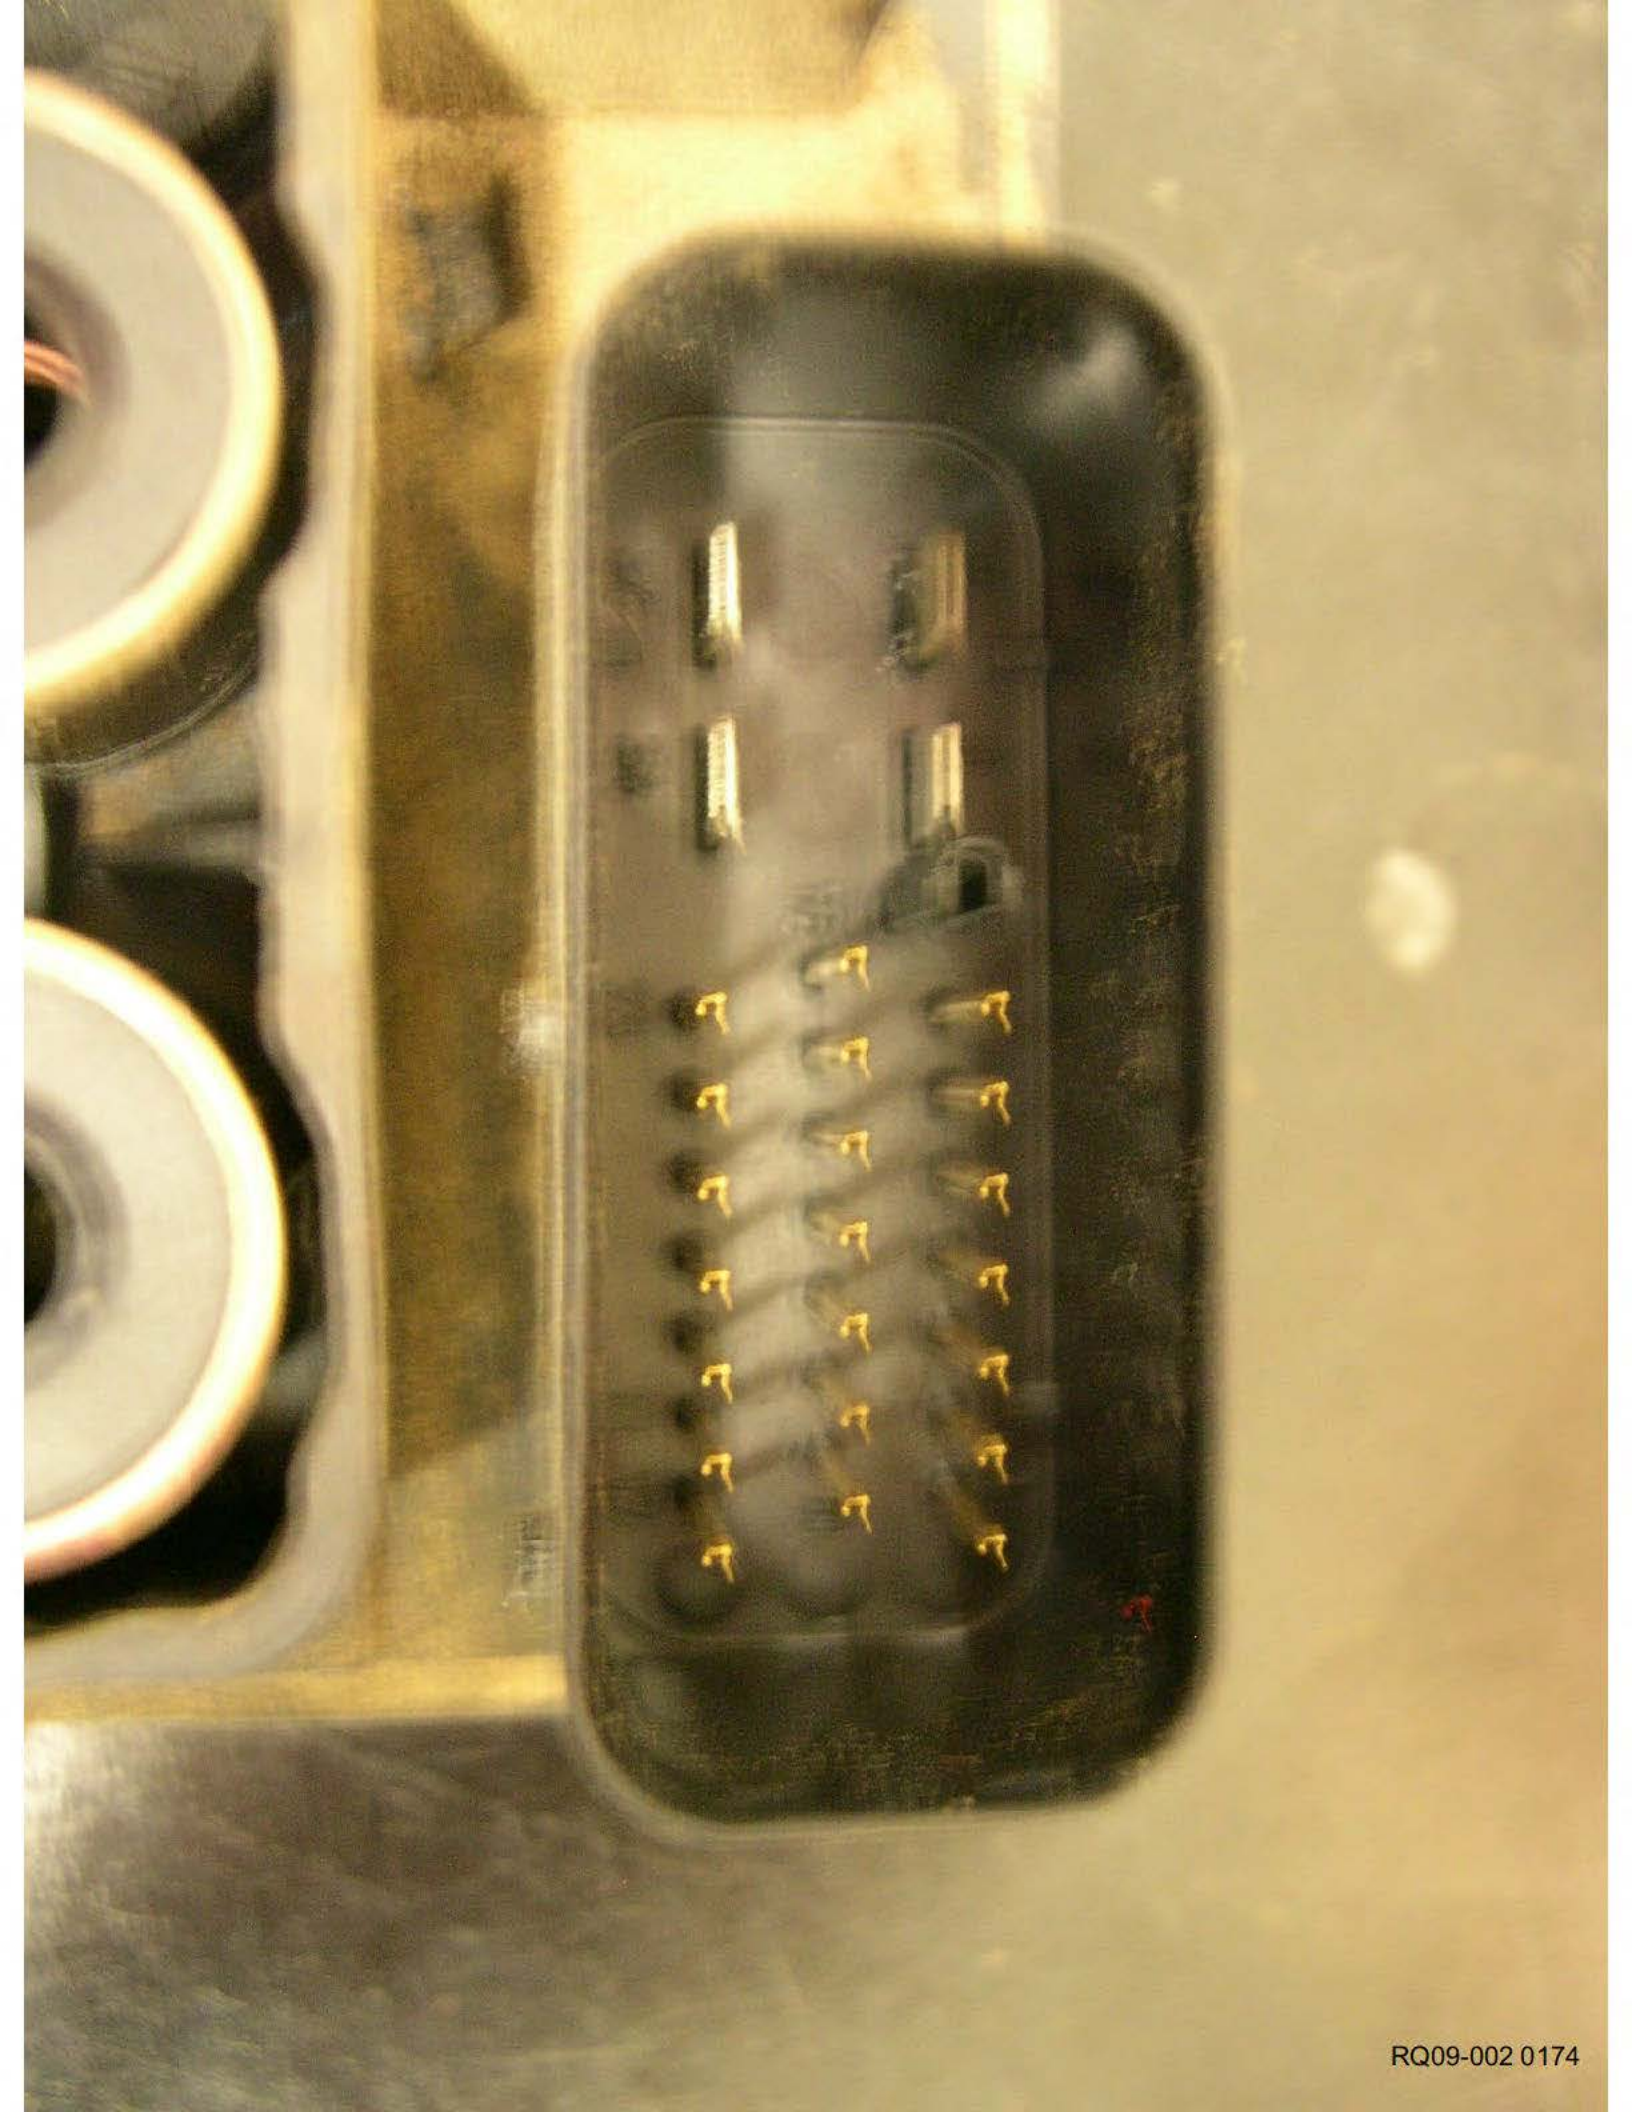
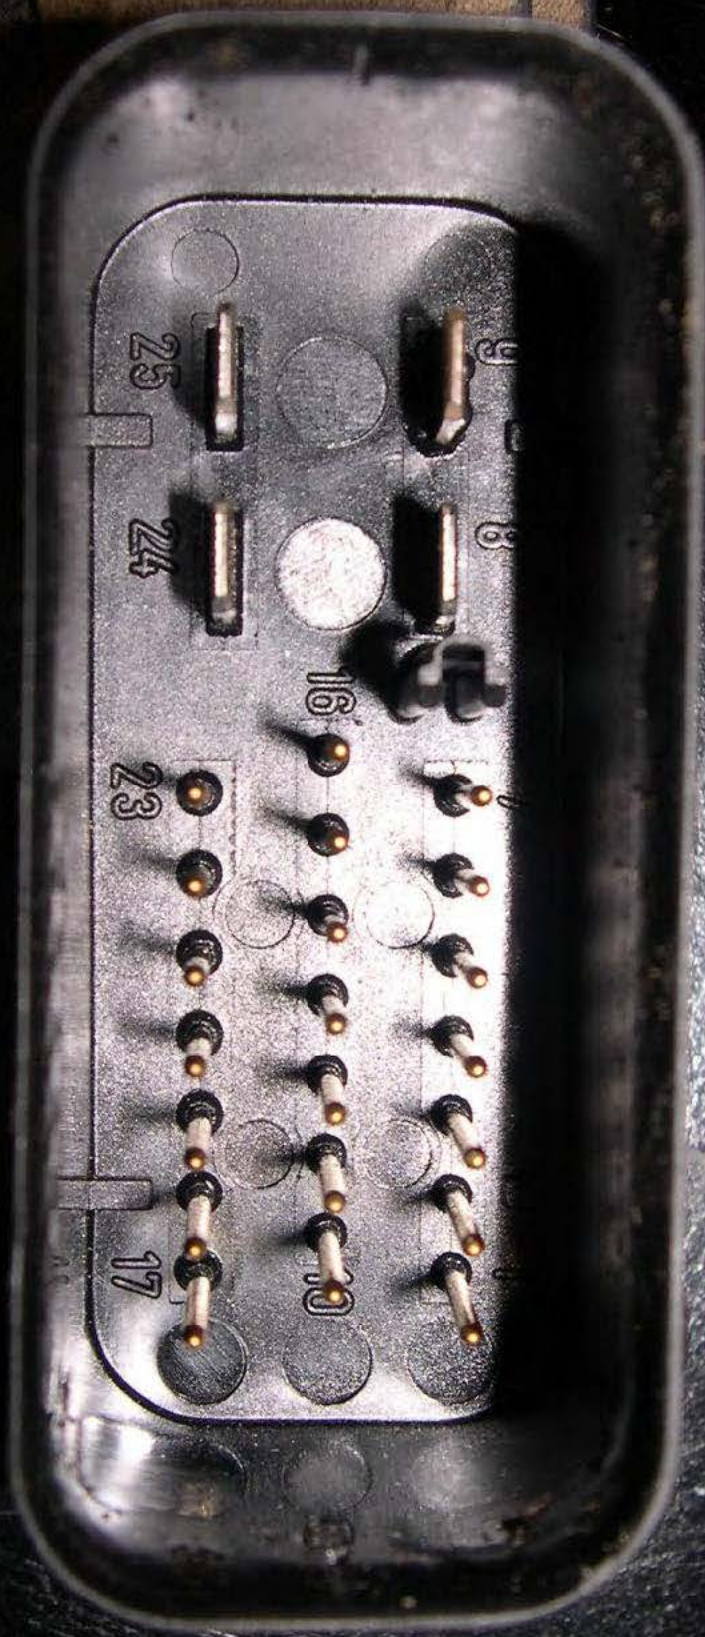
Contamination\_corrosion \_no  
grease

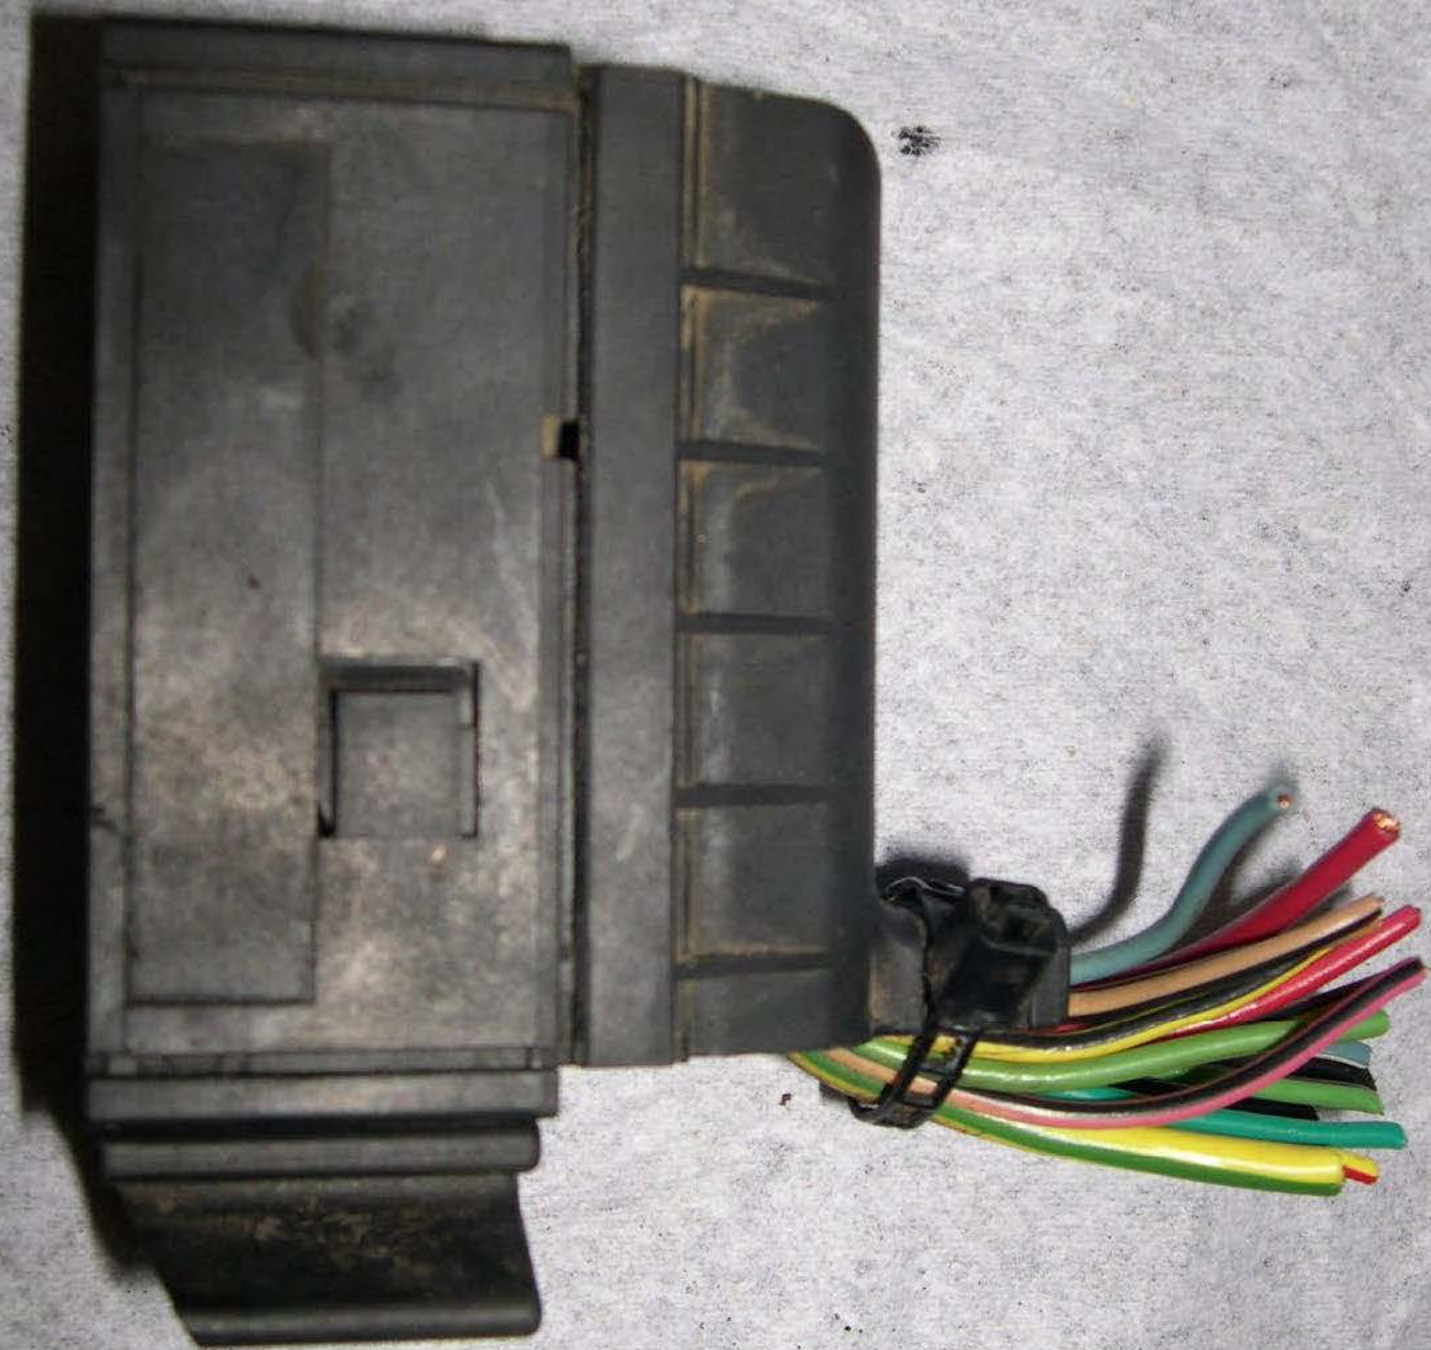
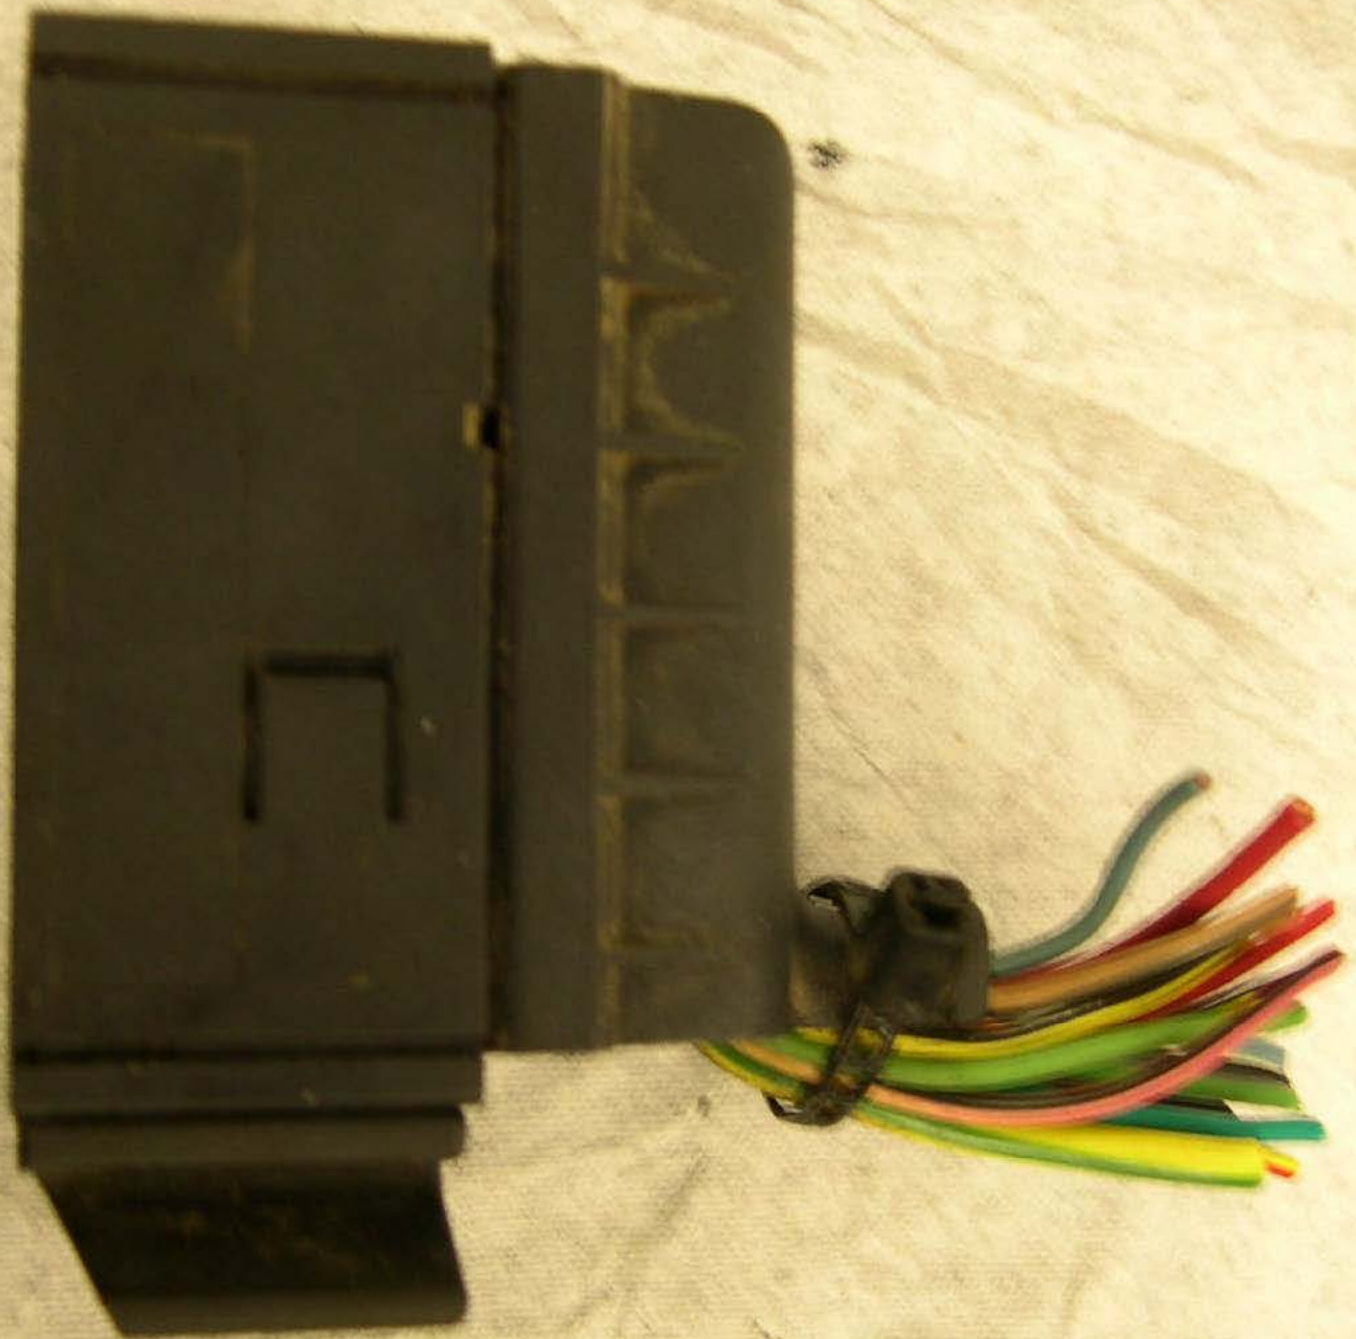
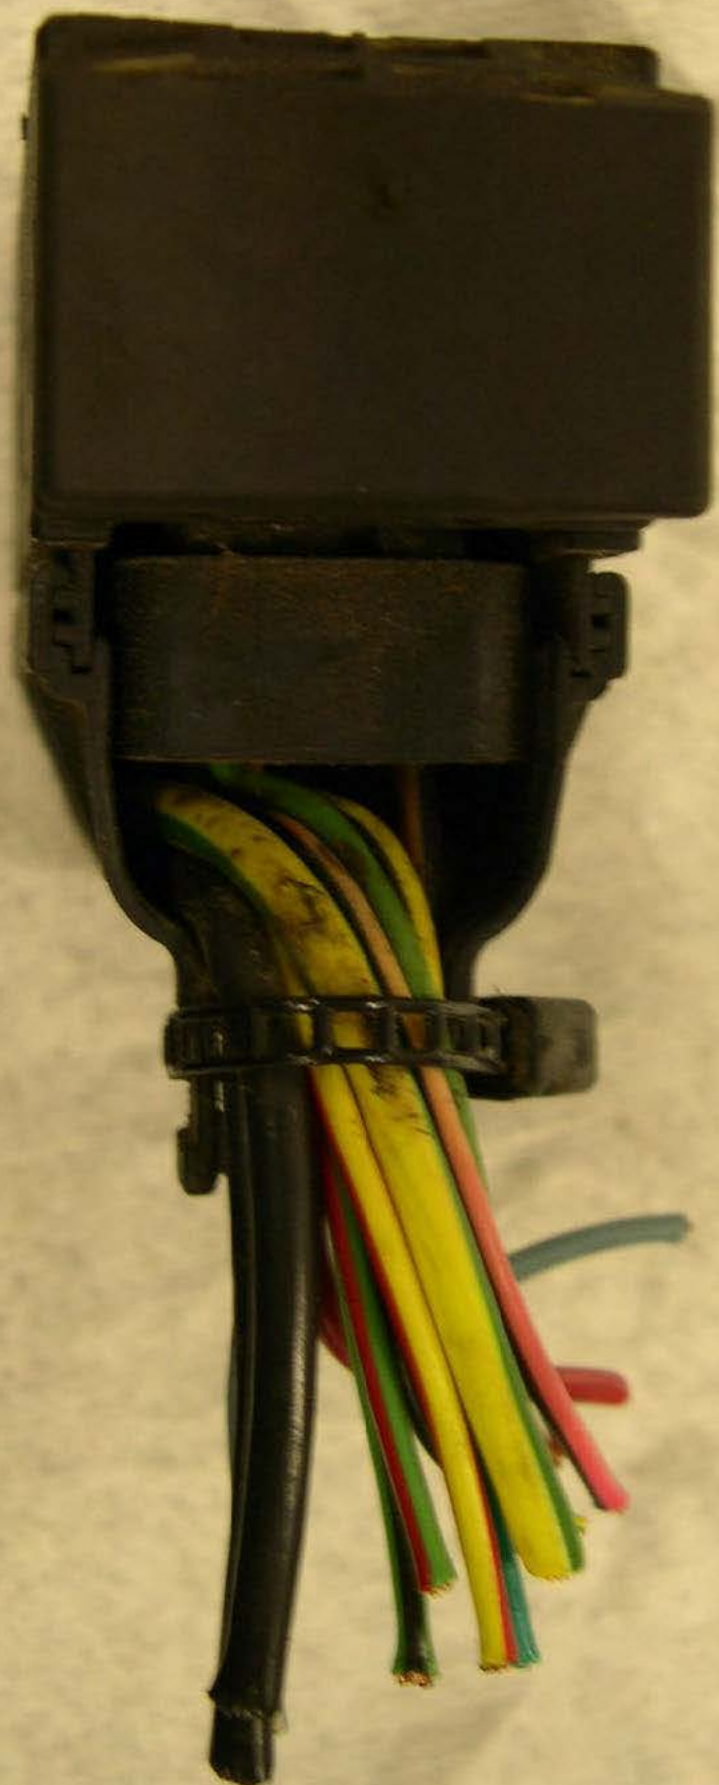
factory tie-wrap in place
