RQ09-002

FORD

c39371 grease over corrosion

**From:** Murphy, Gregory [mailto:MurphyG1@autonation.com]  
**Sent:** Thursday, September 06, 2007 8:21 PM  
**To:** sssc@renkim.com  
**Subject:** 2001 escape fire at abs control module pig tail

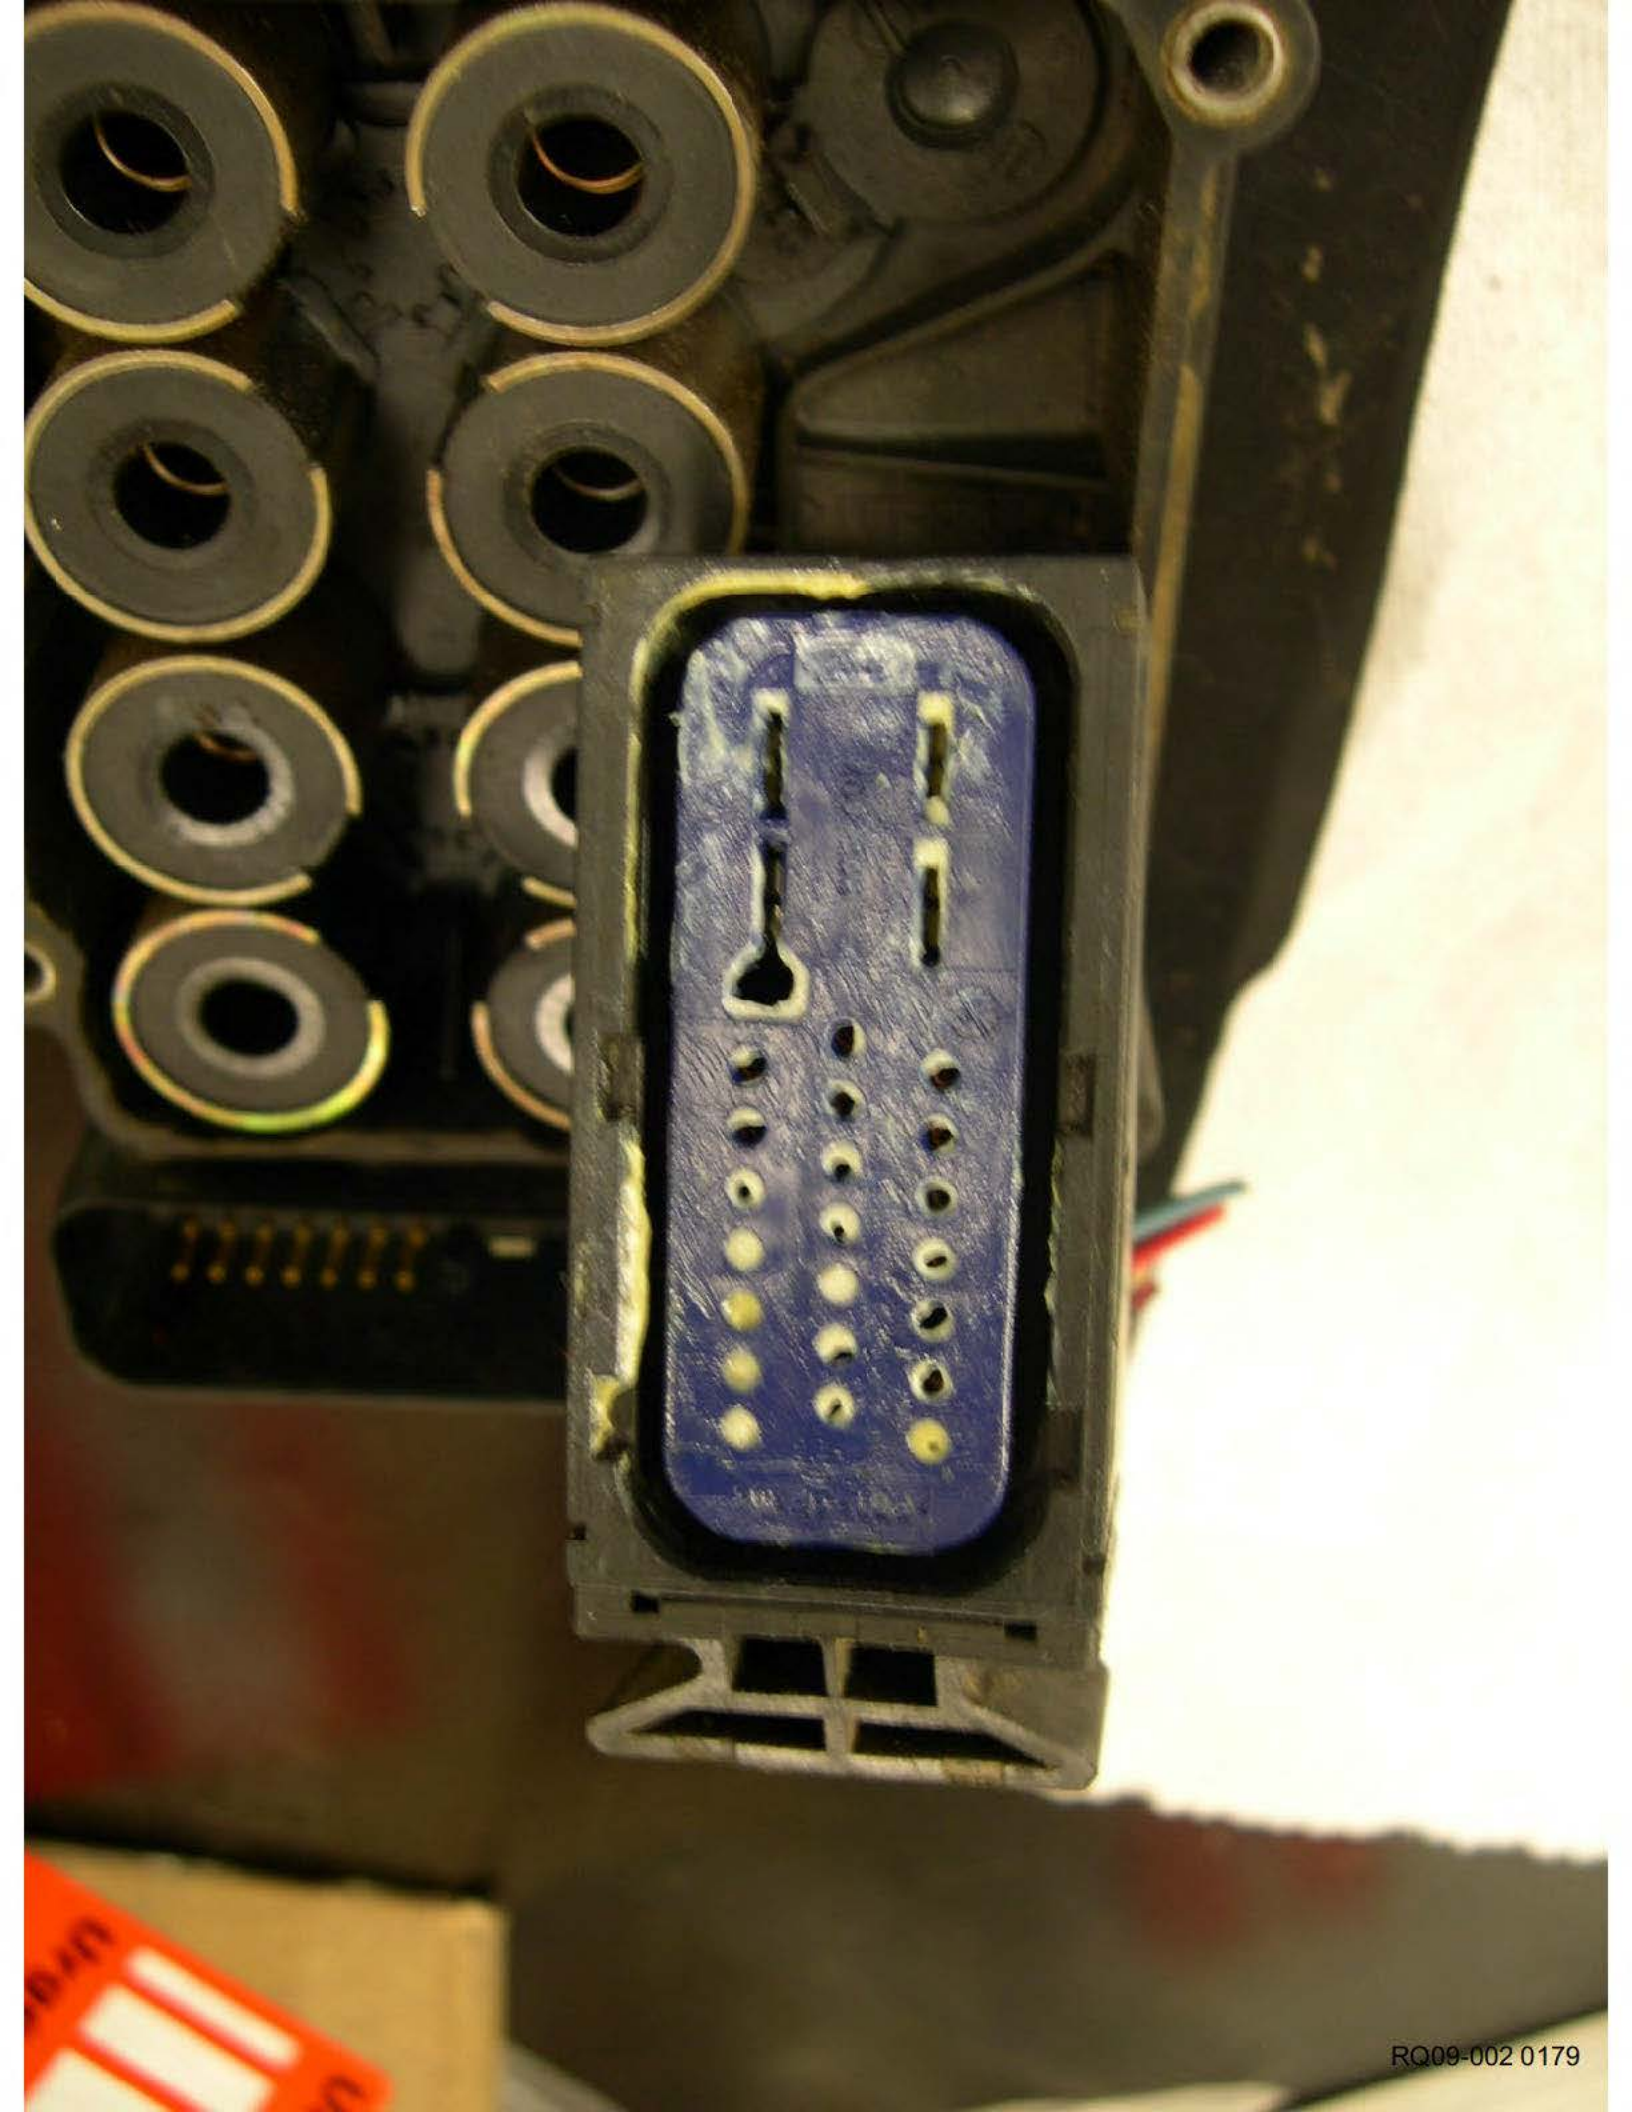
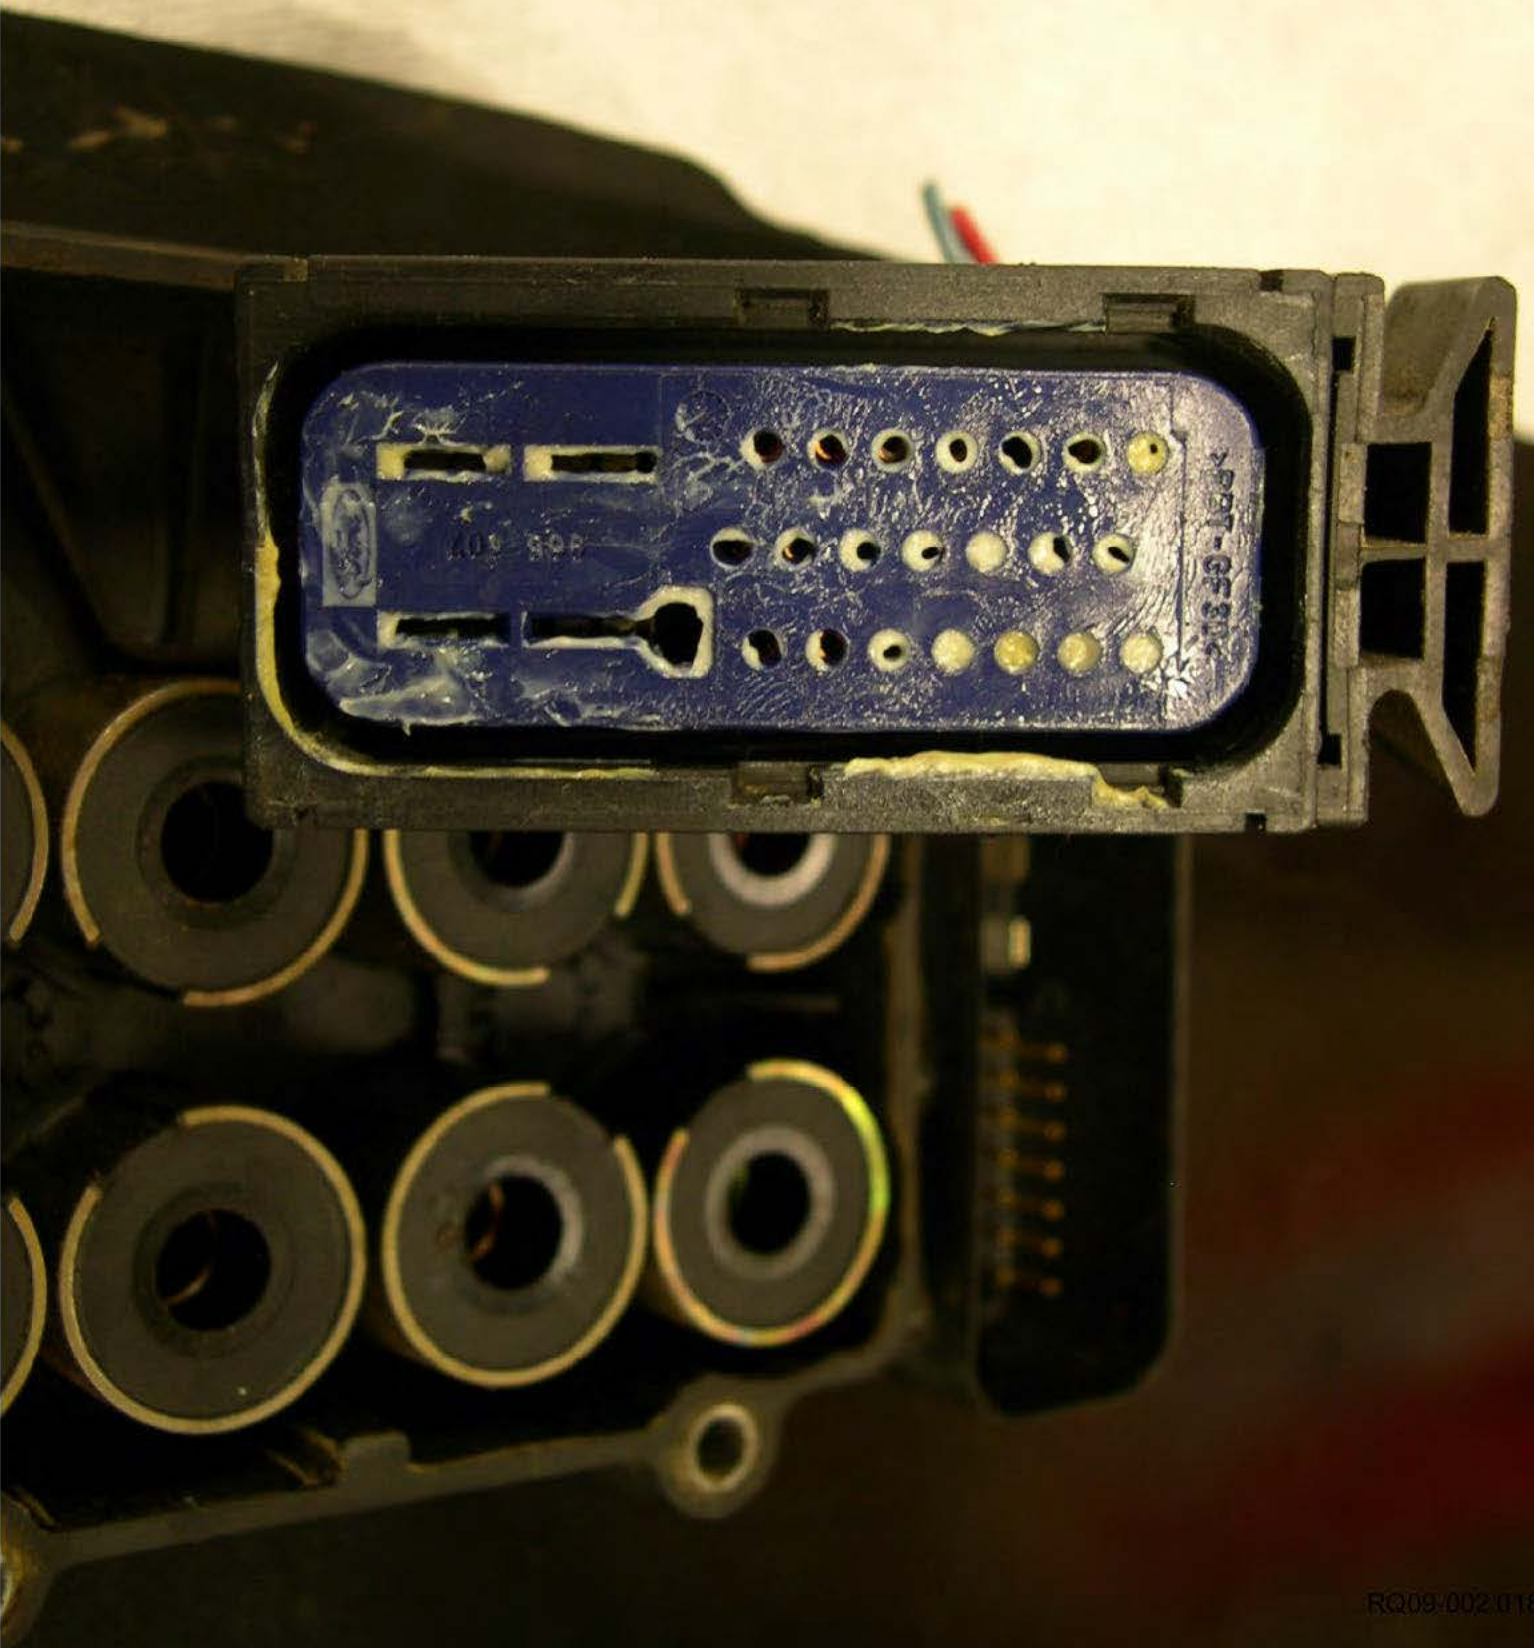
incorrect grease

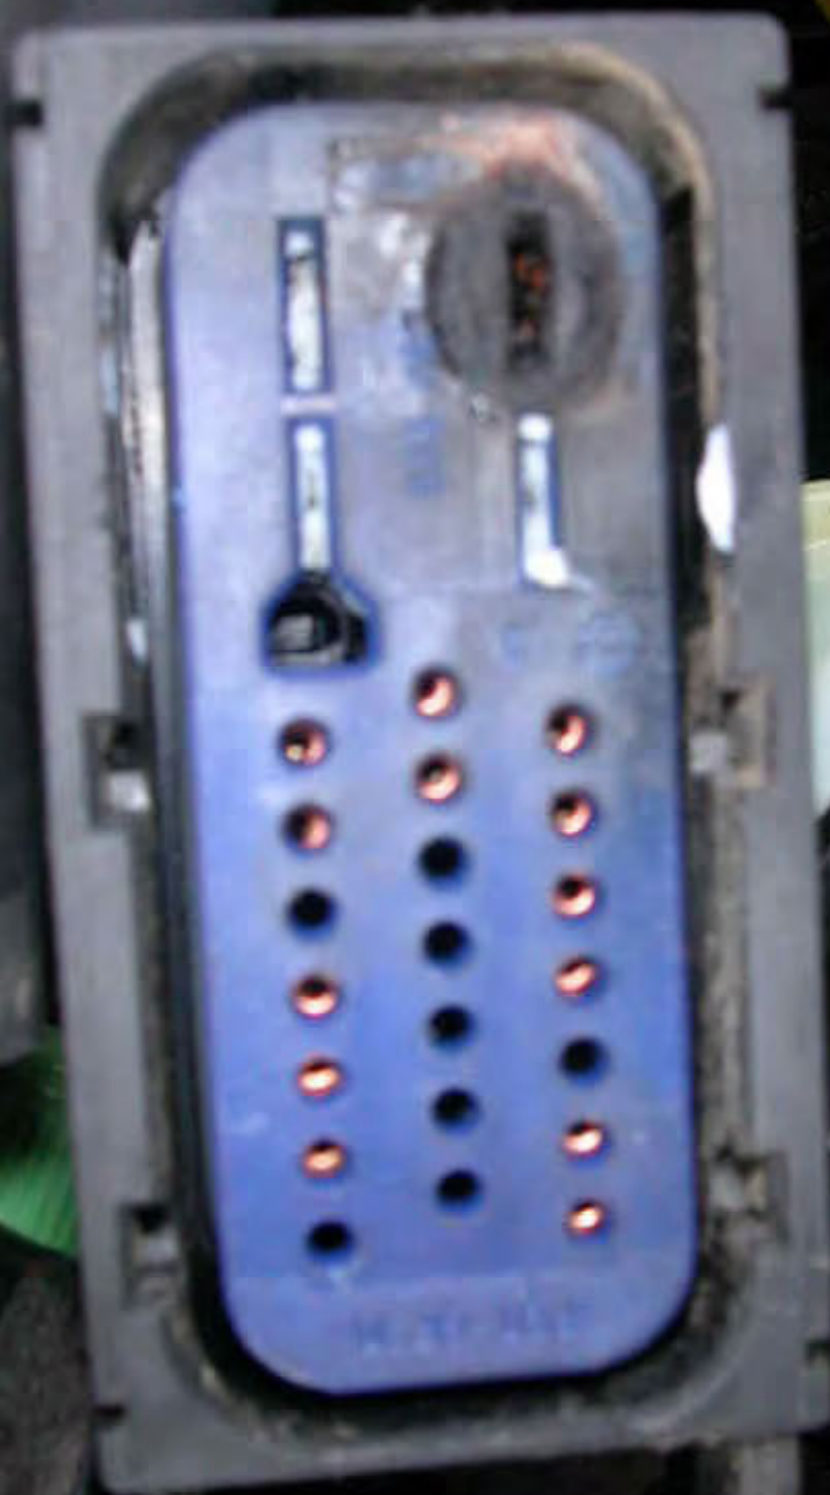
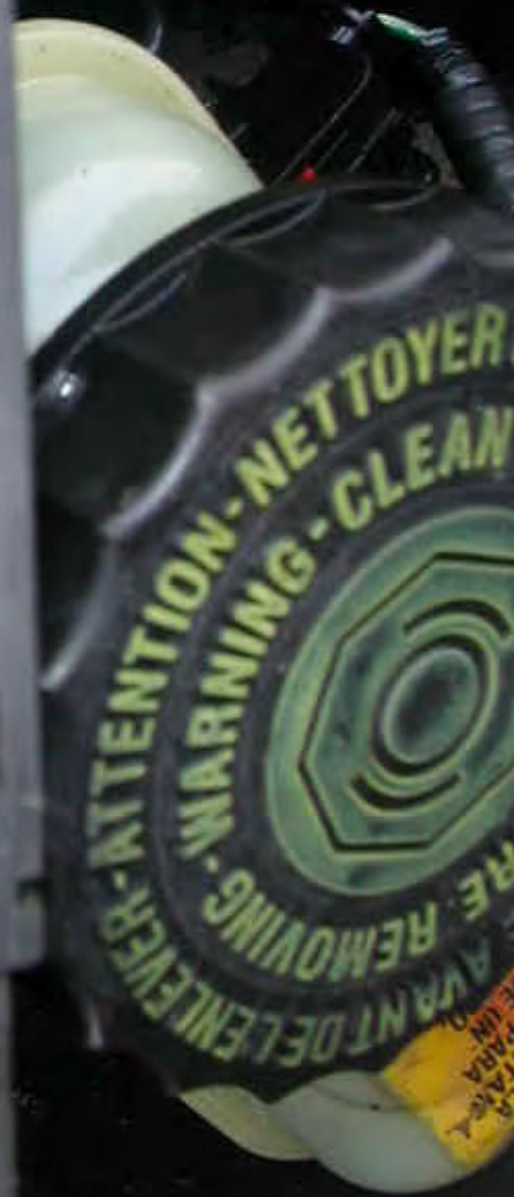
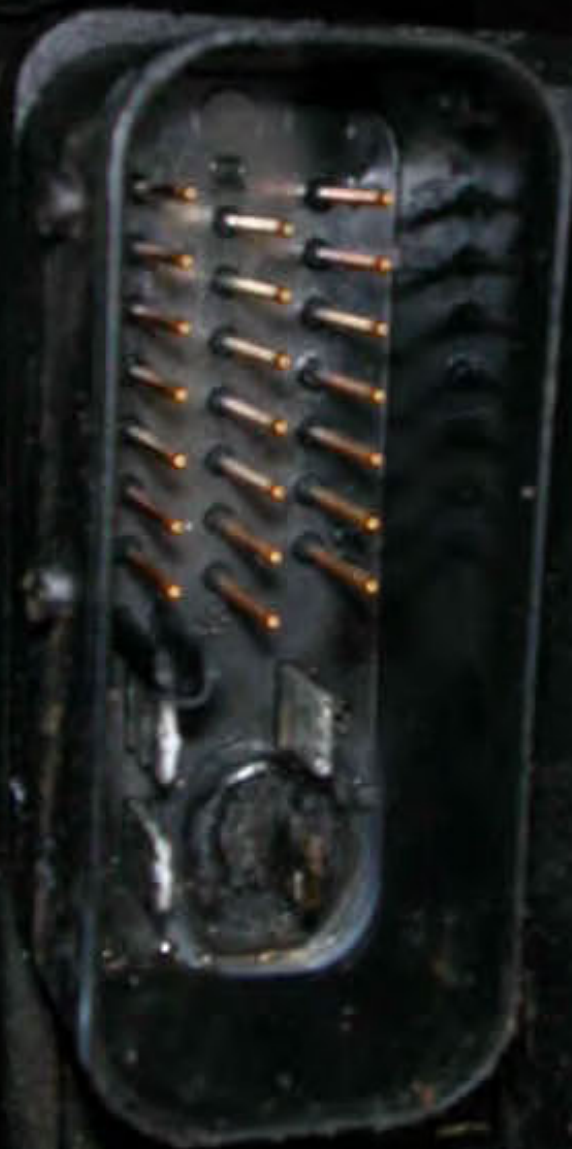
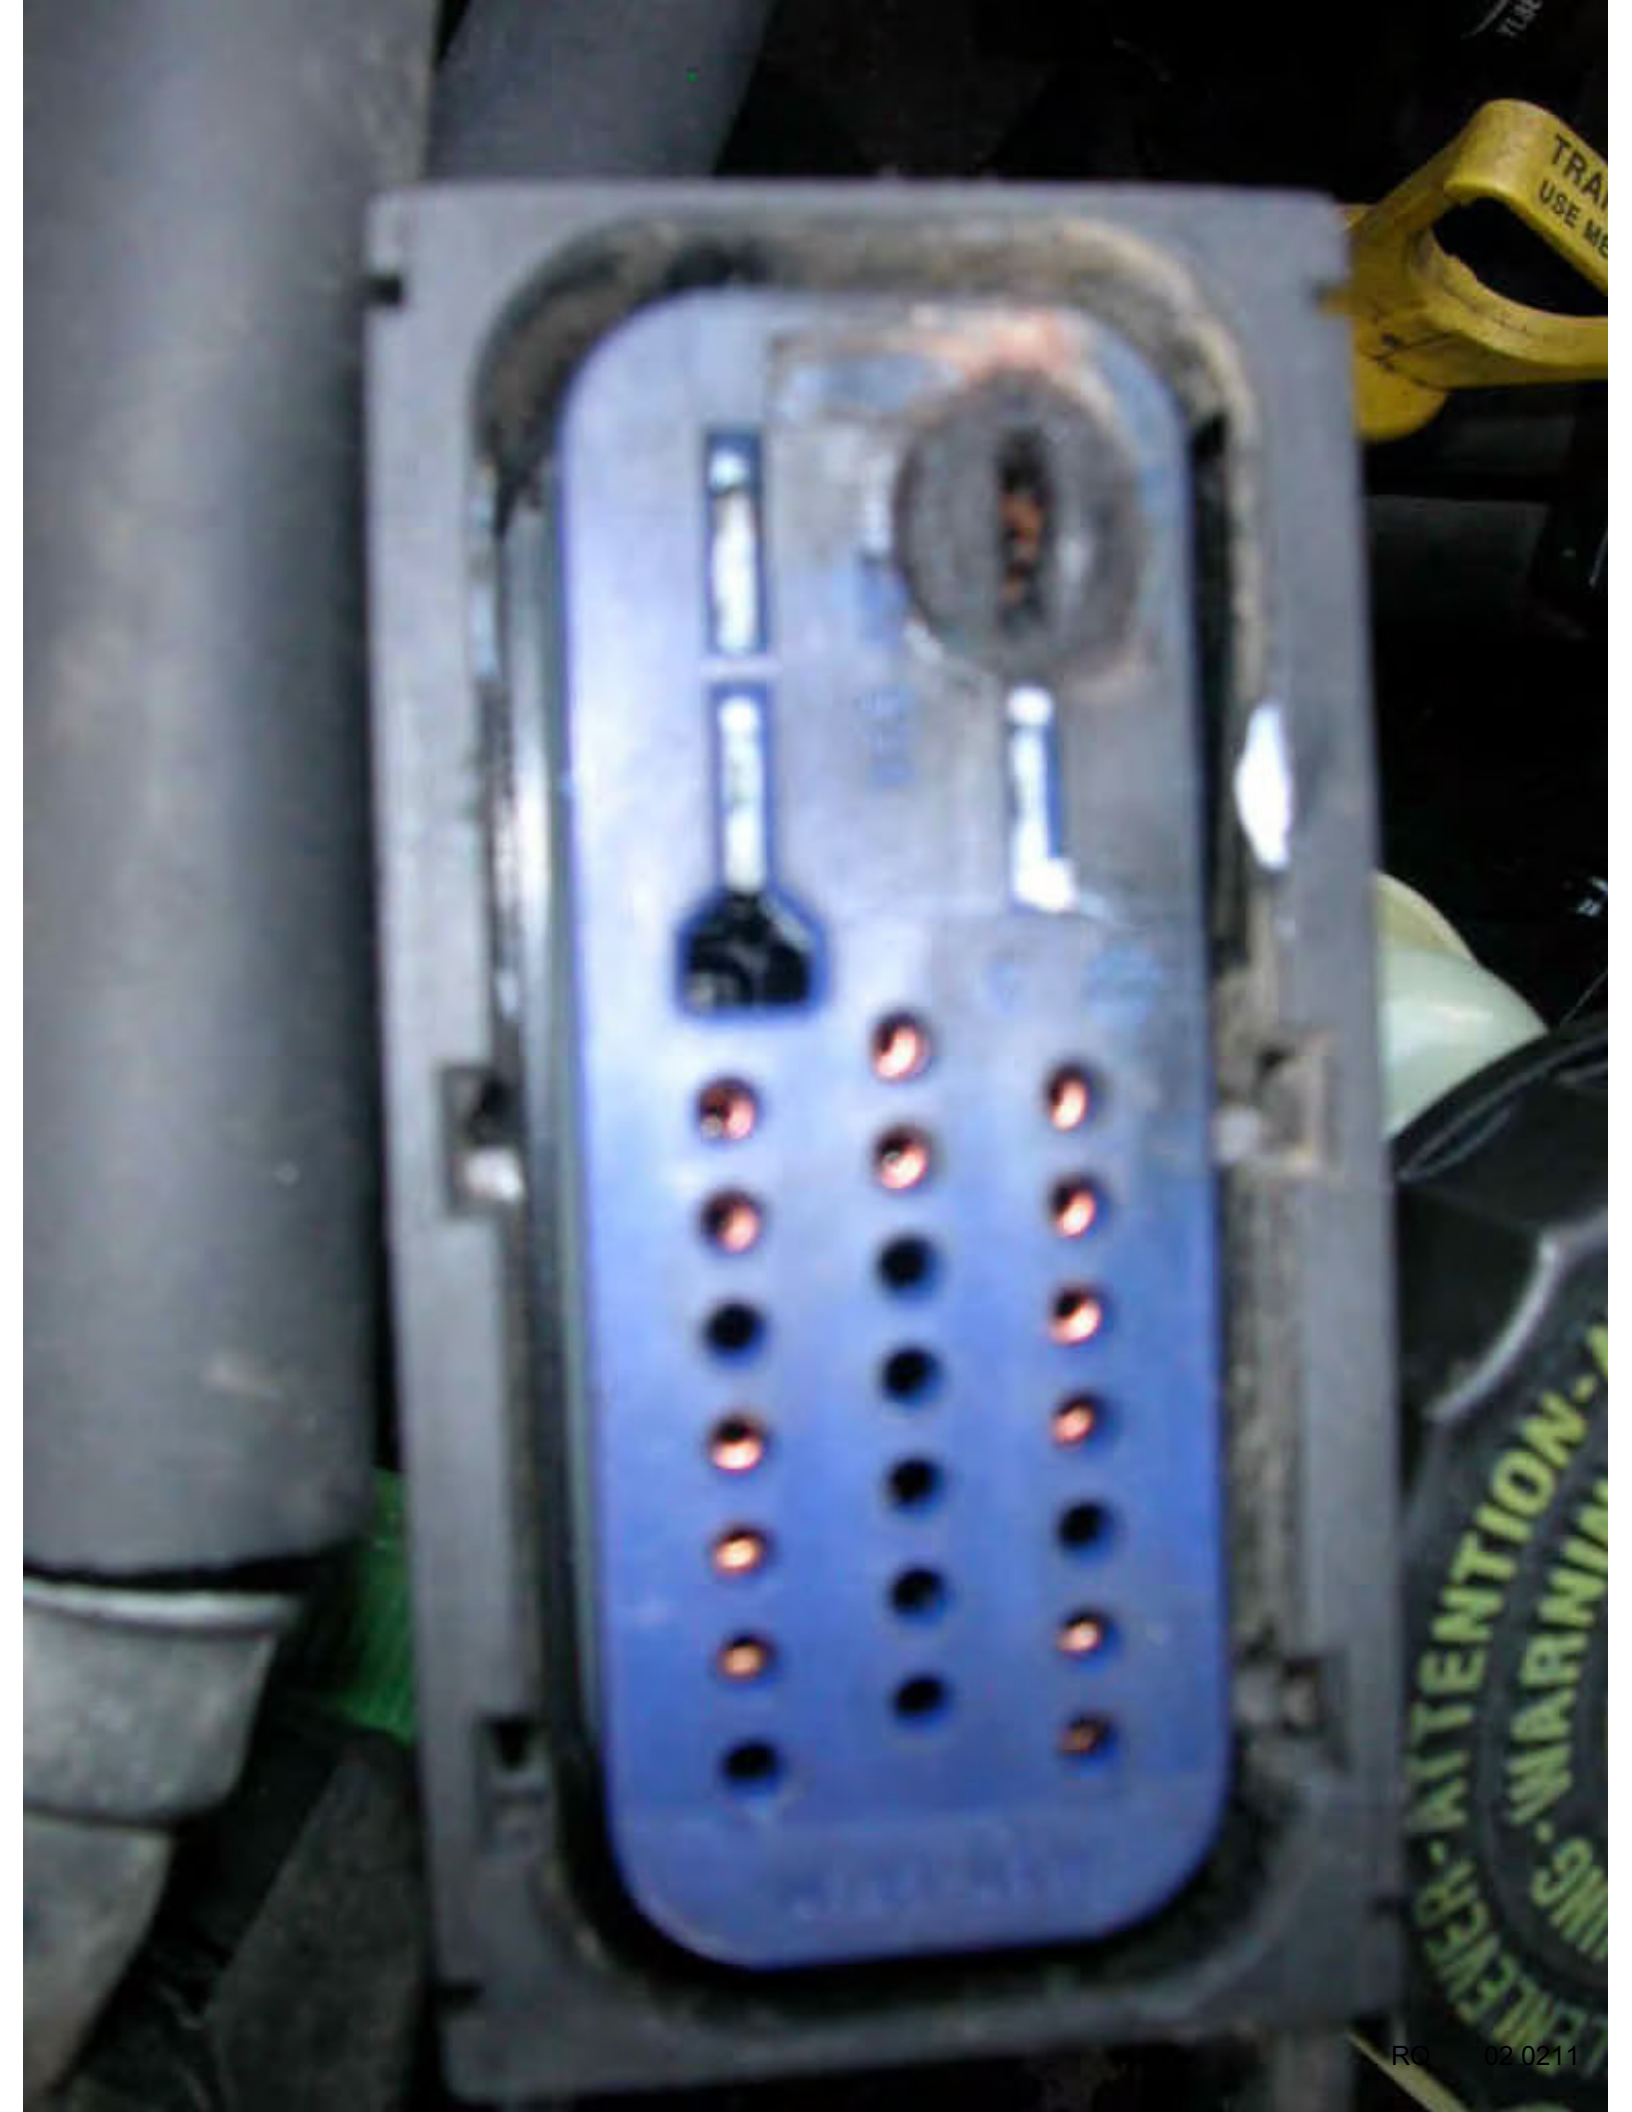
insufficient grease

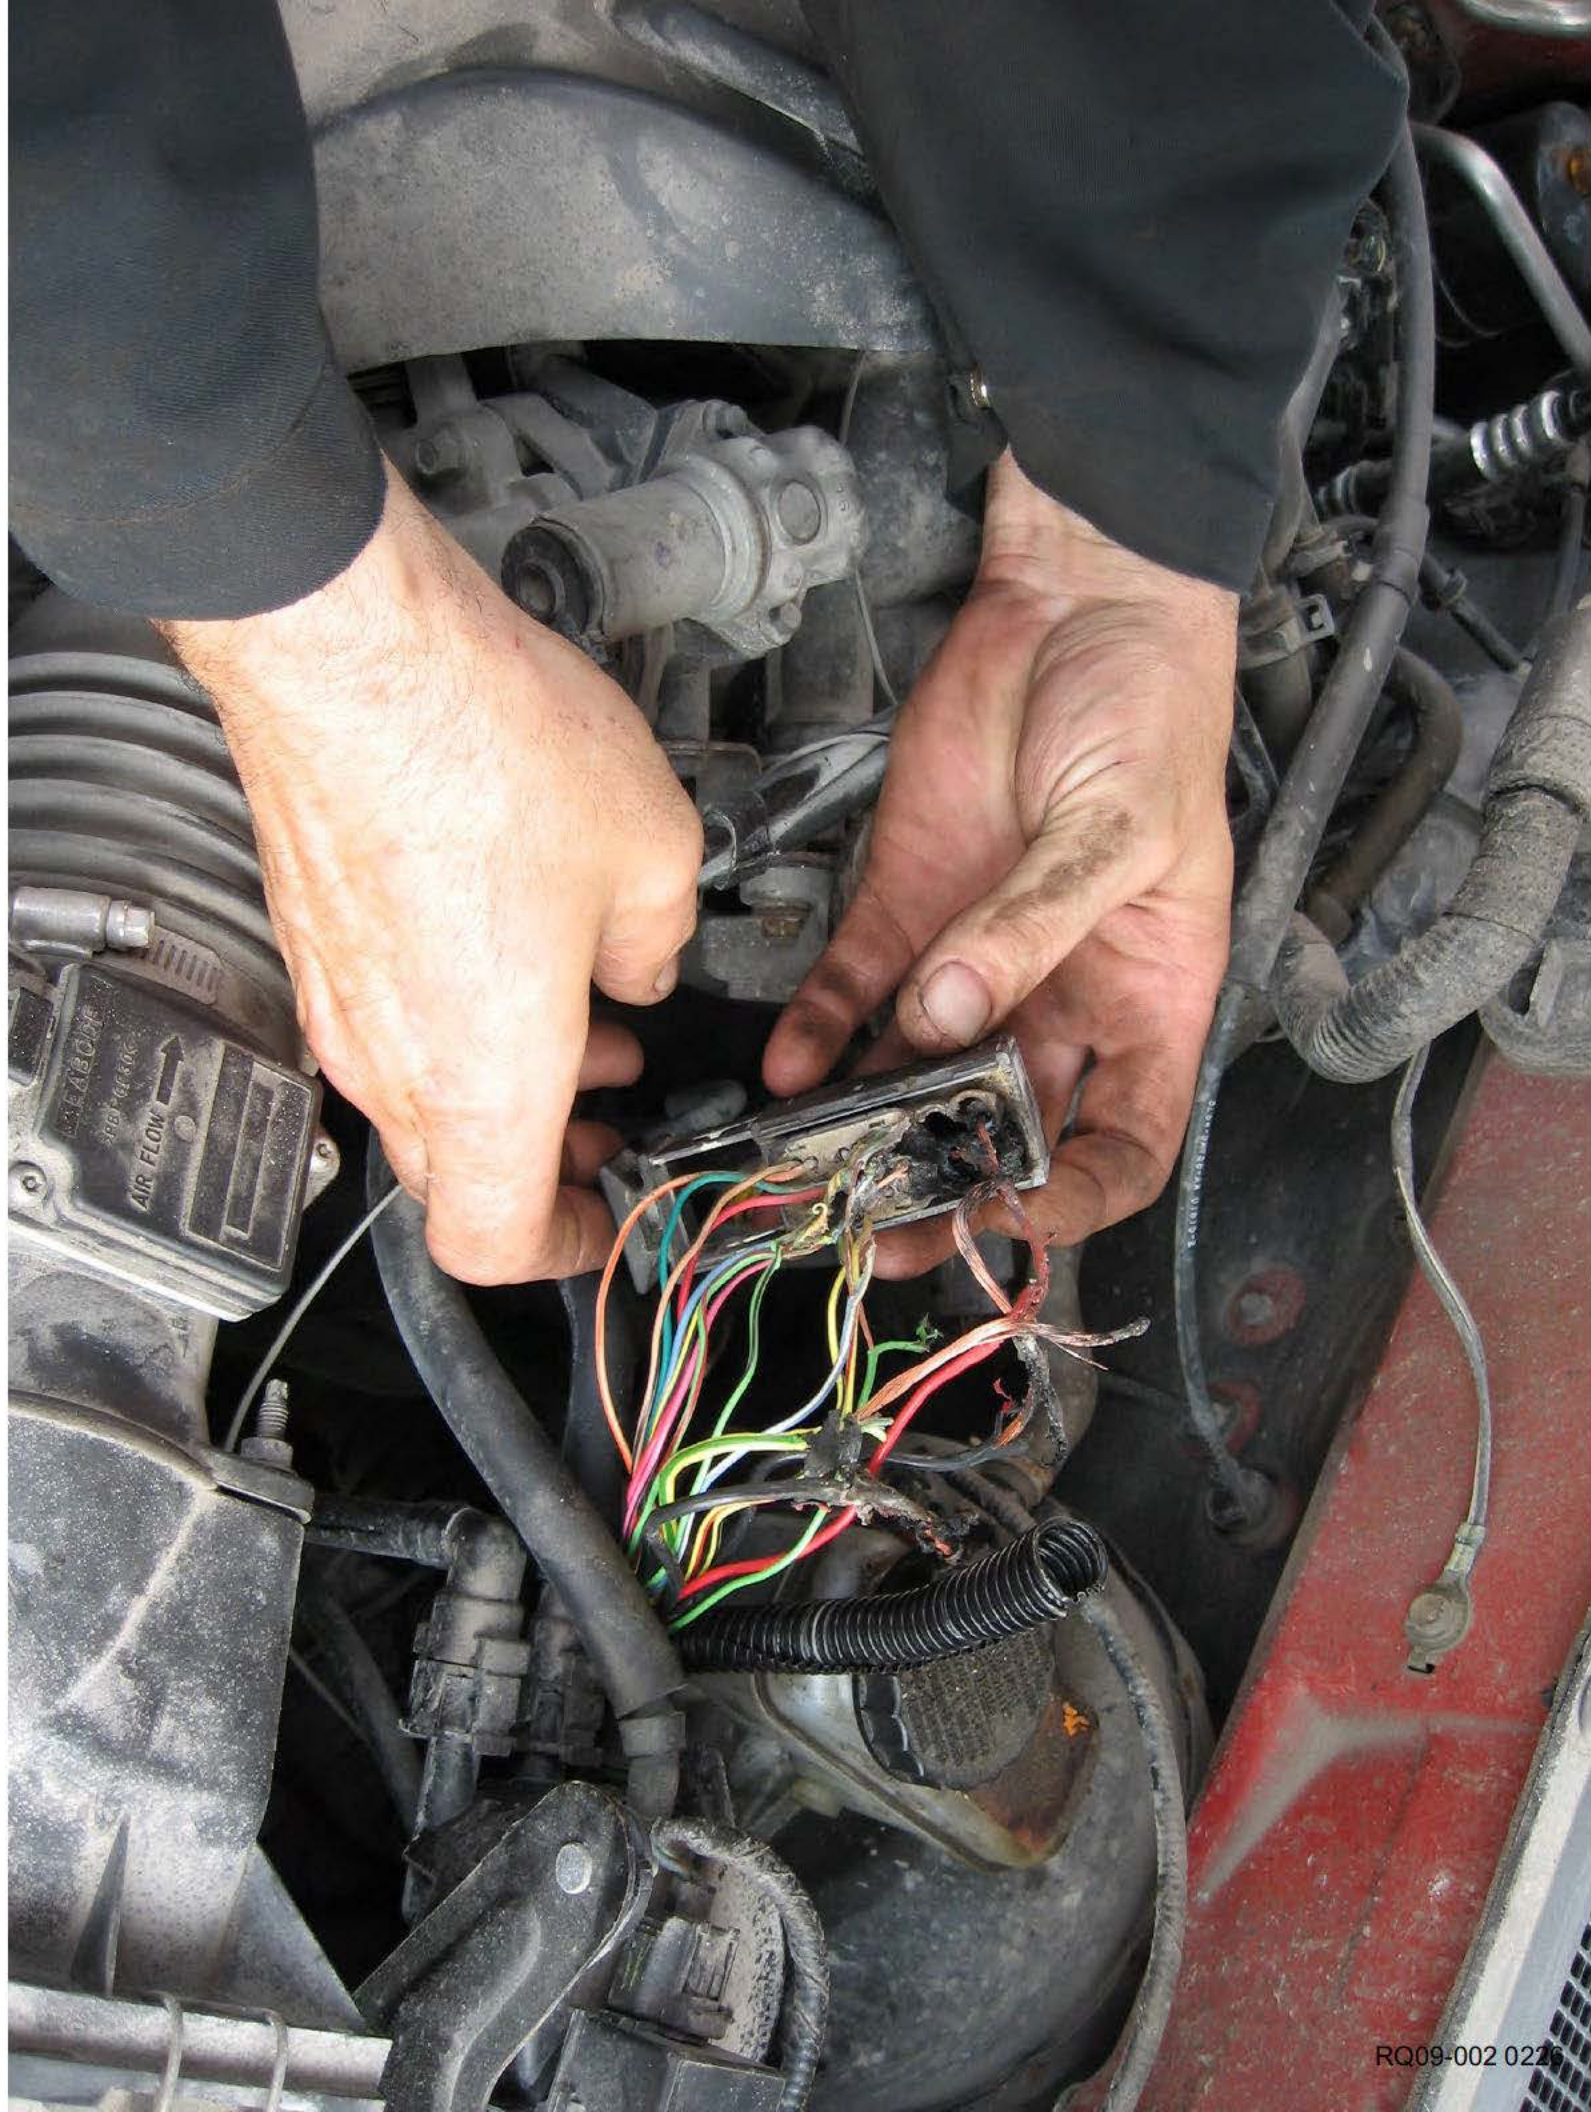
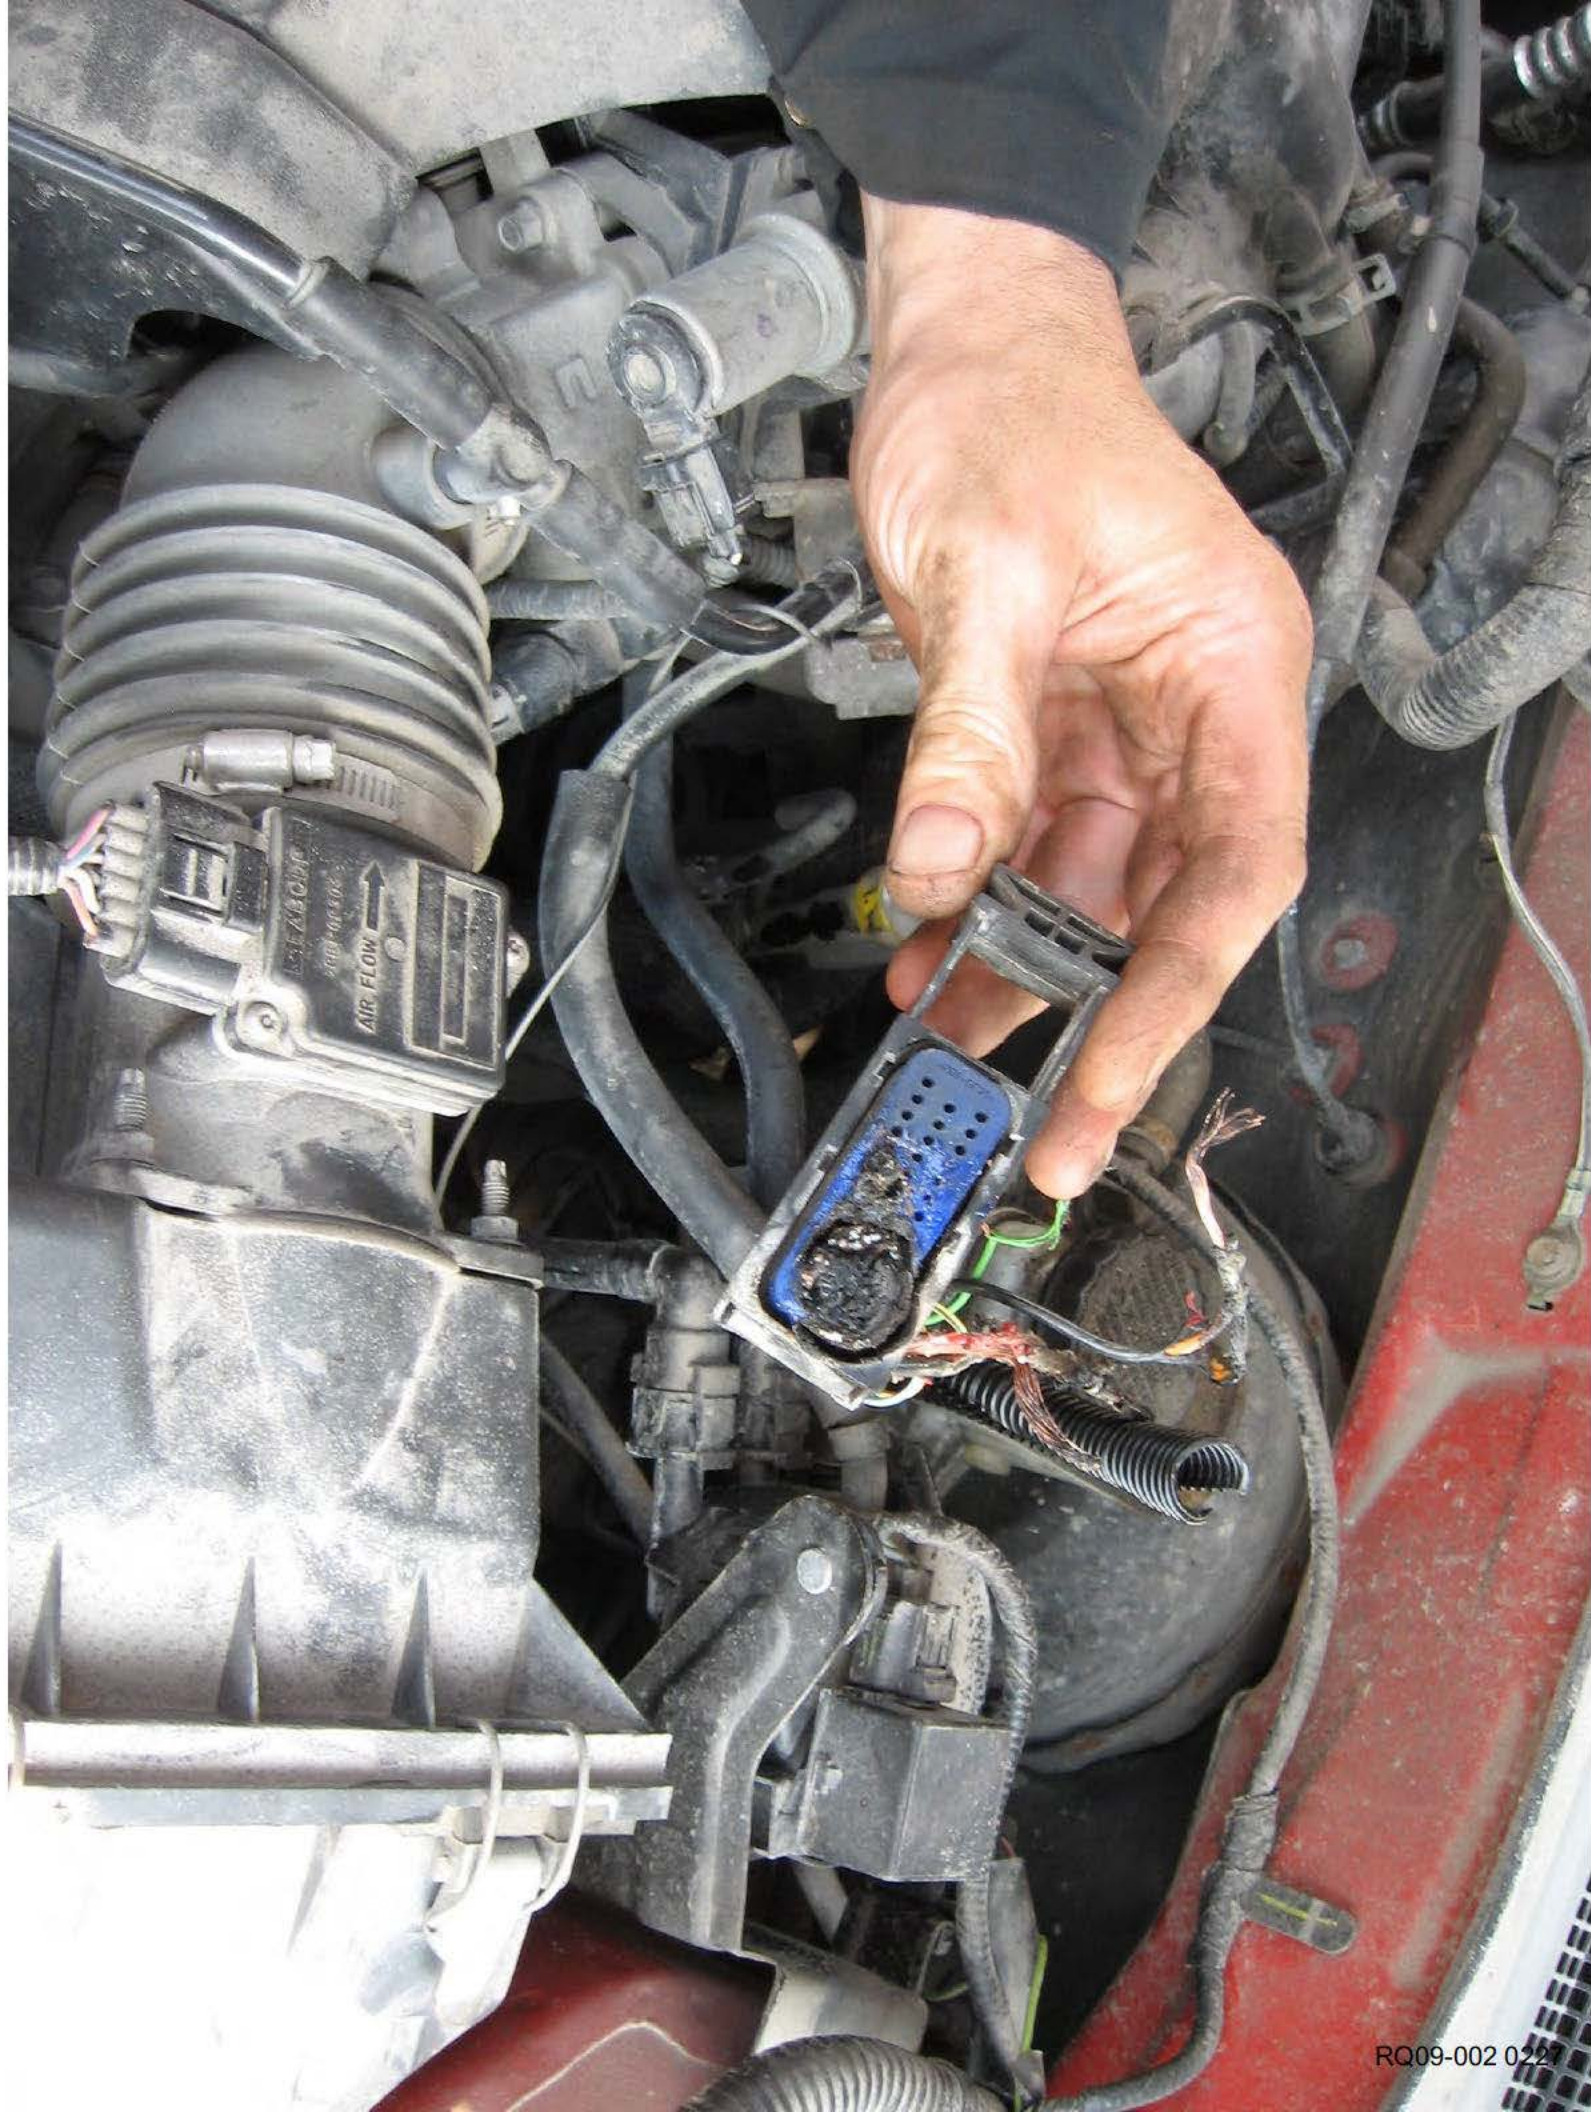
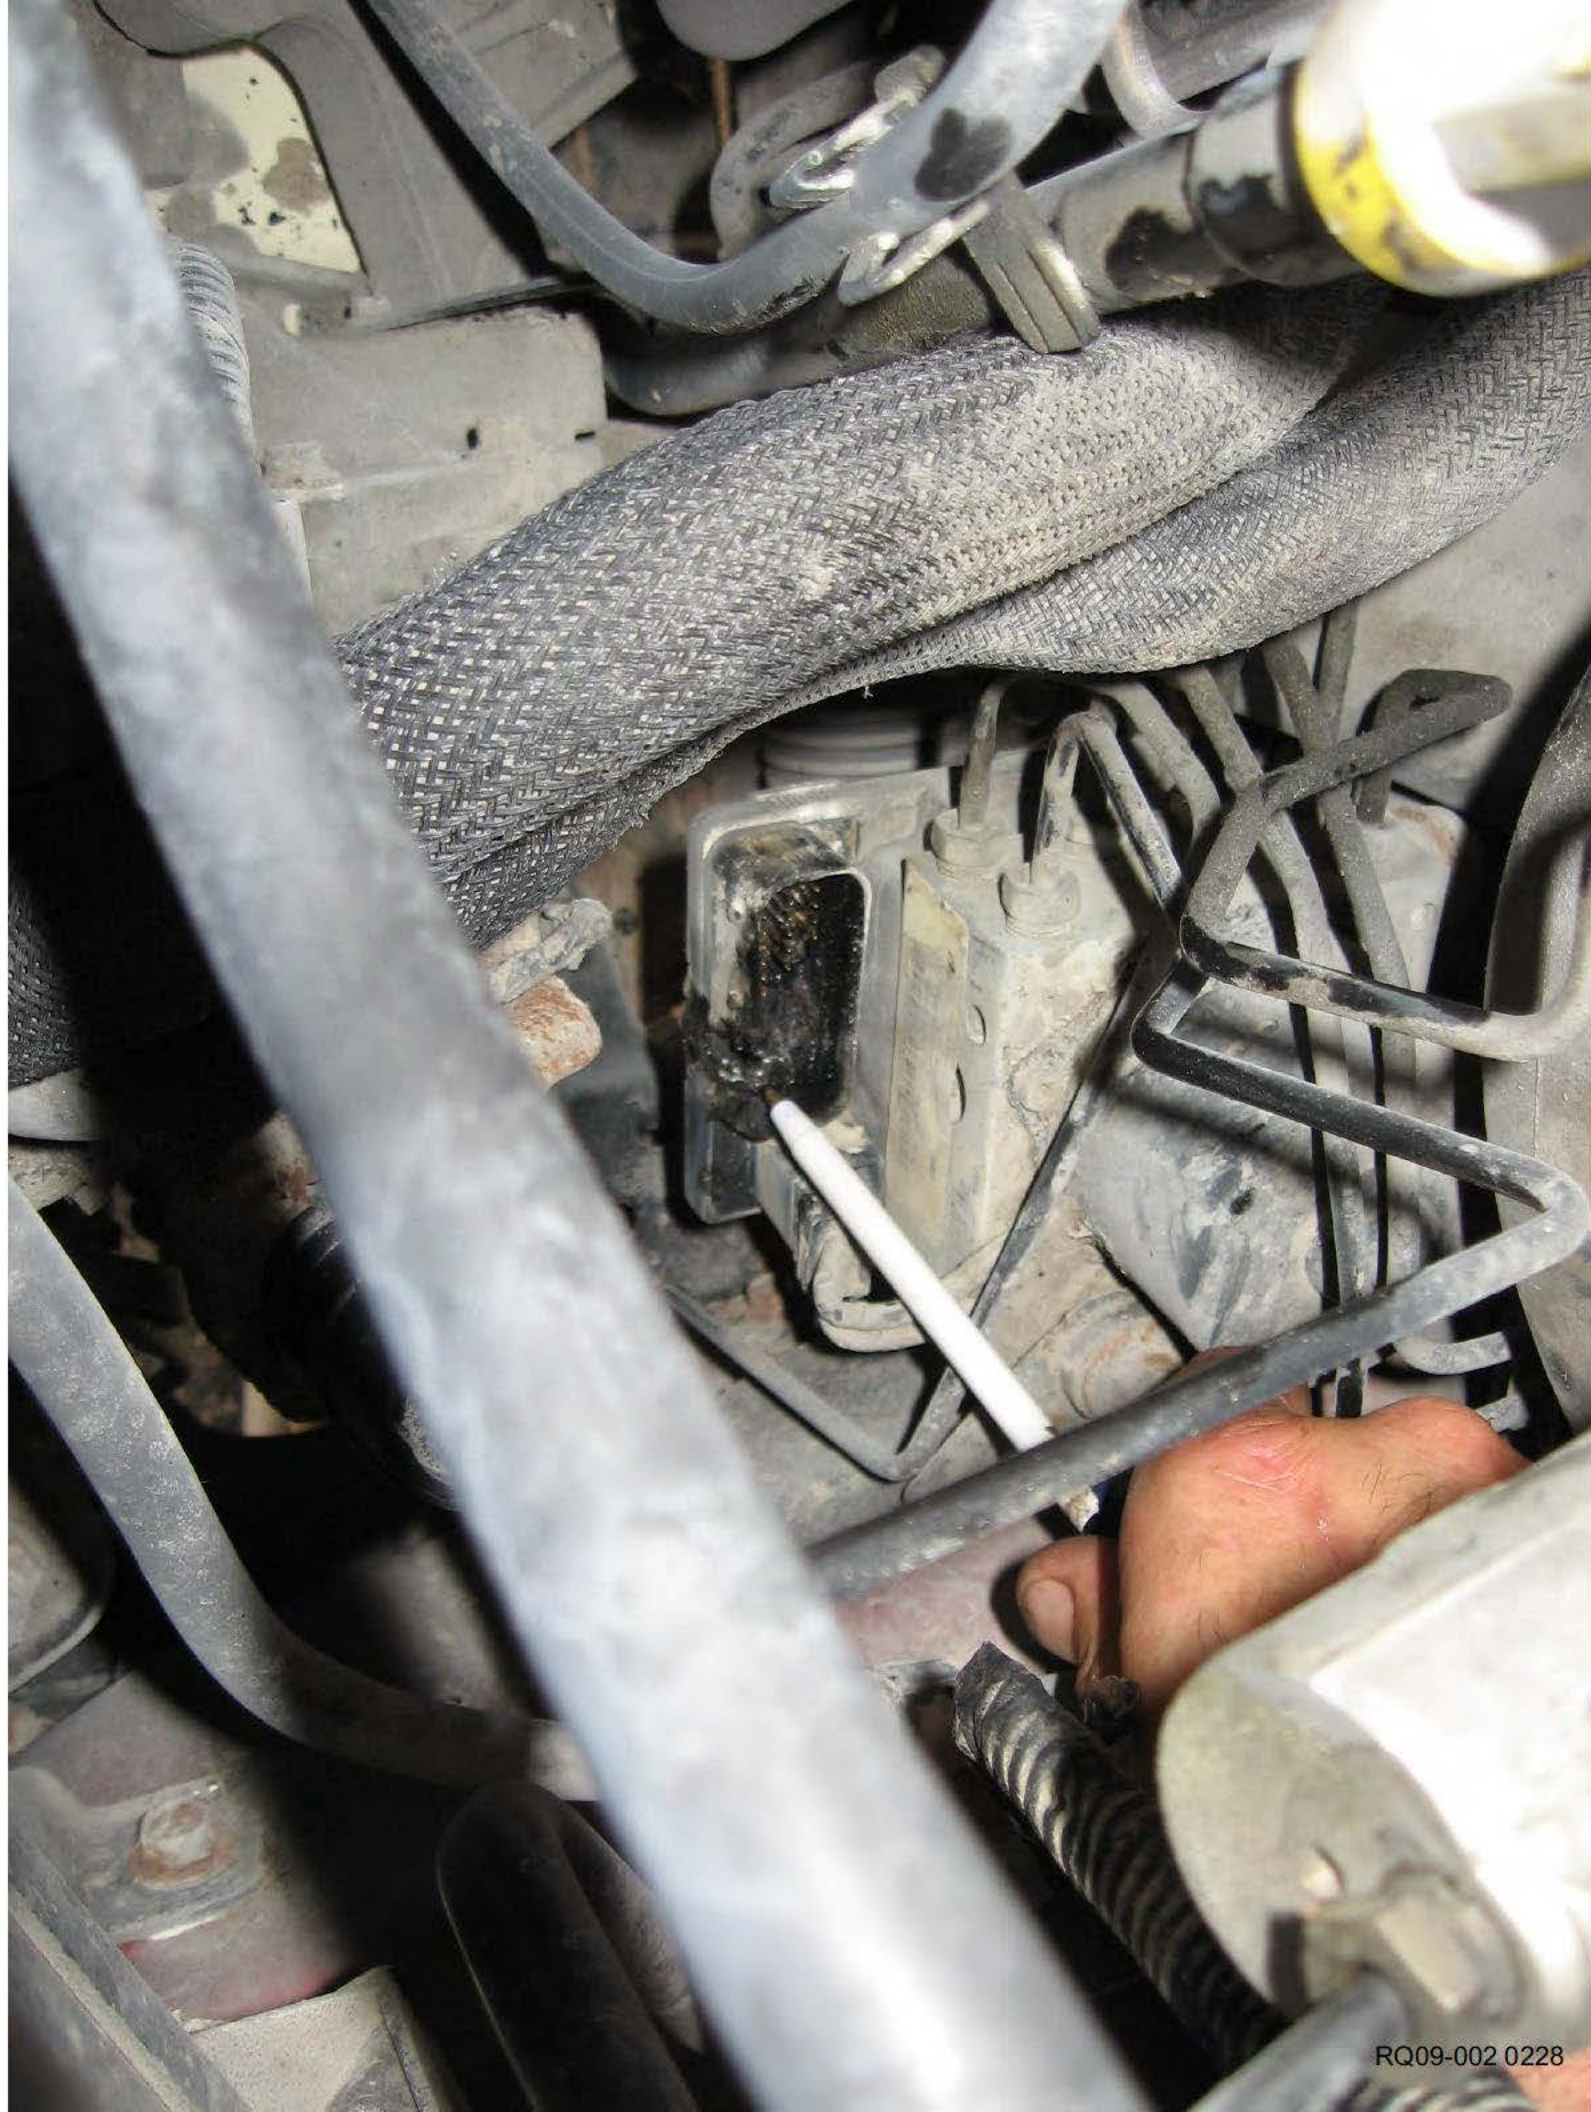
no grease2
