# Net Meeting Summary Sheet

**Issue:** ABS Module and/or harness damage after FSA 07S51

**Vehicle:** Escape

**Model Year(s):** 2001 and 2002

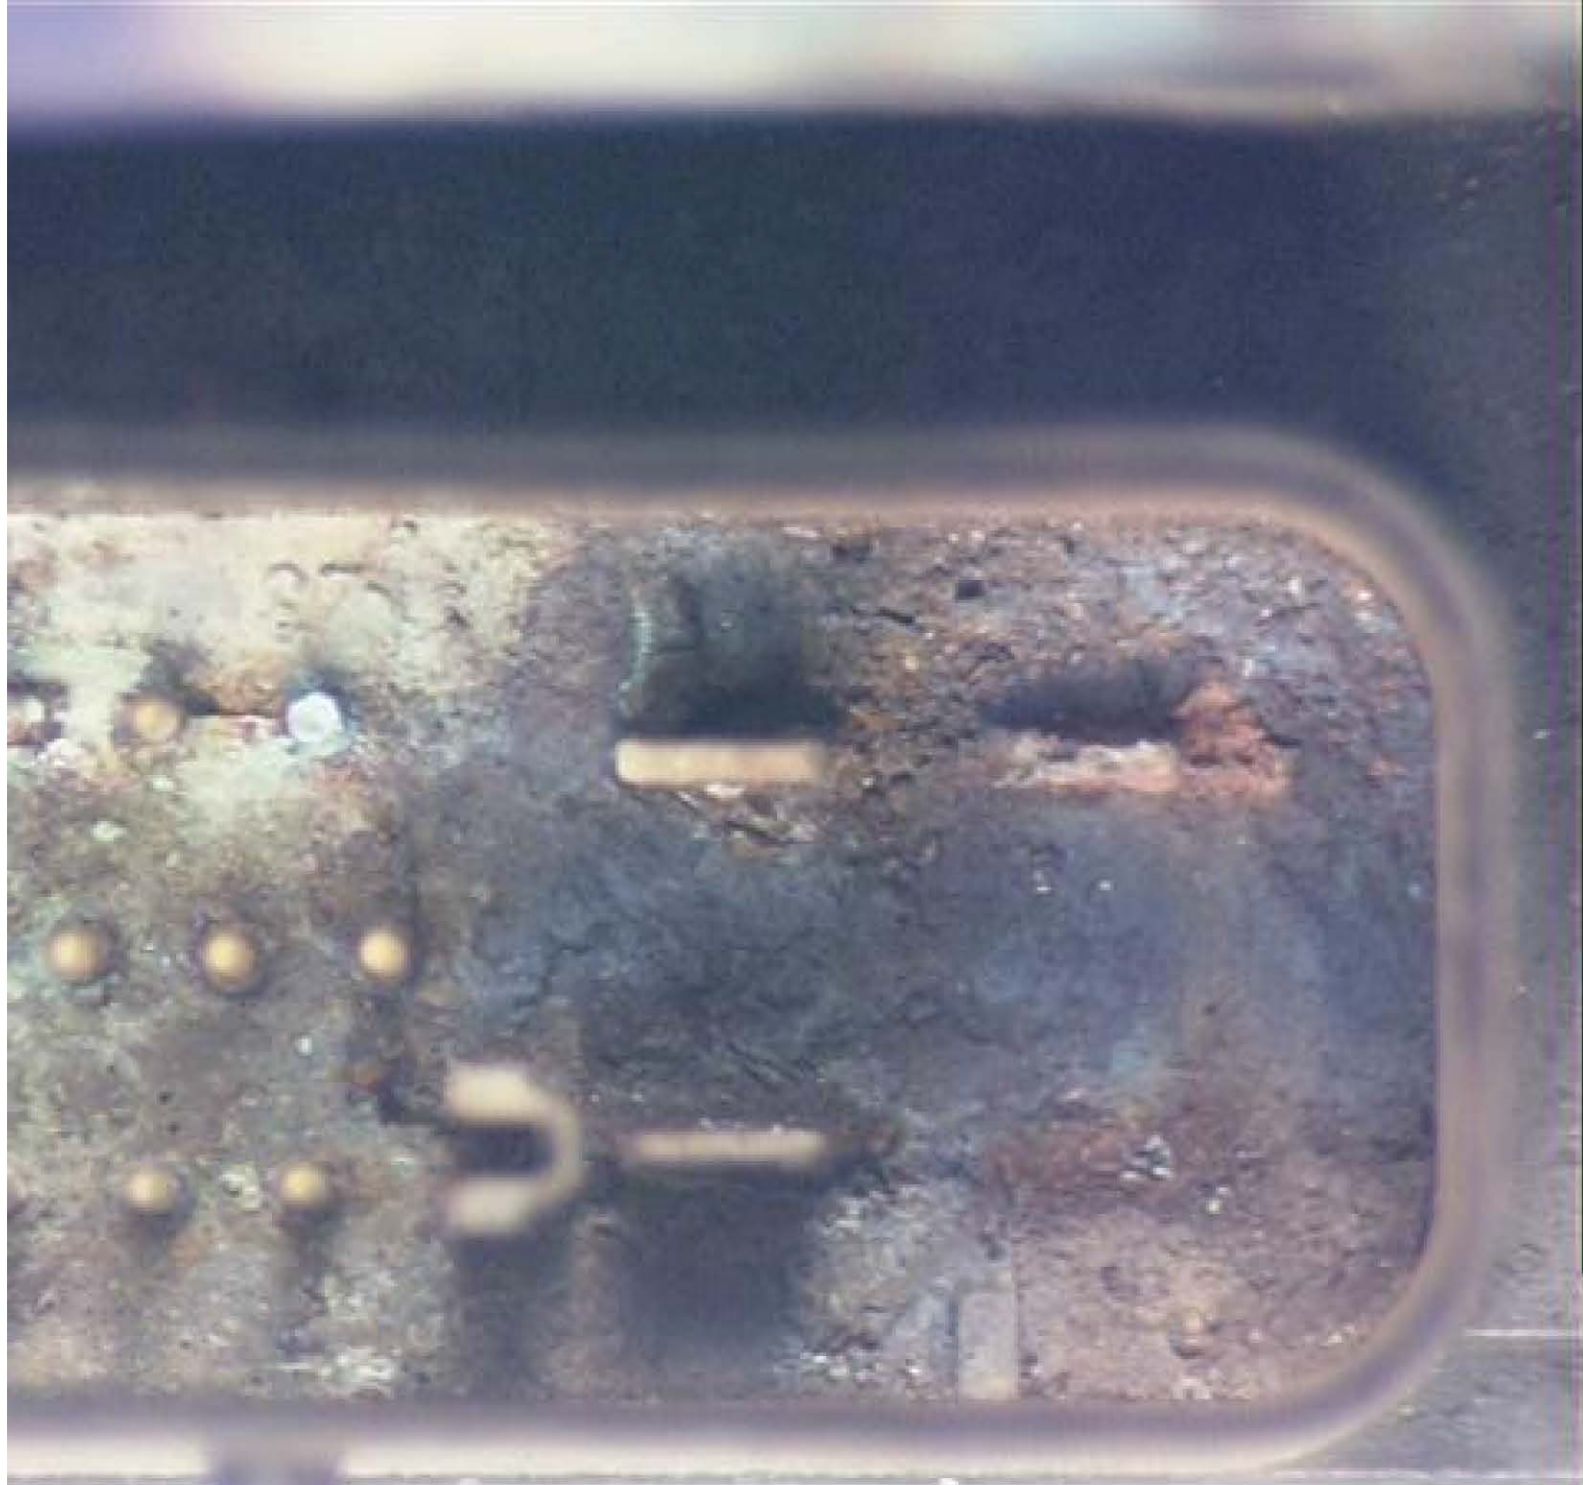
Pin Eroded & Broken Off

**Dendrites**

**Corrosion**

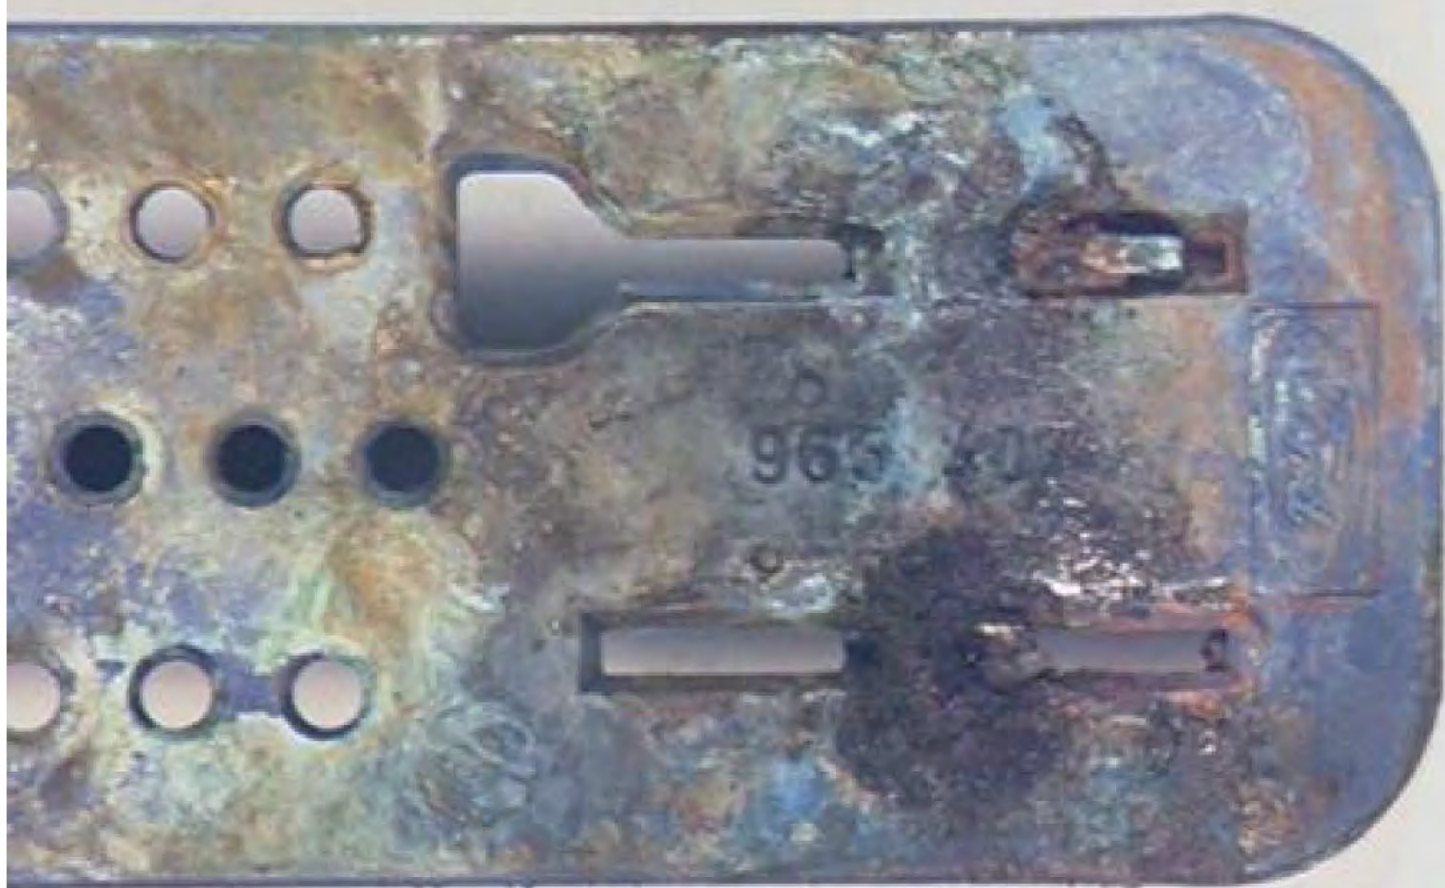
Dendrite Growing between  
pins 22 and 23

Black dendrite growing  
between pins 24 - 25

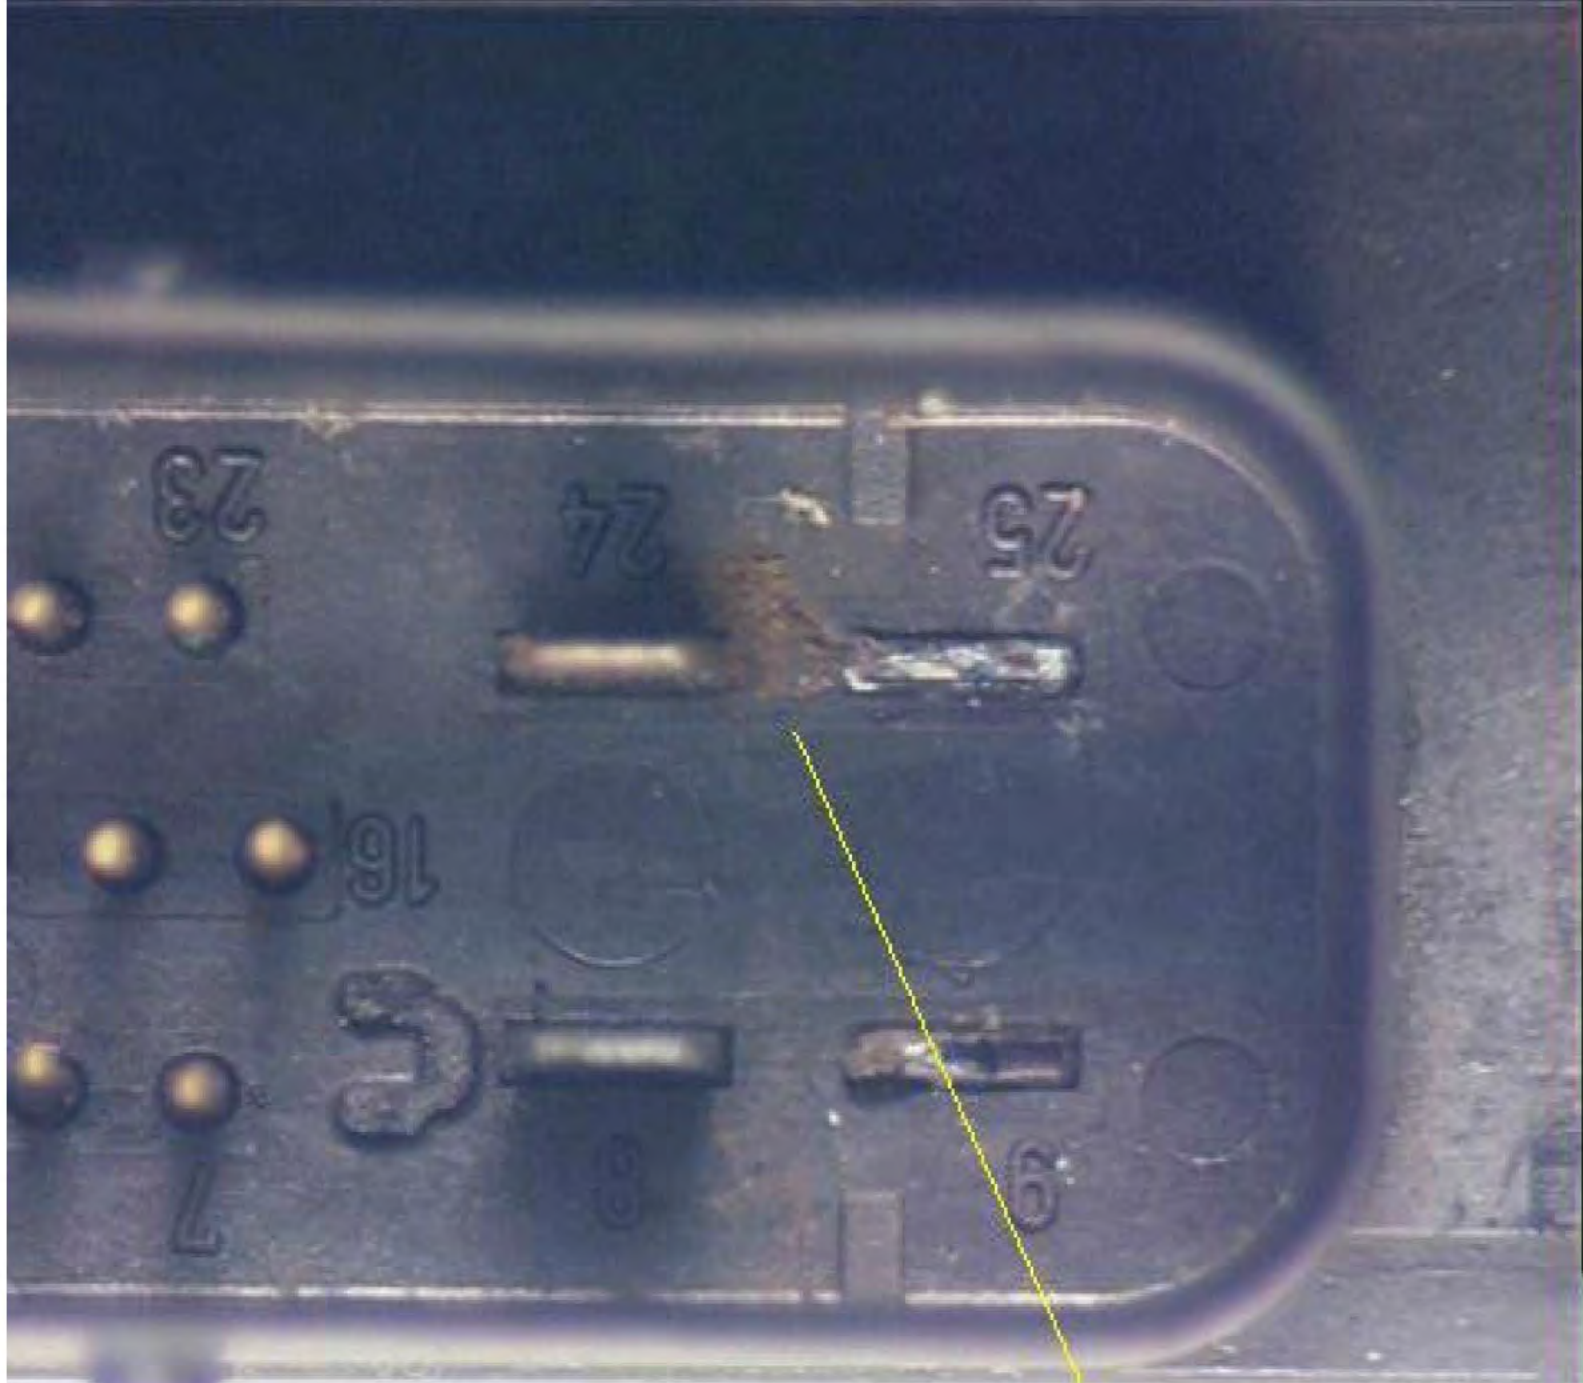
Corrosion

**Dendrites**

**Dendrite growing  
between pins 24 & 25**

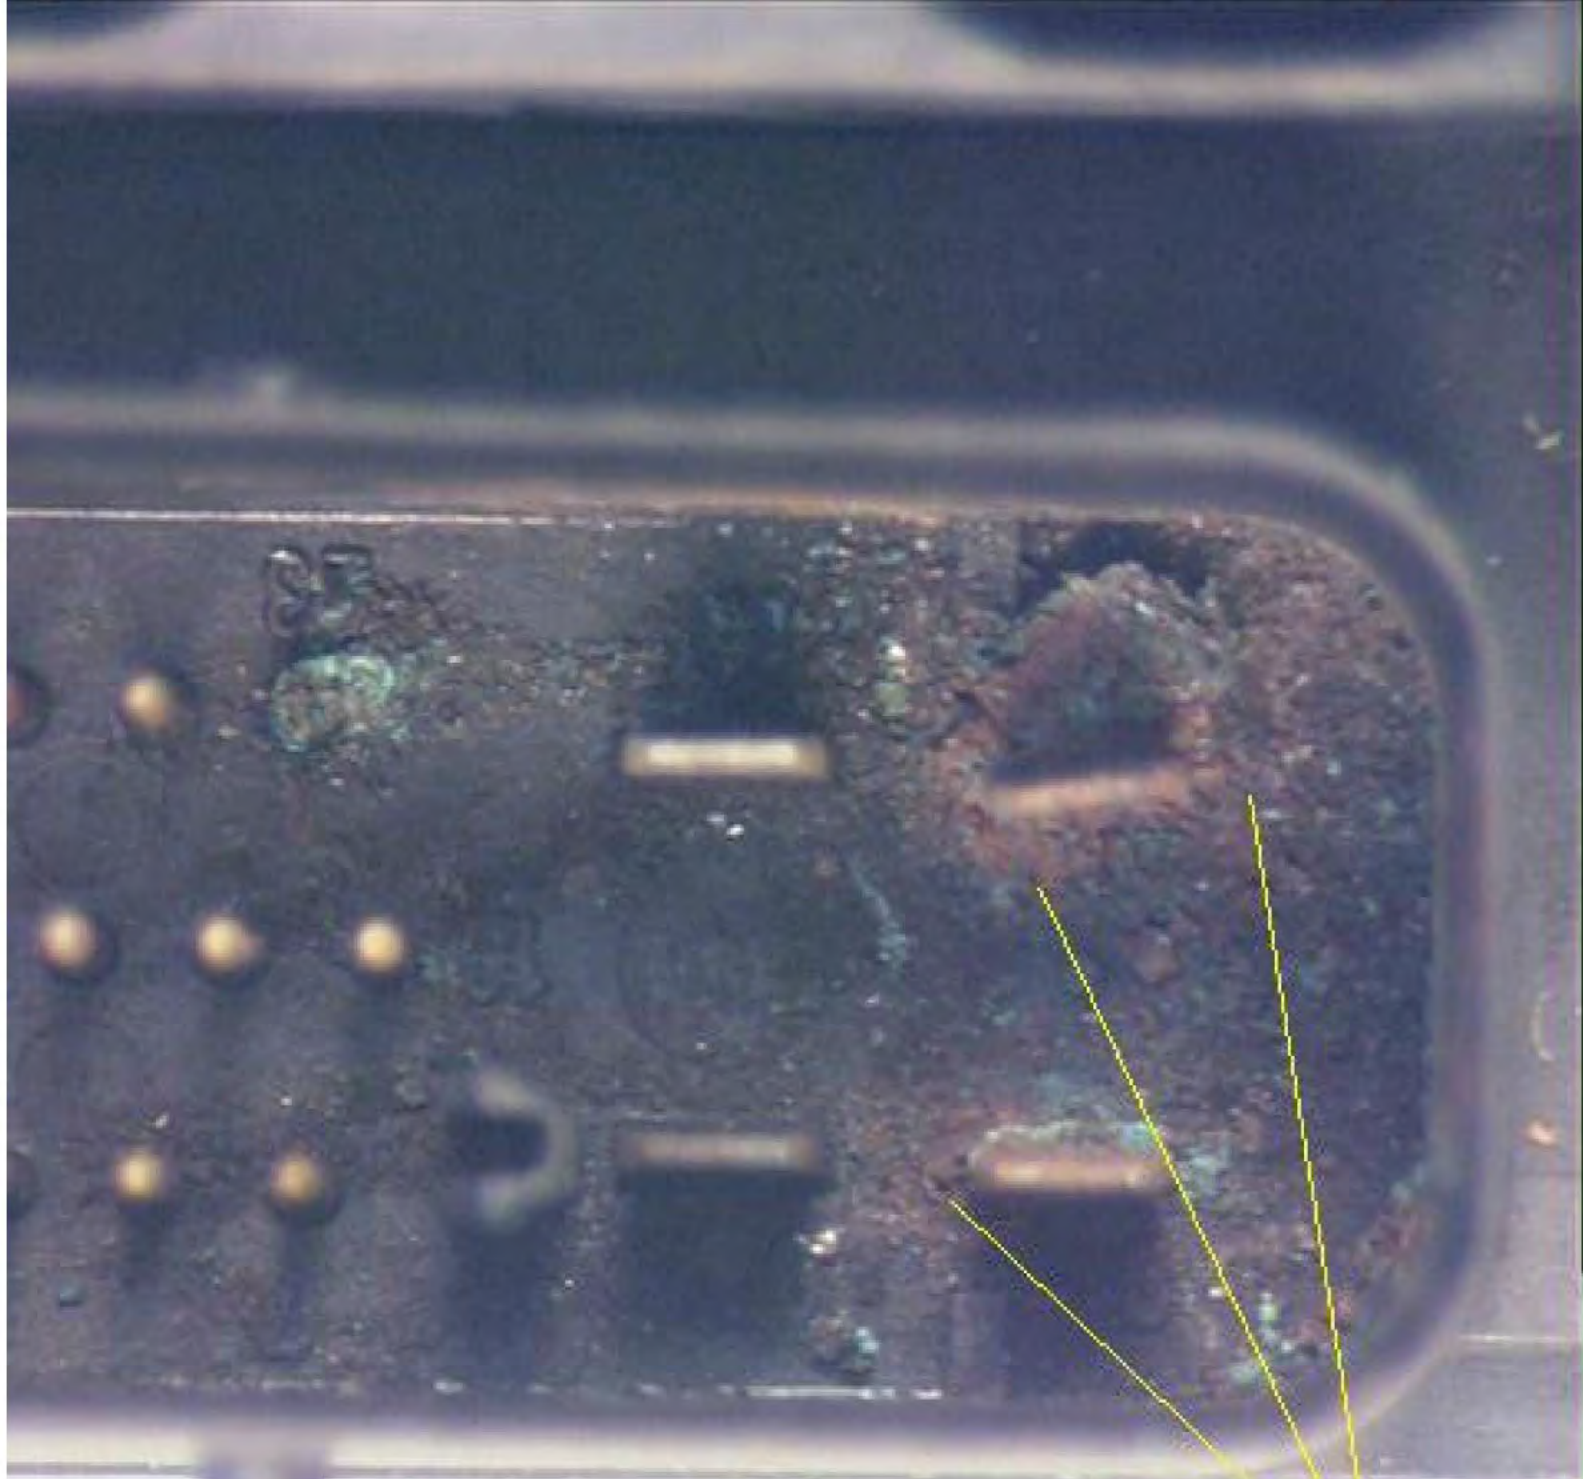
**Shiny Tin Plating**

**Redish Brown  
and/or Black  
Dendrites**

**Green Corrosion**

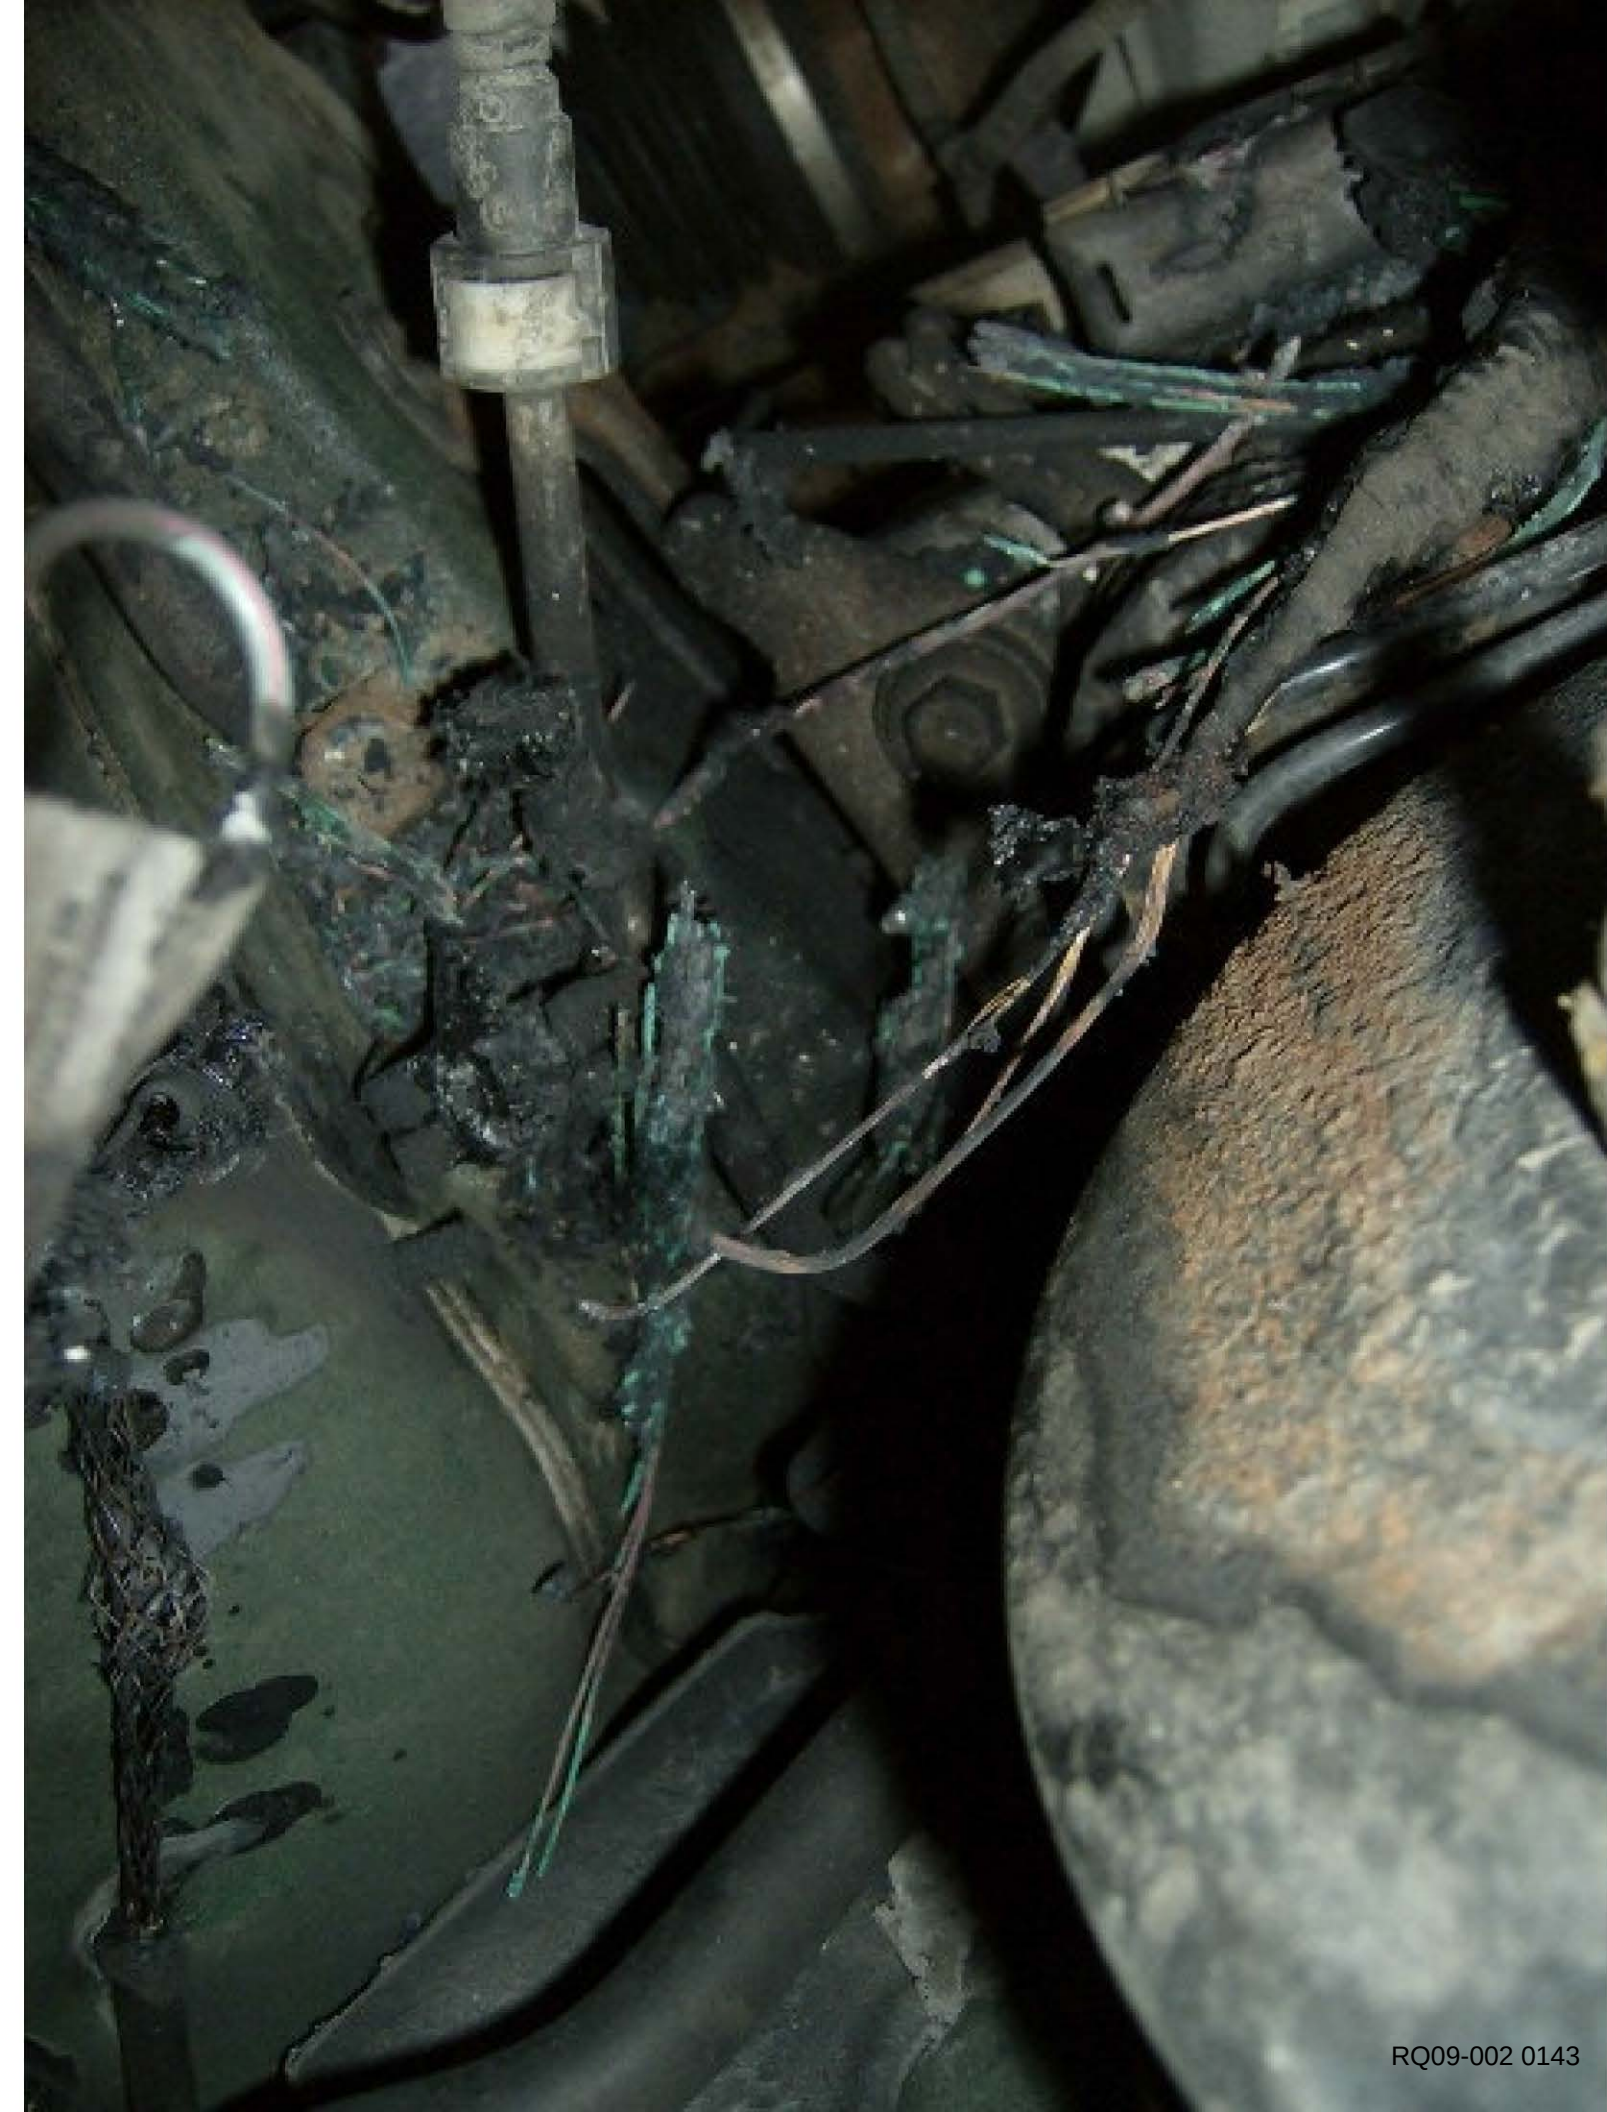
vehicle originally in with ele damage at dside headlamp...possible aftermarket wiring? cust decline repiars, and took vehicle also had labor op a performed..

vehicle came back with thermal damage seen above.

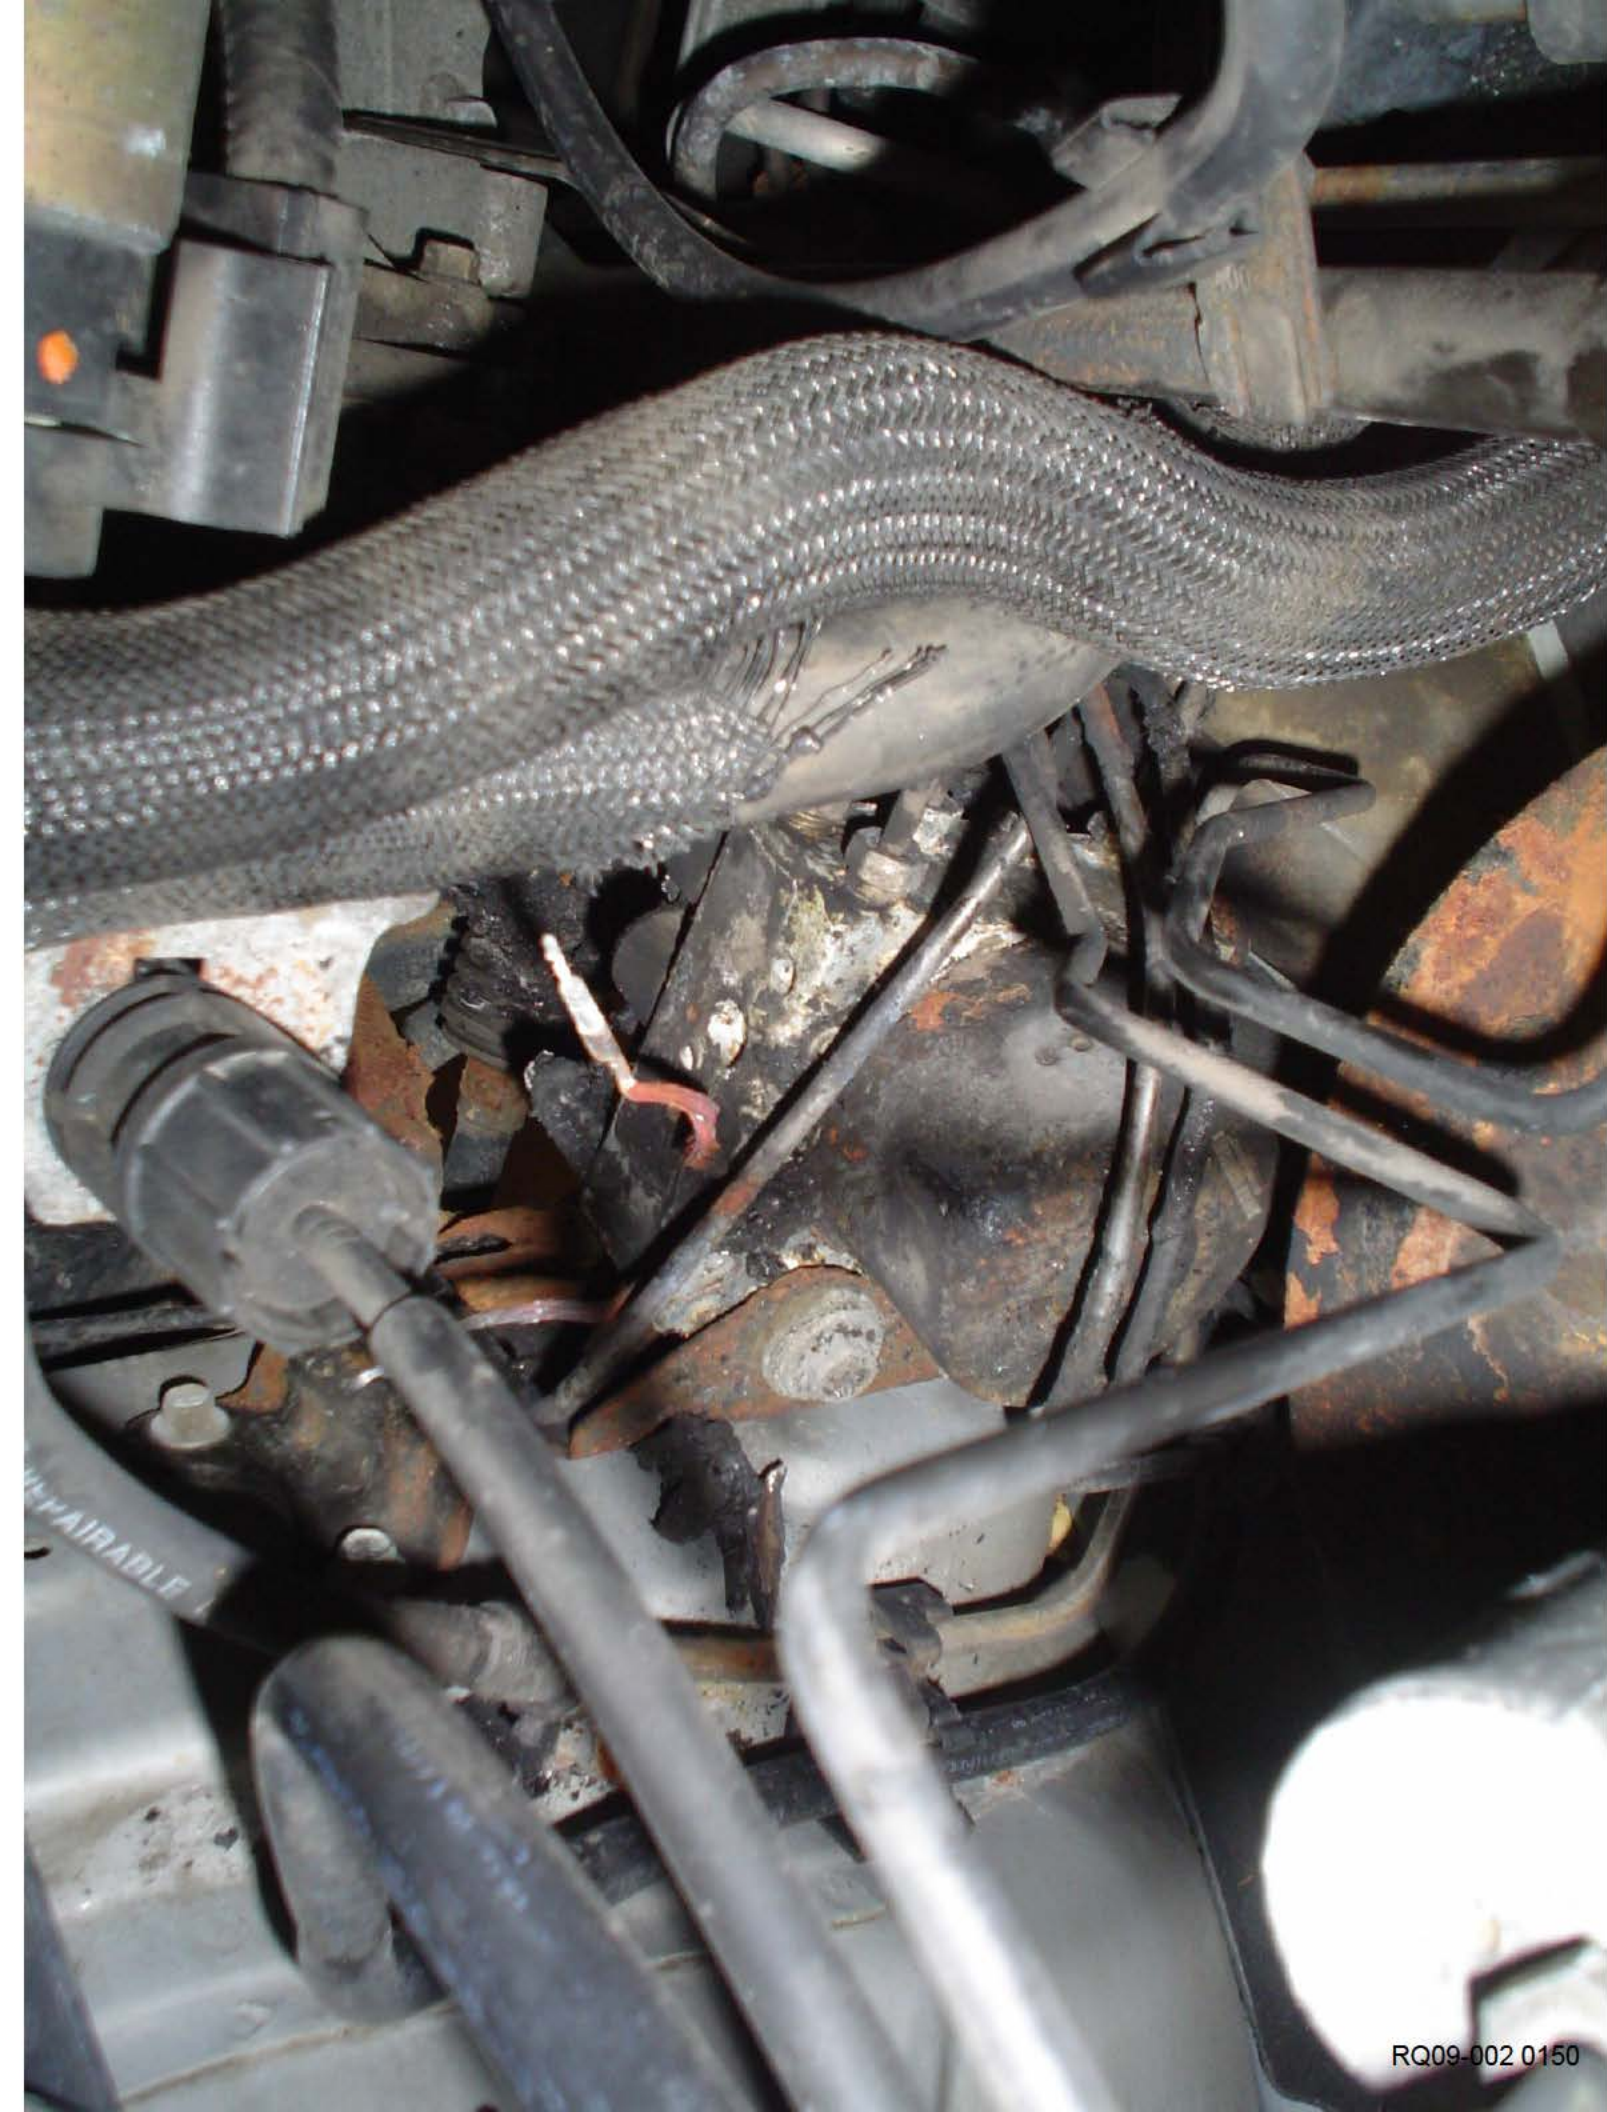
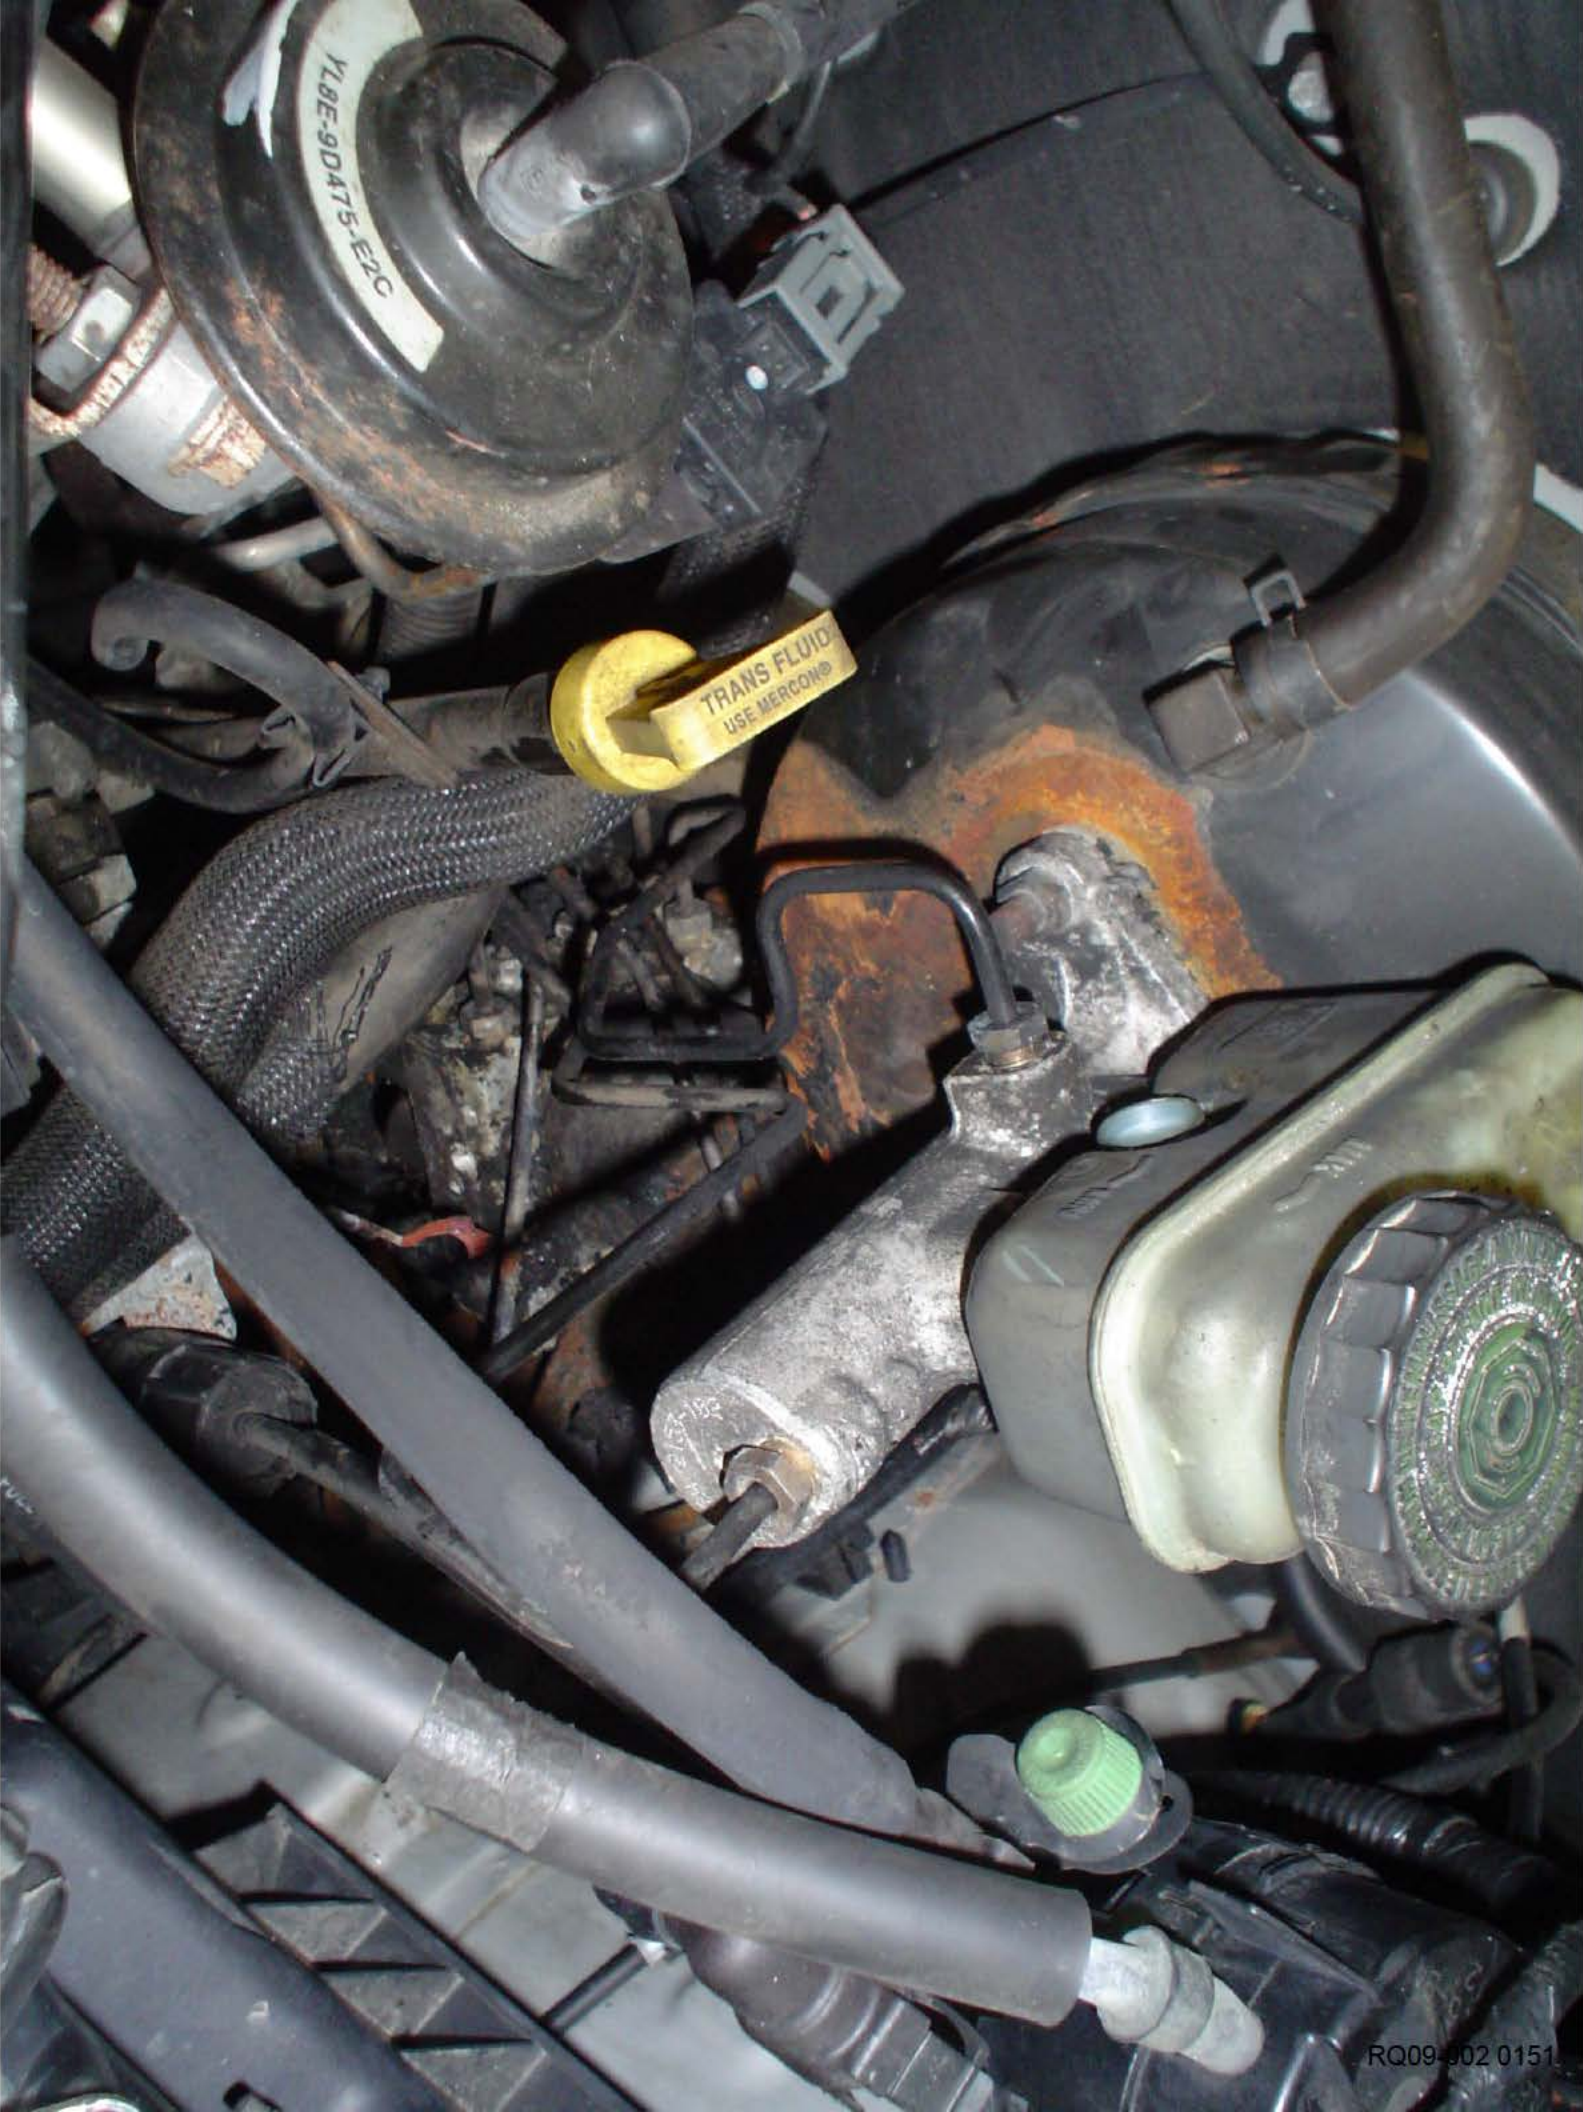
We found the ABS harness caught fire at the ABS controller. The repair estimate is \$996.23 (532.43 parts / 463.80 labor). Parts include: Controller, Booster, Master Cylinder & Reservoir, Harness/Pigtail, Sensor. I attached 2 pictures. Let me know if you need anything else.
