Subject: EA09-013:NVS-213dlr

The Ford Motor Company (Ford) response to the agency's April 5, 2011, letter concerning reports of alleged unintended vehicle movement with a vehicle in Park in 2002 through 2005 model year Ford Explorer and Mercury Mountaineer and 2003 through 2005 model year Lincoln Aviator vehicles is attached.

FORD MOTOR COMPANY (FORD) RESPONSE TO EA09-013

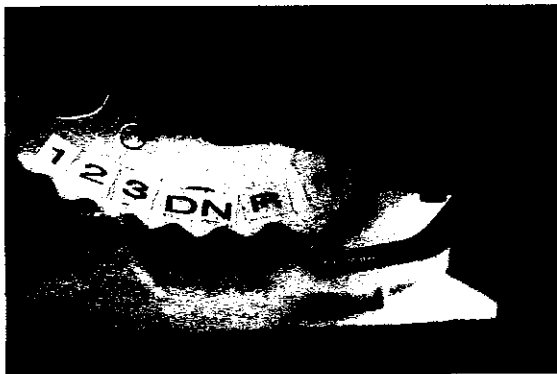
Using parts obtained from complaint vehicles where the BSI solenoid pin prohibited the swing arm from fully rotating into the park position, Ford found that restricted swing arm movement due to BSI solenoid pin contact results in the detent spring roller being positioned on the Park side of the rooster comb peak. In this position, the transmission is either in a hydraulic neutral condition or in a position that results in partial park pawl engagement in the transmission parking gear. Figures 1 and 2 show two complaint vehicles exhibiting this condition. In the first example, where the swing arm is restricted by the BSI solenoid pin, the roller pin is on the Park side of the rooster comb, and the transmission is in a hydraulic neutral state. In the second sample, where the swing arm is restricted by the BSI solenoid pin, the roller is on the Park side of the rooster comb, and there is partial engagement with the transmission parking gear.

Figure 1: Complaint vehicle example with Swing Arm interacting with BSI Solenoid Pin – in Neutral

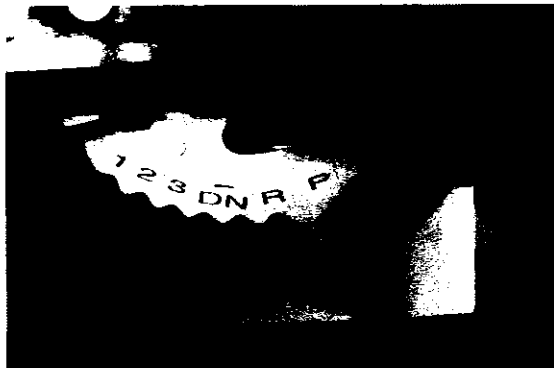
Figure 2: Complaint vehicle example with Swing Arm interacting with BSI Solenoid Pin – in Park

Under these conditions, any movement by the vehicle would be unpowered. In order for the vehicle to experience a powered rollaway, the roller position would need to be on the Reverse side of the rooster comb peak. On vehicles with a divot in the swing arm that may inhibit movement of the shift lever from rotating fully into the Park position, Ford's analysis found that

the corresponding roller pin position was on the Park side of the rooster comb peak. The natural design of the rooster comb peak would preclude the roller from moving over the rooster comb peak onto the Reverse side. Therefore, it is highly unlikely that the interaction between the BSI solenoid pin and the swing arm could result in a powered rollaway condition.
