HEHR INTERNATIONAL INC, 3333 CASITAS AVE LOS ANGELES, CA 90039

Re: Hehr International Inc's Response to NHTSA Letter Regarding Safety Recall 09V-318, Investigation Number EQ09-007 (Tip-In Transom Windows)

This letter responds to NHTSA's September 2, 2009 letter requesting information from Hehr International Inc. ("Hehr") regarding safety recall investigation number EQ09-007, initiated by Daimler Buses North America, Inc. ("Daimler Buses"). The investigation involves Daimler Buses' model years 2006-2009 Orion VII buses. Specifically, Daimler Buses provided notice to NHTSA that the screws for the upper tip-in transom portion of the windows manufactured by Hehr may loosen, allowing the upper window to dislodge and fall into the bus.<sup>1</sup> Hehr is aware of three incidents that occurred between June 20 and July 31, 2009 involving dislodged upper transoms in Toronto, Canada.

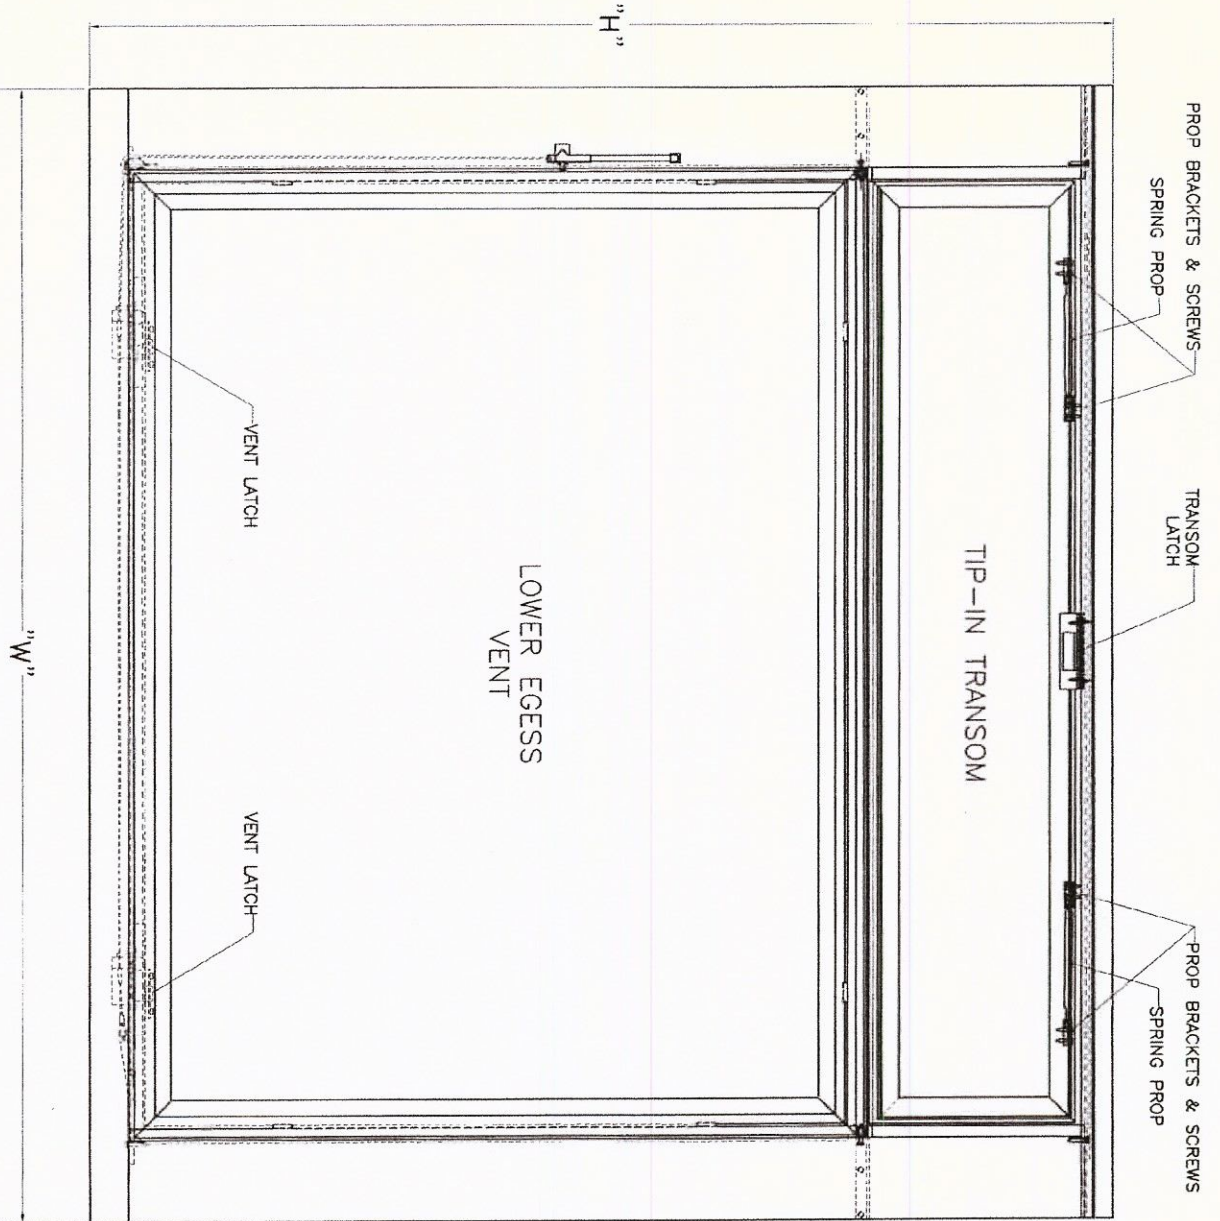
ATTACHMENT A

<sup>1</sup> A diagram of the Hehr 1500 series window subject to this recall is attached hereto as Attachment A. As illustrated, the top portion of the Hehr bus window has a latch allowing it to open and close. The upper transom is supported when opened by two metal props and four brackets. Each bracket has two screws. The brackets and props prevent the upper transom from dislodging when opened.

Hehr recommends that you inspect the screws in the brackets supporting the props of the upper transom windows on a regular basis. Screws that have been loosened and are not fully re-tightened may continue to back out because of road vibration, and ultimately may result in the upper transom window dislodging if the brackets fall out. All screws should be restored back to their fully tightened position. If a screw has been left loose for any period of time, the hole may widen. A larger screw should therefore be used to secure the bracket. The new, larger screw should be fully tightened.
