# ODI RESUME

**Investigation:** EA 10-003  
**Prompted by:** Consumer Complaint  
**Date Opened:** 04/13/2010 **Date Closed:** 03/05/2012  
**Investigator:** Bruce York-B  
**Approver:** Frank Borris  
**Subject:** HVAC Switch Failures

**Manufacturer:** FORD MOTOR COMPANY  
**Products:** 1997-2008 E350/450 Ford Cab/Chassis  
**Population:** 1,076,975  
**Problem Description:** The Blower Motor Control Switch on certain Ford E350/450 vehicles may overheat/melt and catch fire.

**ENGINEERING ANALYSIS CLOSING REPORT****SUBJECT VEHICLES: 1997-2008 E350/450 Ford Cab/Chassis Vehicles****EA No.: 10-003****Date Opened: 13-Apr-10****Date Closed: 05-Mar-12**

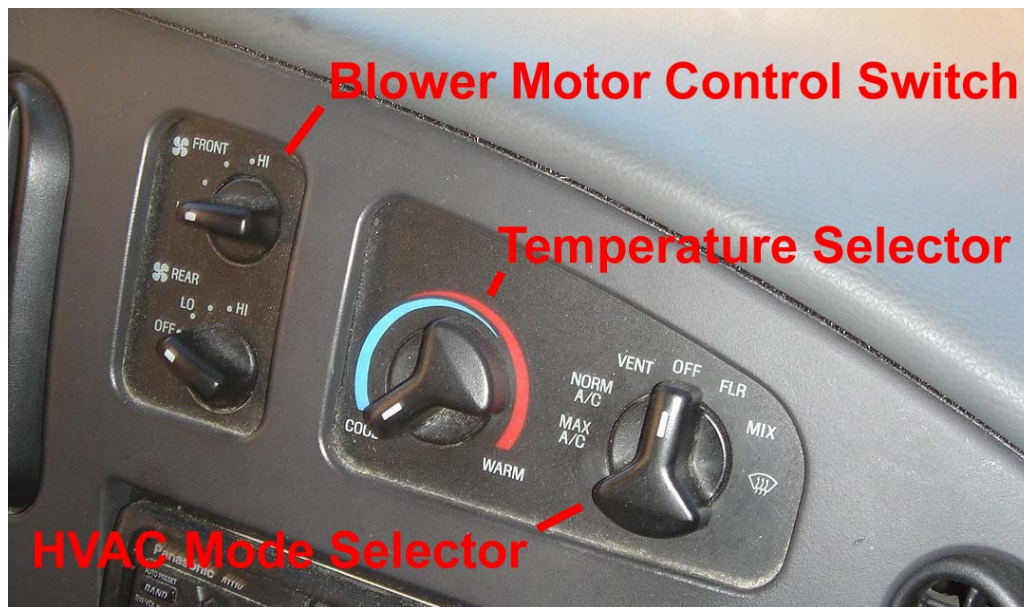
Figure 1. HVAC System Controls

**DESCRIPTION OF COMPONENTS:** The blower motor control switch (pictured and identified in Figure 1.) in the subject vehicles is located on the instrument panel between the driver and front passenger seats. The HVAC blower motor control switch controls the defroster, heat, and air conditioning airflow inside the vehicle.

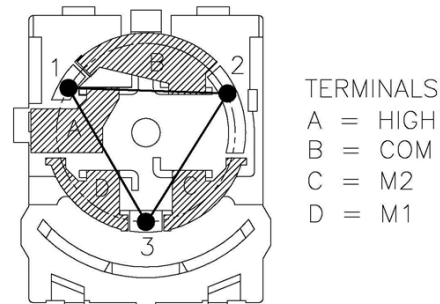
Figure 2.

The first mode involves over heating of switch components resulting from resistance building up between internal switch contacts. As discussed in the Description of Components section above, the blower motor control switch has four speed settings. When the switch is rotated from one speed to another, metal contacts inside the switch slide from one set of terminals to another (see Figure 2.). As the contacts bridge the different terminal sets current flows through various resistors thus altering the amount of current to the blower motor and the speed.

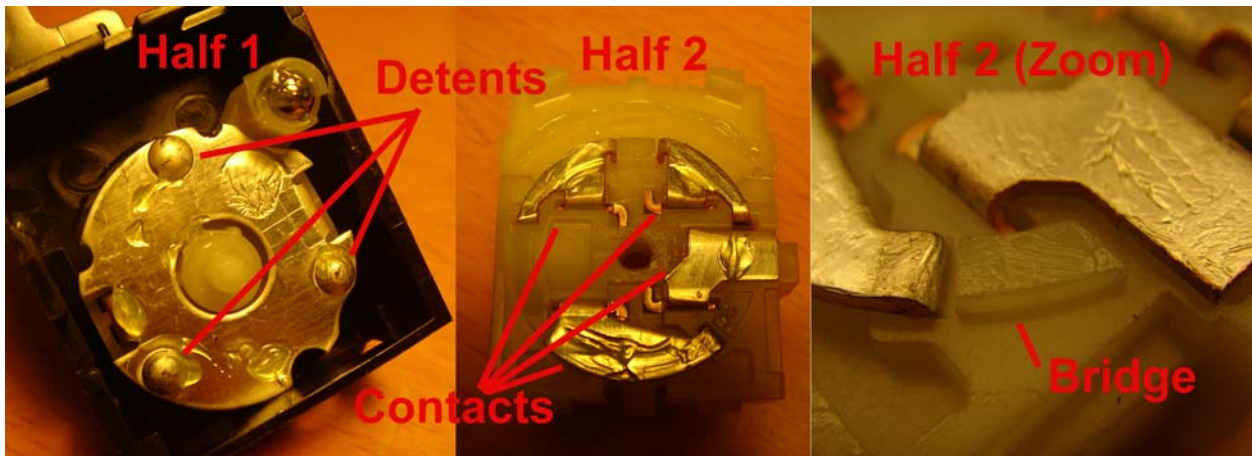
When the contacts separate and re-join the terminals, a small arc occurs that can cause pitting in the terminal material and can potentially lead to a high resistance connection. This high resistance can then lead to overheating of the switch materials. In addition to the pitting that occurs on the terminals, products of the arcing can potentially interact with grease that is inside the switch (as a lubricant) and act to further increase resistance between the contacts. Figure 3. shows the two halves of the contact set inside the switch. The one half of the contact set is attached to the knob turned by the operator. This first half is forced against the second half by a set of 3 small springs. When the operator wants to change the blower motor speed, the switch is rotated, forcing 3 round detents on the first half (that make electrical connections with the second half) to slide across plastic bridges. As the detents slide off of the plastic bridges and again make electrical contact (thus completing a different circuit and changing the blower motor speed) an

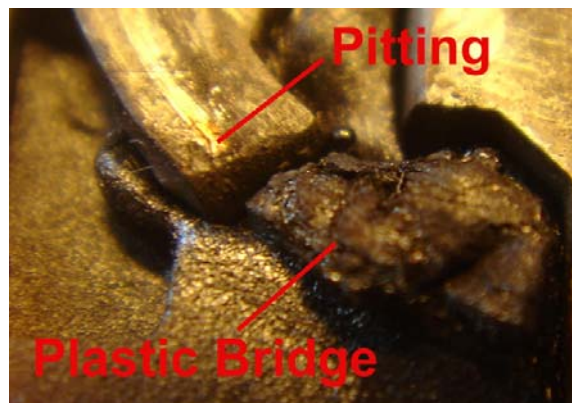
arc can occur. Figure 4. shows a close-up image of the leading edge of a terminal (from a failed switch) following one of the plastic bridges where pitting in the terminal material can be seen.
