# ODI RESUME

**Investigation:** PE 10-048  
**Date Opened:** 12/07/2010  
**Investigator:** Tom Bowman  
**Approver:** Frank Borris  
**Subject:** Hitch Receiver Fracture

**Manufacturer:** Winnebago Industries, Inc  
**Products:** 2006 Model Year Winnebago Itasca  
**Population:** 9,300 (Estimated)

### Hitch Receiver Assemblies Installed in Model Year 2006 Winnebago and Itasca Recreational Vehicles: Concern that Hitch Receiver May Fracture in Service Resulting in the Separation of the Towed Vehicle

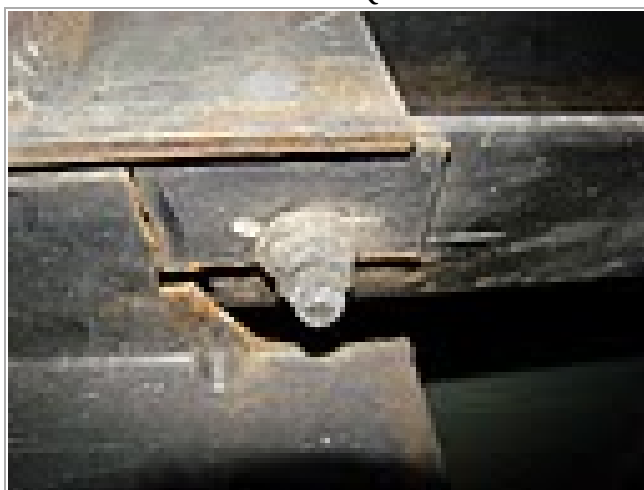
On November 29, 2010, ODI received VOQ 10368002 submitted by the original purchaser and then-current owner of a 2006 Winnebago Itasca recreational vehicle who reported that the hitch receiver installed in his vehicle had exhibited cracks and fractures. Since the incurred damage had not progressed to the point of complete fracture / separation of the hitch receiver from the towing vehicle, the hitch receiver, towing system, and towed vehicle had remained attached to the towing vehicle.

Photograph No. 3 – Fractured Attachment Bracket of Hitch Receiver  
Described in VOQ 10368002

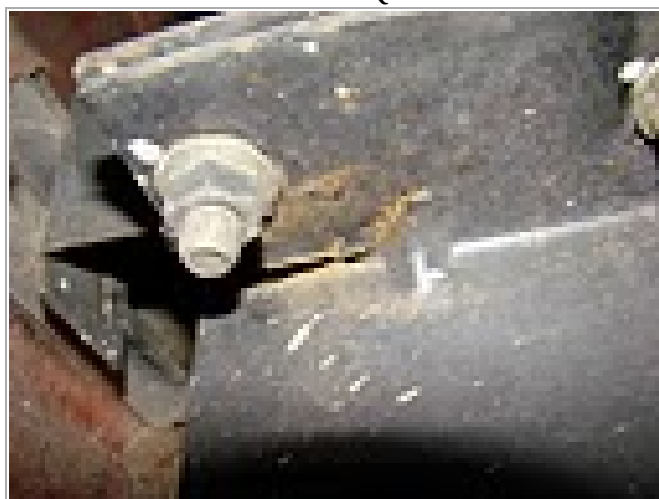
Photograph No. 4 – Cracked Attachment Bracket of Hitch Receiver  
Described in VOQ 10368002

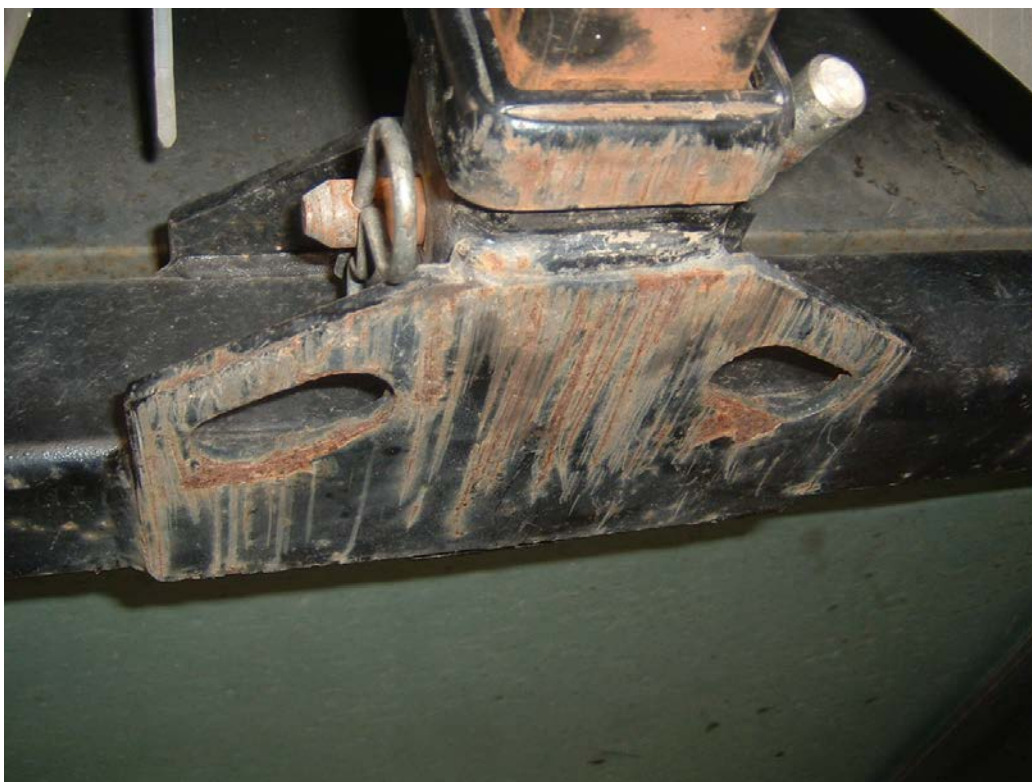
bottom of the hitch had occasionally scraped the road surface (due to the terrain being negotiated in conjunction with the vertical offset [“drop”] of the hitch), particularly remembering a recurring experience at a service center ramp in the Tampa, FL area.

This hitch receiver was later returned to Winnebago facilities for examination. ODI’s representative photographed the removed hitch receiver during an inspection conducted on June 21, 2011. This visit had been scheduled primarily to review the vehicle associated with newly reported incident #2 (See Table 5) and secondarily to discuss the inspection of the hitch receiver from VOQ 10368002. Photograph 5 (below) illustrates longitudinal scrape marks on the bottom face of the center-mounted hitch receiver plate. These scrape marks are consistent with the owner’s account of occasionally dragging the tail of the vehicle when maneuvering over certain difficult / uneven road contours.

Photograph 5 - Bottom face of the hitch receiver plate that had been installed in the 2006 Winnebago Itasca vehicle described in VOQ 10368002.
