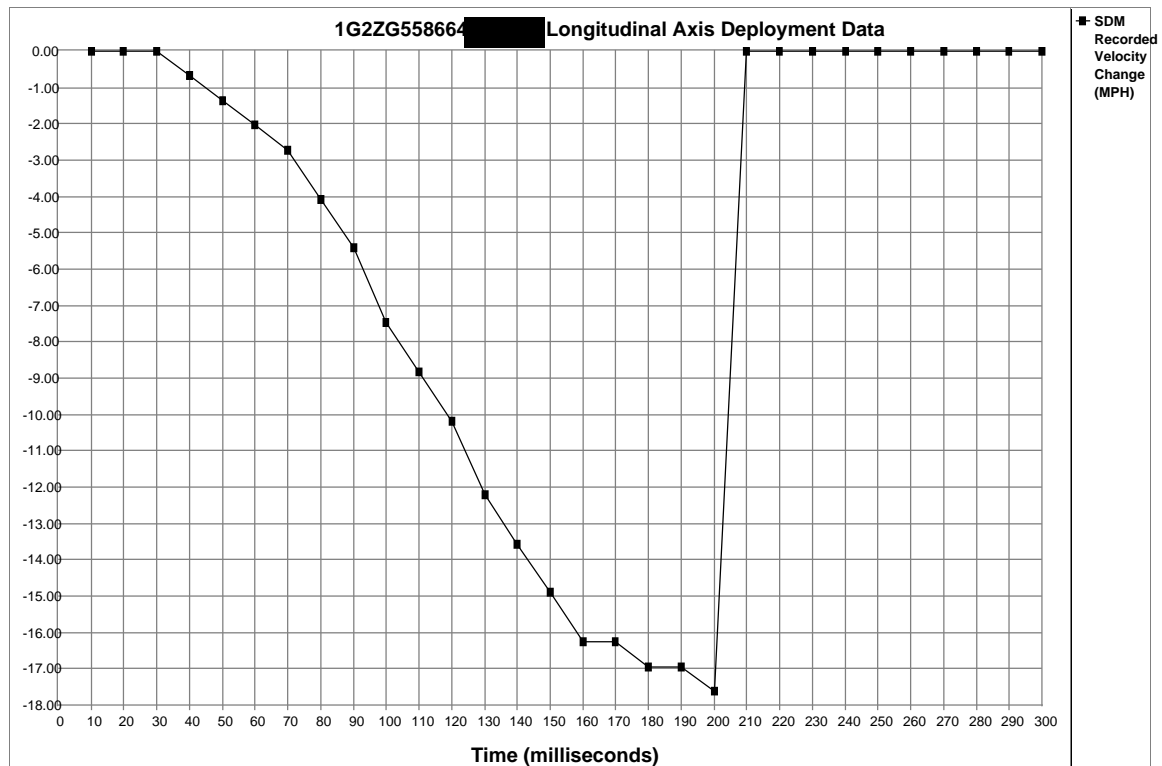
Time (milliseconds)	10	20	30	40	50	60	70	80	90	100	110	120	130	140	150
Longitudinal Axis Recorded Velocity	0.00	0.00	0.00	-0.68	-1.36	-2.03	-2.71	-4.07	-5.42	-7.46	-8.81	-10.17	-12.20	-13.56	-14.91
Time (milliseconds)	160	170	180	190	200	210	220	230	240	250	260	270	280	290	300
Longitudinal Axis Recorded Velocity	-16.27	-16.27	-16.95	-16.95	-17.62	0.00	0.00	0.00	0.00	0.00	0.00	0.00	0.00	0.00	0.00

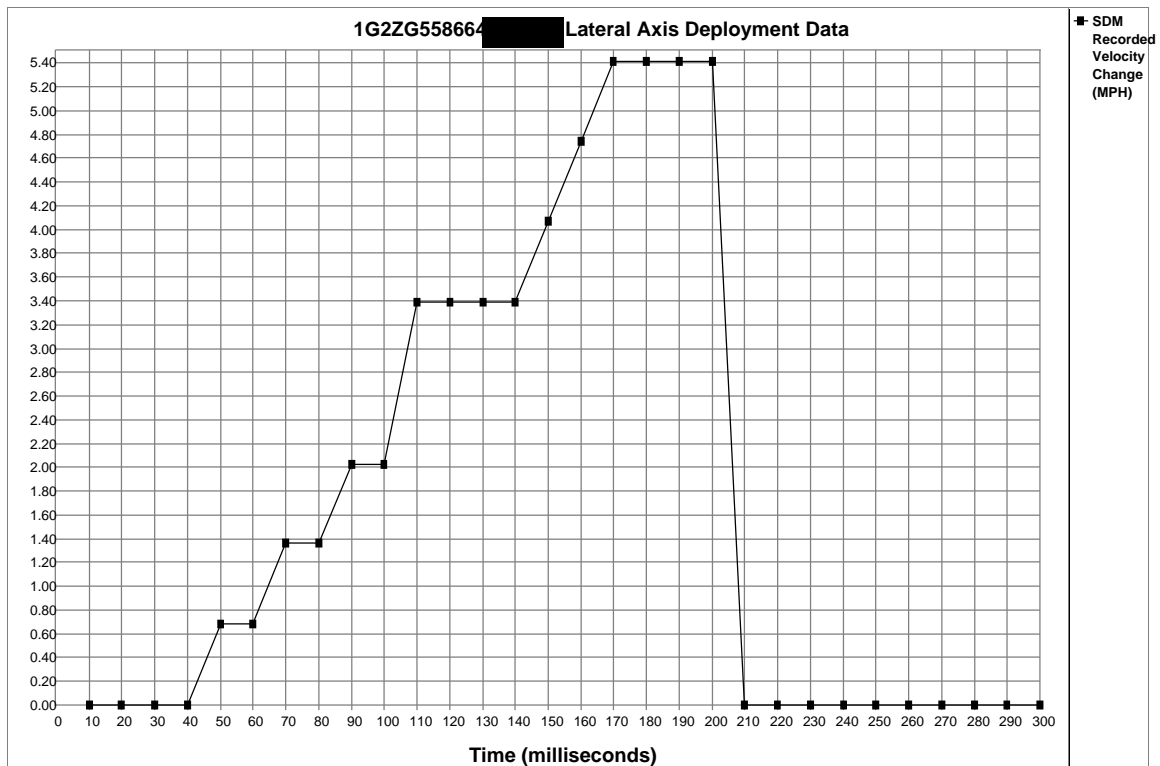
Time (milliseconds)	10	20	30	40	50	60	70	80	90	100	110	120	130	140	150
Lateral Axis Recorded Velocity Change (MPH)	0.00	0.00	0.00	0.00	0.68	0.68	1.36	1.36	2.03	2.03	3.39	3.39	3.39	3.39	4.07
Time (milliseconds)	160	170	180	190	200	210	220	230	240	250	260	270	280	290	300
Lateral Axis Recorded Velocity Change (MPH)	4.74	5.42	5.42	5.42	5.42	0.00	0.00	0.00	0.00	0.00	0.00	0.00	0.00	0.00	0.00

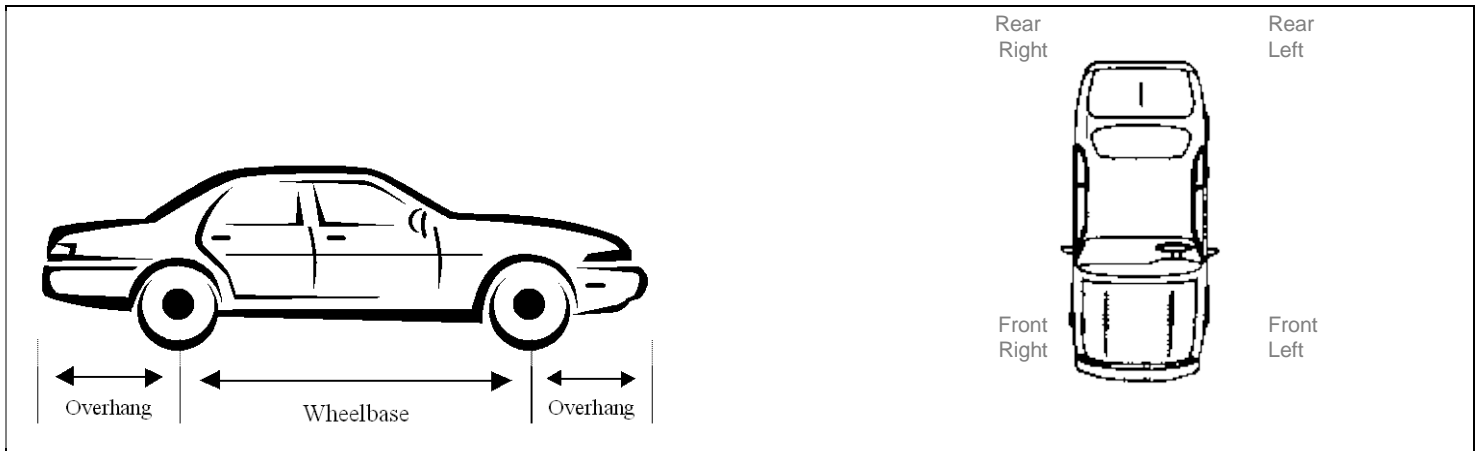
{
STRUCTURAL DEFORMATION - CRUSH AREAS

Underbody damage appears to be limited to that which is generally forward of the front of dash. There is no indication of impact from road surfaces or other ground impact.

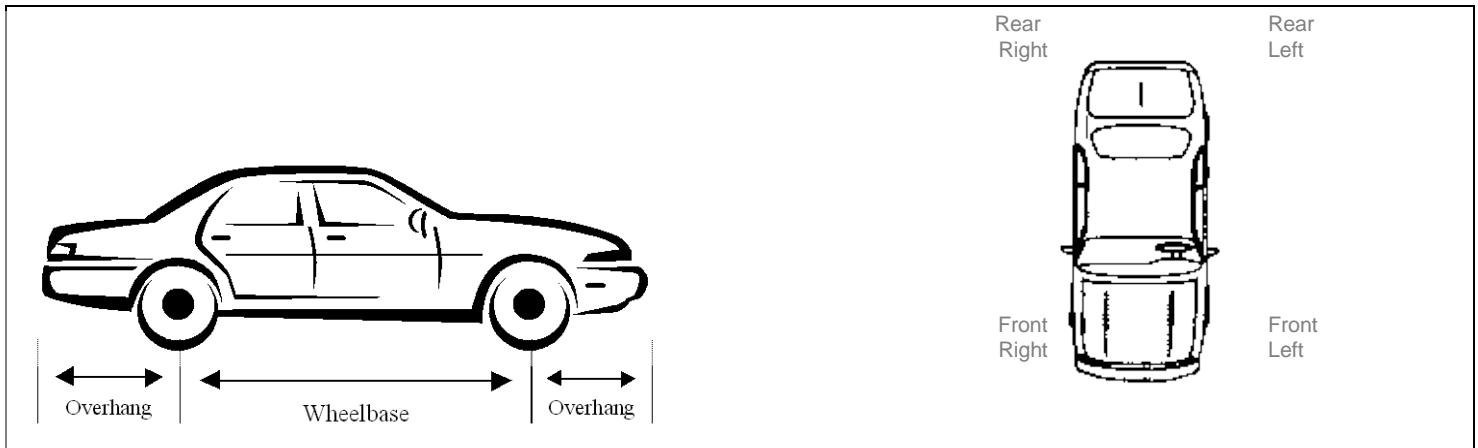
{
STRUCTURAL DEFORMATION - CRUSH AREAS

Underbody damage appears to be limited to that which is generally forward of the front of dash. There is no indication of impact from road surfaces or other ground impact.
