**Photo Log**  
**PAR 1-401424761**  
**1G1ZS52F05FXXXXXX**  
**Photographs by Donald J. Hutelin, EAA**  
**4/13/2006**

Vehicle Identification Number	1G1ZS52F05F [REDACTED]
Investigator	Donald J Hutelin, EAA
Case Number	1-401424761
Investigation Date	Thursday, April 13 2006
Crash Date	Saturday, March 25 2006
Filename	1G1ZS52F05F [REDACTED].CDR
Saved on	Thursday, April 13 2006 at 10:57:50 AM
Collected with CDR version	Crash Data Retrieval Tool 2.800
Collecting program verification number	9238B95E
Reported with CDR version	Crash Data Retrieval Tool 2.800
Reporting program verification number	9238B95E
Interface used to collected data	Block number: 00 Interface version: 4A Date: 11-08-05 Checksum: 7500
Event(s) recovered	Non-Deployment

Customer's Name: (REDACTED) Inspection Date: 4/13/2006  
 Vehicle Brand: Chevrolet Model: Malibu  
 File # 1-401424761 VIN: 1G1ZS52F05FXXXXXX

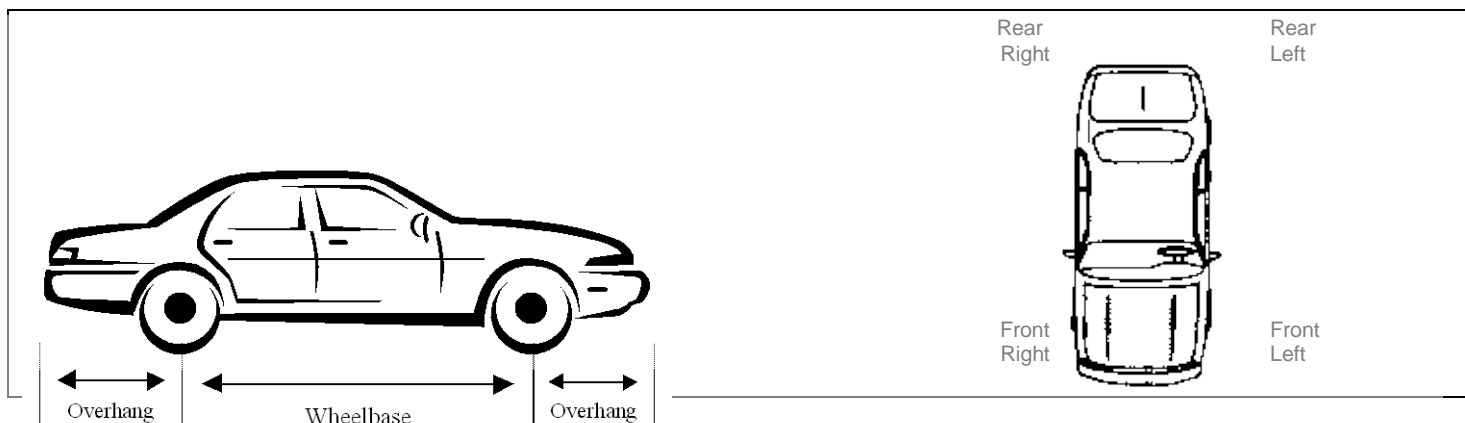
**STRUCTURAL DEFORMATION - CRUSH AREAS**

**Witness marks on underside of RF frame rail, rear of RF inner fender. RF shock tower damaged. Front control arms bent.**
