Service Request: 71-586274528

We would like to discuss your request for assistance regarding your 2005 Chevrolet Malibu MAXX, but we have been unsuccessful in our attempts to contact you.

**PRODUCT ALLEGATION RESOLUTION
PRELIMINARY INSPECTION
STEERING, SUSPENSION, AXLE, TIRE AND WHEEL SYSTEMS**

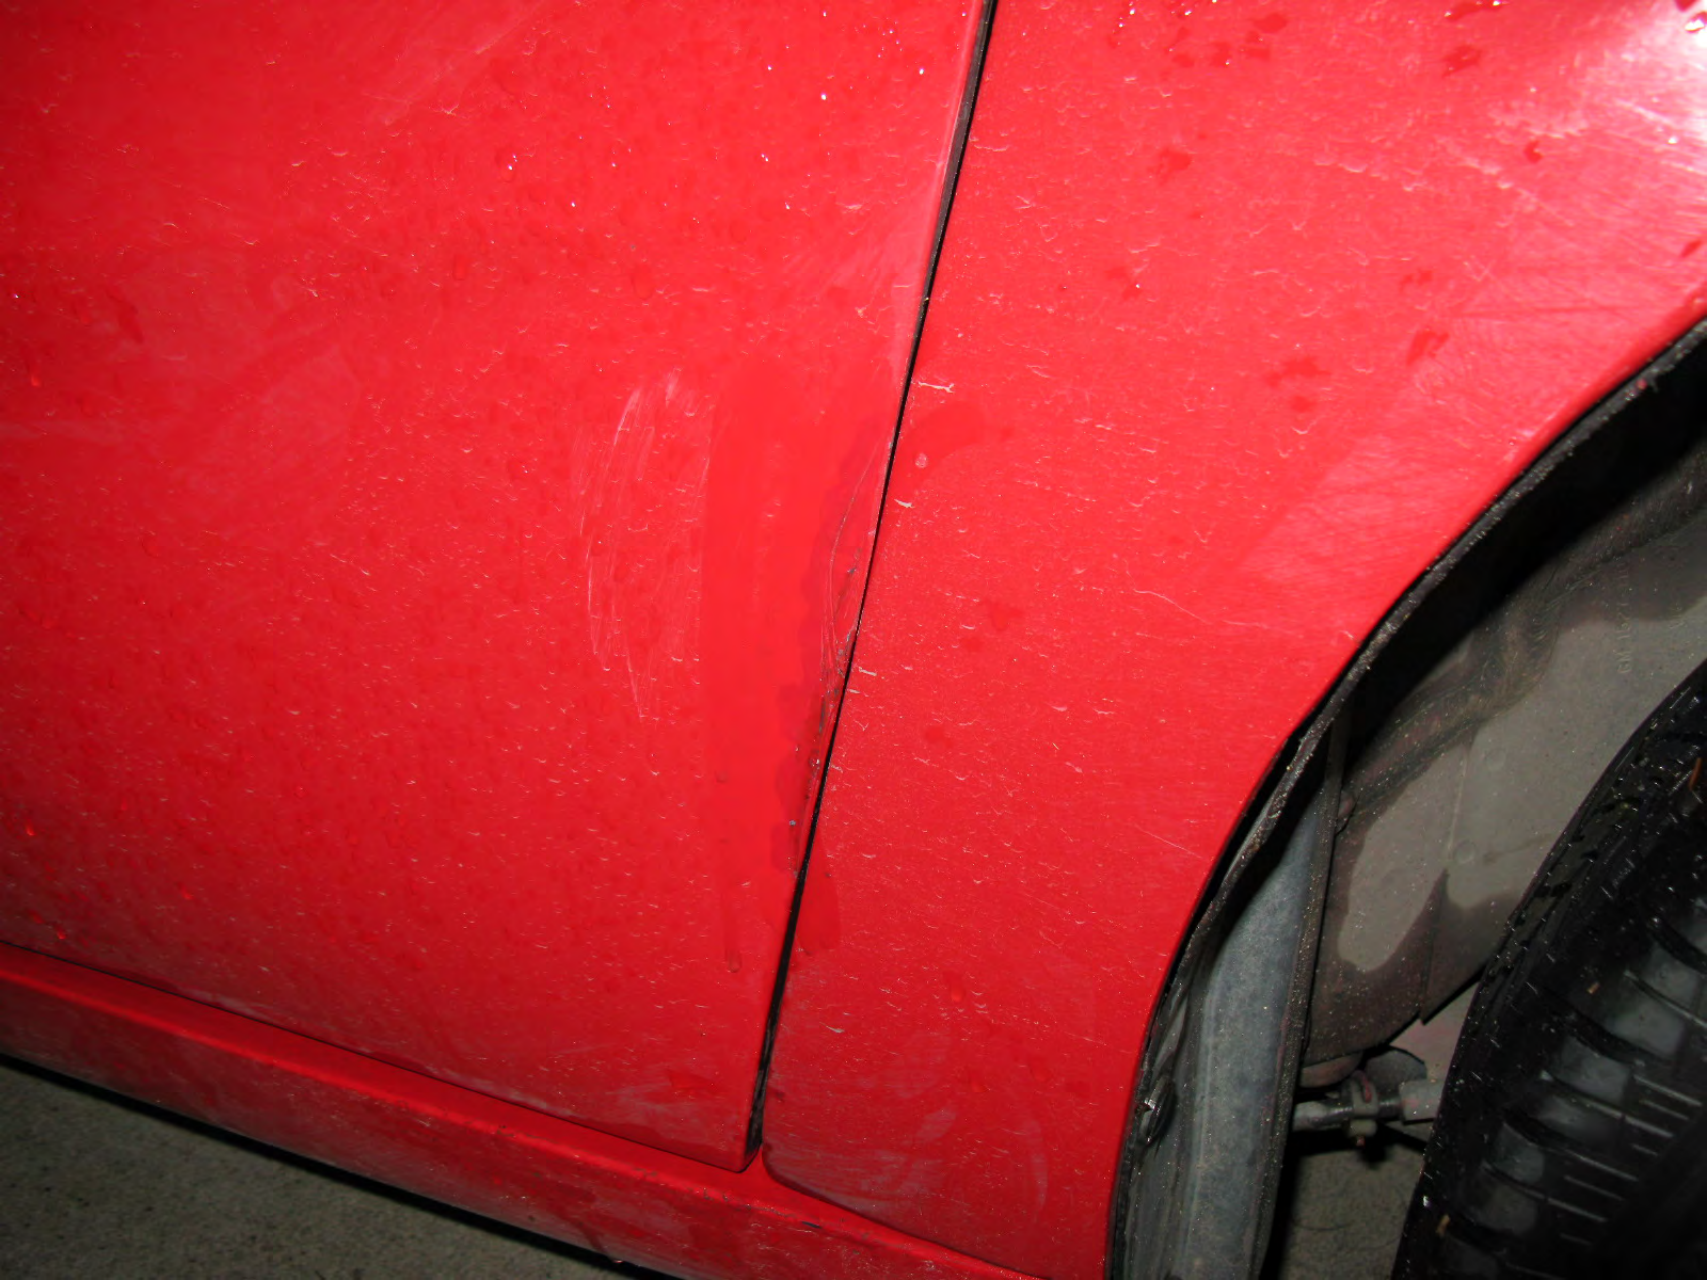
*Prior body repair
LR door edge*

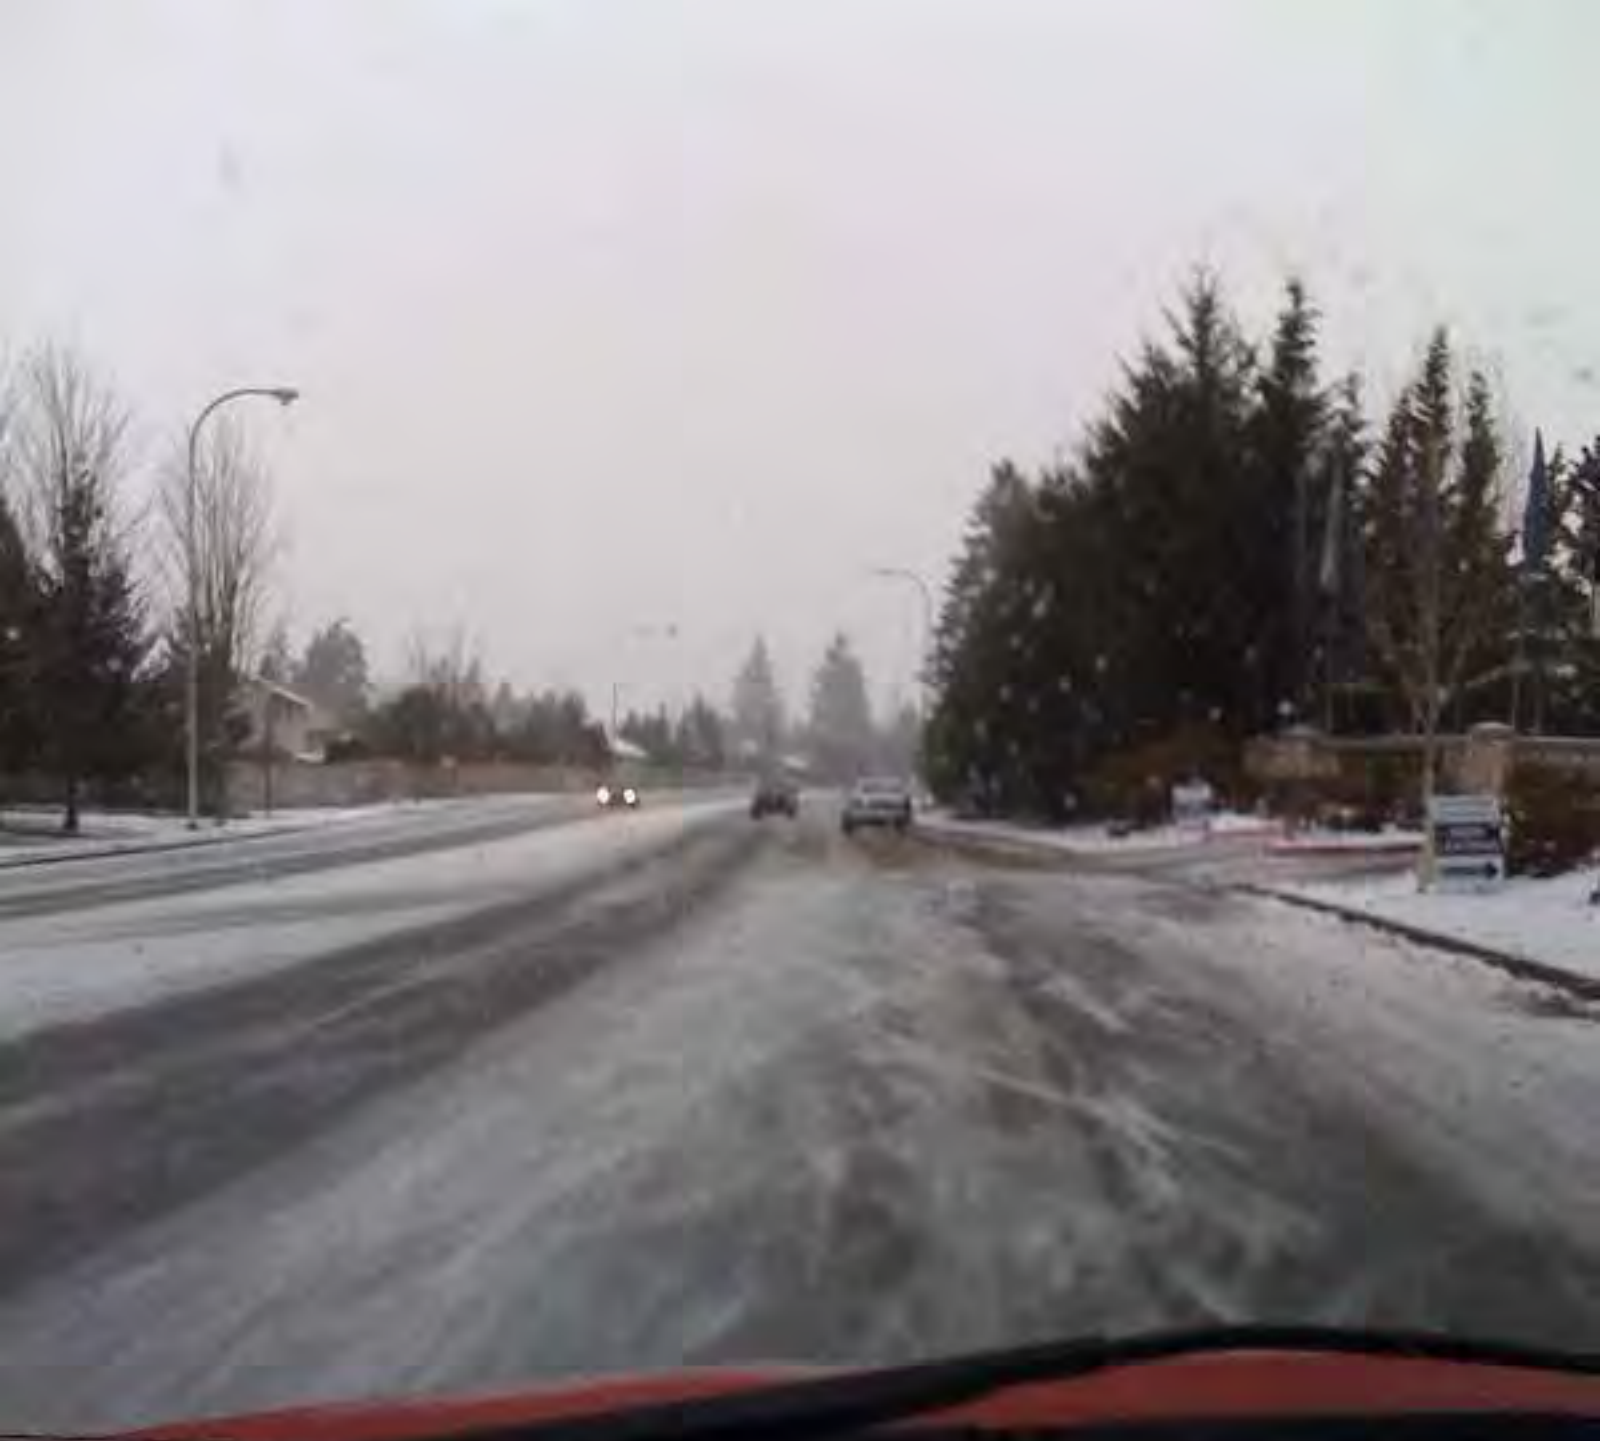
***Road condition day of incident
(photo by: Jasmine Quezada)***
