PE10-015

GM

ATTACHMENT 1

GM Investigation

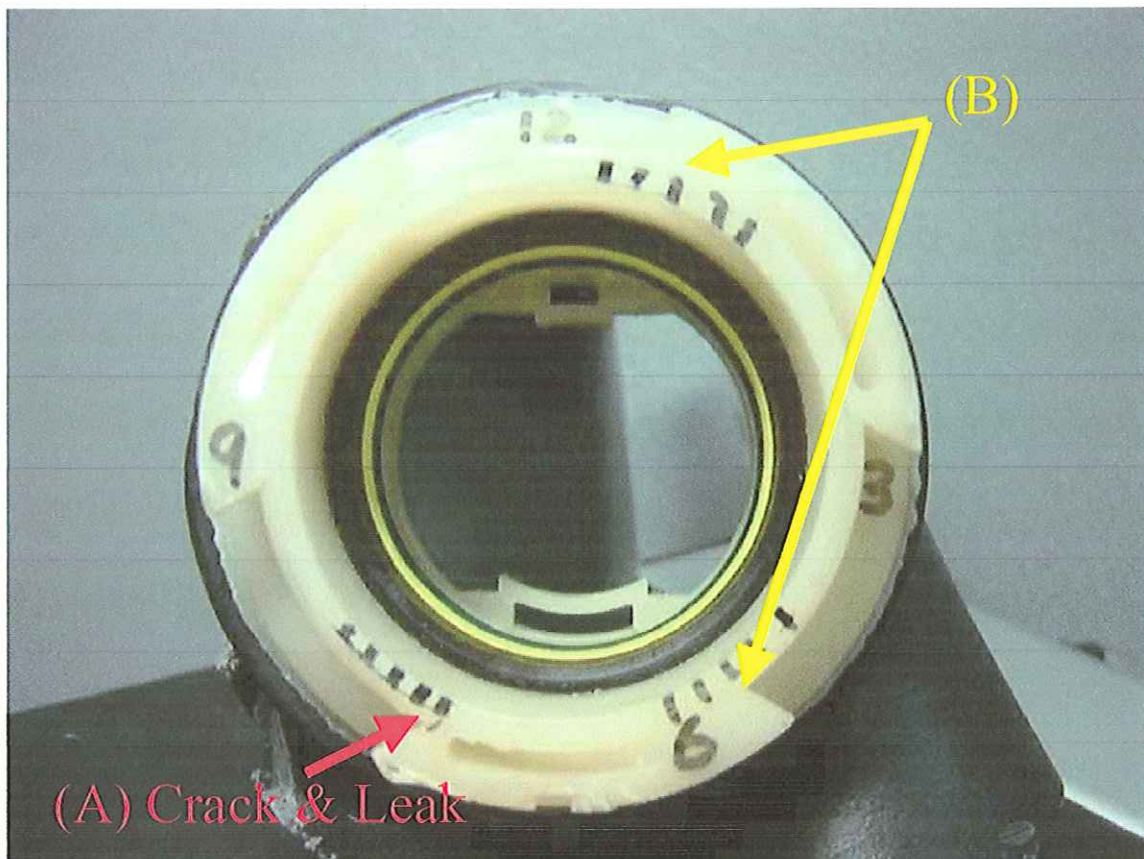
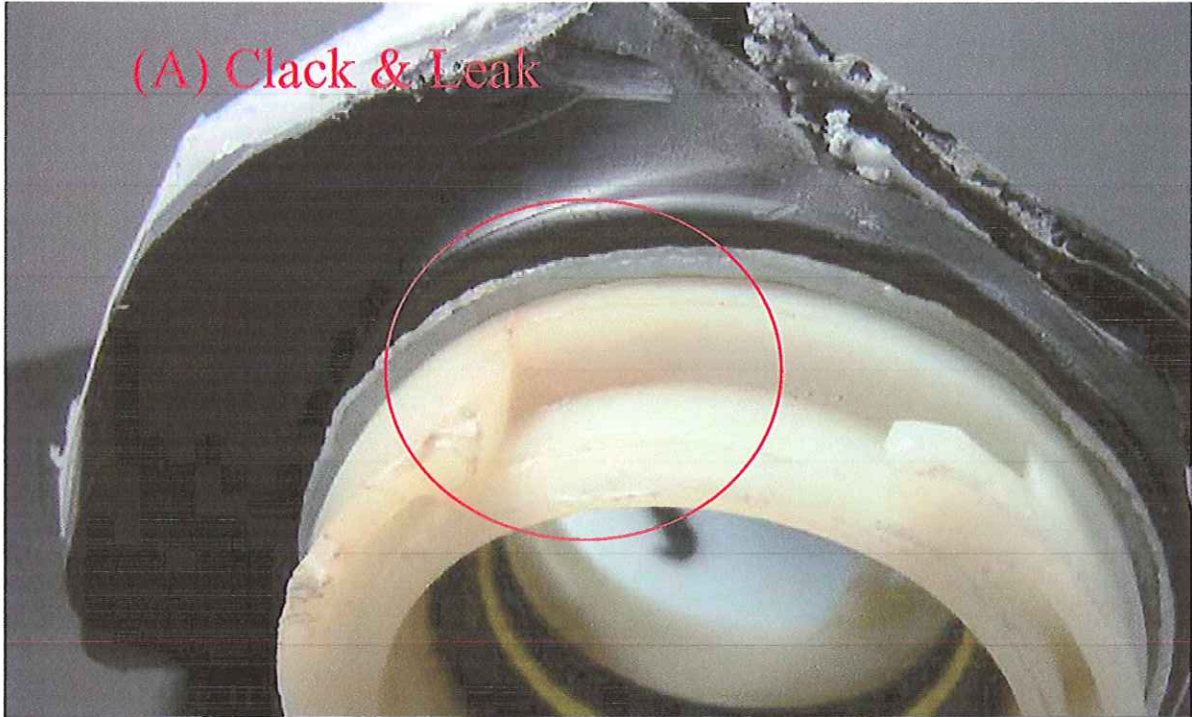
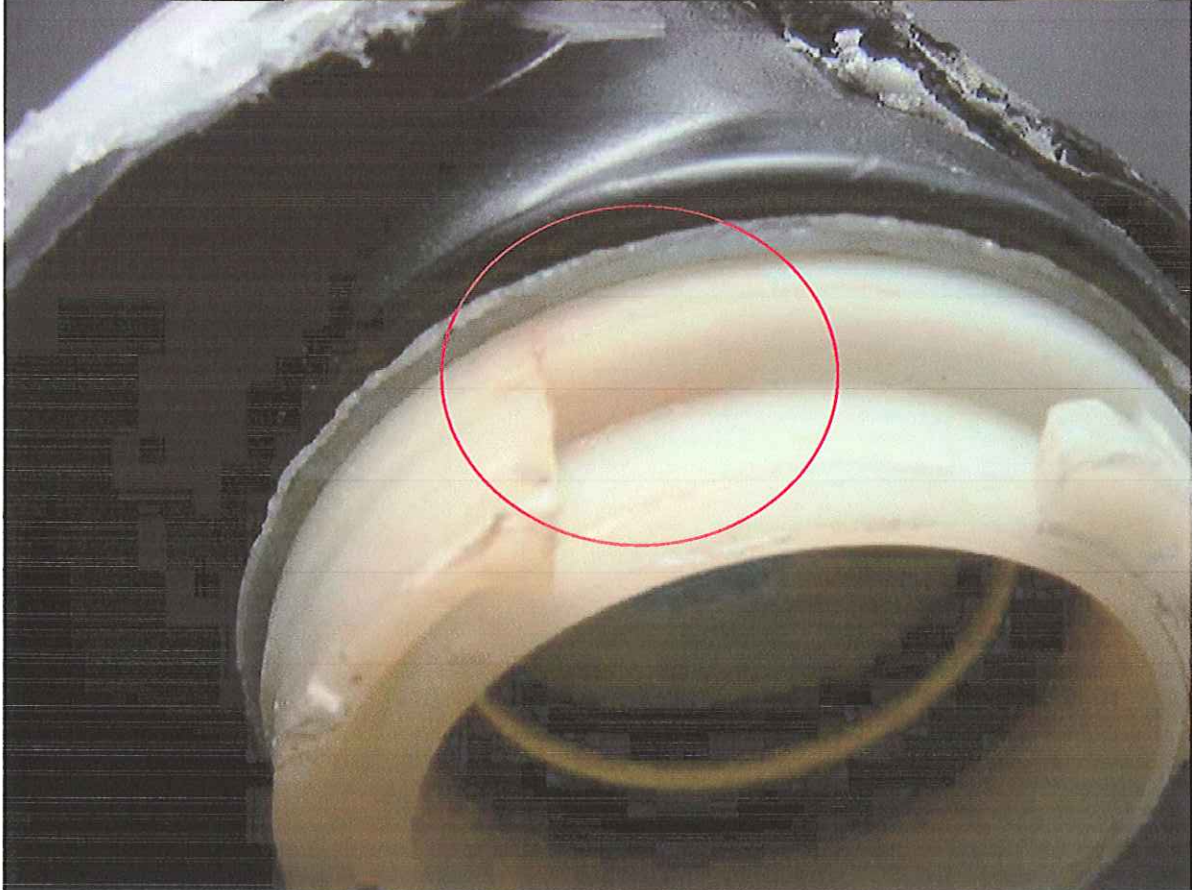
(A) Clack & Leak

(A) Actual leak was seems from the crack located between 9' and 6'.

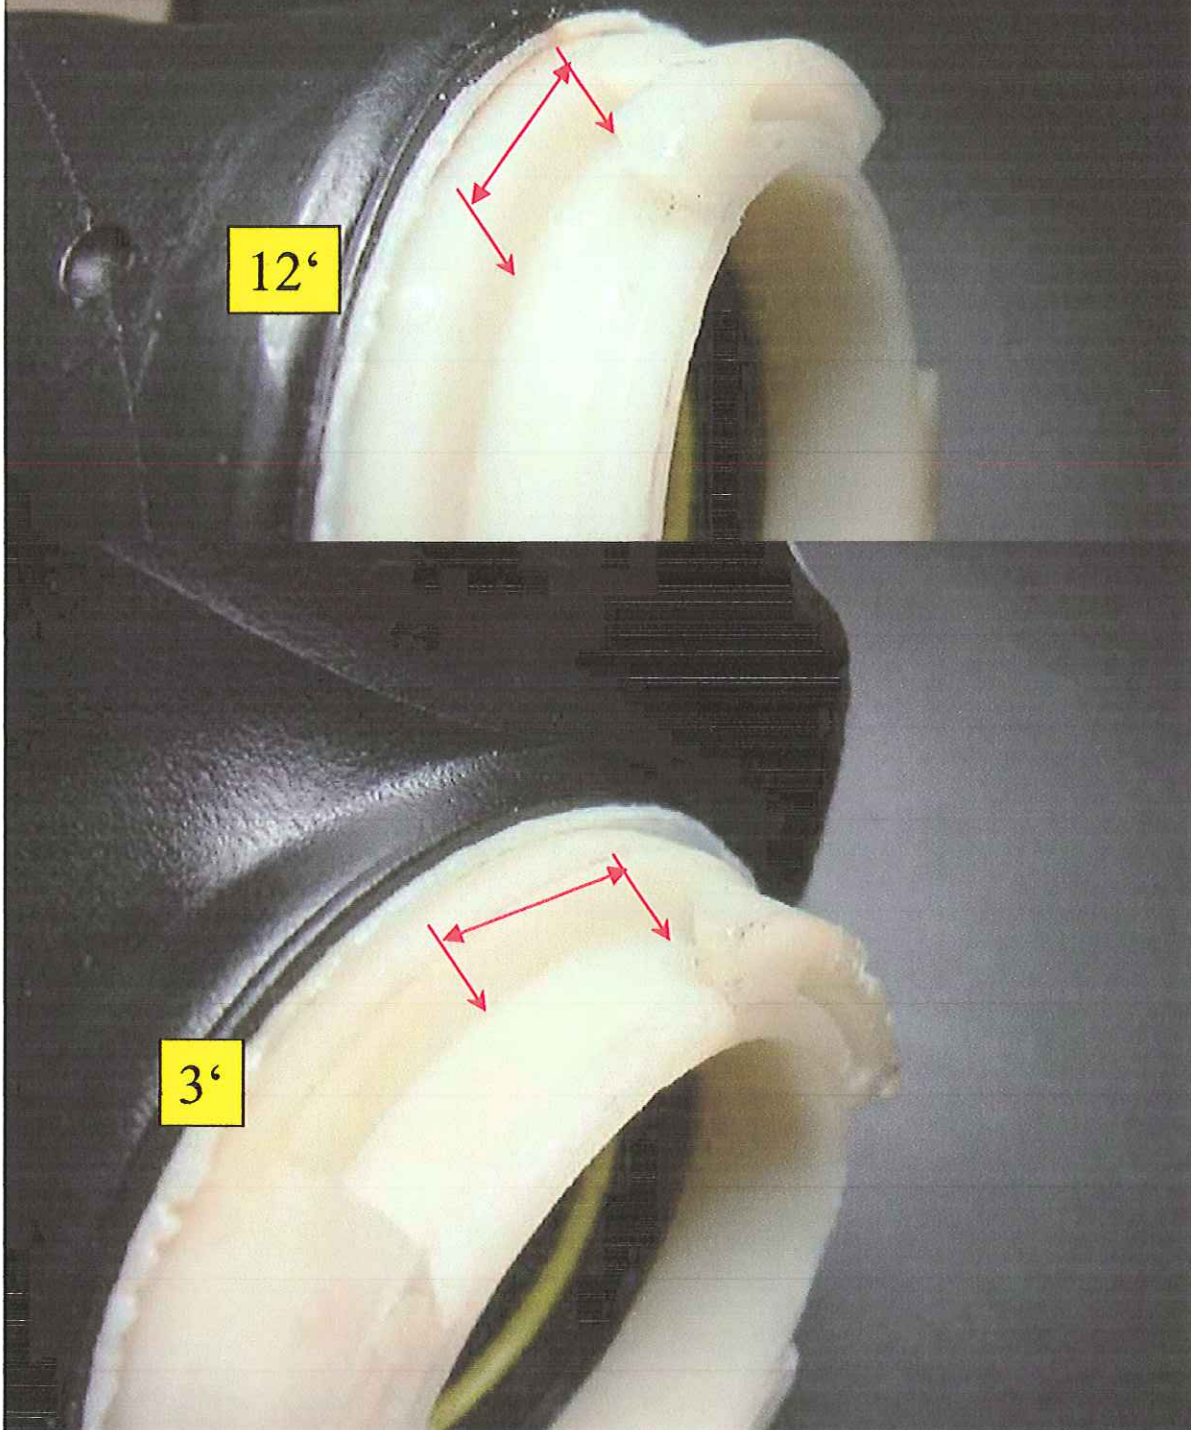
(B) Stretched markings

(B) There also stretched markings (white in color) at two additional locations between 12' & 3' and 3' & 6'.
