<u>Condition</u>: The 2" Quick Connect (Q.C.) which is used to interface the right and left hand fuel tanks via a Stainless Steel convoluted tube is cracking at the intersection of the weld flange & Q.C. body.

2004 MY Corvette/XLR Warranty

Fuel tank Replacement, L1281 15 Nov 2005

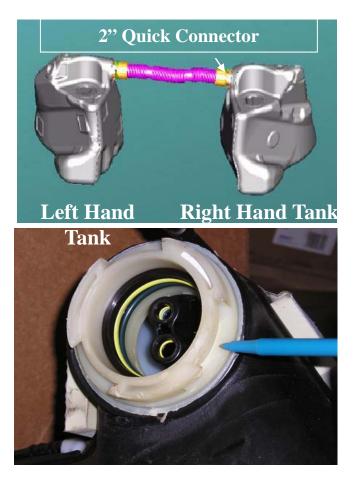
- The Condition is created by an interaction...
- All known failures are from the same lot of material, lot 2637.
- Suspect timeframe: 10/22/2003 3/16/2004
- Vehicle Population: ~ 15,109 vehicles
- •Total number of warranty claims ~ 931

✓ Failure originates as stress whitening

\checkmark Crack propagates over time due to temperature and fuel exposure
