**Title** CEM Fault Tracing

**Ref No** US16352.1.2 en-GB

SUBJECT: CEM harness terminal corrosion due to water entrance in plenum (Instruction for new harness installation)

Various electrical function and communication symptoms may occur in M/Y 2005-2006 vehicles caused by wet corrosion in the CEM connector.

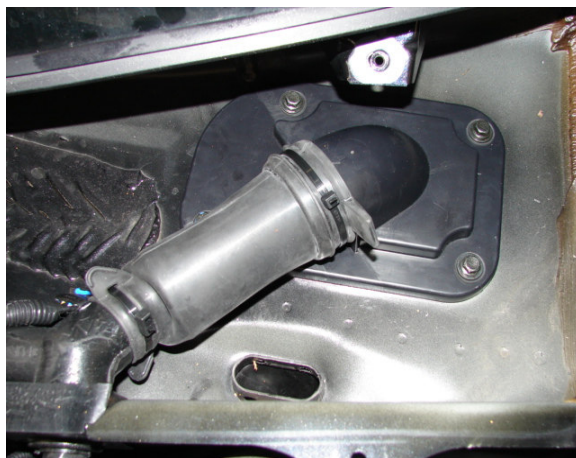
**Modified replacement  
harness**

**PRODUCT MODIFICATION:** A new plenum sealing strategy with integrated rubber grommet was introduced in production from 2005 week 45. See photo below. This new sealing strategy will be carried over to the replacement engine bay harnesses on the chassis numbers indicated, by modification of the replacement harness.

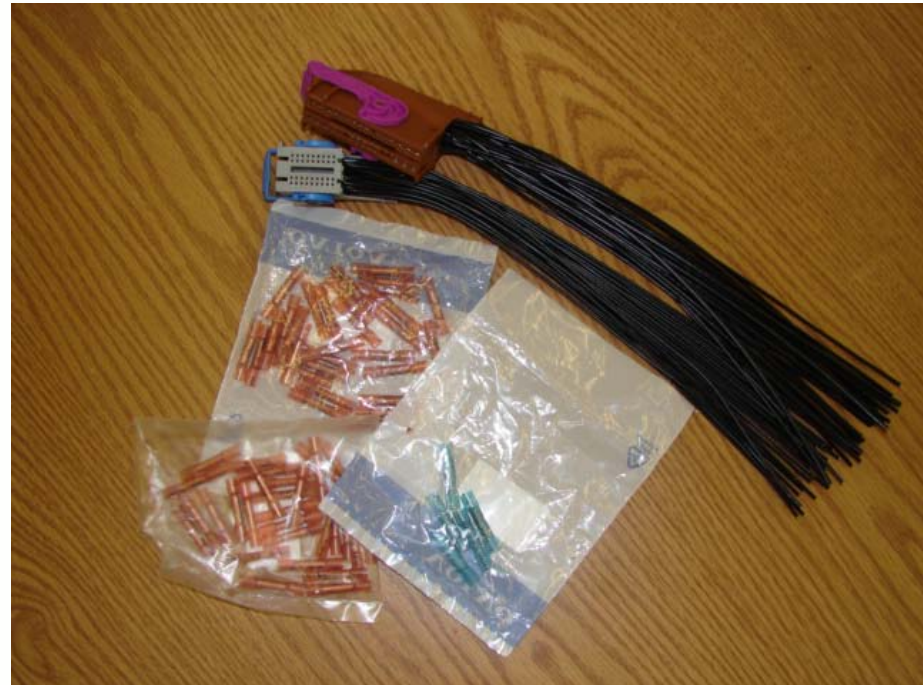
**DESCRIPTION: In the past we have replaced the Engine harness if water ingress has damaged the connector at the CEM.**

**Extensions with assembled connectors will be spliced into the engine harness instead of replacing the entire harness**

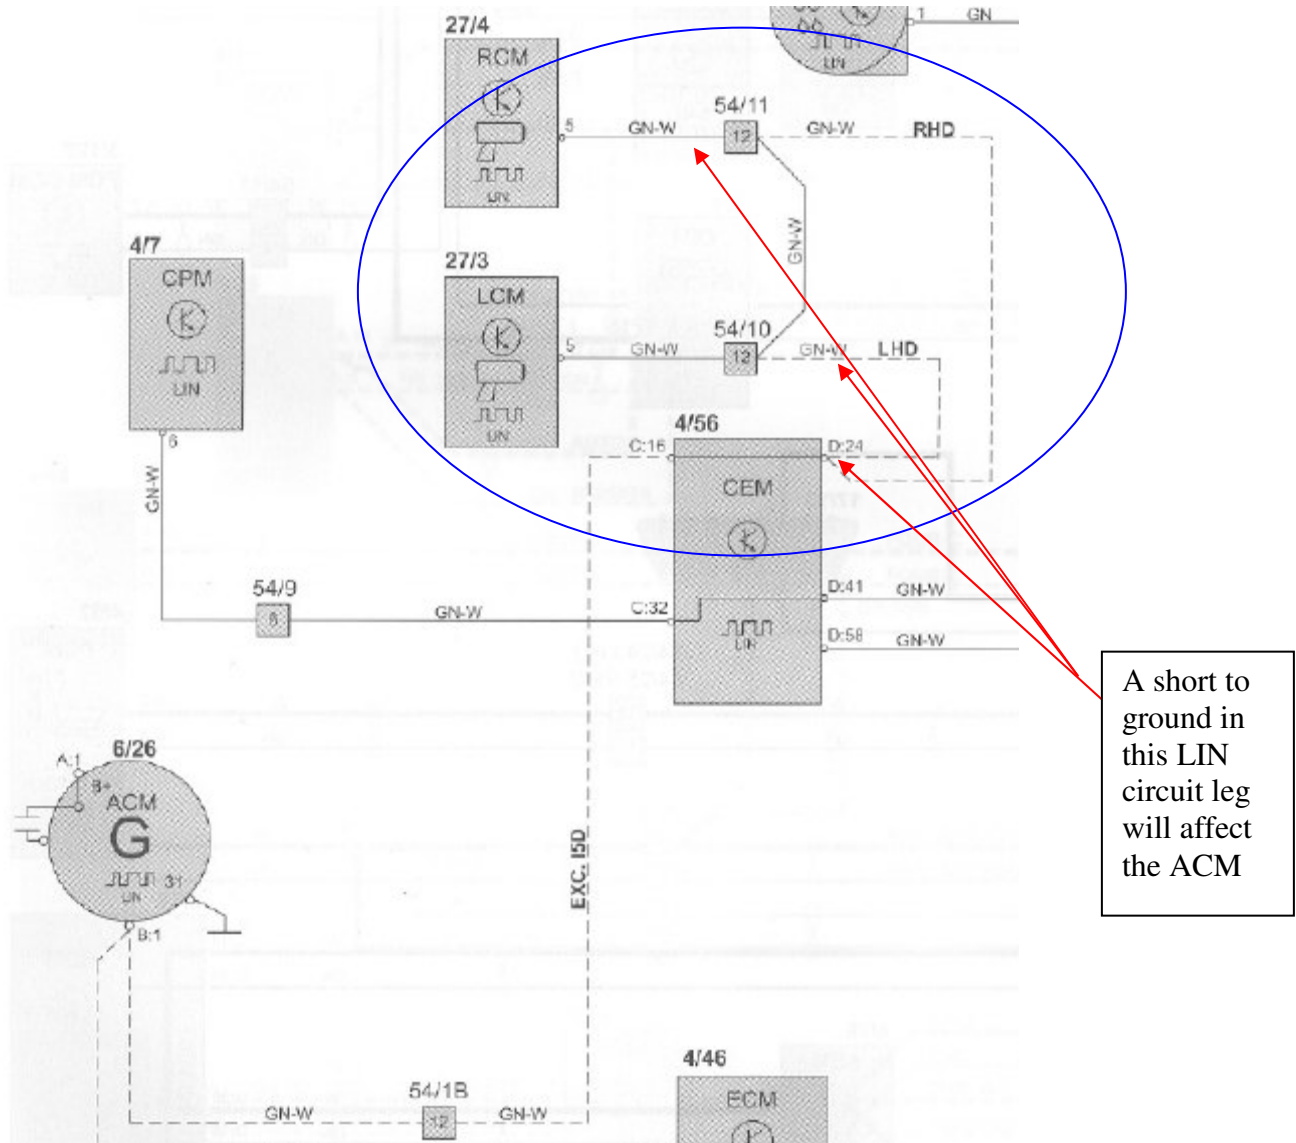
The LIN-bus is also connected internally inside the CEM (see updated wiring diagram). When fault tracing a CEM-DD21, please assure that the RCM and LCM circuits are not overlooked. The BLIS circuits are not indicated in the Wiring Diagram for MY2005, but have been corrected for MY2006.

If there is a short to ground in the circuit from CEM D24, repair the affected wiring as necessary.

If the DTC CEM-DD21 remains, perform normal fault tracing for the DTC per VIDA instruction.

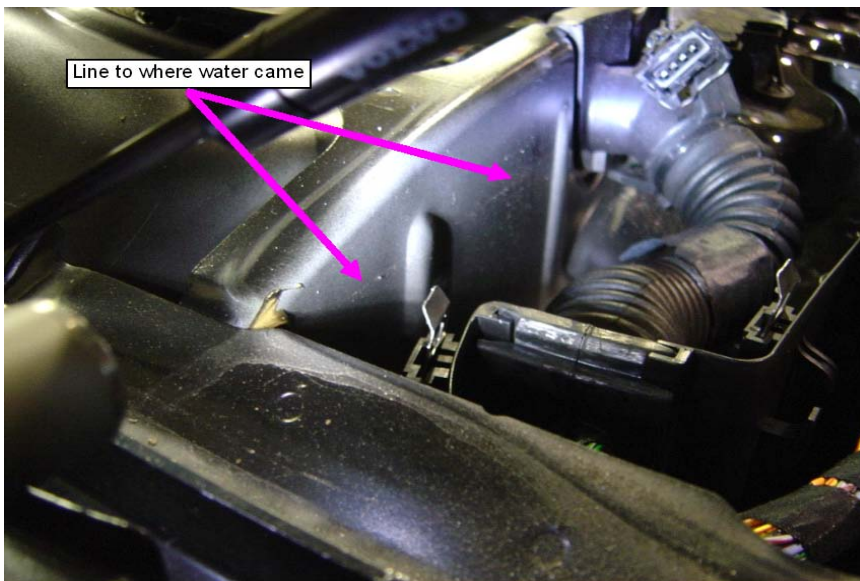
Line to where water came

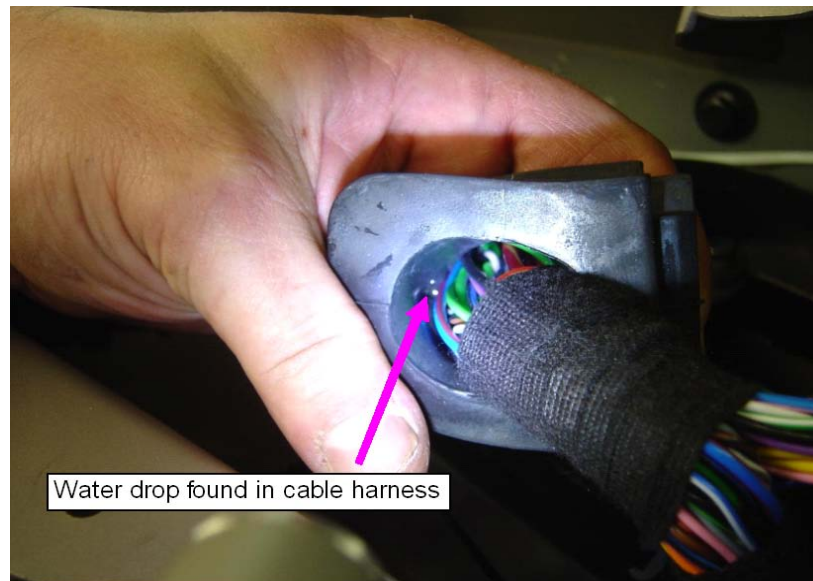
Water drop found in cable harness

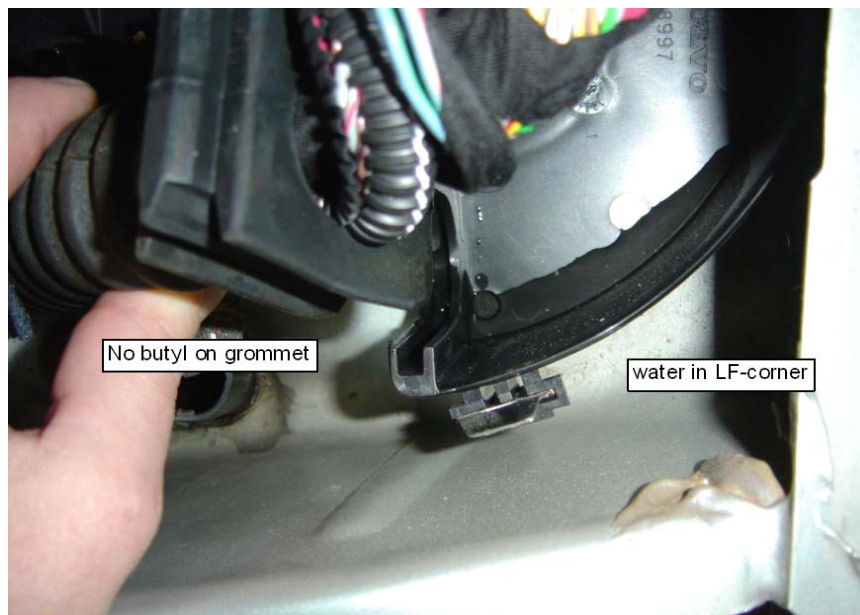
No butyl on grommet

water in LF-corner

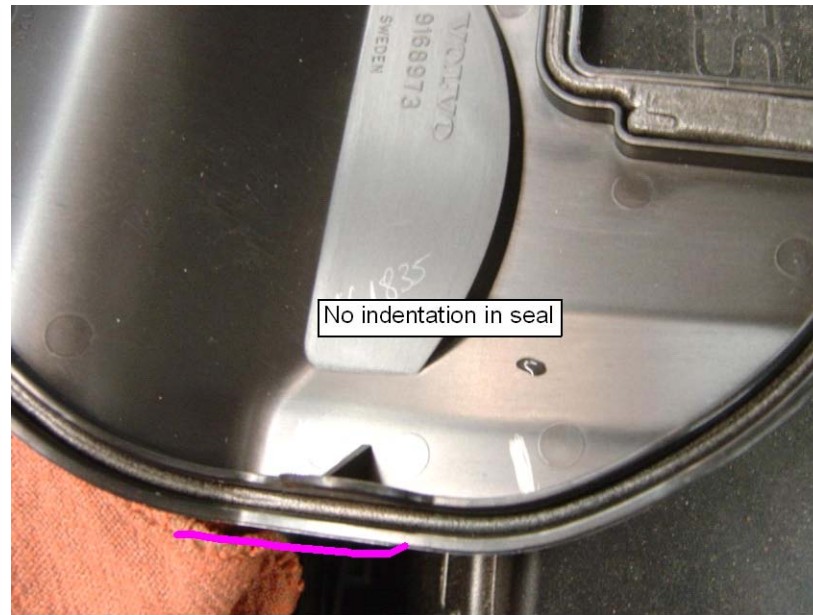
No indentation in seal

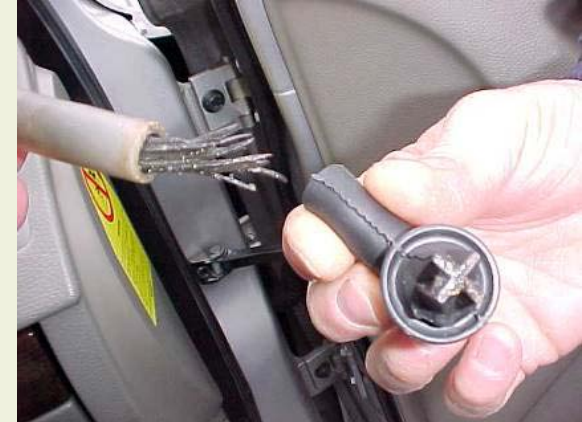
## Hose clogged

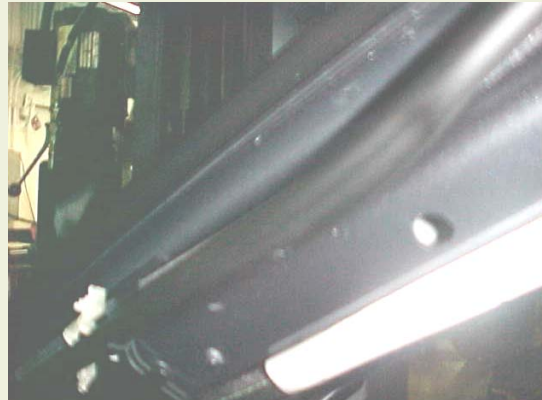
## Hose pinched

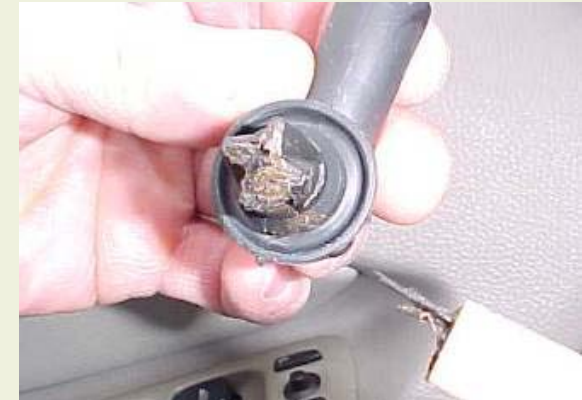
## Sound trap clogged

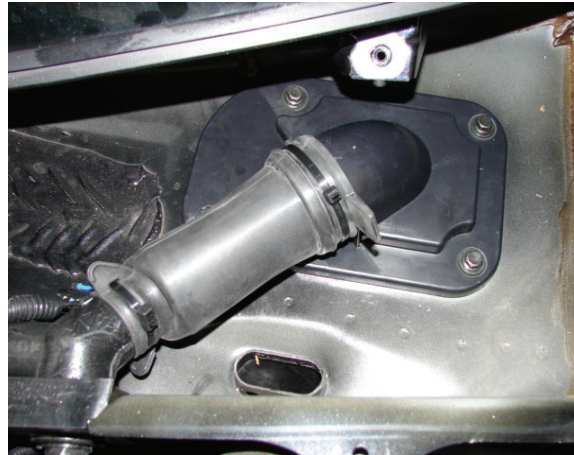
**Modified replacement harness**

**PRODUCT MODIFICATION:** A new plenum sealing strategy with integrated rubber grommet was introduced in production from 2005 week 40. See photo below. This new sealing strategy will be carried over to the replacement engine bay harnesses on the chassis numbers indicated, by modification of the replacement harness.
